## Electrostatic discharge impacts on the main shaft bearings of wind turbines

Zhao, J., Xu, X., Carlson, O. (2023). Electrostatic discharge impacts on the main shaft bearings of wind turbines. Wind Energy Science, 8(12): 1809-1819. <http://dx.doi.org/10.5194/wes-8-1809-2023>

Jian Zhao, Xiangdong Xu, and Ola Carlson

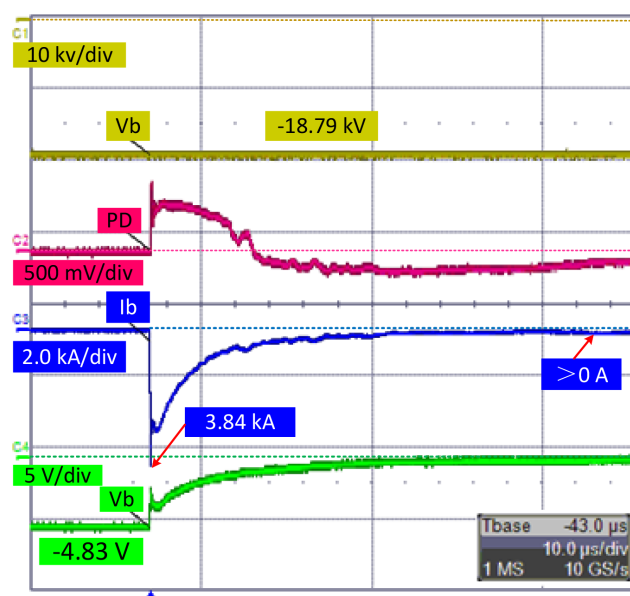
**Figure 22.** Bearing voltage and current at  $-18.79$  kV needle voltage.

Further increasing the charge density, the applied needle voltage was adjusted to  $-18.79$  kV. As indicated in Fig. 22, the induced shaft voltage reached  $-4.83$  V. The breakdown occurred in the bearing during rotation, with the current flowing through the bearing peaking at  $3.84$  kA. After the breakdown, the bearing's operating state reverted to a conductive state. There was a continuous current flow through the bearing, even after the voltage had dropped to nearly zero.

channels inside the bearing grease. From the test results shown in Fig. 22, it is obvious that, after the breakdown, the shaft voltage gradually dropped to nearly zero, but the current was maintained at a stable value.
