de Andrade Schwerz, C., Moverare, J., Sundar, V. et al (2024). Mechanical properties of Hastelloy X produced by laser powder bed fusion and affected by spatter redeposition. *Journal of Materials Research and Technology*, 29: 4200-4215.
<http://dx.doi.org/10.1016/j.jmrt.2024.02.150>

Mechanical properties of Hastelloy X produced by laser powder bed fusion and affected by spatter redeposition

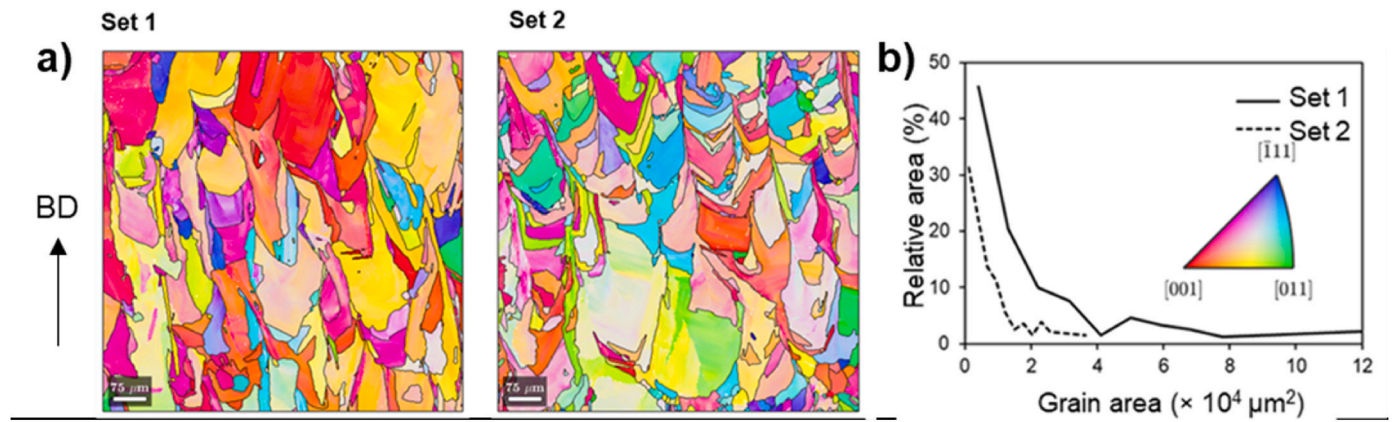
Fig. 2. (a) EBSD orientation maps along the build direction (BD) from the two sets. (b) Grain size distributions.

Electron backscattered diffraction was performed in selected specimens from set 1 and set 2. EBSD orientation maps originating from the two sets are presented below in Fig. 2a. In both maps, the typical appearance of melt pools and elongated grains can be discerned. Grain areas were measured in larger corresponding maps, thus allowing the comparison of grain size distributions, presented in Fig. 2b. It is noticeable that set 2 displayed a shift in the distribution toward finer grains, which is expected based on the process parameters used during manufacturing: the melt pool dimensions are similar in both sets due to the constant laser parameters (energy distribution profile, spot size, power and scan speed) [30]; however, the larger nominal layer thickness in set 2 allows smaller volumes of material to be re-processed, thus restraining the epitaxial grain growth typically observed in additively manufactured materials [18].
