Research report 2024:04

# **Towards improved regulations and procedures for damaged wheels – Assessment of wheel impact load detectors**

Department of Mechanics and Maritime Sciences  
CHALMERS UNIVERSITY OF TECHNOLOGY  
Göteborg, Sweden 2024

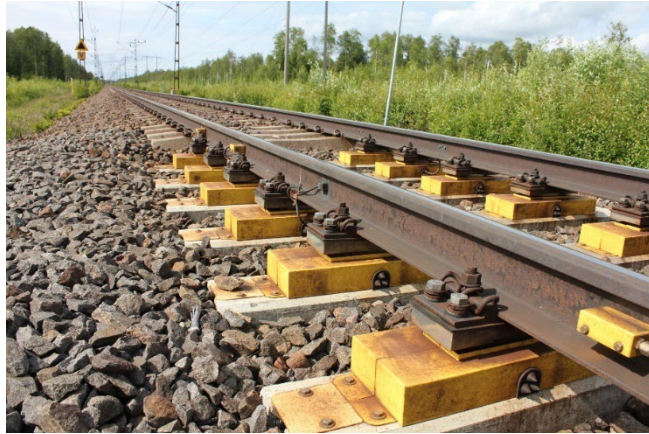
Figure 2.1 (a) Wheelscan1 detector by Schenck. Photo by Matthias Asplund, Trafikverket. (b) Positions of rail acceleration measurements within, and adjacent to, the Wheelscan1 detector at Sunderbyns sjukhus [6]. (c) Impact hammer and accelerometer [6]. (d) Measured rail acceleration and coherence at selected positions.

The Wheelscan detectors, cf. Figure 2.1(a), consist of eight weighing sleepers, electrical equipment and a workstation for data processing [5]. Each weighing sleeper is equipped with two weighbeams (one below each rail). These beams are used to measure the vertical wheel loads (sum of static and dynamic loads) using strain gauges. There are two generations of Wheelscan detectors (Wheelscan1 and Wheelscan2). The first generation is characterised by deeper sleepers, which led to difficulties in performing track maintenance activities such as tamping. This resulted in undesired track settlements and to the adoption of detectors of the second generation Wheelscan2.

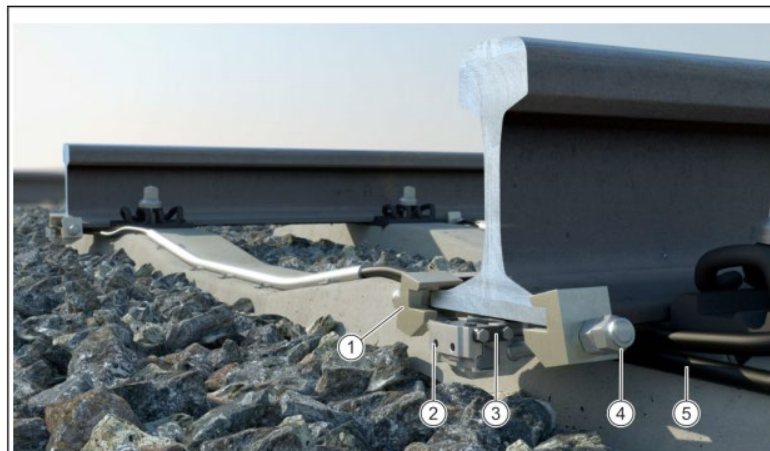
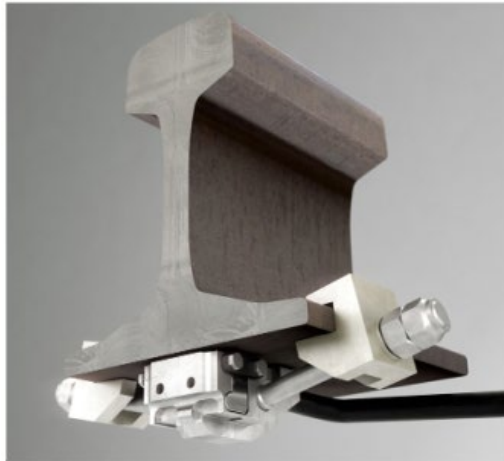
Figure 2.2 Fibre optic sensor installed under the rail of a zentrak detector. From [7].

Item	Description	Item	Description
1	Sensor clamp	4	Lock nut
2	Sensor	5	Fibre optic sensor cable to FOC box
3	Sensor locking plate

The zentrak detectors, cf. Figure 2.2, are based on sixteen fibre optic load sensors (eight per rail) designed to measure the relative rail rotation at the bottom of the rail foot as a result of rail bending during the passage of a train wheel [7]. The rail sensor is calibrated when installed or moved. The advantage with optical sensors is that measurements are not influenced by external electromagnetic disturbances, and that the sensor itself does not emit electrical disturbances and therefore has no influence on other devices mounted nearby [7]. The sensors are connected to a site detector cabinet by means of fibre optic cables. As the optical sensors are clamped under the rail foot, zentrak detectors cannot be distinguished from the rest of the line as easily as the Wheelscan detectors, see Figure 2.2.

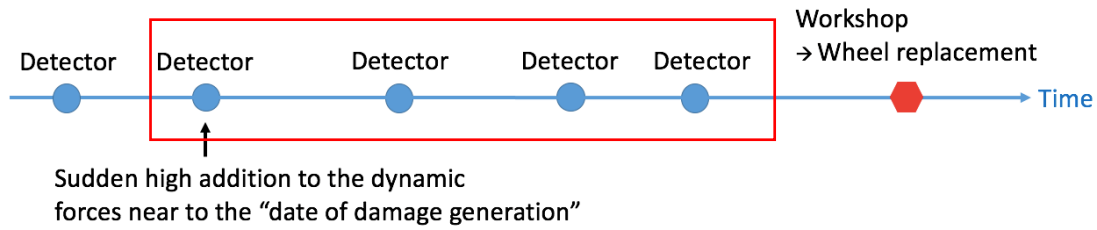
Figure 4.1 Timeline describing the approach used to extract detector data to be included in the analysis. In this example, data from four detector passages by the same wheelset were selected for the analysis. From [14].

All data from passages at train speeds below 40 km/h were filtered out since the RFID tag used for identifying wheelsets was not considered accurate for those speeds. Only the highest peak load per axle and detector passage was included in the analysis. The wagons in the analysis were either loaded or unloaded. The analysis of unloaded wagons consisted of wagons with axle loads in the interval 4.5 – 6 tonnes and speeds between 69 and 120 km/h. The number of detector passages with unloaded wagons was 645. The loaded wagons, on the other hand, had a range of axle loads between 17 and 25 tonnes and speeds in the interval 64 – 90 km/h. The number of detector passages for the loaded cases was 159. Figure 4.2 illustrates a summary of peak loads for all detector passages included in the analysis. Note that the blue line indicates the warning levels issued by Trafikverket. It is observed that most warning alarms were generated by unloaded wagons in the form of ratio alarms for wagons with axle loads of around 5 tonnes.

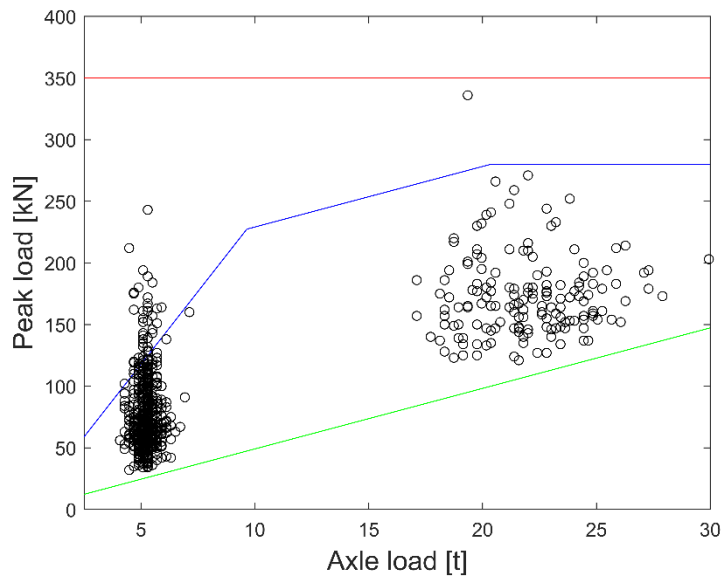
Figure 4.2 Influence of axle load [tonnes] on measured peak load for all 823 analysed detector passages. The red line is the ‘high’ alarm at 350 kN. The blue line indicates warning levels set by Trafikverket in terms of ratio (axle loads up to 10 tonnes), dynamic load (axle loads in the interval 10 – 20 tonnes) and peak load. The green line illustrates the relation between mean load and axle load. From [14].

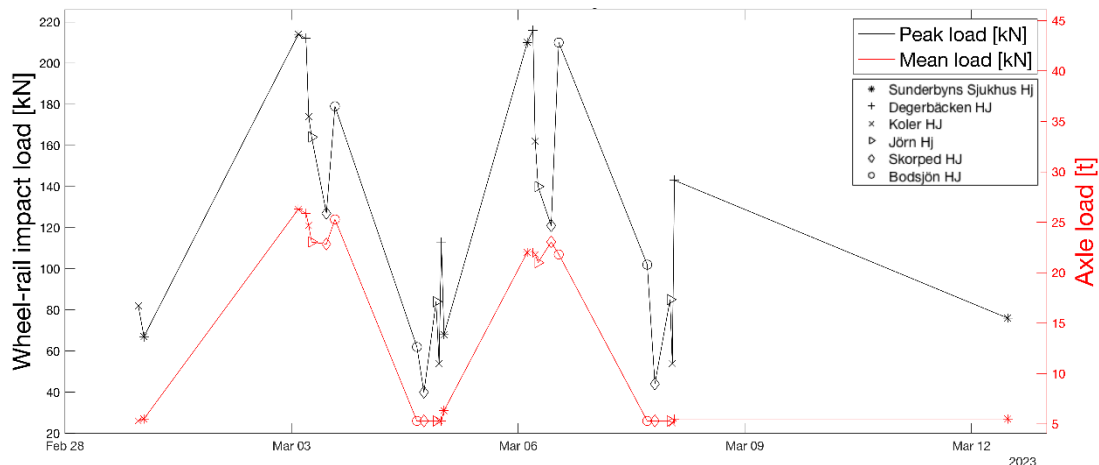
Figure 4.8 Peak loads and axle loads for one given wheel flat with length 75 mm measured in six WILDs along the route for Stålpendeln. From [14].

For a given 75 mm wheel flat among those studied in Sections 4.1 and 4.2, all registered peak loads and mean loads in six different WILDs along the route for Stålpendeln have been studied, see Figure 4.8. The presented data covers the period from when the flat was generated until the wheelset was taken out of service for repair. Two journeys in loaded conditions and three journeys in tare conditions are considered. A large variation in measured loads between different detectors during a given journey is observed. Further, a clear pattern in how the detectors measured relative to each other is noted, see for example differences in data from the detectors at Degerbäcken and Skorpéd. This indicates that besides the variation in speed and other influencing variables, the condition of the detectors might have affected the measured loads. For example, the time since calibration and measurement accuracy may vary between the individual detectors. Unfortunately, time histories from each wheel passage in the different detectors and the routine for post-processing of data are not available for a more detailed analysis of the measured loads.

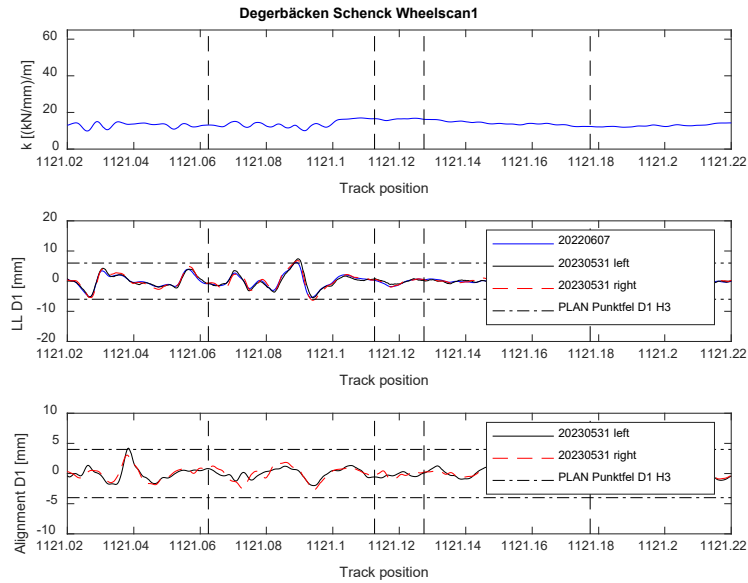
Figure 4.10 Foundation stiffness, longitudinal level (bandpass filtered 1 – 25 m) and alignment (1 – 25 m) measured over a distance of 200 m in the WILD at Degerbäcken. Blue curves were measured on 2022-06-07. Black (left rail) and red (right) curves were measured on 2023-05-31. The inner pair of vertical lines indicates detector area 1 (15 m), while the outer pair of vertical lines indicates detector area 2 (50 m on either side of detector area 1). Horizontal dash-dotted lines indicate suggested tolerances in terms of planned maintenance for tracks with maximum allowed speed up to 160 km/h. From [15].

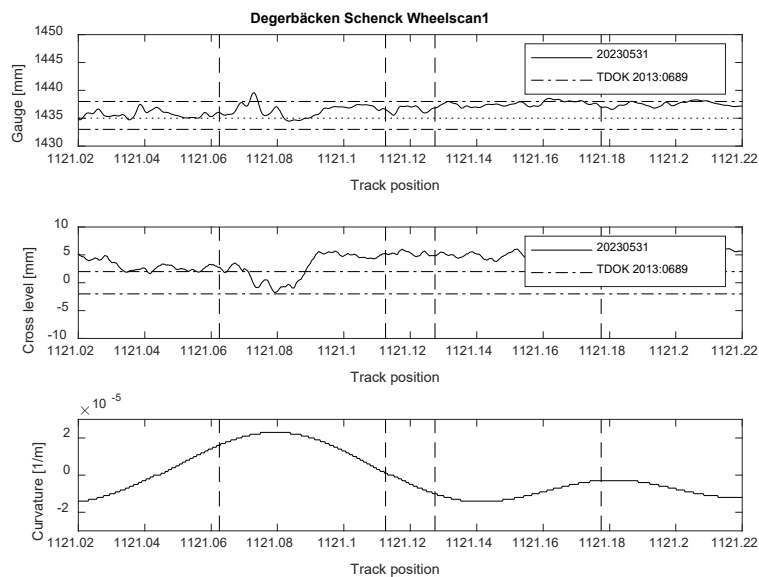
Figure 4.11 Gauge, cross level and curvature over a distance of 200 m in the WILD at Degerbäcken. The inner pair of vertical lines indicates detector area 1 (15 m), while the outer pair of vertical lines indicates detector area 2 (50 m on either side of detector area 1). Horizontal dash-dotted lines show tolerance limits according to TDOK 2013:0689. From [15].

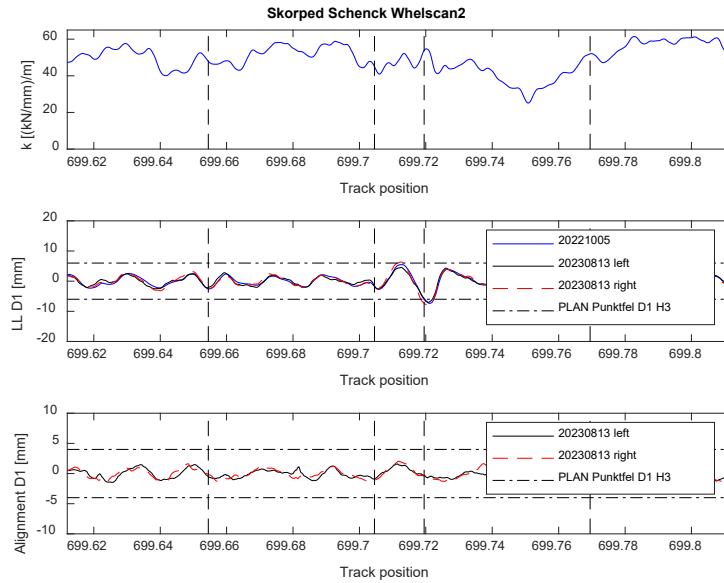
Figure 4.12 Foundation stiffness, longitudinal level (bandpass filtered 1 – 25 m) and alignment measured in the WILD at Skorped. Blue curves: 2022-10-05. Black and red curves: 2023-08-13. See also caption to Figure 4.10. From [15].

On the other hand, it is observed that the WILD at Skorped has irregularities within the detector area both in terms of track stiffness (although at much higher magnitudes), longitudinal level, alignment and cross level. In particular, the cross level exceeds the tolerance limit. Irregularities in track geometry could affect the vehicle dynamics while passing through the detector. The corresponding figures for the detectors at Sunderbyn, Koler, Jörn, Bodsjön, Mellansjö and Hållsta are presented in the Appendix. Note that the detector at Mellansjö is placed in a short tangent track section between two curves, see Figure A10. In summary, the calibration of the detectors, as well as the measured variations in track stiffness and track geometry at the detector sites might have contributed to the scatter in measured peak loads.

- Overall, the WILD at Skorped seems to measure correct mean loads both in unloaded and loaded vehicle conditions. According to Figures 4.12 and 4.13, irregularities in track geometry and track stiffness are present in the detector area. The variation in support conditions along the detector could have an influence on the vehicle dynamics and the accuracy of the detector.

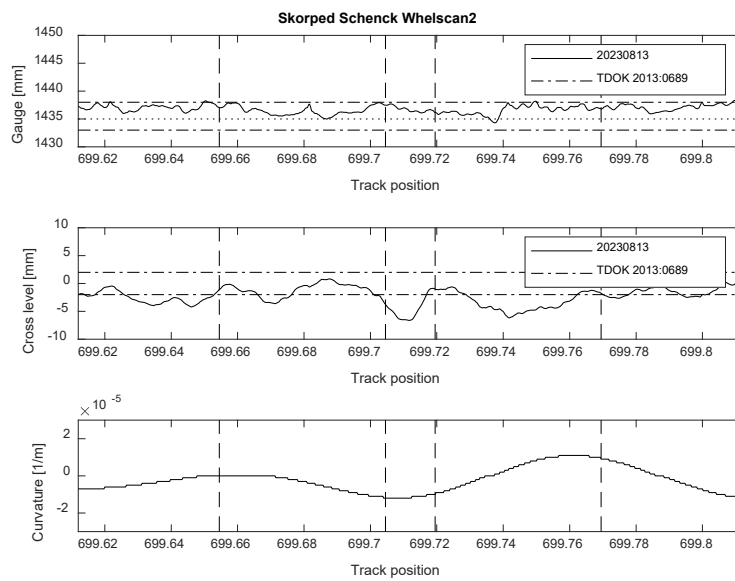
Figure 4.13 Gauge, cross level and curvature over a distance of 200 m in the WILD at Skorped. See also caption to Figure 4.11. From [15].

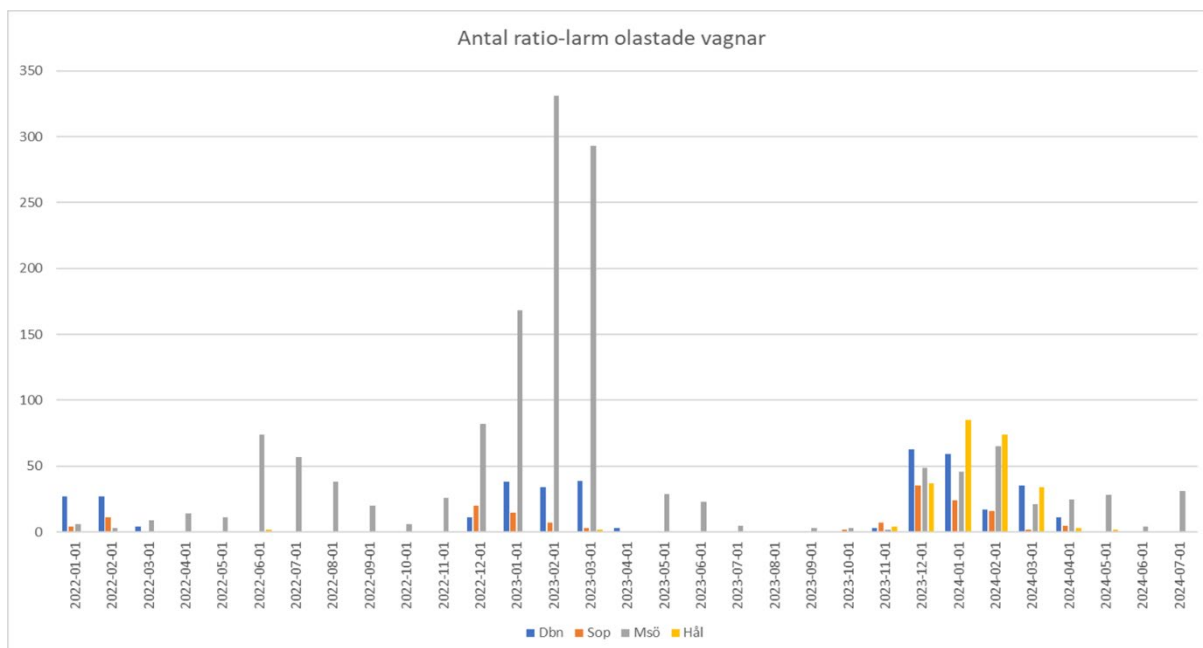
Figure 6.0 Number of alarms generated by both Y25 and NACO bogies in each of the detectors at Degerbäcken, Skorped, Mellansjö and Hållsta over the period from January 2022 to July 2024. Unloaded wagons.

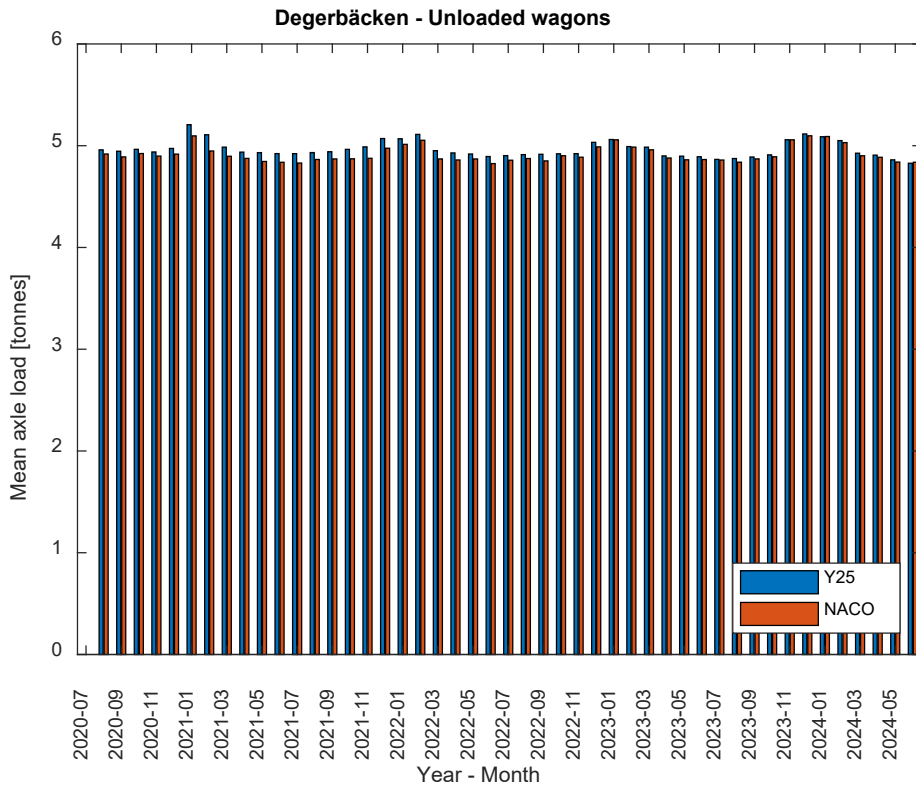
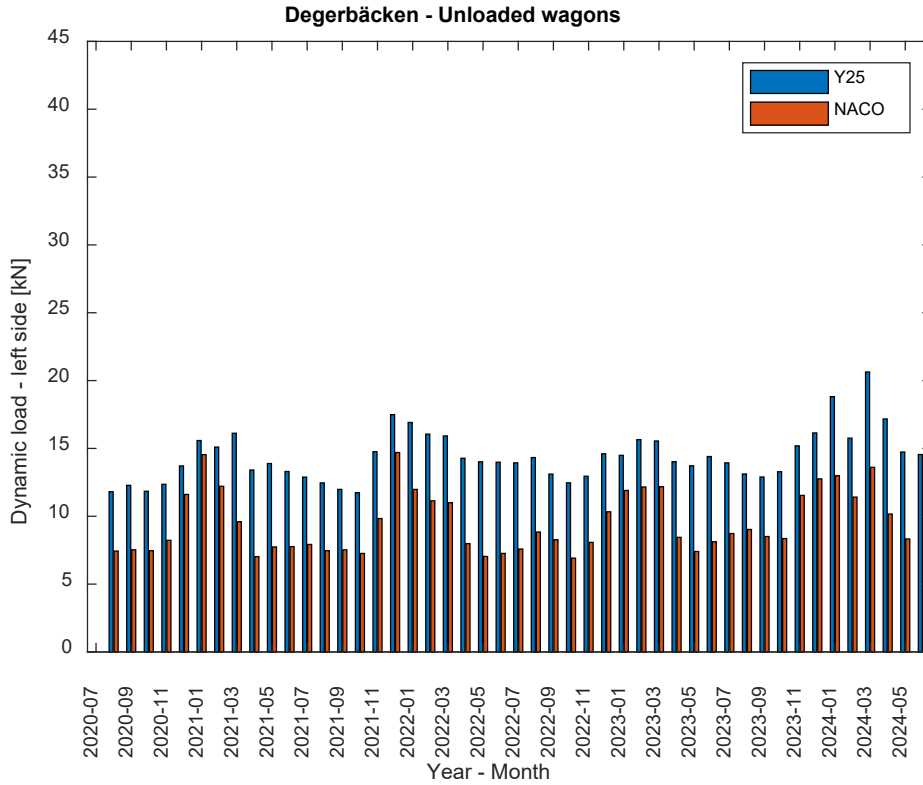
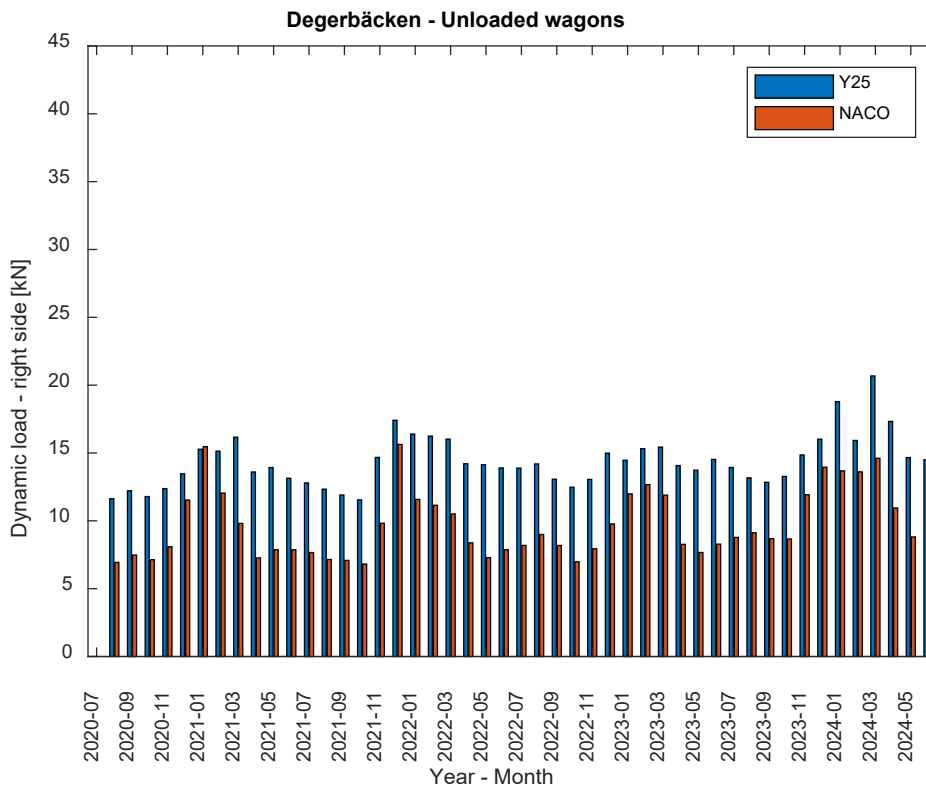
Figure 6.1 Long-term measurement in the Schenck detector at Degerbäcken – unloaded steel shuttle wagons: (a) Number of measured axles with either Y25 or NACO bogies, and mean vehicle speed. (b) Mean axle load. (c) Mean of dynamic loads per wheel – left side, (d) Mean of dynamic loads per wheel – right side.

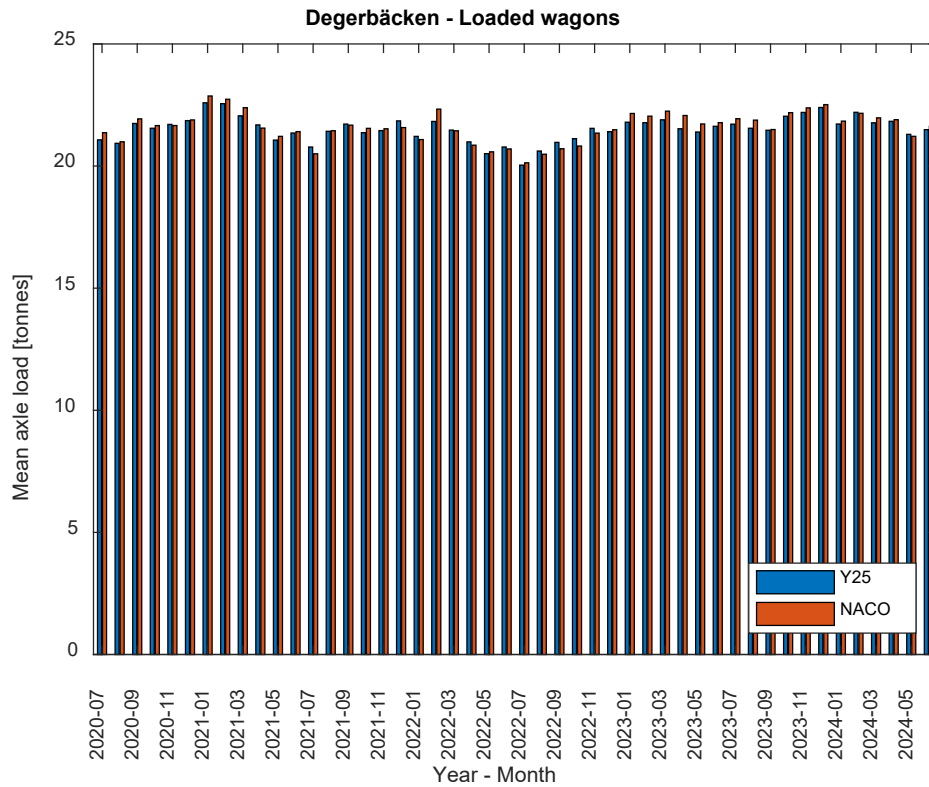
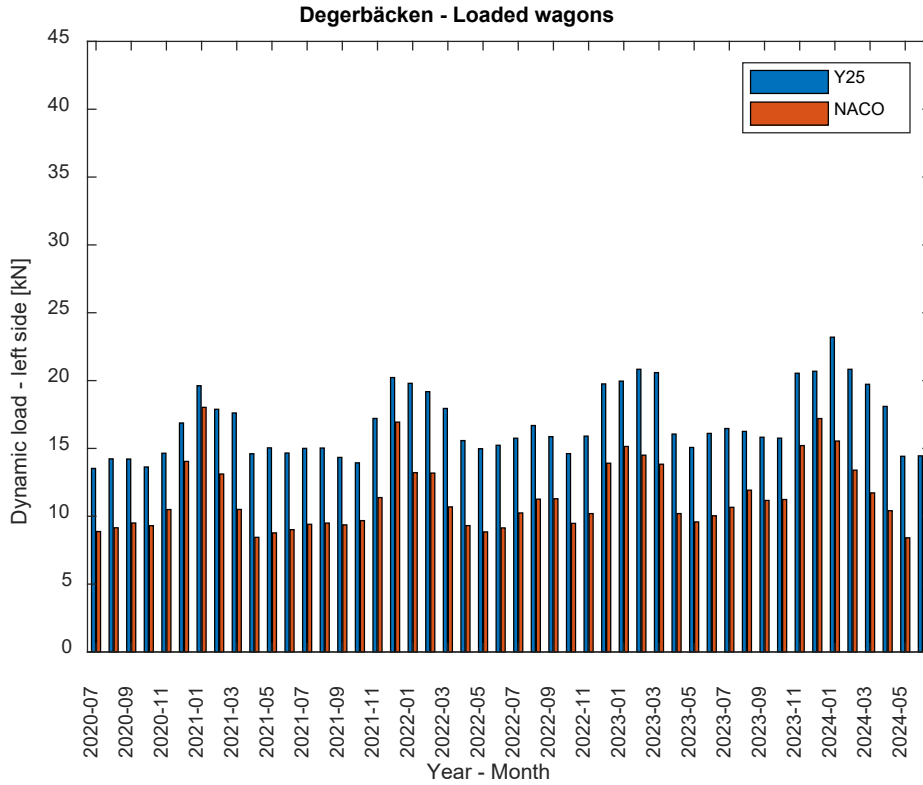
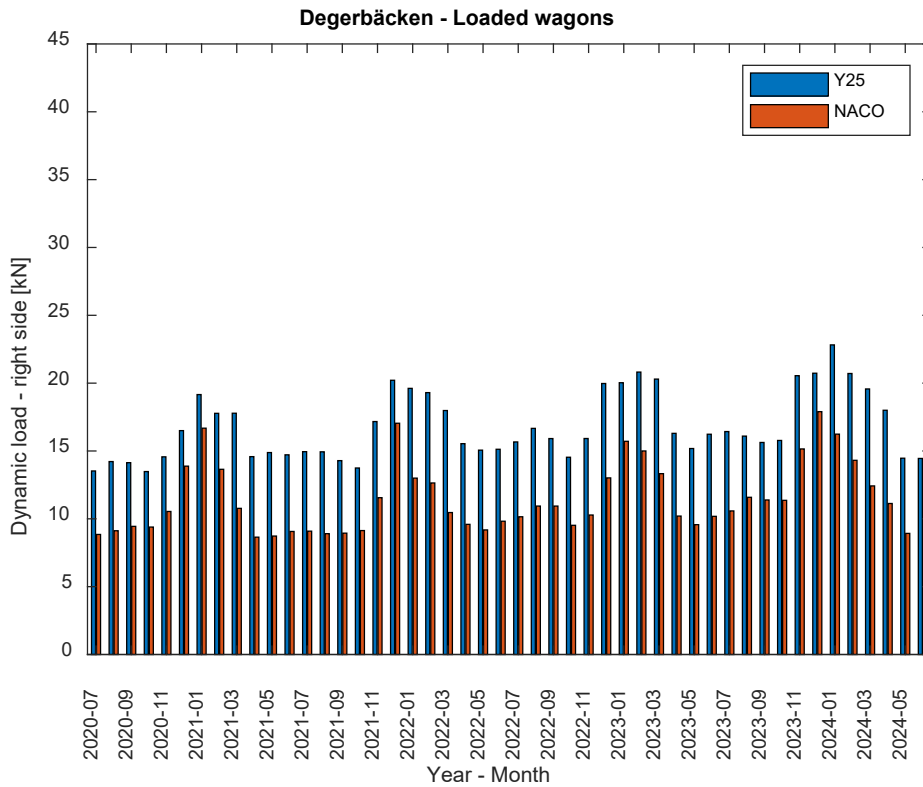
Figure 6.2 Long-term measurement in the Schenck detector at Degerbäcken – loaded steel shuttle wagons: (a) Number of measured axles with either Y25 or NACO bogies, and mean vehicle speed. (b) Mean axle load. (c) Mean of dynamic loads per wheel – left side, (d) Mean of dynamic loads per wheel – right side.

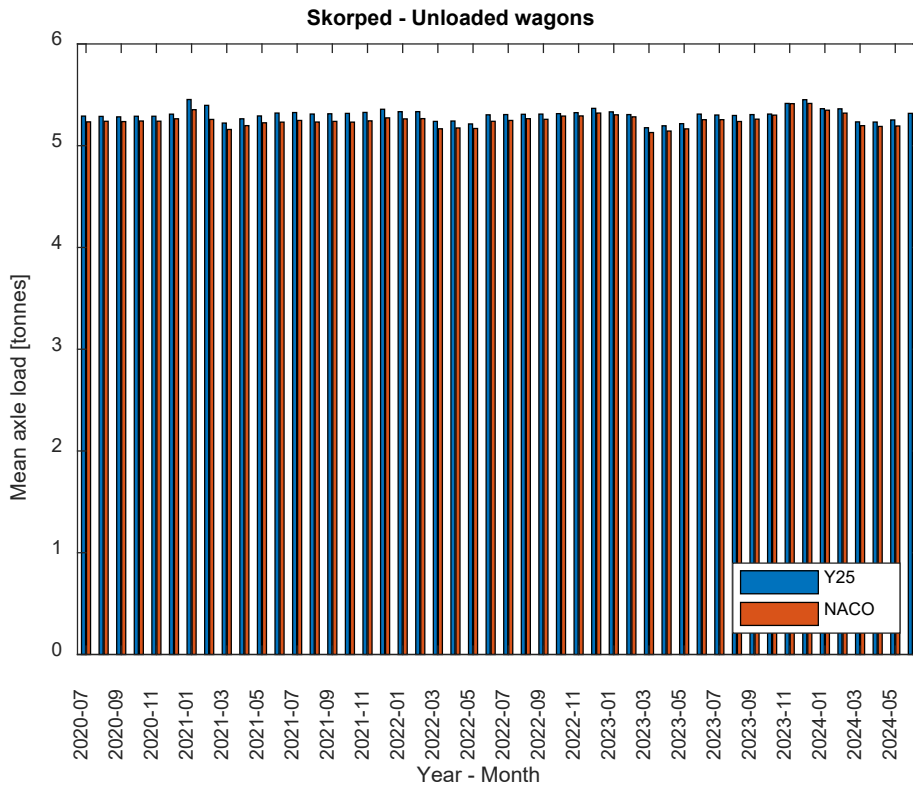
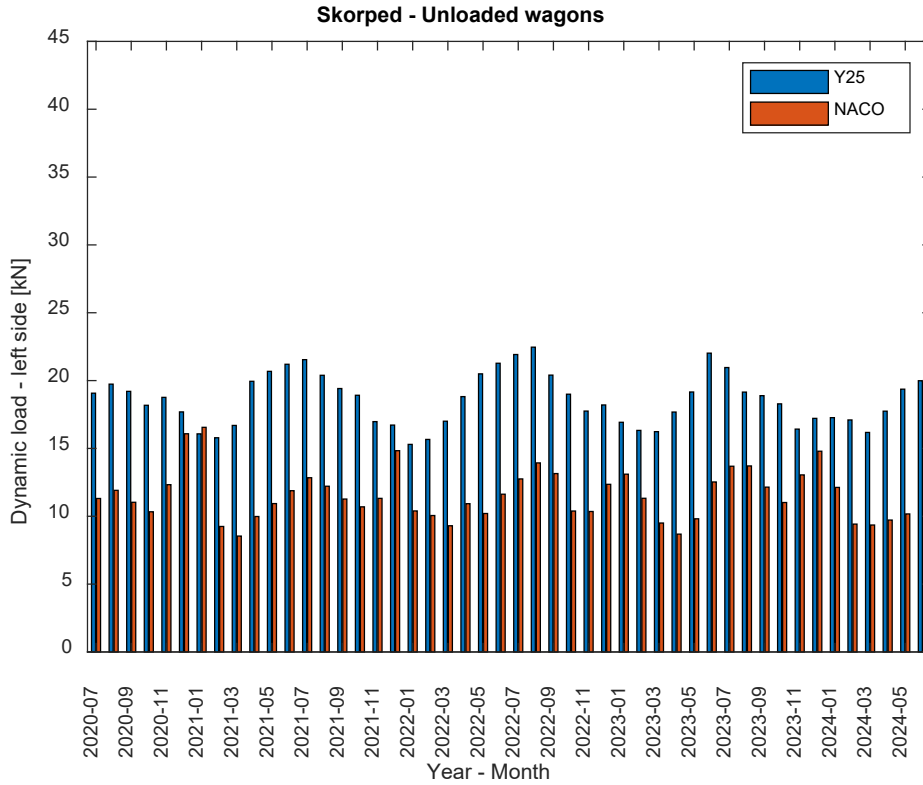
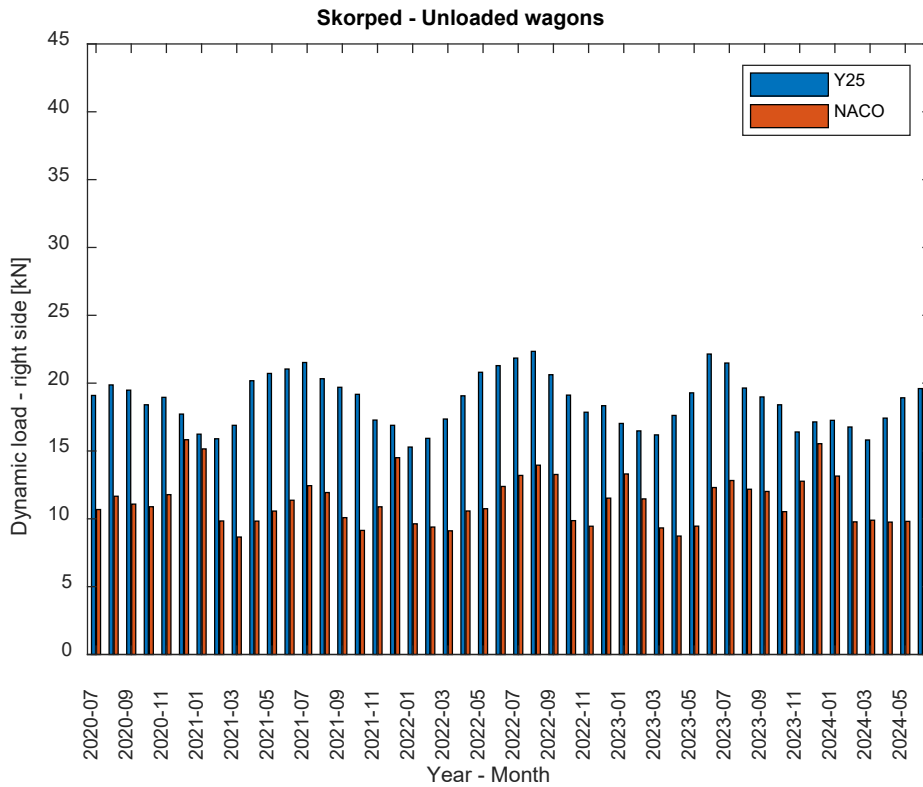
Figure 6.3 Long-term measurement in the Schenck detector at Skorped – unloaded steel shuttle wagons: (a) Number of measured axles with either Y25 or NACO bogies, and mean vehicle speed. (b) Mean axle load. (c) Mean of dynamic loads per wheel – left side, (d) Mean of dynamic loads per wheel – right side.

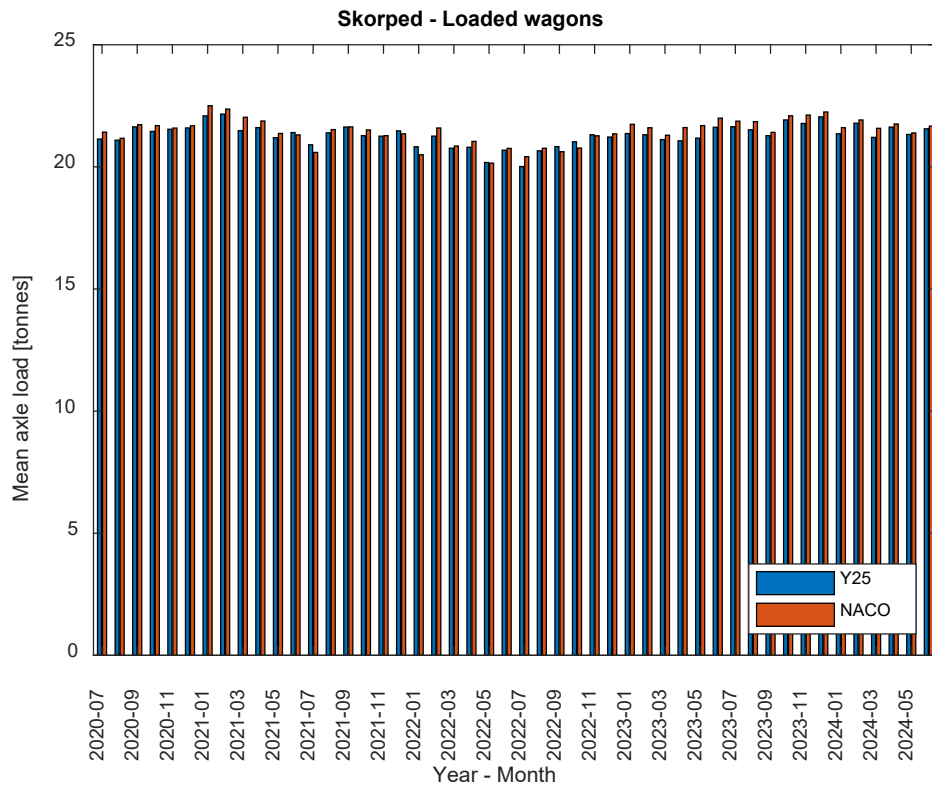
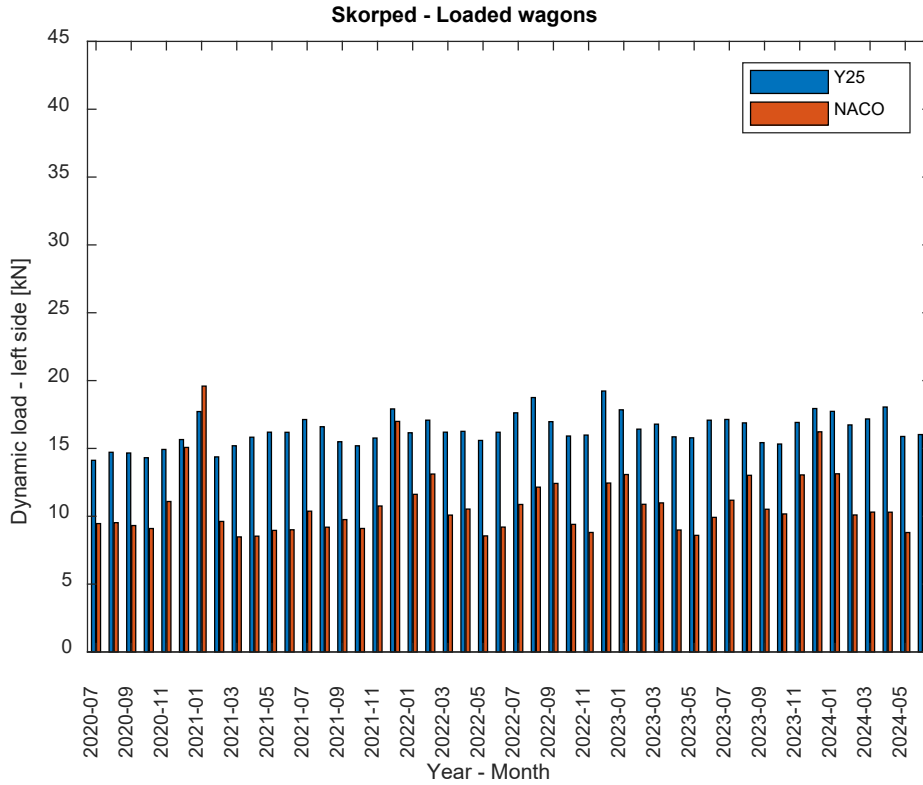
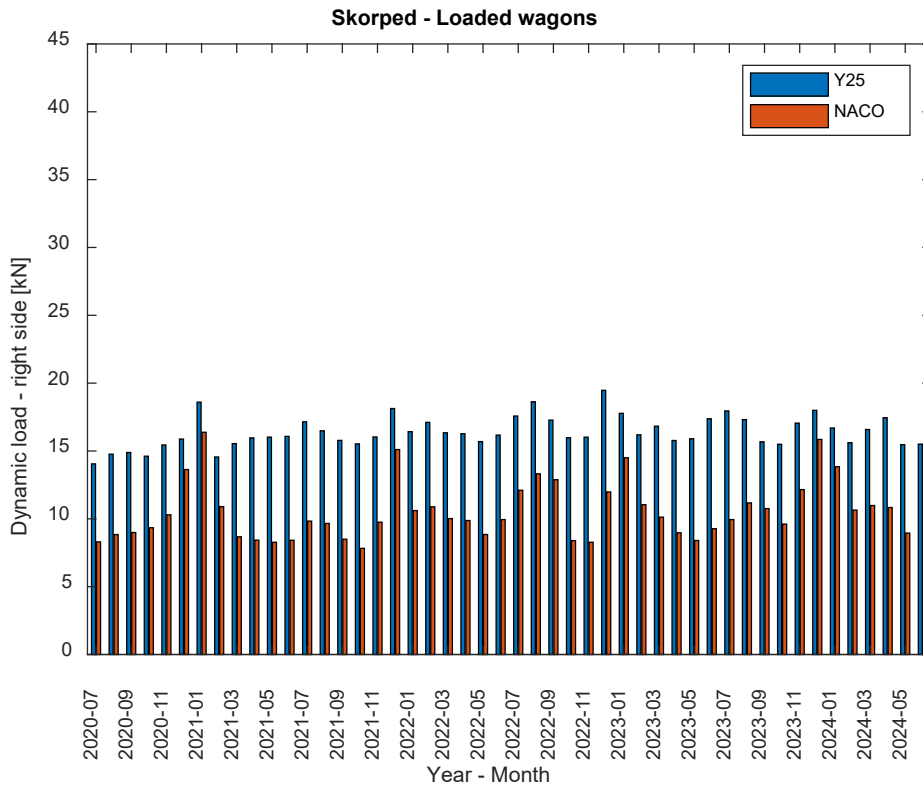
Figure 6.4 Long-term measurement in the Schenck detector at Skorped – loaded steel shuttle wagons: (a) Number of measured axles with either Y25 or NACO bogies, and mean vehicle speed. (b) Mean axle load. (c) Mean of dynamic loads per wheel – left side, (d) Mean of dynamic loads per wheel – right side.

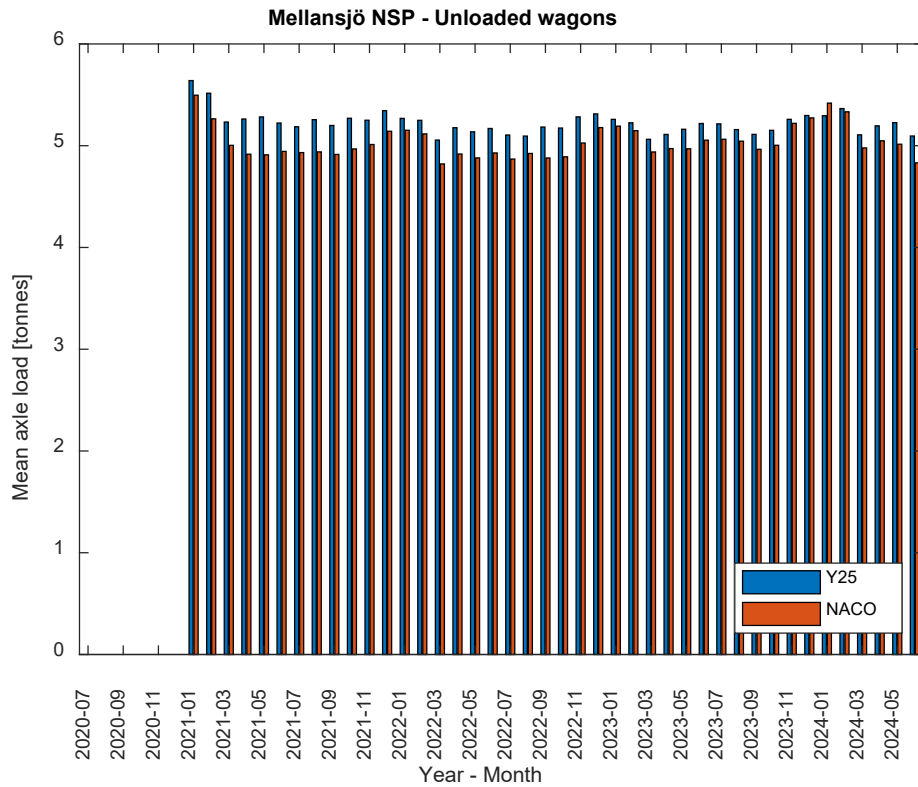
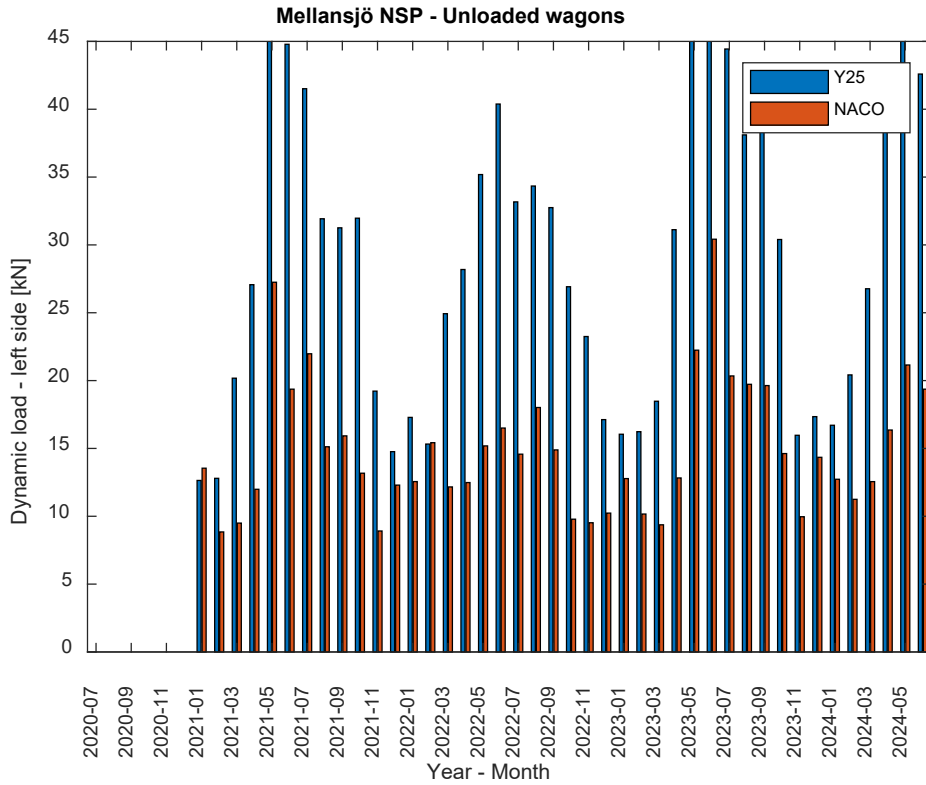
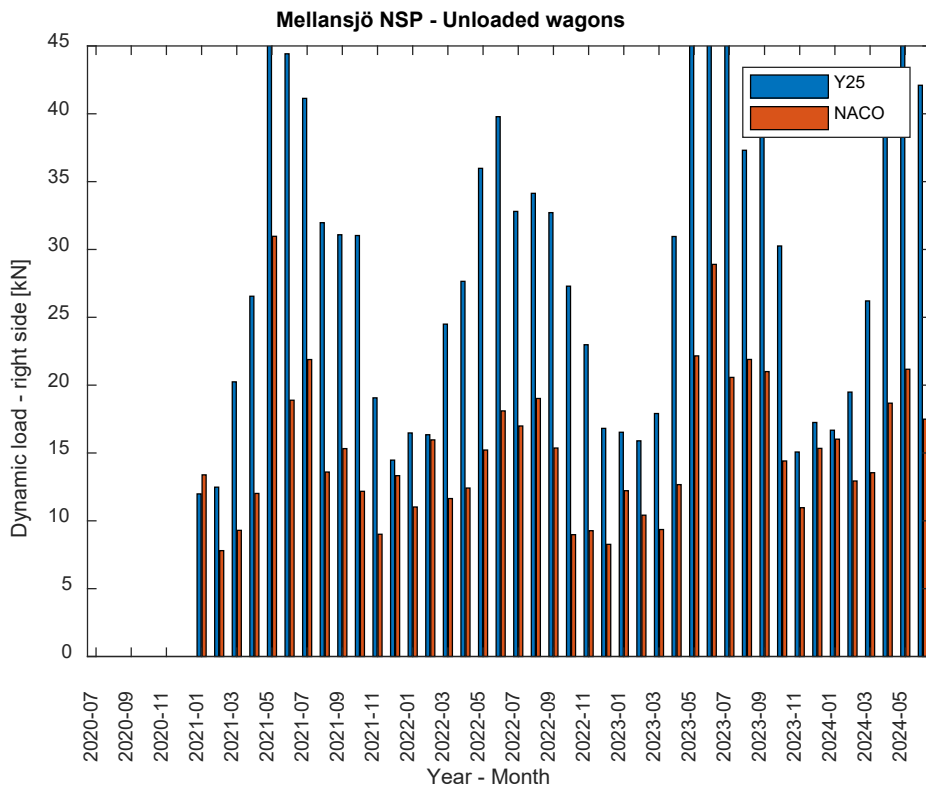
Figure 6.5 Long-term measurement in the PHOENIX MDS detector at Mellansjö NSP – unloaded steel shuttle wagons: (a) Number of measured axles with either Y25 or NACO bogies, and mean vehicle speed. (b) Mean axle load. (c) Mean of dynamic loads per wheel – left side, (d) Mean of dynamic loads per wheel – right side.

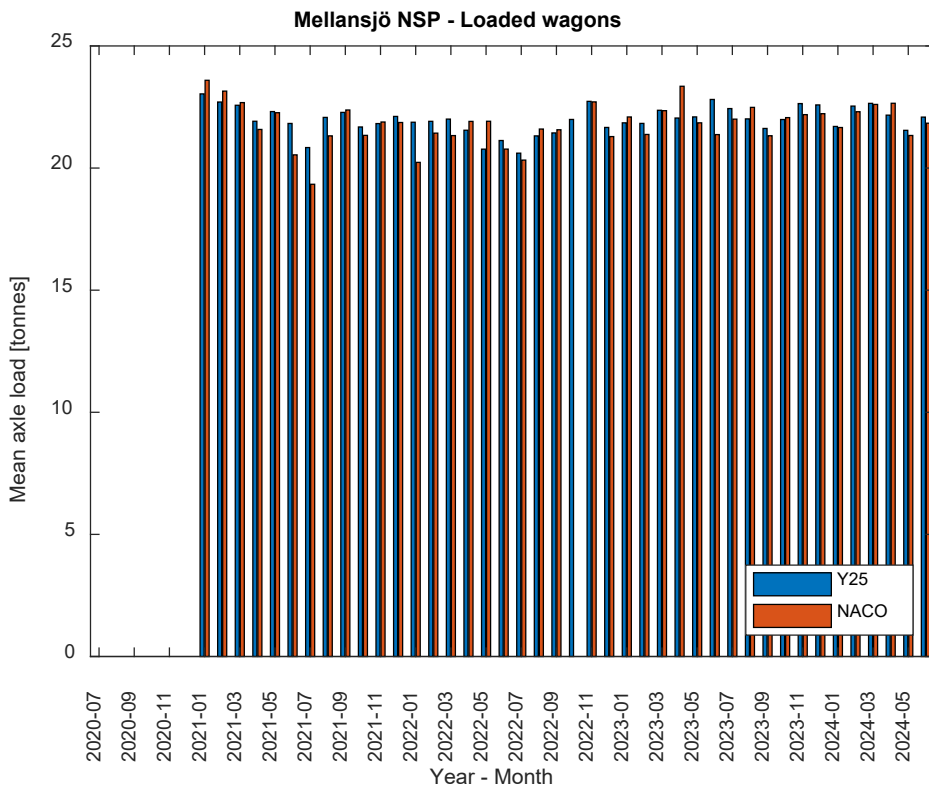
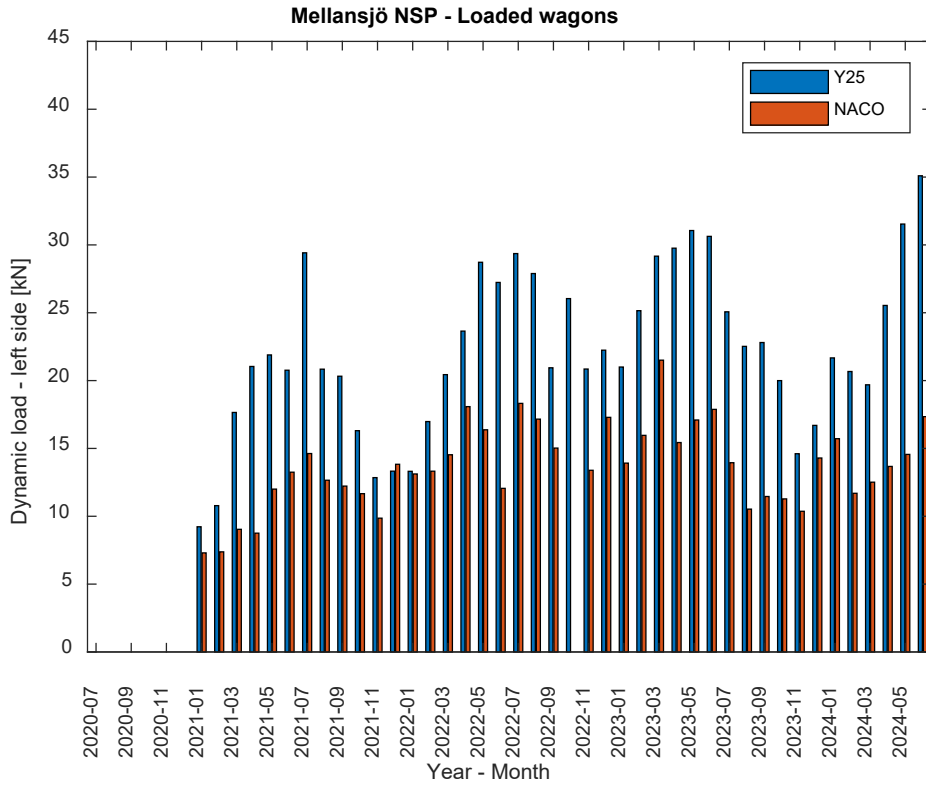
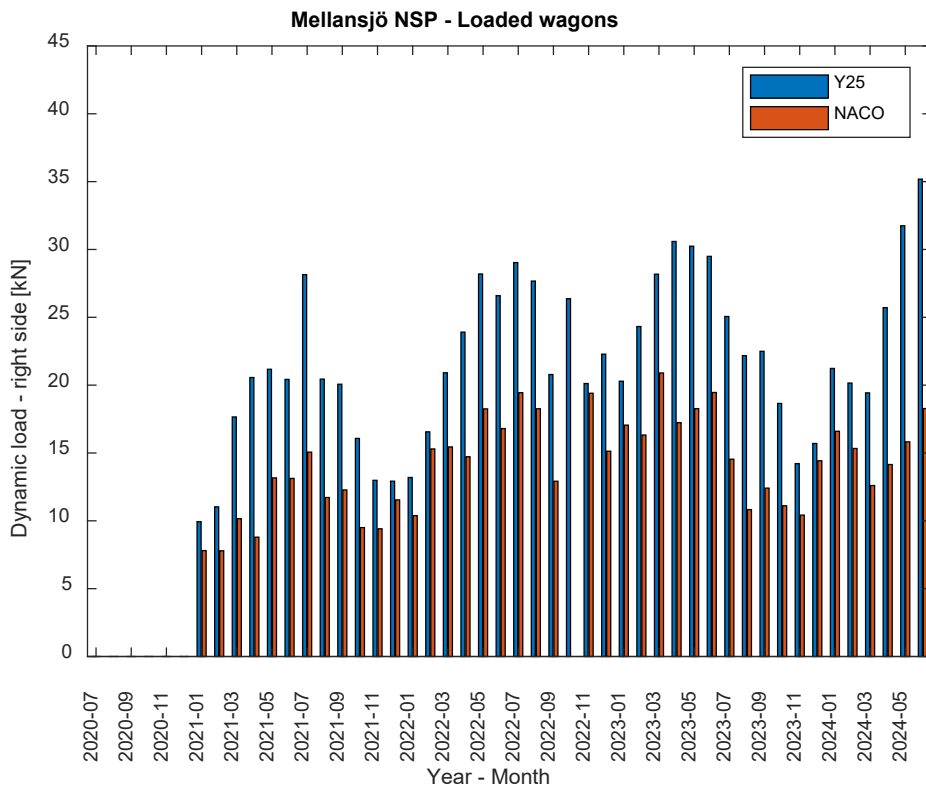
Figure 6.6 Long-term measurement in the PHOENIX MDS detector at Mellansjö NSP – loaded steel shuttle wagons: (a) Number of measured axles with either Y25 or NACO bogies, and mean vehicle speed. (b) Mean axle load. (c) Mean of dynamic loads per wheel – left side, (d) Mean of dynamic loads per wheel – right side.

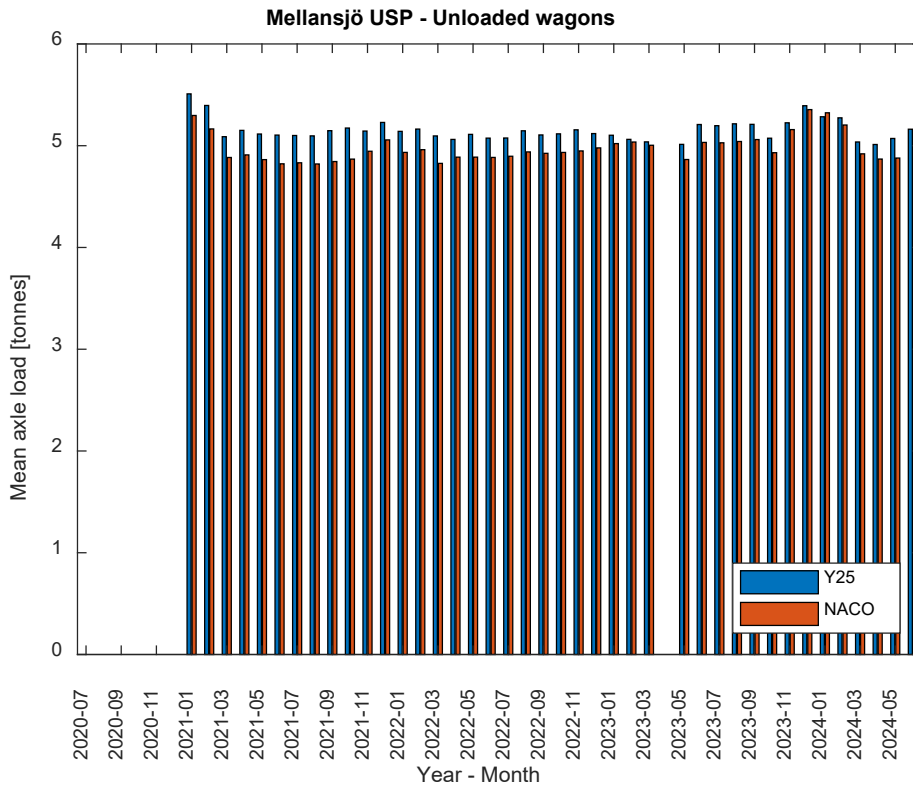
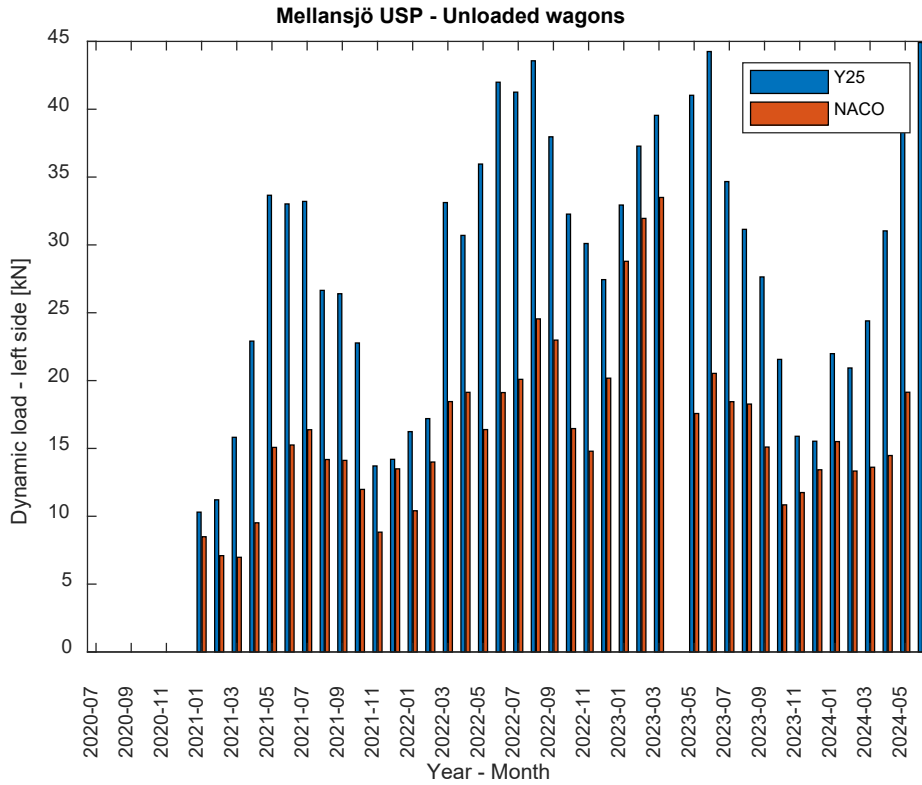
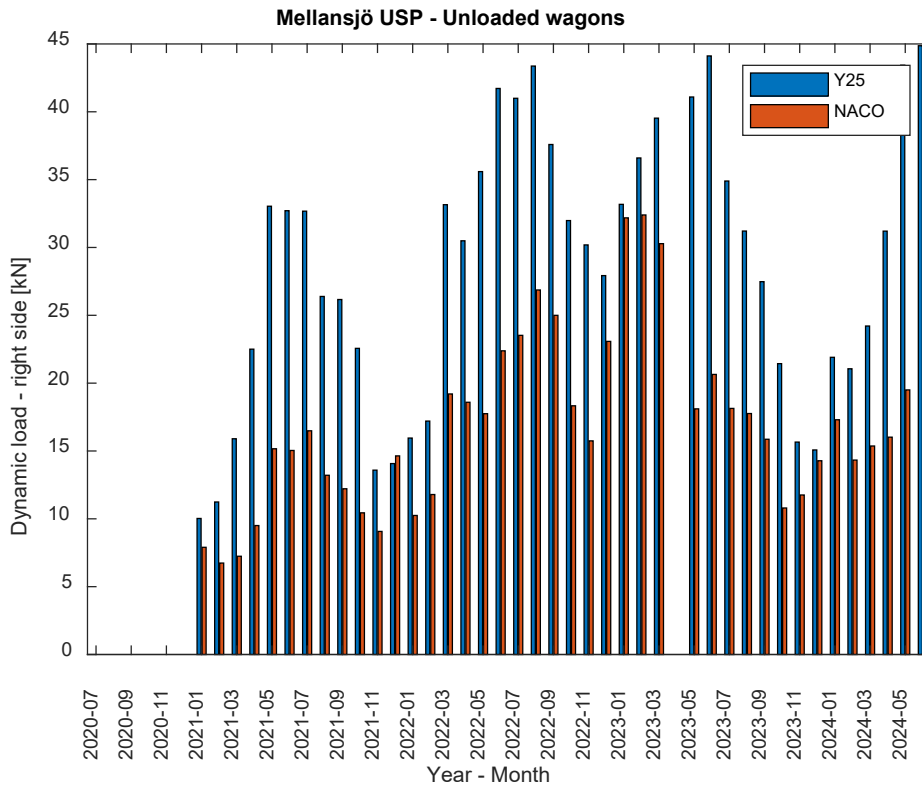
Figure 6.7 Long-term measurement in the PHOENIX MDS detector at Mellansjö USP – unloaded steel shuttle wagons: (a) Number of measured axles with either Y25 or NACO bogies, and mean vehicle speed. (b) Mean axle load. (c) Mean of dynamic loads per wheel – left side, (d) Mean of dynamic loads per wheel – right side.
