Research report 2024:04

# **Towards improved regulations and procedures for damaged wheels – Assessment of wheel impact load detectors**

Department of Mechanics and Maritime Sciences  
CHALMERS UNIVERSITY OF TECHNOLOGY  
Göteborg, Sweden 2024

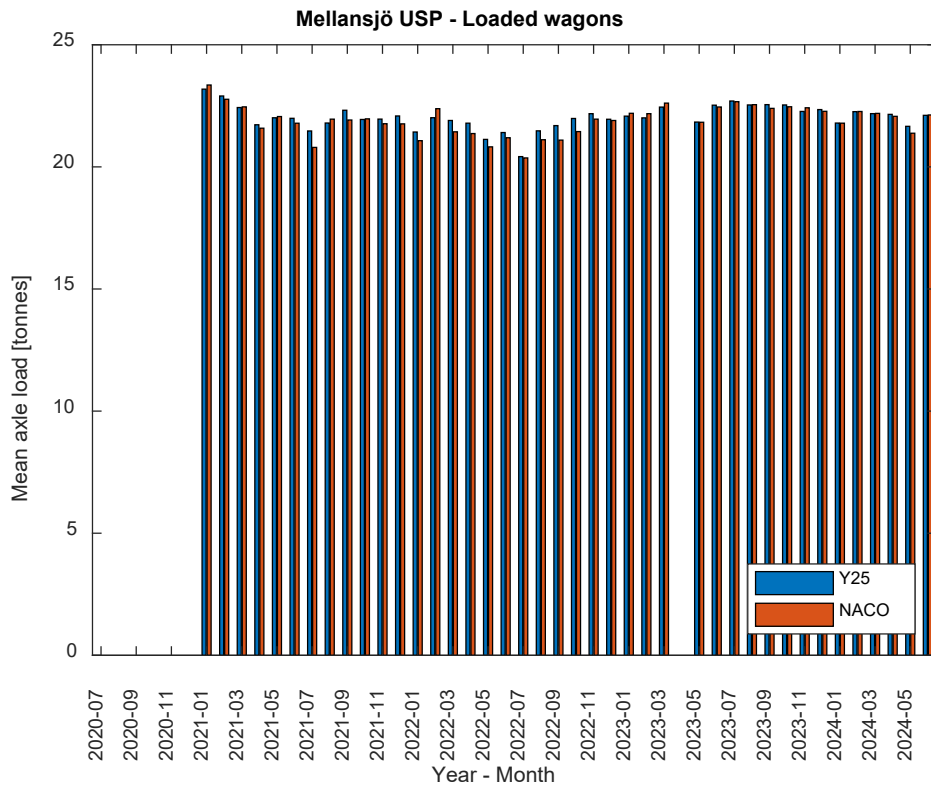
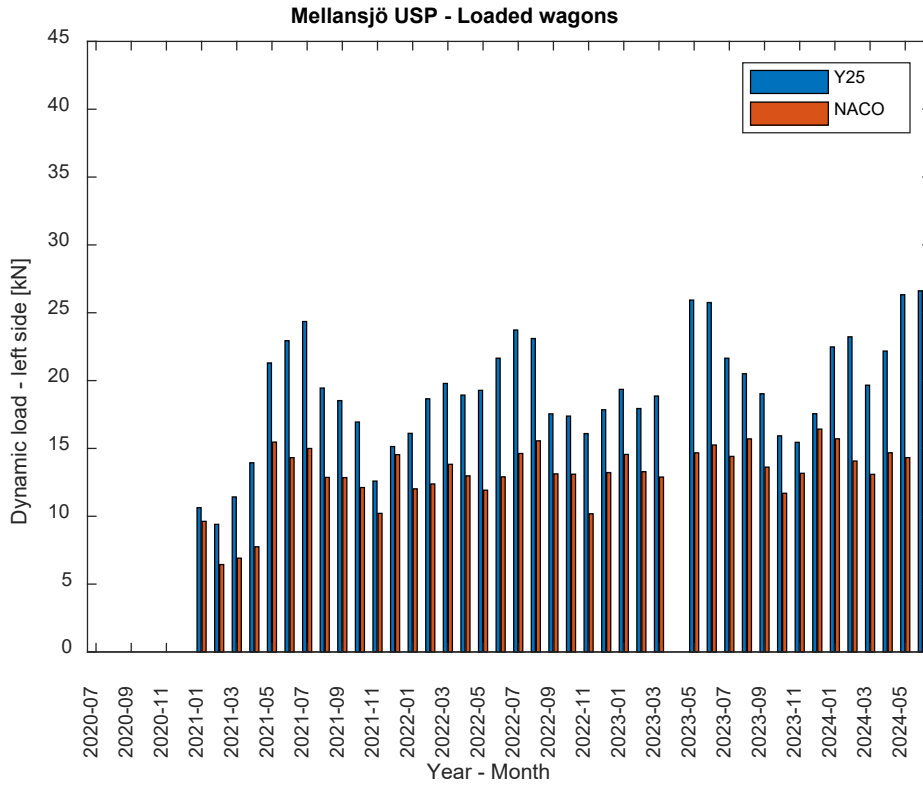
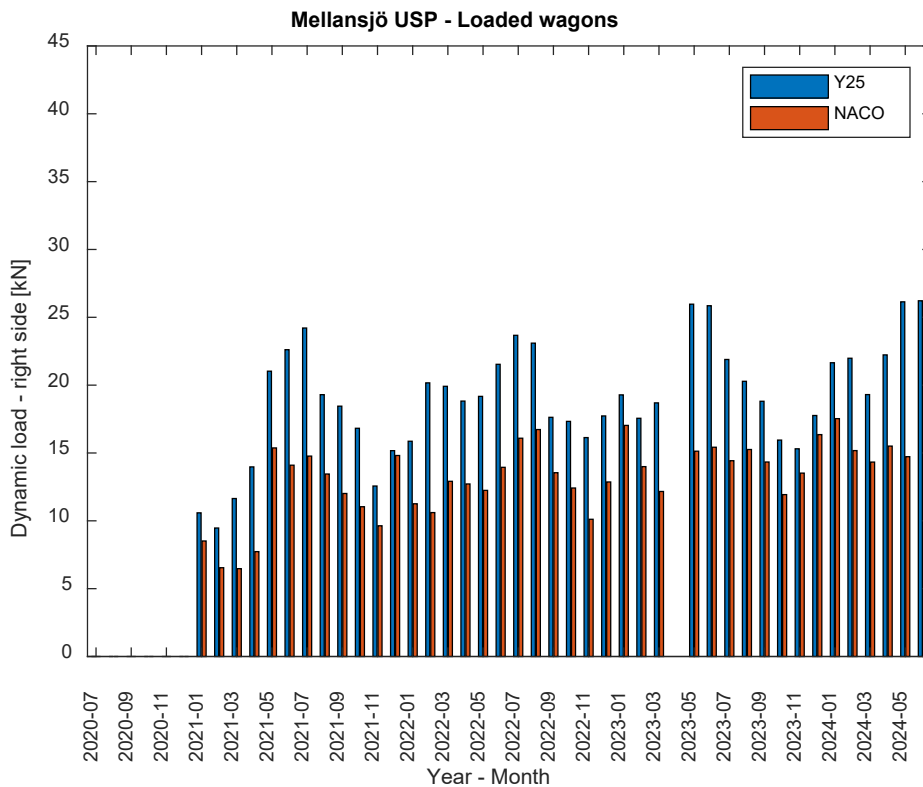
Figure 6.8 Long-term measurement in the PHOENIX MDS detector at Mellansjö USP – loaded steel shuttle wagons: (a) Number of measured axles with either Y25 or NACO bogies, and mean vehicle speed. (b) Mean axle load. (c) Mean of dynamic loads per wheel – left side, (d) Mean of dynamic loads per wheel – right side.

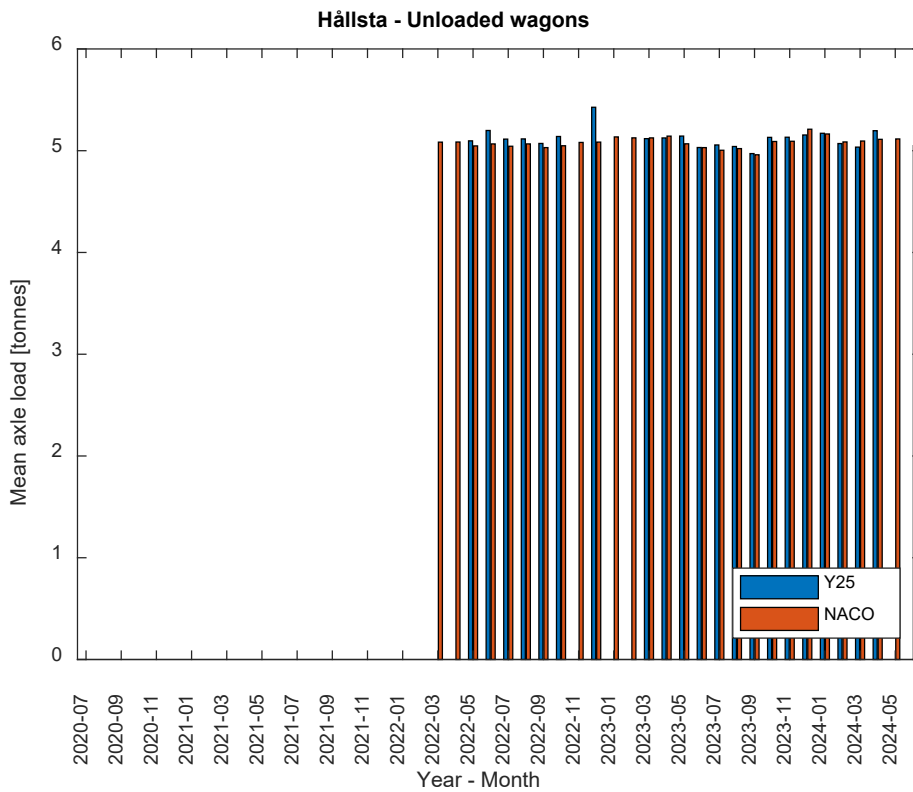
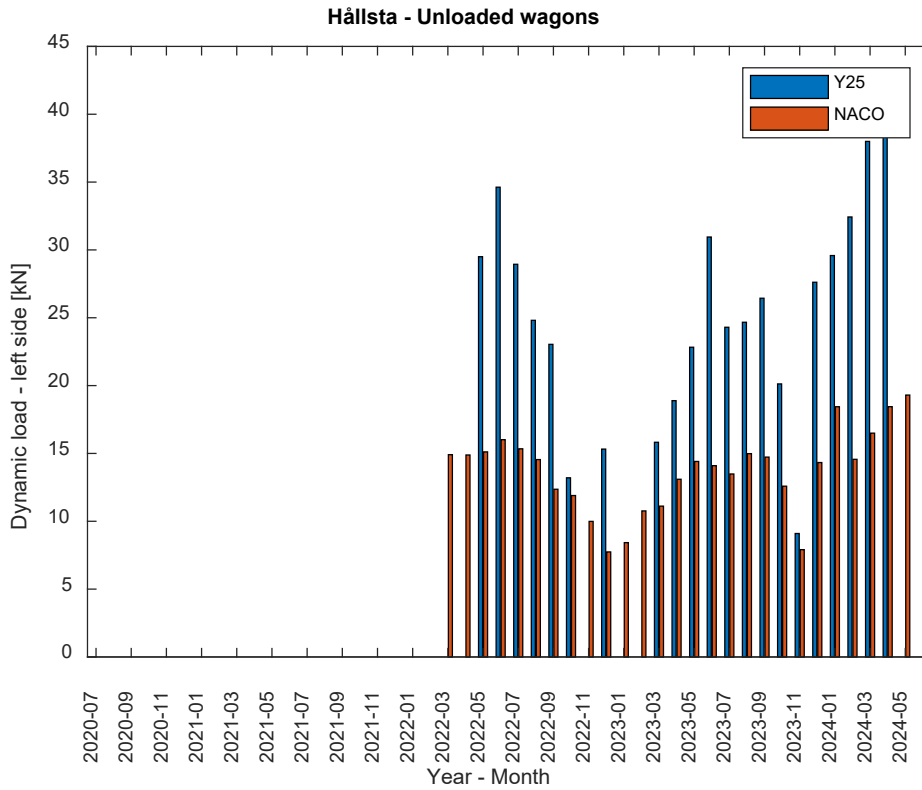
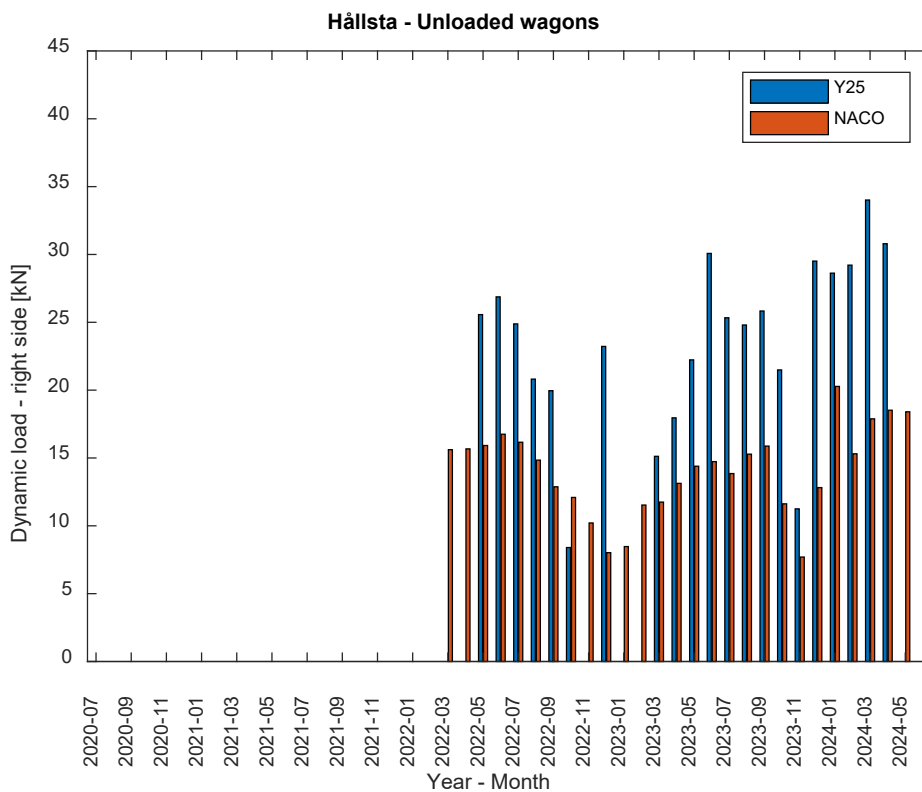
Figure 6.9 Long-term measurement in the PHOENIX MDS detector at Hällsta – unloaded steel shuttle wagons: (a) Number of measured axles with either Y25 or NACO bogies, and mean vehicle speed. (b) Mean axle load. (c) Mean of dynamic loads per wheel – left side, (d) Mean of dynamic loads per wheel – right side.

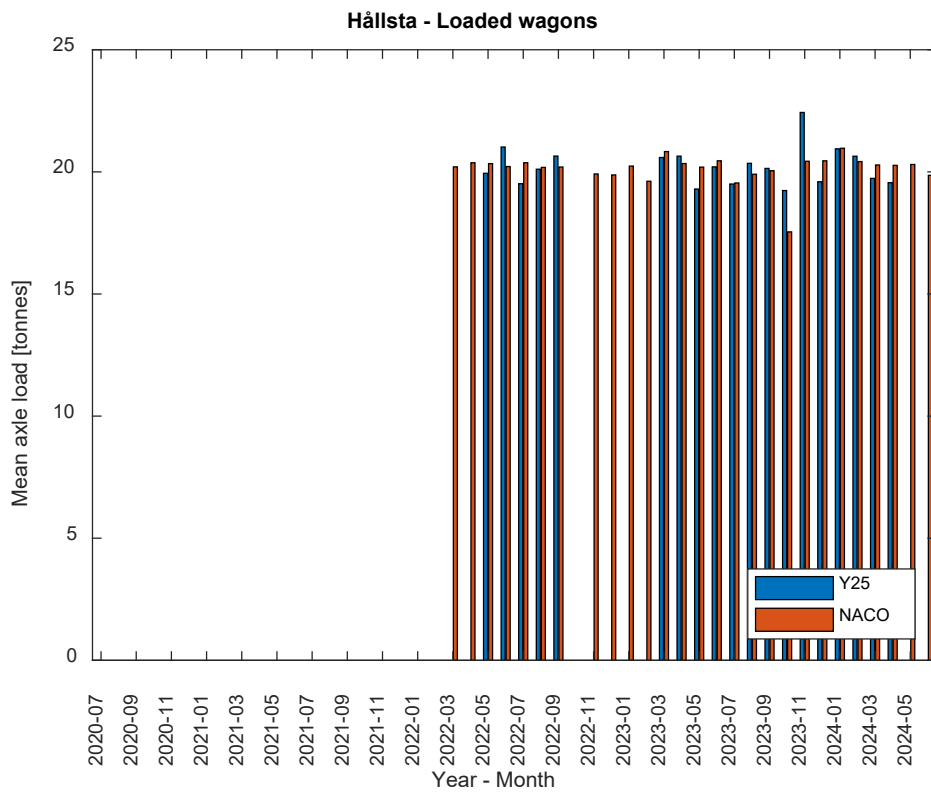
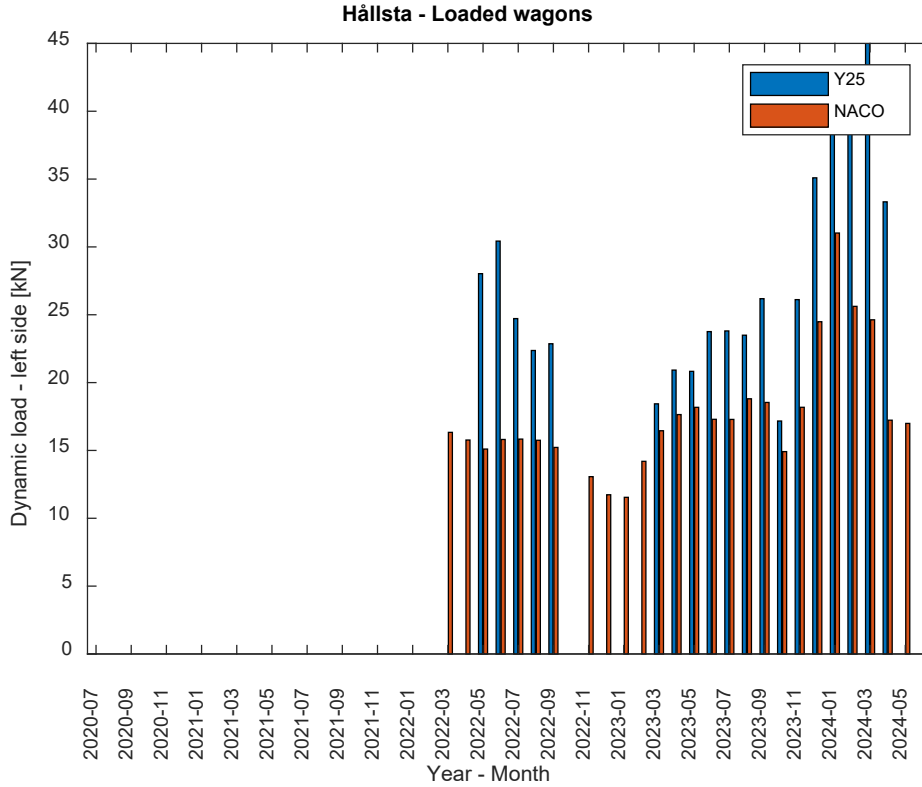
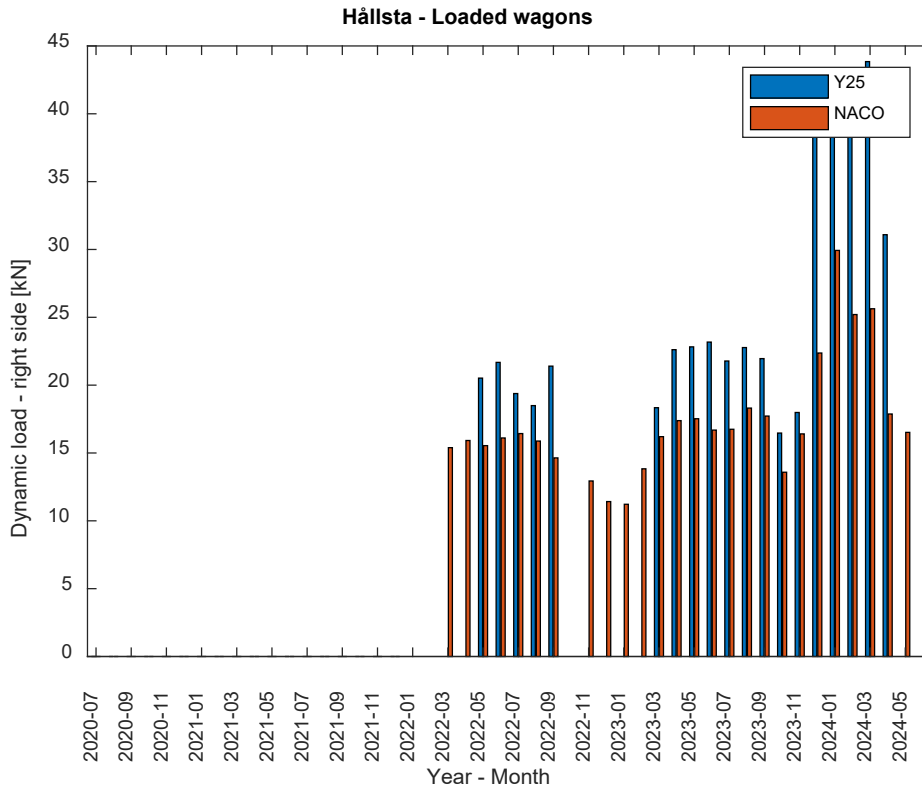
Figure 6.10 Long-term measurement in the PHOENIX MDS detector at Hållsta – loaded steel shuttle wagons: (a) Number of measured axles with either Y25 or NACO bogies, and mean vehicle speed. (b) Mean axle load. (c) Mean of dynamic loads per wheel – left side, (d) Mean of dynamic loads per wheel – right side.

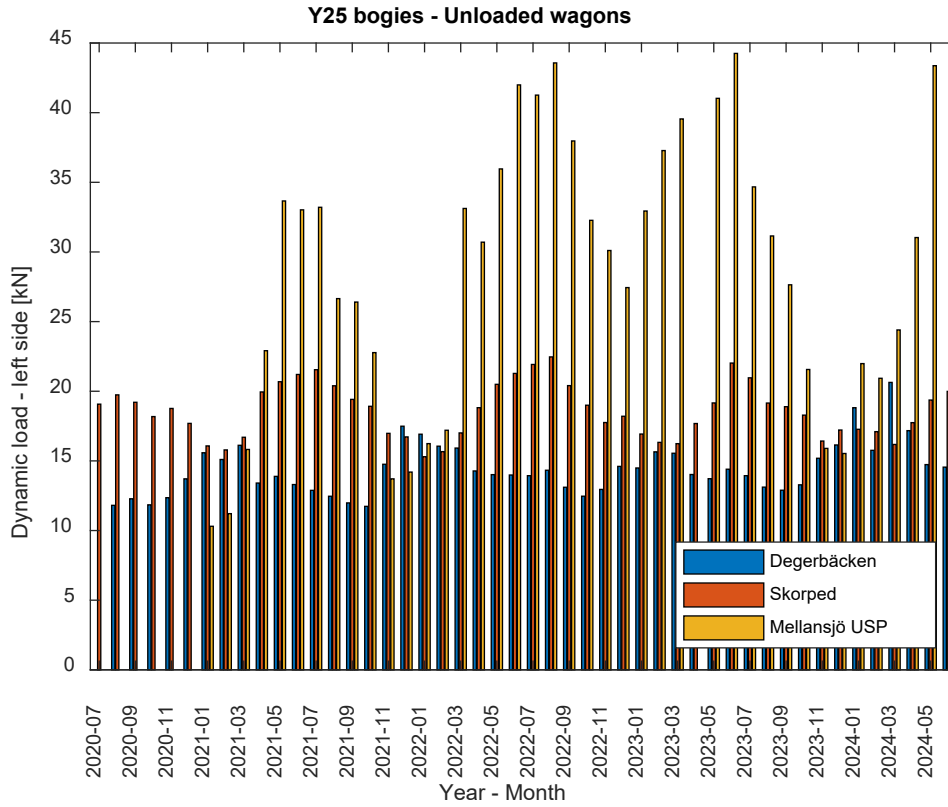
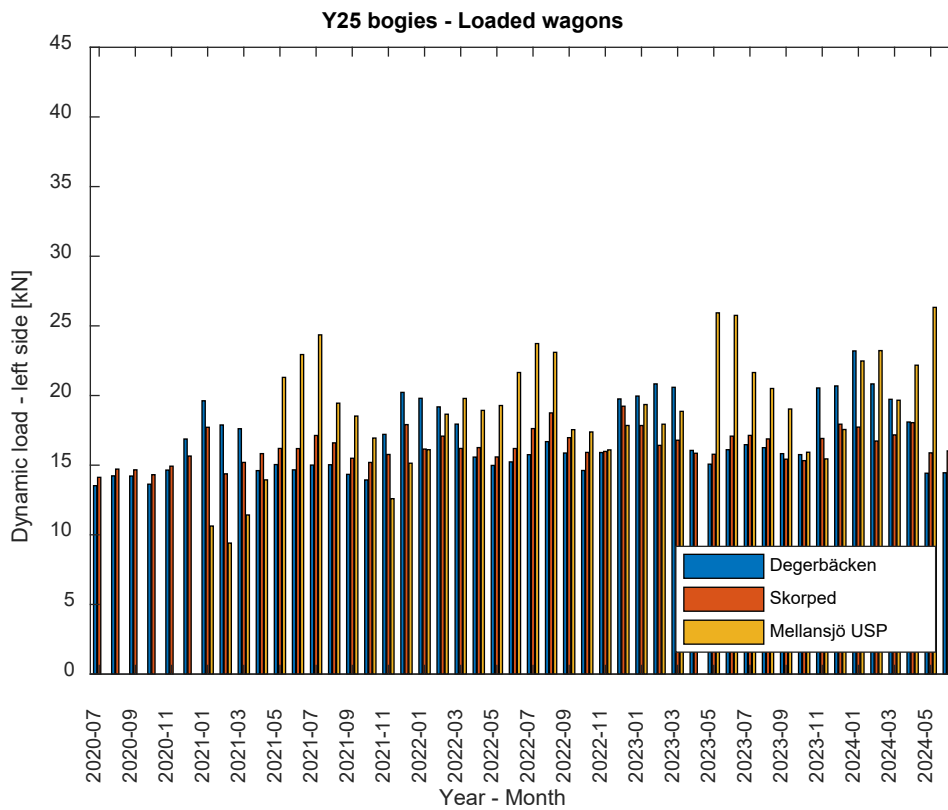
Figure 6.11 Long-term measurement of dynamic loads in the Schenck detectors at Degerbäcken and Skorped and PHOENIX MDS detector at Mellansjö USP – steel shuttle wagons with Y25 bogies: (a) Unloaded wagons, (b) Loaded wagons.

- It is observed that the measured dynamic loads are generally higher in the detector at Mellansjö than in the detectors at Degerbäcken and Skorped, particularly for the unloaded wagons.
- For the unloaded Y25 wagons, the dynamic loads are higher in the detector at Skorped than at Degerbäcken. This could possibly be due to the observed irregularities in track geometry and track stiffness at Skorped.
- For the loaded wagons (both Y25 and NACO), there is good agreement between dynamic loads measured in the detectors at Degerbäcken and Skorped.
- The reason for the seasonal variation in dynamic loads, particularly for the unloaded wagons in the detector at Mellansjö but also to some extent in the detector at Skorped, is unknown.

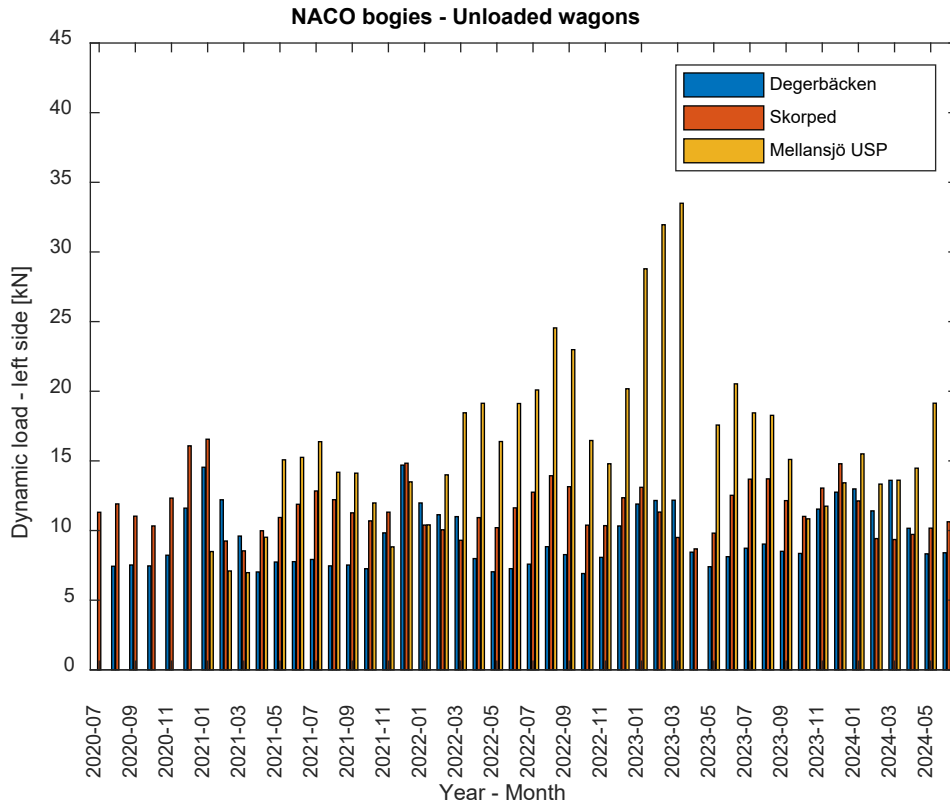
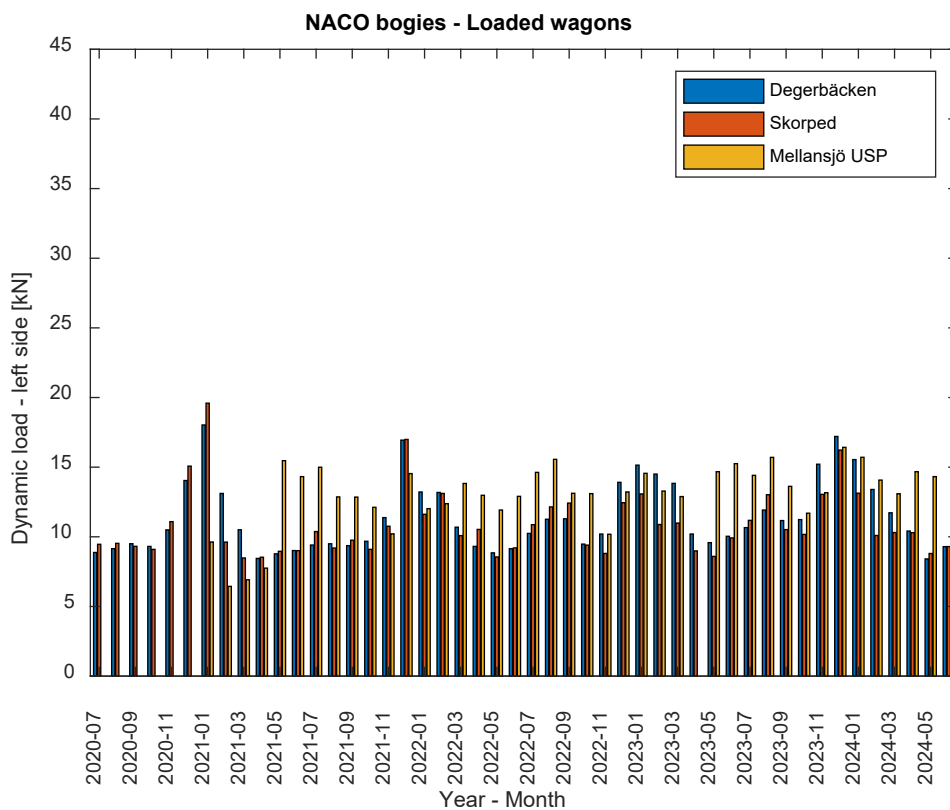
Figure 6.12 Long-term measurement of dynamic loads in the Schenck detectors at Degerbäcken and Skorped and PHOENIX MDS detector at Mellansjö USP – steel shuttle wagons with NACO bogies: (a) Unloaded wagons, (b) Loaded wagons.

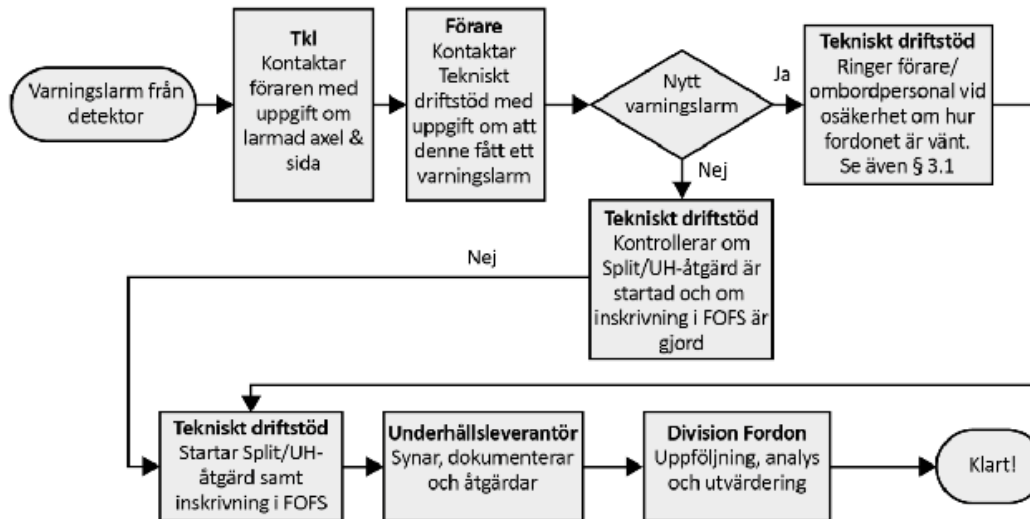
Figur 1. Flödesschema för hantering av varningslarm

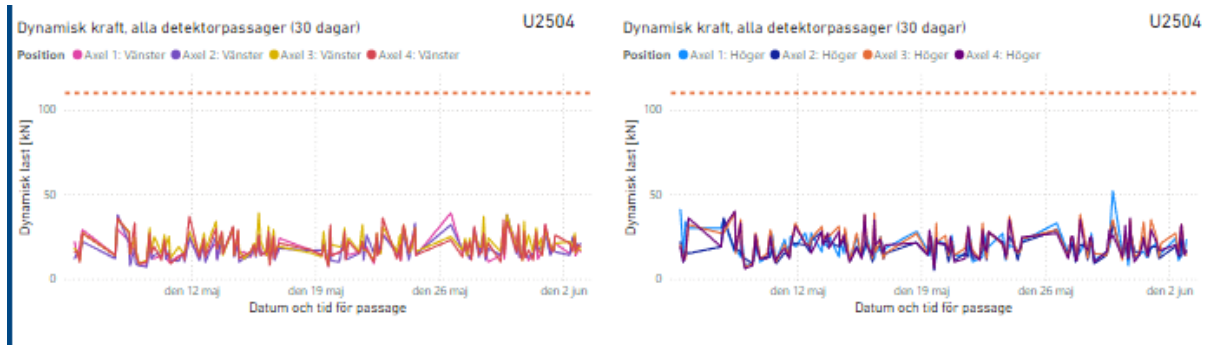
for the different vehicles of an X2 trainset. The numbers Uxxxx are SJ's numbers for vehicle individuals. The low load magnitudes indicate that all wheels are in good condition.

Figure 7.4. Measured dynamic load per wheel in different detectors over 30 days. Extracted from the maintenance monitoring system 'Imperium' and visualised in a Power BI report.

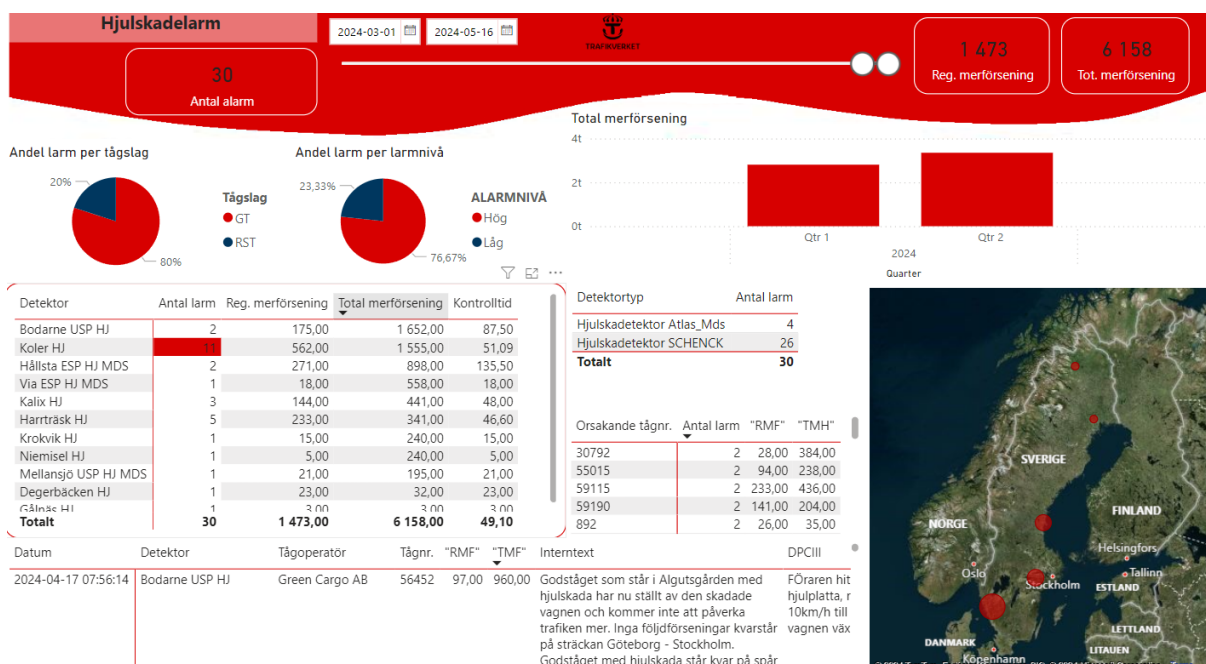
Figure 7.5. Example of 'Common situation picture' for the period 2024-03-01 – 2024-05-16.

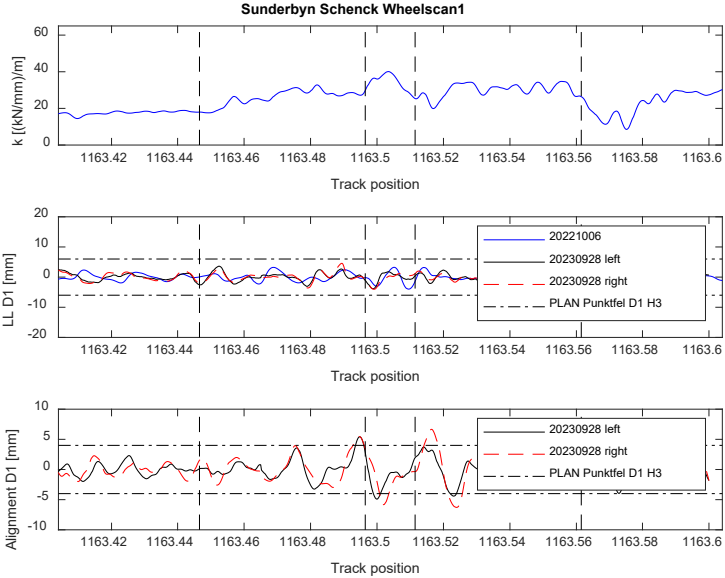
Figure A.1 Foundation stiffness, longitudinal level (bandpass filtered 1 – 25 m) and alignment measured in the WILD at Sunderbyn. See also caption to Figure 4.10.

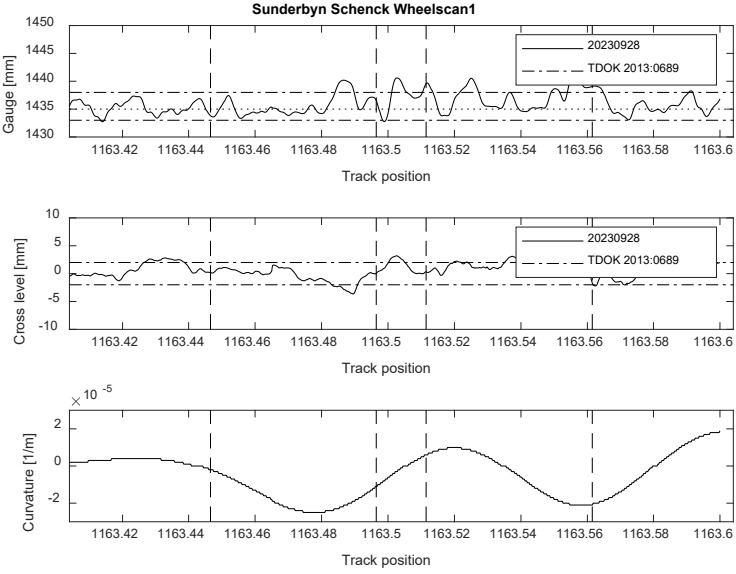
Figure A.2 Gauge, cross level and curvature over a distance of 200 m in the WILD at Sunderbyn. See also caption to Figure 4.11.

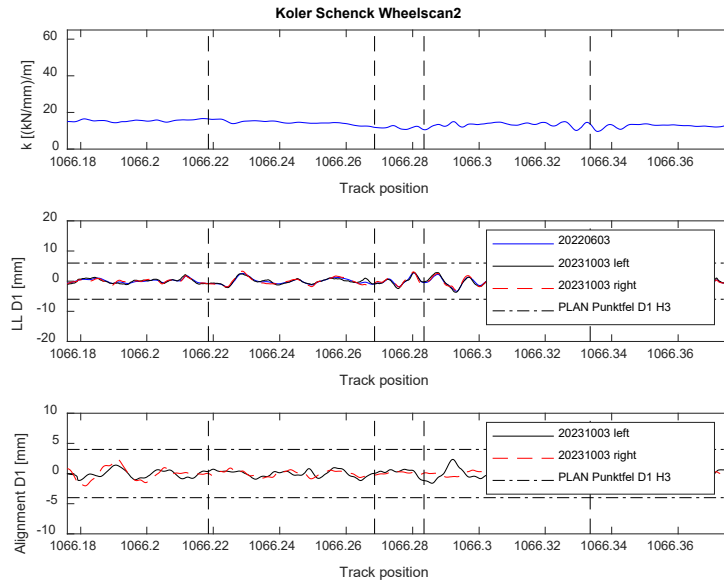
Figure A.3 Foundation stiffness, longitudinal level (bandpass filtered 1 – 25 m) and alignment measured in the WILD at Koler. See also caption to Figure 4.10.

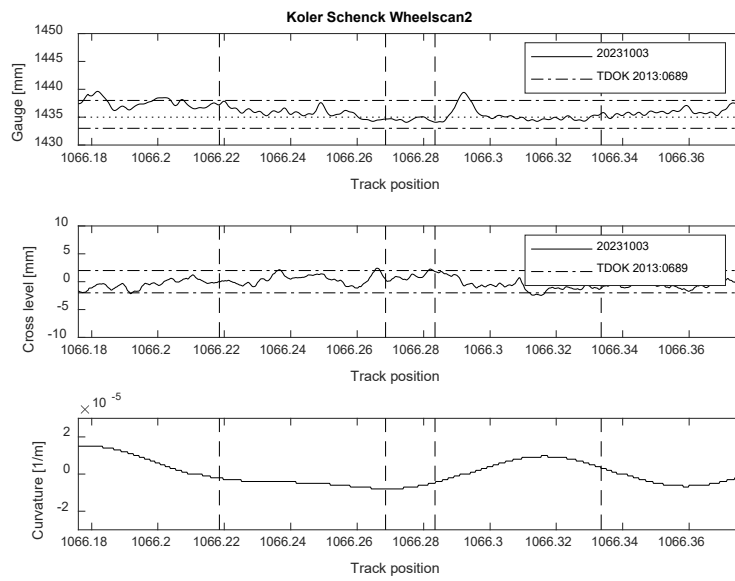
Figure A.4 Gauge, cross level and curvature over a distance of 200 m in the WILD at Koler. See also caption to Figure 4.11.

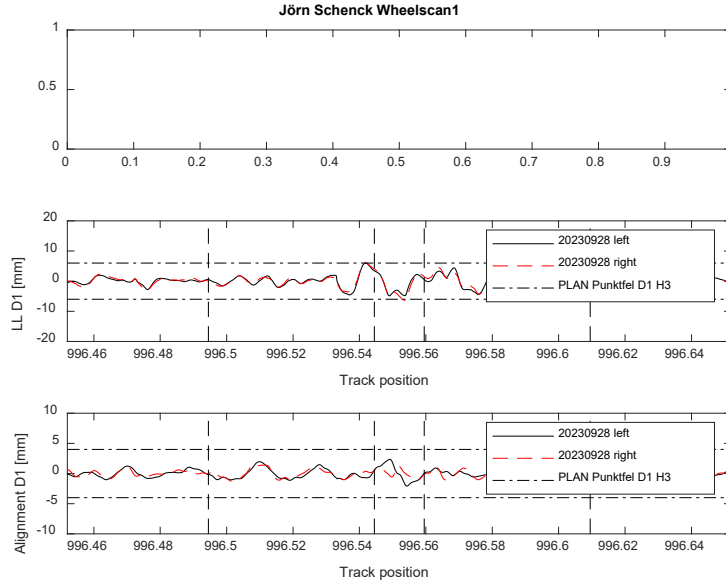
Figure A.5 Longitudinal level (bandpass filtered 1 – 25 m) and alignment measured in the WILD at Jörn (no measurement of track stiffness). See also caption to Figure 4.10.

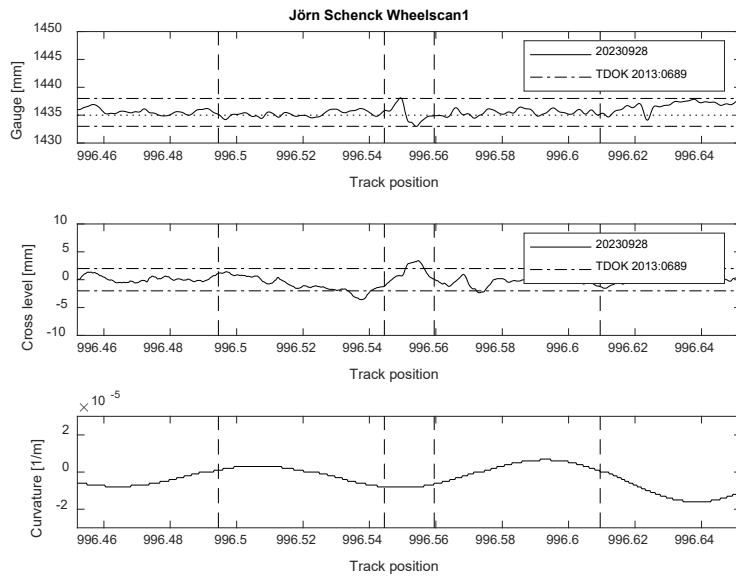
Figure A.6 Gauge, cross level and curvature over a distance of 200 m in the WILD at Jörn. See also caption to Figure 4.11.

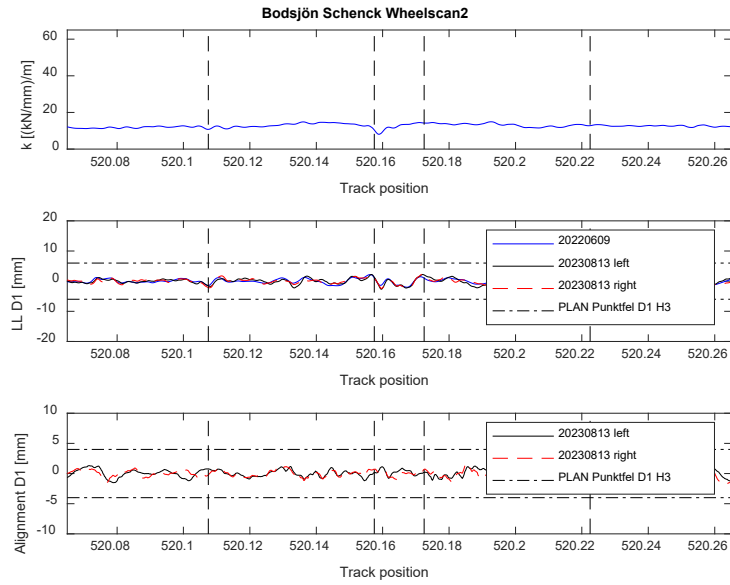
Figure A.7 Foundation stiffness, longitudinal level (bandpass filtered 1 – 25 m) and alignment measured in the WILD at Bodsjön. See also caption to Figure 4.10.

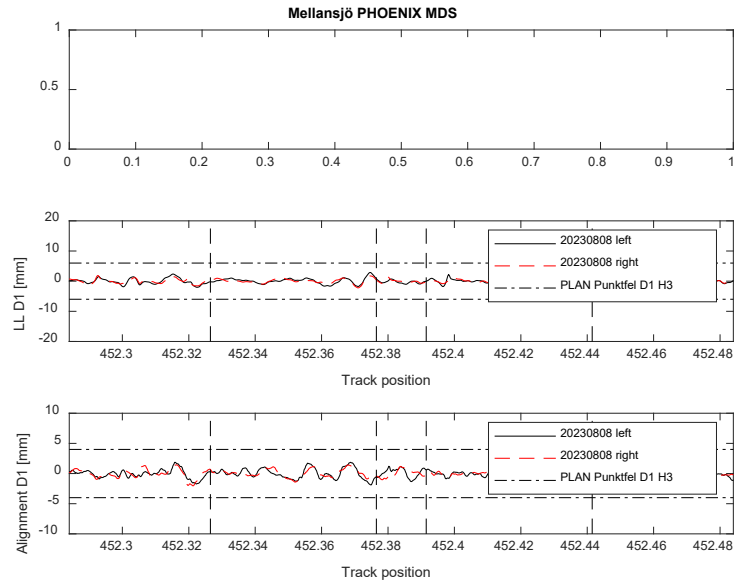
Figure A.9 Longitudinal level (bandpass filtered 1 – 25 m) and alignment measured in the WILD at Mellansjö (no measurement of track stiffness). See also caption to Figure 4.10.

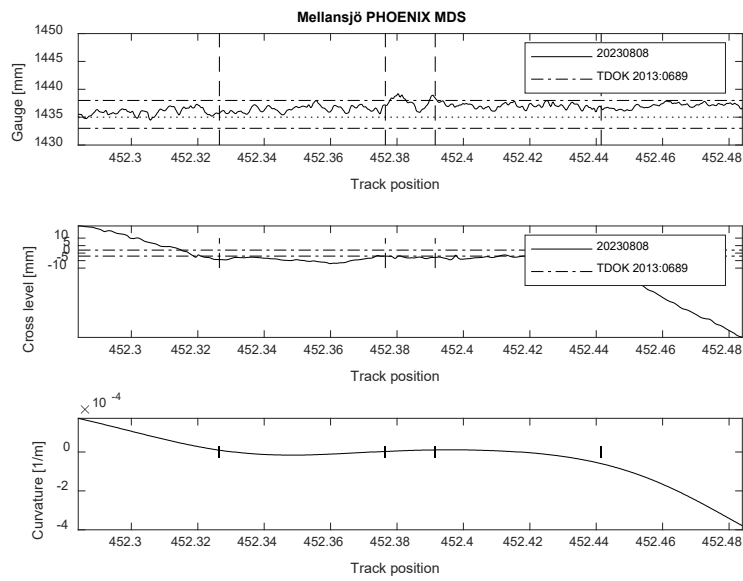
Figure A.10 Gauge, cross level and curvature over a distance of 200 m in the WILD at Mellansjö. See also caption to Figure 4.11.

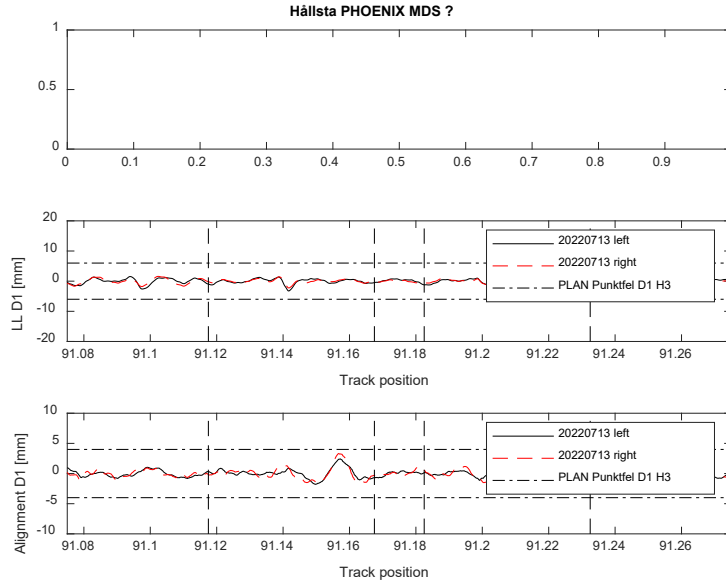
Figure A.11 Longitudinal level (bandpass filtered 1 – 25 m) and alignment measured in the WILD at Hällsta (no measurement of track stiffness). See also caption to Figure 4.10.

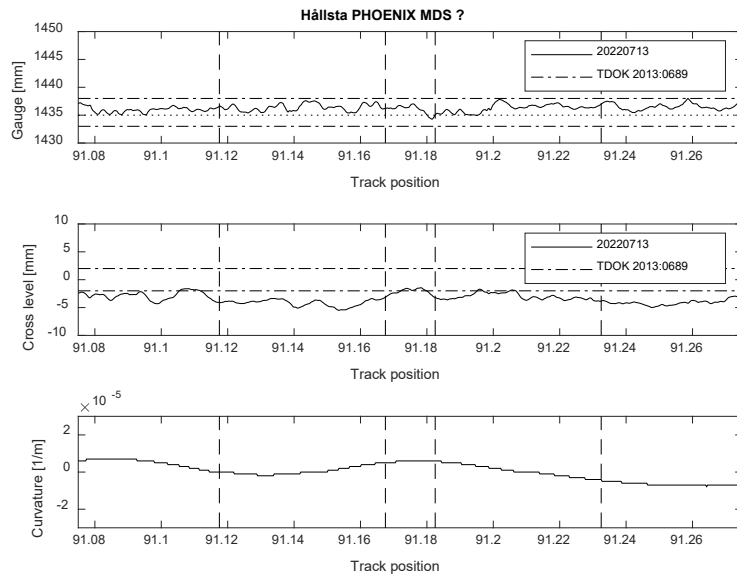
Figure A.12 Gauge, cross level and curvature over a distance of 200 m in the WILD at Hällsta. See also caption to Figure 4.11.
