## **Characterisation of steel corrosion and matrix damage in reinforced mortar combining analytical, electrical and image-based techniques**

# Characterisation of steel corrosion and matrix damage in reinforced mortar combining analytical, electrical and image-based techniques

Andreas Alhede<sup>a</sup>,\*, Jelke Dijkstra<sup>a</sup>, Alessandro Tengattini<sup>b,c,d</sup>, Karin Lundgren<sup>a</sup>

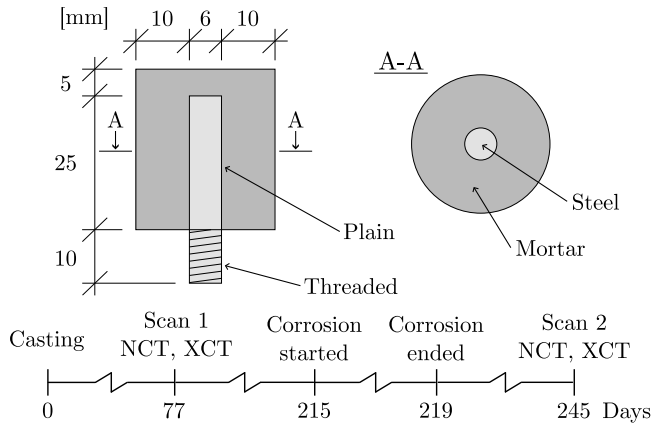
Fig. 1. Drawing of the sample geometry and timeline of the experimental campaign for specimens in series NX10.

Two cylindrical reinforced mortar samples, NX10B and NX10C, were manufactured and Neutron and X-ray Computed Tomography (NCT and XCT) were acquired at the NeXT Instrument at the Institut Laue-Langevin [33] at two different stages - prior to and after accelerated corrosion, see Fig. 1.

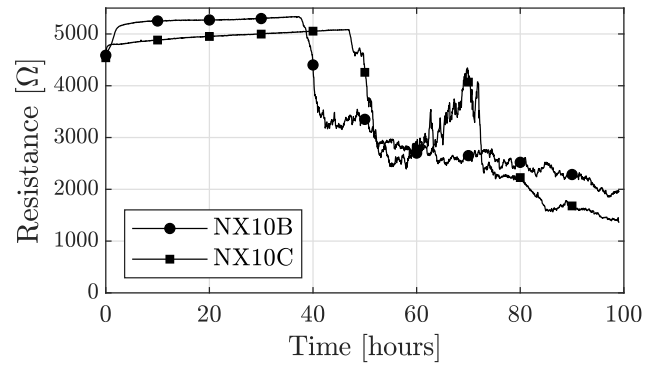
Fig. 2. Electrical resistance measurements of the specimens during the accelerated corrosion process.

Corrosion of the steel bars was induced using impressed current. Specimens cast with sodium bromide, NX10B and TC10B1-3, were placed in separate plastic containers filled with a water solution containing 3% sodium bromide, while specimens cast with sodium chloride, NX10C and TC10C1-3, were immersed in a water solution containing 3% sodium chloride. The positive terminal was connected to the reinforcing steel (the anode) and the negative terminal was connected to a copper mesh (the cathode) surrounding the specimen to close the electrical circuit. In order to mimic the process of natural corrosion, the current density was set to  $50 \mu\text{A cm}^{-2}$ , which is considered acceptable [35]. The current was kept constant for a period slightly less than 100 h using a custom-made constant current source that adjusted the electrical potential when the resistivity in the sample changed. The electrical resistance in the circuit was monitored by logging of the electrical potential, and the measurements are shown in Fig. 2.

The electrical resistance measurements of specimens in the NX10 series (Fig. 2), clearly show a drop in electrical resistance, indicating cracking of the mortar. For NX10B, the resistance increased slightly during the initial hours of impressed current and remained stable thereafter, until a sudden drop after 37 h. Subsequently, the resistance gradually decreased.

The resistance of NX10C increased slightly for a period of 47 h before dropping. Unlike NX10B, the resistance of NX10C partially recovered before a second drop occurred. This might be attributed to a gradually developing crack pattern that fully propagated through the cover at the time of the second drop in resistance.

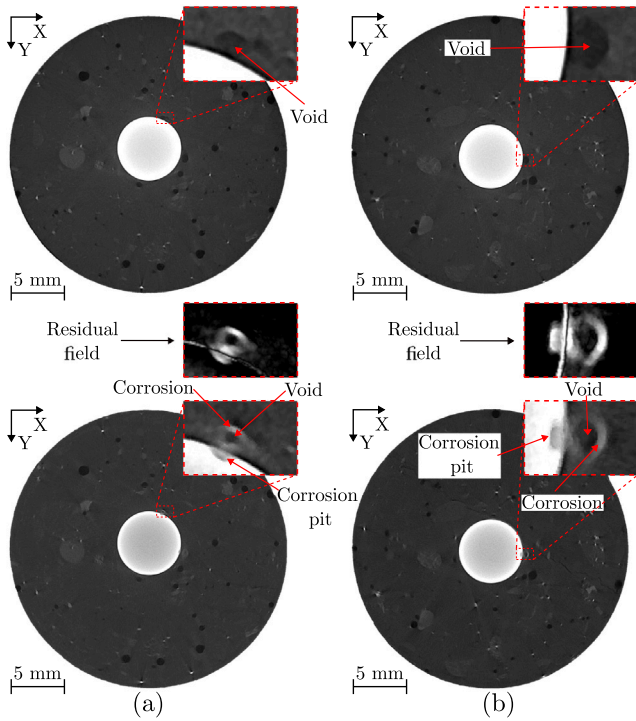
Fig. 3. Horizontal slices of X-ray Tomographies revealing partially filled voids at the SCI, used for estimation of the volumetric expansion coefficient. Top and bottom rows: before and after corrosion, respectively. (a) NX10B and (b) NX10C.

The volumetric expansion coefficient of the corrosion products was quantified from the XCT data using Eq. (1). For this quantification, the partially filled voids shown in Fig. 3 were analysed. The selection of partially filled macroscopic interfacial voids was crucial, as the methodology for quantifying this coefficient (Section 2.3) relies on the volume balance between the (bulk) volume of accumulated corrosion products in the void and on the volume loss of the neighbouring steel. If the voids are completely filled with corrosion products, the estimation of the bulk volume is affected by the possible compaction of corrosion products within the void. This was not the case for the voids considered here.

The volumetric expansion coefficient of corrosion products was determined to be  $\eta = 3.90$  for NX10B, and  $\eta = 3.84$  for NX10C. These values suggest that the corrosion products could be either Iron(II) hydroxide,  $\text{Fe}(\text{OH})_2$  ( $\eta \approx 3.75$ ), or Iron(III) hydroxide,  $\text{Fe}(\text{OH})_3$  ( $\eta \approx 4.1$ ) [2], or a mix of both. The values are higher than the reference value of around two, which is often assumed in the modelling of the corrosion

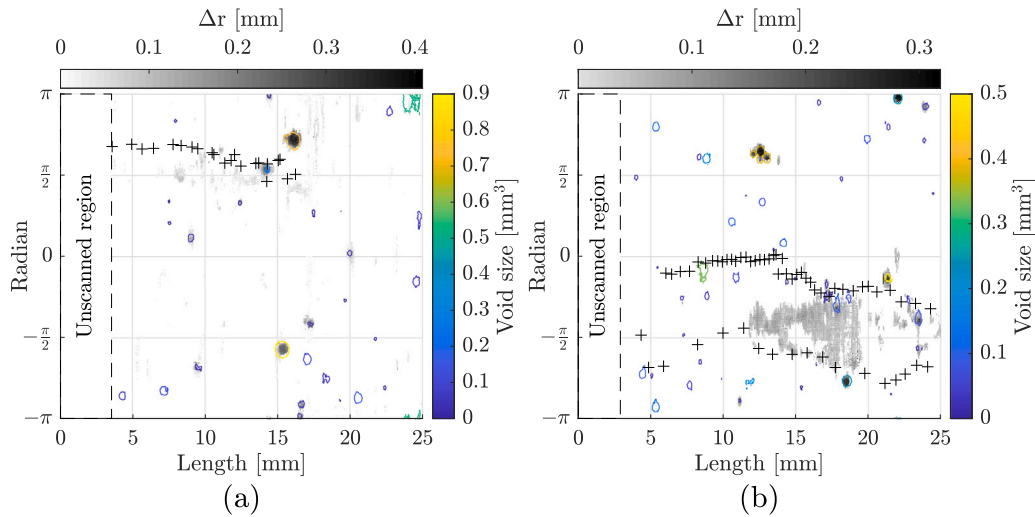
**Fig. 4.** Loss in steel radius, in greyscale, macroscopic interfacial voids, in colour, and location of mortar cracking at the SCI marked with plus-signs. The plotted size of the voids corresponds to the contact area with the steel while the colour represents their total size. (a) NX10B and (b) NX10C. (For interpretation of the references to colour in this figure legend, the reader is referred to the web version of this article.)

volume. Finally, the plus signs in the figure mark the location of cracks in the mortar in the vicinity of the steel.

The figure highlights how the corrosion morphologies are non-uniform, and are concentrated near cracks and in regions containing macroscopic interfacial voids. For NX10B, the average loss in steel radius for the corroded regions is 39 µm, while the highest loss in steel radius is 0.4 mm, located in a corrosion pit at a distance of 16.2 mm from the left bar end and at an angle slightly smaller than  $\frac{3\pi}{4}$  rad. The size of the void at this pit is 0.75 mm<sup>3</sup>.

For NX10C (Fig. 4b), corrosion is localised between two longitudinal cracks in the mortar. Similar to NX10B, pitting corrosion is observed in regions with macroscopic interfacial voids. The average loss in steel radius for the corroded regions of NX10C is 52 µm, somewhat higher than for NX10B. The highest reduction in steel radius (0.32 mm) is found in a pit, 22 mm from the left bar end at an angle of approximately  $\pi$  rad. As with NX10B, this pit is also located in a region with a macroscopic interfacial void, although the size of this void is significantly smaller (0.25 mm<sup>3</sup>).

An interesting observation in the figure is that not all macroscopic interfacial voids contain corrosion, possibly due to varying moisture content within these voids. Angst et al. [14] suggested that the moisture condition influences where pitting corrosion occurs. Fully or partially saturated voids tend to increase the risk of corrosion initiation within the void, while air-filled voids or those not in direct contact with the steel may lead to corrosion outside the void.

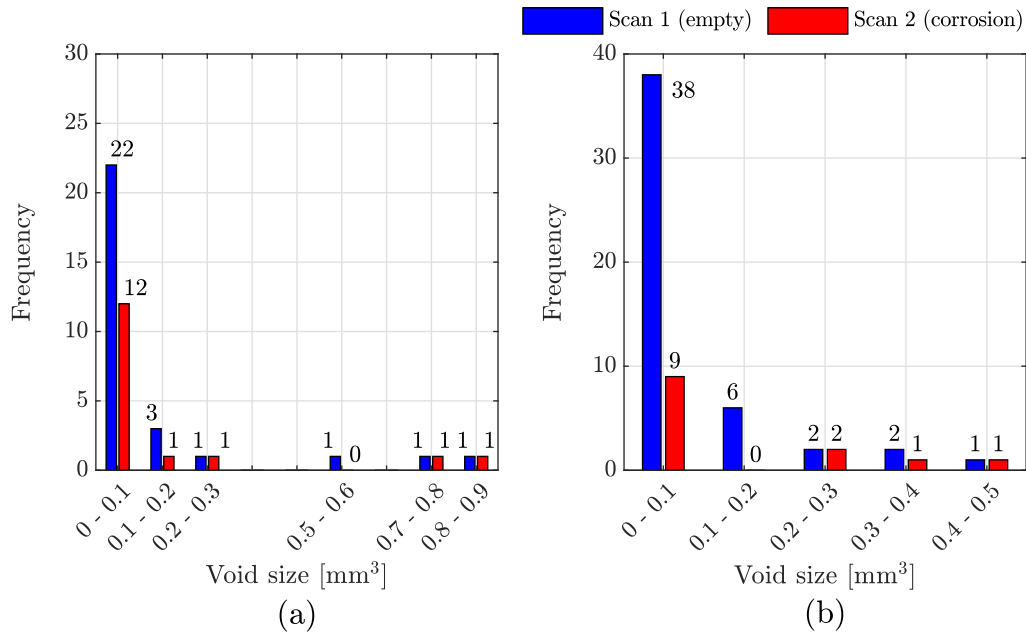
**Fig. 5.** Distribution of macroscopic interfacial void sizes at the SCI for (a) NX10B and (b) NX10C, showing empty voids (in blue) and voids containing corrosion products after the corrosion period (in red). (For interpretation of the references to colour in this figure legend, the reader is referred to the web version of this article.)

For NX10B, in Fig. 5a, 29 macroscopic interfacial voids were present at the SCI, out of which 22 (76%) had a volume smaller than 0.1 mm<sup>3</sup>. After the corrosion propagation period, corrosion products had accumulated in 12 of these voids (55%). Only 24% of the voids at the SCI had a volume larger than 0.1 mm<sup>3</sup>, however, almost all of these larger voids contained corrosion products in the subsequent tomography scan.

Although the largest macroscopic interfacial void for NX10C (Fig. 5b) is smaller than that for NX10B, the ratio of voids smaller than 0.1 mm<sup>3</sup> is 78%, which is very close to the ratio for NX10B. Despite this similarity, only 24% of these smaller macroscopic interfacial voids

were prone to accommodate corrosion products, a significantly lower percentage than for NX10B. The trend of corrosion accumulation in voids larger than 0.1 mm<sup>3</sup> was similar to that in NX10B, except for voids sized 0.1 to 0.2 mm<sup>3</sup>, where none contained any corrosion products after the second scan. These results are consistent with prior research, where it was found that the risk of corrosion initiation in voids at the SCI increases as the void size increases [12,13].

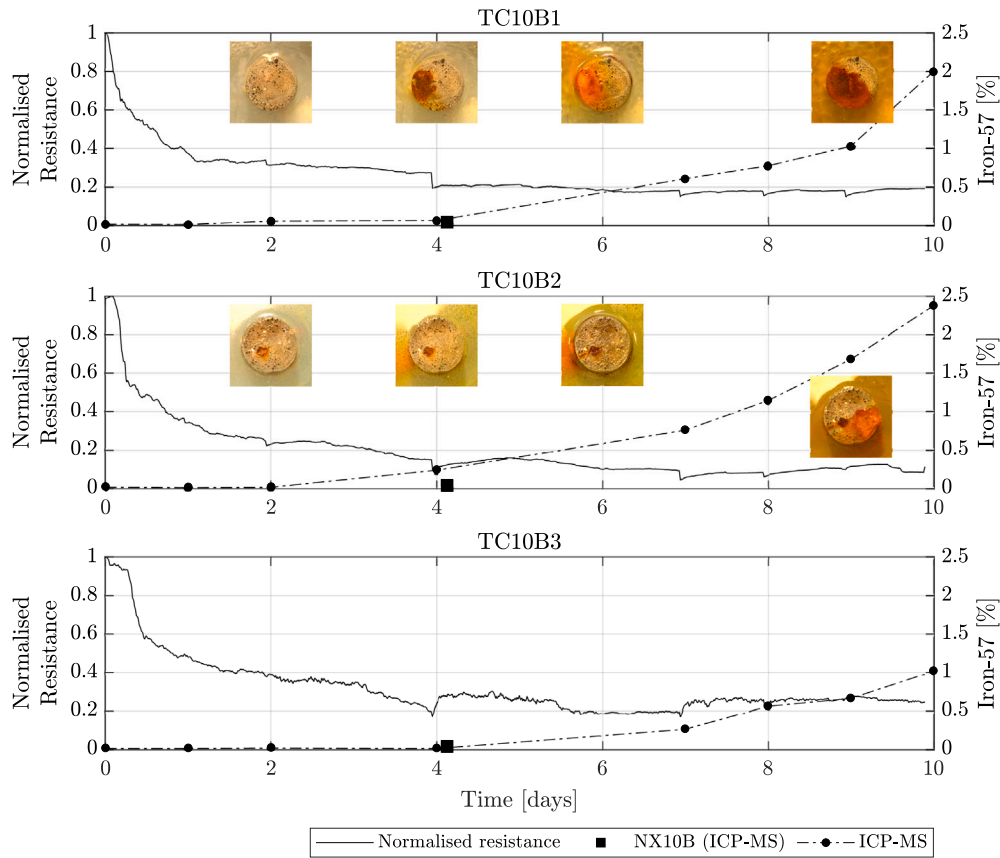
**Fig. 6.** Electrical resistance and Iron-57 concentration in the water surrounding specimens TC10B1-3 as a function of time. A single Iron-57 measurement (square) from the surrounding water of specimen NX10B at the time of the second tomography scans is also shown. The figure also reports top-view images of TC10B1-2 at 2, 4, 6 and 9 days of accelerated corrosion. (For interpretation of the references to colour in this figure legend, the reader is referred to the web version of this article.)

During the first four days of the experiment, the concentration of Iron-57 remained low for all specimens except for TC10B2, where the

concentration started to increase already after two days of impressed current. The top-view image of TC10B2 confirms the transport of corrosion products out of the specimen at this time, as corrosion products were visible on the top surface of the specimen.

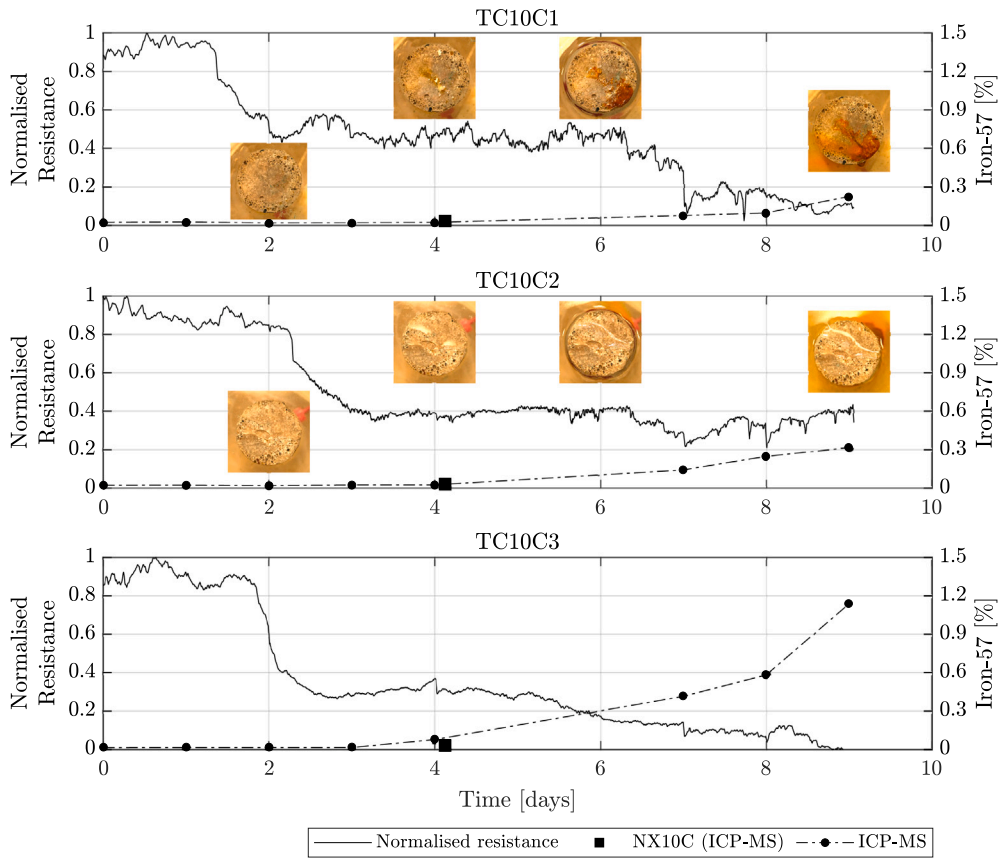
Fig. 7. Electrical resistance and Iron-57 concentration in the water surrounding specimens TC10C1-3 as a function of time. A single Iron-57 measurement (square) from the surrounding water of specimen NX10C at the time of the second tomography scans is also shown. The figure also reports top-view images of TC10C1-2 at 2, 4, 6 and 9 days of accelerated corrosion. (For interpretation of the references to colour in this figure legend, the reader is referred to the web version of this article.)

<sup>1</sup> In the top-view images of specimen TC10C2 (Fig. 7), a red electrical cable can be seen in the upper right corner. This cable might be mistaken for corrosion products; however, it is part of the experimental setup and does not represent actual corrosion.

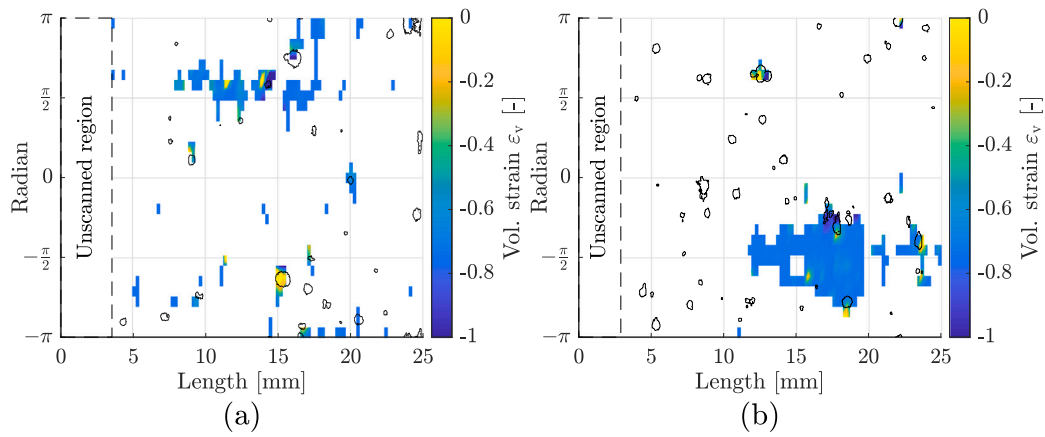
**Fig. 8.** Volumetric strain in the corrosion layer for (a) NX10B and (b) NX10C (coloured) and the location of macroscopic interfacial voids (black). (For interpretation of the references to colour in this figure legend, the reader is referred to the web version of this article.)

4. Phase segmentations of the samples were achieved using multimodal X-ray and Neutron Computed Tomography. Through this segmentation, the volumetric strain in the corrosion layer was estimated based on a relationship between the volume of compressed corrosion products and their free volume expansion. The average volumetric strain was found to be relatively high in both samples ( $\bar{\epsilon}_v = -0.69$  and  $\bar{\epsilon}_v = -0.68$ ).

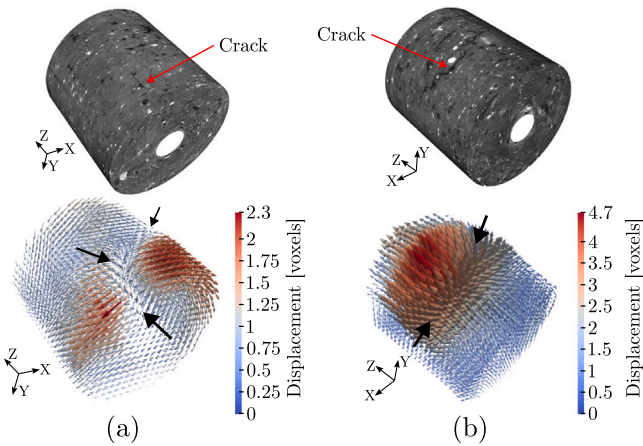
**Fig. 9.** Rendering of the XCT acquired after corrosion (top) and displacement field (bottom) for (a) NX10B and (b) NX10C. (For interpretation of the references to colour in this figure legend, the reader is referred to the web version of this article.)

Fig. 9 presents renderings of the XCT of the two specimens after the accelerated corrosion process (top) and the corresponding filtered displacement fields (bottom). Surface cracks are visible in both specimens. In this view, the crack in specimen NX10B can be seen to propagate longitudinally, while specimen NX10C exhibits a crack propagating in the transverse direction. The latter observation is noteworthy and unexpected, as corrosion-induced cracks typically propagate in the longitudinal direction of the steel. The presence of cracks in the specimens correlates well with the observed behaviour of the electrical resistance measurement (Fig. 2), where sudden drops, indicating a sudden change in resistivity of the samples, were recorded.

The displacement field of NX10B reveals the presence of the longitudinal crack. The width and orientation of this crack varies along the specimen. Similar local damage was also observed for NX10C.

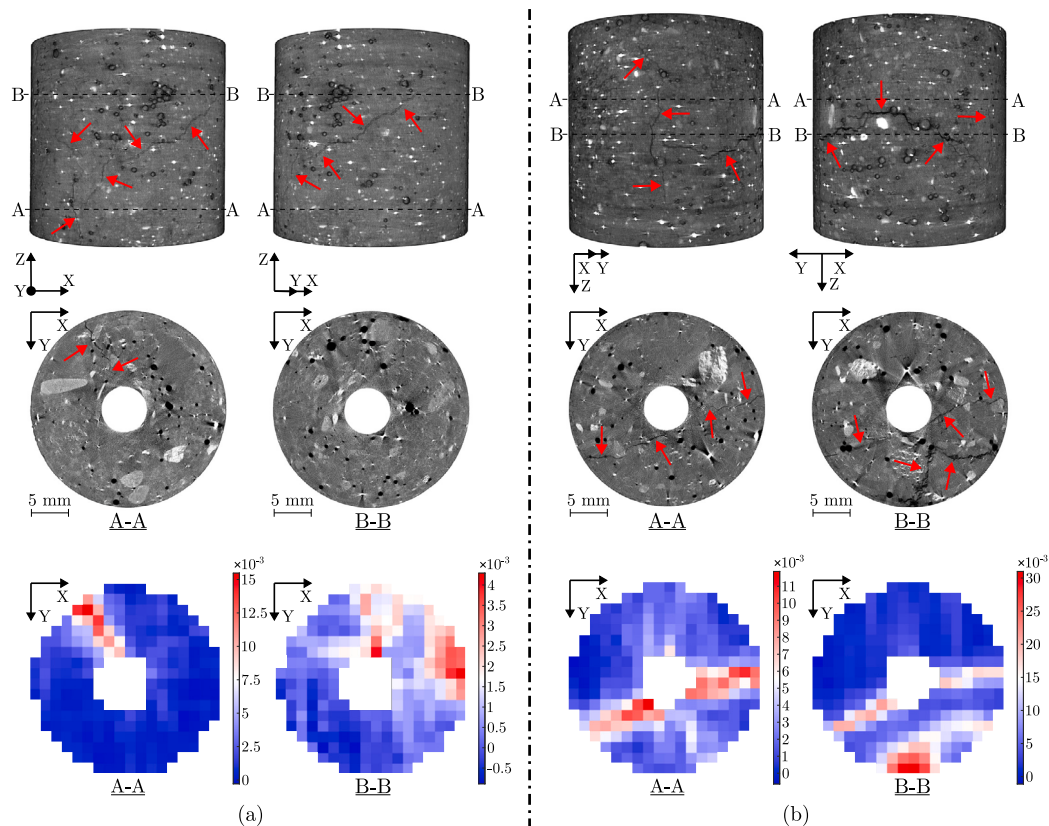
Fig. 10. Illustration of the orientation of mortar cracks at the surface (top), cross-sectional slices at different locations in the samples (mid) and the corresponding distribution of the first principal strain for (a) NX10B and (b) NX10C. Please note the different scales in the colourbars. (For interpretation of the references to colour in this figure legend, the reader is referred to the web version of this article.)

In Fig. 10, the orientation of the cracks at the surface of the two specimens are shown for a 3D rendering of each specimen. Arrows mark the location of mortar cracks as visible from the images. Furthermore, two cross-sectional slices of each specimen are shown along with the corresponding distribution of first principal strains (mid and bottom, respectively). For specimen NX10B and cross-section A-A, one radial crack is visible, and strain localisation can be seen in correspondence with this crack, which confirms the reliability of the DVC results. For cross-section B-B, the crack is partly identifiable at the surface and is hard to identify in the cross-section.

For specimen NX10C, a transverse crack is observed in between two longitudinal cracks, which are not as clearly visible. It is reasonable to assume that this transverse crack formed as to accommodate the dominant longitudinal cracking, most likely induced by a local weakness in the mortar. Similar to NX10B, strain localisation was measured in regions where cracks could be identified from the image data. The results from the DVC are consistent with previous studies [26,41], supporting the methodology as such for measuring corrosion-induced deformations.
