Corrosion Characteristics of Studsvik R2 Al-Alloy by Hydrogen Evolution Under Simulated Repository Conditions

Corrosion Characteristics of Studsvik R2 Al-Alloy by Hydrogen Evolution Under Simulated Repository Conditions – 25123

Marvin Schobel *, Christian Ekberg *, Teodora Retegan Vollmer *, Anders Puranen **

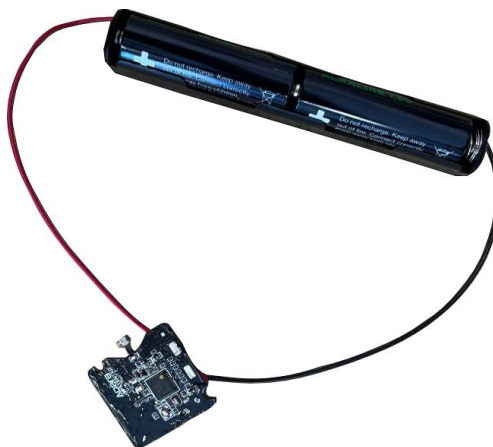
Temperature, humidity and pressure sensors (T1, Aqara, China) were dismantled. As the usual button cell for this type of sensor only lasted a few weeks under the humid and salty experimental conditions, a double AA battery pack was soldered to each sensor as a replacement. The sensor boards were coated to prevent failure due to moisture induced corrosion (Figure 1).

Figure 1: Modified pressure sensor with attached battery pack.

A Raspberry Pi single board computer (Zero WH v.1.1, Raspberry Pi Ltd., UK) was set up with a Zigbee-based broker and a Zigbee coordinator (CC2652R, Slaesh GmbH, Germany) was connected via USB. A Python script was written and used to automatically collect data from the modified sensors. The sensor wirelessly sent data when changes were detected.

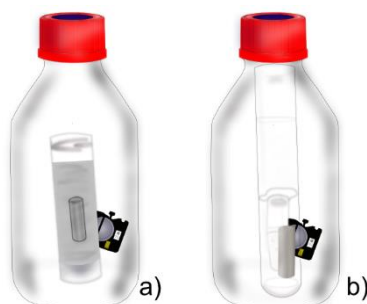
In concrete: 5 ml of concrete was filled into a 30 ml vial. The samples were immersed in the middle of the concrete layer which hardened for about five minutes until stable. The vial was filled up to 20 ml with concrete. It was then carefully filled into a 500 ml GL45 overpressure bottle (pressure plus+, DURAN Group GmbH, Germany) along with a modified sensor (T1, Aqara, China). The overpressure bottles can withstand an overpressure of up to 1.5 bar, and the sample size was selected so that the pressure build-up does not reach the limit even if the material would corrode completely. A silicone septum was used for the first tests. As it began to leak after a few weeks, it was replaced by a bromobutyl septum (DURAN group GmbH, Germany) in order to seal the bottle tightly and to be able to take gaseous (or liquid) samples when continuing the experiments. The bottle was sealed with a lid (DURAN group GmbH, Germany) (Figure 2a). The experiment was conducted in triplicate and repeated with pure aluminum as a reference.

In CW: A 30 ml vial was filled with 20 ml of the prepared CW with the CaO-containing Erlenmeyer tube. The samples were immersed in the CW and then added to the vial along with a modified sensor. The bottle was sealed with a bromobutyl septum and closed with a lid (Figure 2b). The experiment was performed in triplicate and repeated with pure aluminum as a reference. Data was collected over a period of up to 8 months.

Figure 2: Experimental setup. a) Vial with sample immersed in concrete in overpressure bottle with bromobutyl septum and lid. b) Vial with sample immersed in CW with pressure sensor in bottle with bromobutyl septum and lid.

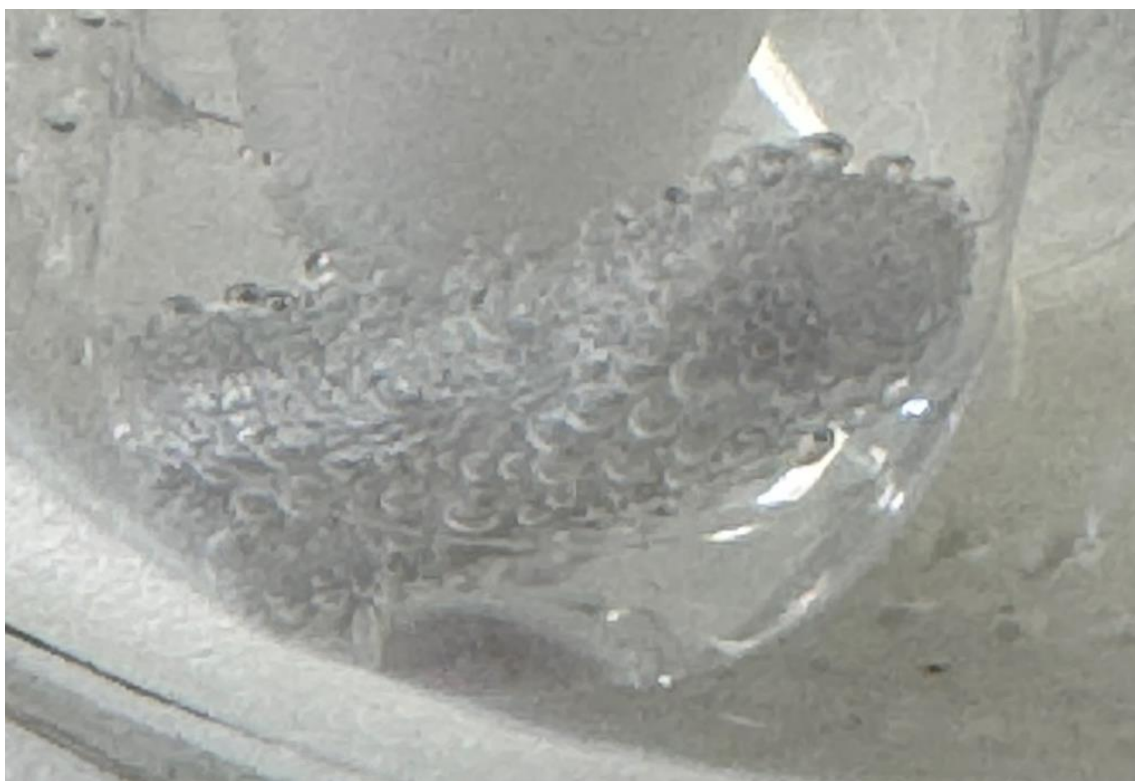
Figure 3: Rapid hydrogen evolution on the surface of the R2 alloy in CW.

Figure 3 shows a sample rod of the R2 reactor alloy immediately after starting the experiment caused by the rapid hydrogen evolution while forming the oxide layer. Figure 4 shows the calculated corrosion rates in $\mu\text{m/y}$ of the R2 reactor vessel alloy and a pure aluminum metal as a reference for a period of four weeks in concrete including an insert over lower corrosion rates and a shorter time span. While some of the sensors stopped working, those samples could still be used for mass loss evaluation and analysis of the corrosion products. Standard deviations in all figures were calculated from triplicates and averages over the specific time intervals. The data was extrapolated to 24 weeks with a power fit, considering data from individual samples run over longer periods of time. The initial corrosion rates for both the R2 alloy and the metal are immediately in the order of hundreds of thousands $\mu\text{m/y}$ (outside the scale of Figure 4) and have high uncertainties caused by the immediate onset of corrosion, which varies due to slight variations in sample preparation and the calculation of time-dependent averages of corrosion rates. Rates for both materials start to drop sharply after the first few hours, then level off and drop to a corrosion rate of $434 (\pm 178) \mu\text{m/y}$ after 4 weeks for the R2 alloy. The rate of pure aluminum slowed down to $606 (\pm 222) \mu\text{m/y}$ after 4 weeks. The fit also confirms the trend that the aluminum metal corrodes faster than the R2 alloy.

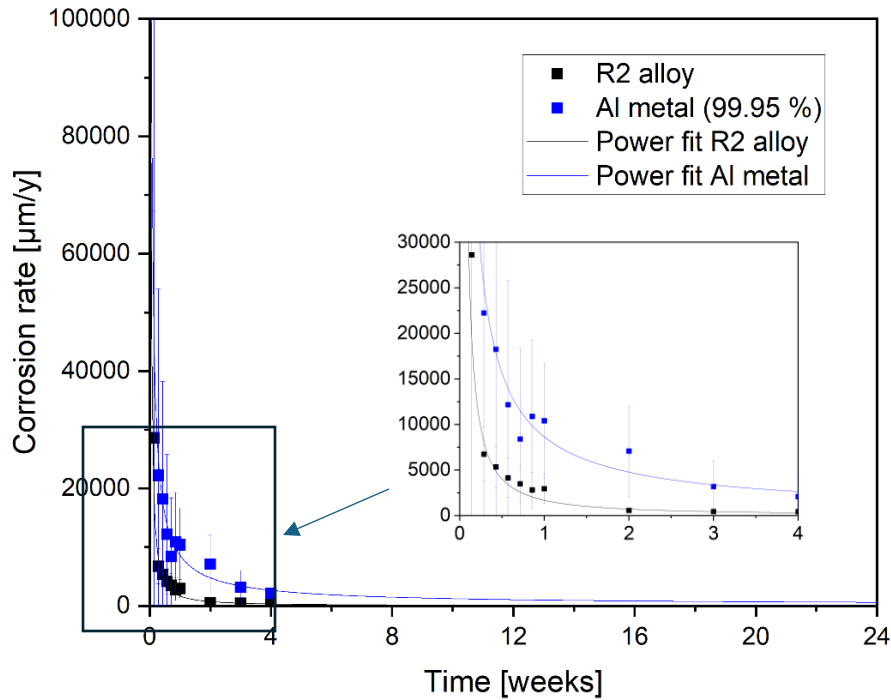
Figure 4: Corrosion rates and extrapolation of R2 reactor alloy and aluminum metal up to 24 weeks in concrete. Insert on lower corrosion rates.

The corrosion rates of the samples in concrete (Figure 4) slowed down less rapidly than in the CW (Figure 5), which could indicate less aggressive conditions in the concrete. In addition, the long-term trend of corrosion rates in concrete (Figure 4) indicates faster corrosion trends for the aluminum metal compared to the R2 reactor alloy, most likely due to the purity of the rapidly corroding aluminum under alkaline conditions [1, 4, 6, 9, 10]. In CW, pure aluminum and the R2 reactor alloy show similar corrosion rates. However, there is a slight trend that is consistent with the results of the experiment in concrete. The calculated surface layer thicknesses also indicate faster corrosion of pure aluminum in both concrete and CW.

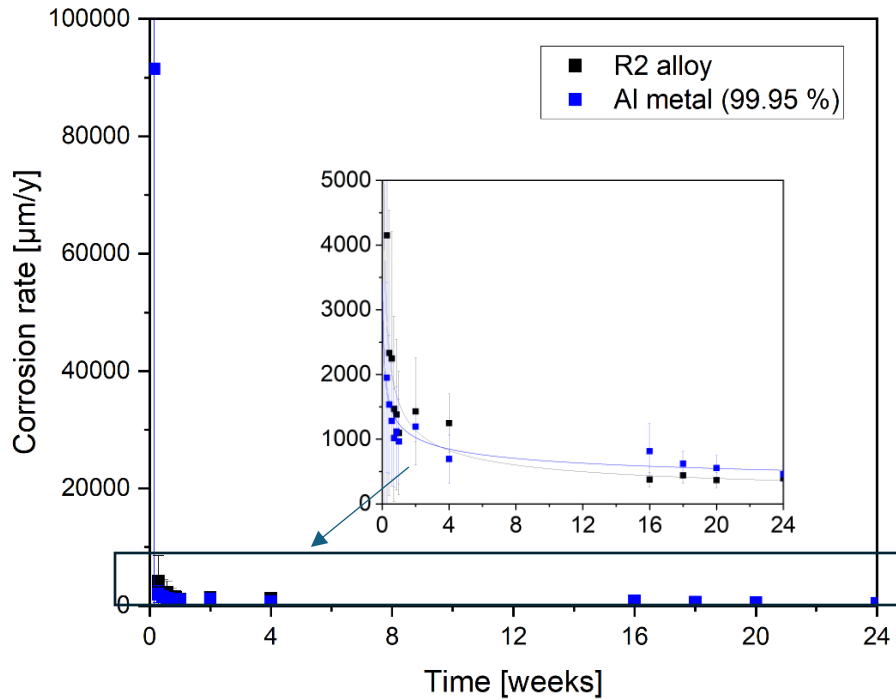
Figure 5 shows the corrosion rates of the R2 reactor alloy and the pure aluminum metal in artificial cement water over a period of 24 weeks. The initial corrosion rates are extremely high and subject to large uncertainties, which was also observed for the samples in concrete. The missing data between weeks 4 and 16 is due to a change in the sensor's battery system. The corrosion rate of the R2 reactor alloy decreased to $397 (\pm 114) \mu\text{m}/\text{year}$, while that of the pure aluminum decreased to $458 (\pm 127) \mu\text{m}/\text{year}$ after 24 weeks. The power fit also slightly indicates a trend for the aluminum metal to corrode faster than the R2 alloy as the curve flattens out with longer term corrosion.

Figure 5: Corrosion rates of R2 reactor alloy and aluminum metal up to 24 weeks in CW. Insert on lower corrosion rates.

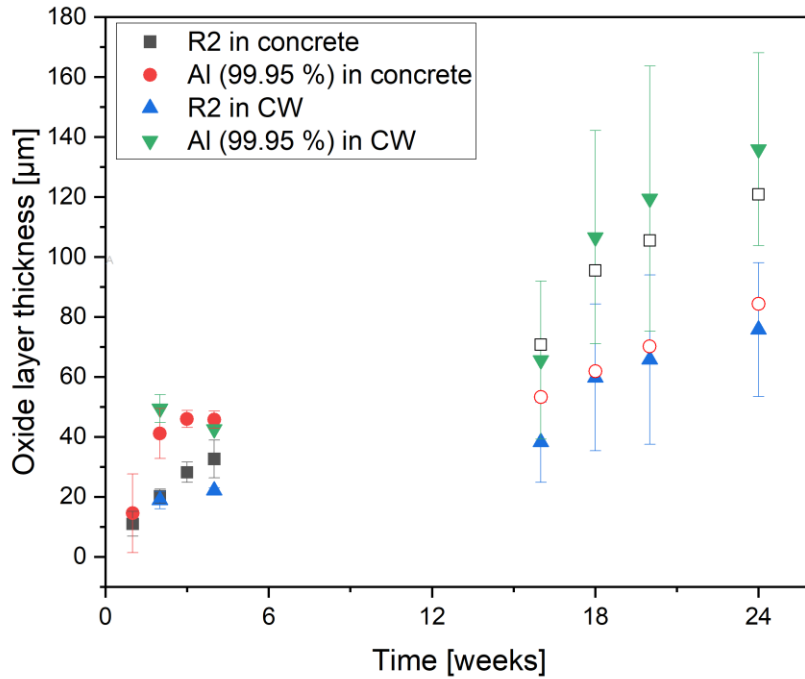
The thicknesses of the surface layers of the samples were calculated from the hydrogen evolution and can be seen in Figure 6. The R2 reactor alloy in concrete had a layer thickness of $20 (\pm 2) \mu\text{m}$ after 2 weeks and a thickness of $33 (\pm 6) \mu\text{m}$ after 4 weeks. For CW, the actual rates after 24 weeks can only be estimated as the sensors did not measure when the battery method was changed. Open symbols are single samples without replicates. The R2 alloy had a calculated layer thickness of $62 (\pm 6) \mu\text{m}$ after 2 weeks and more than $78 (\pm 26) \mu\text{m}$ after 24 weeks. Pure aluminum had a surface layer thickness of $41 (\pm 8) \mu\text{m}$ after 2 weeks and $46 (\pm 3) \mu\text{m}$ after 4 weeks in concrete and $49 (\pm 5) \mu\text{m}$ after two weeks and $136 (\pm 40) \mu\text{m}$.

Figure 6: Calculated layer thickness of the R2 alloy and pure aluminum in concrete and in CW.

The oxide layer thicknesses are consistent with the trend of pure aluminum corroding faster than the R2 reactor alloy in CW. No conclusions can be drawn about the corrosion in concrete and the similarity of the conditions in CW and concrete as the samples in concrete are not available in replicates for data over longer periods of time and the values are within a possible uncertainty range.
