Schobel, M., Ekberg, C., Retegan Vollmer, T. et al (2025). Study of Corrosion Characteristics of AlMg3.5 Alloy by Hydrogen-Induced Pressure and Mass Loss Evaluation Under Simulated Cementitious Repository Conditions. Corrosion and Materials Degradation, 6(3): 27-. <http://dx.doi.org/10.3390/cmd6030027>

# Study of Corrosion Characteristics of AlMg3.5 Alloy by Hydrogen-Induced Pressure and Mass Loss Evaluation Under Simulated Cementitious Repository Conditions

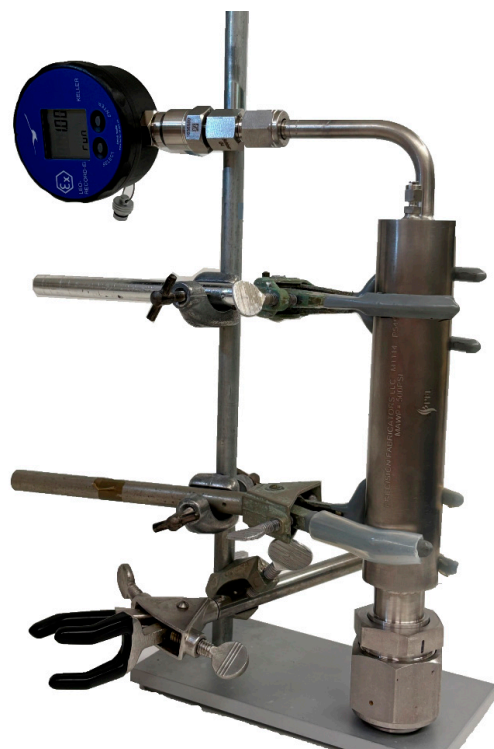
**Figure 1.** Pressure vessel setup for hydrogen pressure measurements. Customized steel autoclave with pressure gauge designed for hydrogen use.

**Pressure measurements.** Samples were immersed in 20 mL of concrete in plastic test tubes and stored in 165 mL pressure vessels (Precision Fabrication LLC, Ligonier, IN, USA) (Figure 1). Leak tests were repeatedly performed with a semi-conductor hydrogen detector (Multitec 540, Sewerin, Gütersloh, Germany), with no indication of leakages. The pressure was measured with a pressure gauge designed for hydrogen use (LEO-Record-H2Ei, Keller, Basel, Switzerland). The measured pressure was observed in PressureSuite (Keller, Switzerland). The sample size was selected so that the possible pressure of full corrosion of the samples would not exceed the operating pressure (3447 kPa) of the vessels (design pressure 6895 kPa). The experiment was conducted in duplicates at room temperature (ca. 19 °C).

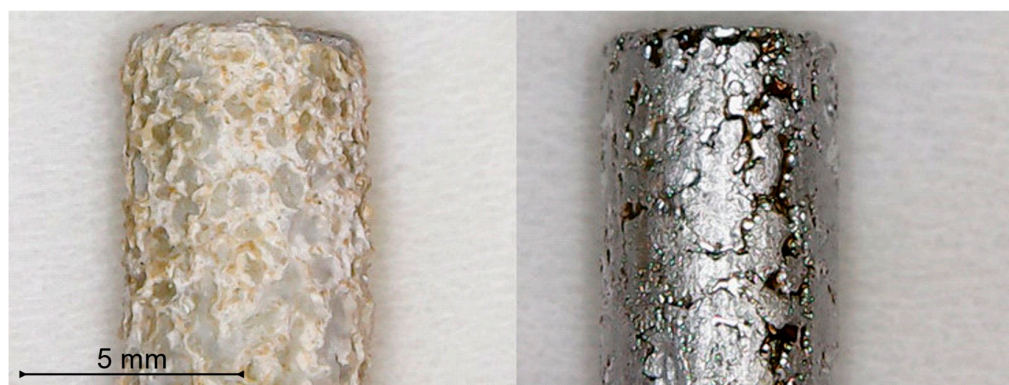
**Figure 2.** Retrieved R2 alloy sample after one year of exposure embedded in concrete (left) and sample after fully removing concrete residues and oxide (right).

**Mass loss evaluation.** Separate samples in triplicates were immersed in concrete and CW in unpressurized containers at room temperature and were exposed for one to twelve months. Afterwards, destructive measurements were conducted by cracking open the concrete and pickling the samples. Full removal of the concrete and oxide layer was performed by pickling the samples in an ultrasonic bath (Thermo Fisher Scientific, Waltham, MA, USA) for 20 min in 20% nitric acid. Thereafter, the samples were soaked in silicon oil for about 24 h to soften and loosen residues of the oxide layer. The residues were carefully scraped off and the samples were pickled in 20% nitric acid again. This process was repeated until no further mass loss was registered. The samples were cleaned in acetone, dried, and weighed, and the mass loss was determined by weighing. Figure 2 shows a sample after one year of exposure in concrete (left) and after fully removing the concrete and oxide layer (right).

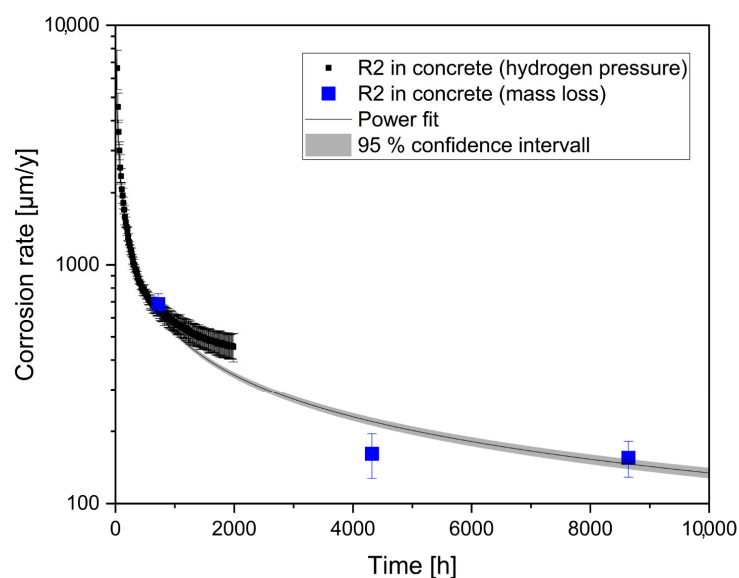
**Figure 3.** Corrosion rate of R2 alloy in concrete over a time period of 2000 h calculated by  $\text{H}_2$ -induced pressure (black) in logarithmic scale. Uncertainties calculated from sample duplicates as standard deviations with Bessel's correction. Corrosion rate of R2 alloy in concrete calculated by mass loss evaluation (blue). Uncertainties calculated from sample triplicates. Power fit with 95% confidence interval to highlight compatibility of methods.

The corrosion rates from the gas pressure measurements in  $\mu\text{m}/\text{y}$  of the R2 alloy in concrete over a time period of 2000 h are shown in black in Figure 3. Uncertainties were calculated, using duplicates of the samples in identical setups, as standard deviations with Bessel's correction. The corrosion rates start at very high values of more than 10,000  $\mu\text{m}/\text{y}$  and then decrease significantly after only a few days. After 2000 h, the rate is below 500  $\mu\text{m}/\text{y}$ . The blue points are the corrosion rates of the R2 alloy calculated by mass loss evaluation after six months and one year. The rates were 684  $\mu\text{m}/\text{y}$  after one month, 161  $\mu\text{m}/\text{y}$  after six months, and 155  $\mu\text{m}/\text{y}$  after one year. A power fit with a 95% confidence interval is shown to highlight the compatibility of both methods.

The corrosion rates of the alloy in concrete up to 2000 h are shown in Figure 3. High corrosion rates in the beginning come with higher uncertainties due to the immediate start of the corrosion [1,6,7,19]. Small time differences in starting the experiment in the setup can quickly lead to high uncertainties, which diminishes as the experiment proceeds. The high corrosion rates of more than  $10,000 \mu\text{m}/\text{y}$  are assumed to be caused by the early formation of an oxide layer on the sample surface, mainly composed of amorphous  $\text{Al}_2\text{O}_3$  in acute corrosion and crystalline  $\text{Al}(\text{OH})_3$  in chronic corrosion [1,6–8,19]. The rates decreased strongly only after a few hours because the oxidation layer functioned as protection and therefore as a natural prevention of further rapid corrosion rates [1,6–8,19]. Corrosion

slowed down constantly afterwards. Other factors contributing to the decrease in the corrosion rate, such as the dehydration of concrete, precipitation of  $\text{Ca}(\text{OH})_2$ , or changes in pH due to corrosion processes, were assumed to be negligible due to the given W/C ratio in the experiments and the limited amount of exposure time [20,21].

The corrosion rates of the R2 alloy calculated by mass loss evaluation are shown in Figures 3 and 4 after the samples were exposed for six months and one year in concrete and CW. The higher corrosion rates after this period of time for the samples in concrete compared to those in CW were consistent with the results of the  $\text{H}_2$  pressure-induced calculations and with the findings of the previous study [19]. However, the corrosion rates in both media, concrete and CW, were relatively low and the differences between them were considered to be negligible in the long term (several years), which is consistent with the conditions of the artificial cement–water replicating those of weathered cement in crystalline bedrock, and represents longer-term exposure than that with the fresh cement [3,23–25]. To compare the corrosion rates in concrete calculated by  $\text{H}_2$ -induced pressure and by mass loss evaluation, a power fit was used. After one month in concrete, the extrapolated corrosion rate was  $650 \mu\text{m}/\text{y}$ , while the one calculated by mass loss was  $684 \mu\text{m}/\text{y}$ . After six months, the extrapolated rate was  $220 \mu\text{m}/\text{y}$ , which is slightly higher than the rate calculated by mass loss. However, after 12 months, the extrapolated rate was  $147 \mu\text{m}/\text{y}$ , which is in the uncertainty range of the mass loss evaluated rate. The difference after six months could be considered to be caused by the long-term extrapolation. Overall, the lower corrosion rates in CW compared to concrete due to the additional protection from hydrogen bubbles and the lower pH were also seen in the mass loss evaluation. The trends were consistent with the previous study on the same material with the simplified overpressure bottle setup [19].

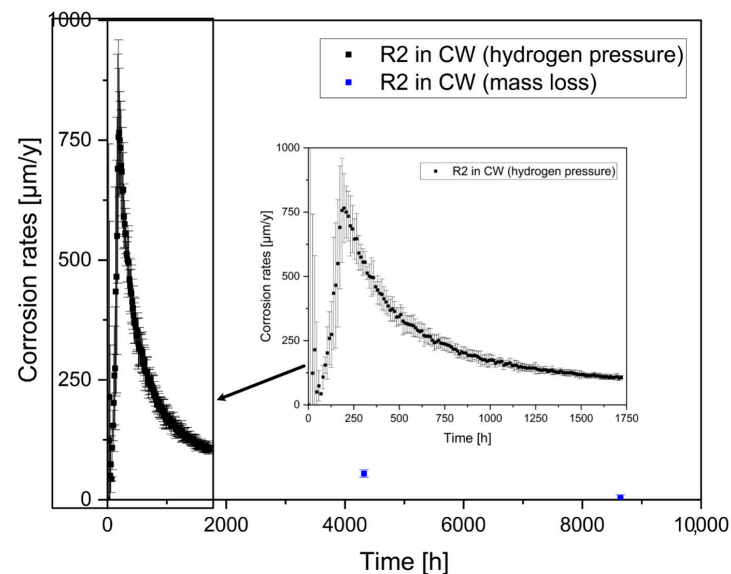
**Figure 4.** Corrosion rate of R2 alloy in CW over a time period of 1700 h calculated by  $\text{H}_2$ -induced pressure (black). Uncertainties calculated from sample duplicates as standard deviations with Bessel's correction. Cutout shows the rates detailed. Corrosion rate of R2 alloy in CW calculated by mass loss evaluation (blue). Uncertainties calculated from sample triplicates.

The corrosion rates of the R2 alloy in CW over a period of 1700 h are shown in black in Figure 4. Uncertainties were calculated using duplicates of the samples as a standard

deviations with Bessel's correction. A closer view of the early rates can be seen in the cutout. The corrosion rates have high uncertainties initially. After approximately 100 h, they start to rise up to 800  $\mu\text{m}/\text{y}$ , while the uncertainties decrease. Afterwards, a decrease is noticeable, to rates of approximately 100  $\mu\text{m}/\text{y}$ . The blue points represent the corrosion rate of the R2 alloy in CW calculated from mass loss evaluation after six months and after one year. The corrosion rates were 55  $\mu\text{m}/\text{y}$  after six months and 3  $\mu\text{m}/\text{y}$  after one year.

The corrosion rates of the R2 alloy in CW calculated using the build-up of hydrogen pressure are shown in Figure 4. The cutout shows a closer view after 1700 h of exposure time. Strong uncertainties were detected in the initial stage of the experiments. This was most likely caused due to small differences between the replicates in the preparation times of the experiments and also due to the initial formation of hydrogen bubbles on the surface of the samples [19]. These could, depending on the relative coverage of the surface, prevent the alloy from rapid corrosion. After approximately 100 h, the corrosion rate increased rapidly up to rates of  $800 \mu\text{m}/\text{y}$ , which might be caused by the release of the hydrogen bubbles and therefore the disappearance of the potentially protective gas layer. Acute corrosion and the formation of the oxide layer lead to a strong increase in the corrosion rate [1,6–8,19]. Another factor with a smaller impact on the delayed increase in the corrosion rates could be the diffusion of hydrogen in the cement–water solution [22]. After only a short period of time, the corrosion rates decreased again due to the protection provided by the oxide layer of the sample surface [1,6–8,19]. The overall lower corrosion rates in the simulated old cement–water compared to the concrete are consistent with the slightly higher pH in the concrete and our previous report on the R2 alloy [19]. This is also supported by a linear dependency between corrosion in CW and concrete, with  $R^2 = 0.98$  after 225 to 500 h, as seen in Figure 5. It can be assumed that the CW conditions predict the corrosion rate in concrete in the longer term. A study showed significantly higher corrosion rates at the beginning of their experiment [19]. This could not be seen in the present study and can be explained by the longer preparation time after exposure in the setup and, therefore, the decrease in the initial corrosion rates. Fluctuations due to the hydrogen bubbles were also not seen in the previous study [19]. This can be explained by the higher sensitivity of the setup used in this study and the corrosion rates being the average of specific time spans in the previous study, which most likely canceled out the effect observed.

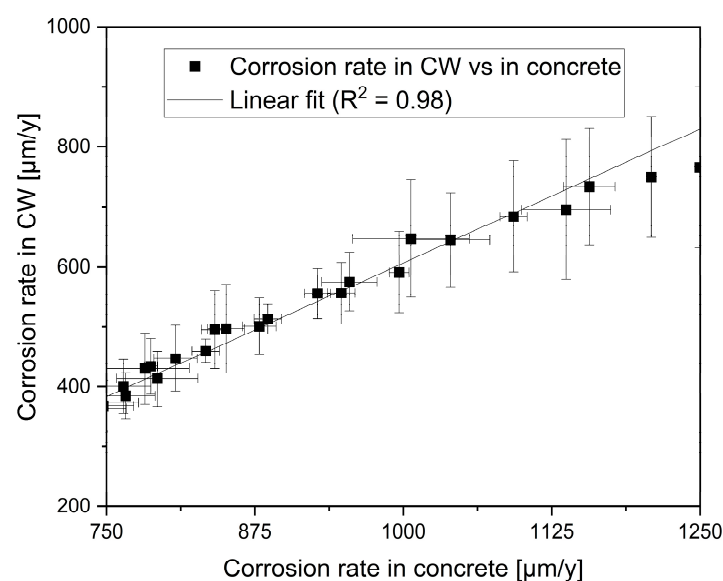
**Figure 5.** Corrosion rate in CW against corrosion rate in concrete over a time span of ca. 275 h between 225 and 500 h of exposure to highlight linear dependency. Uncertainties calculated from sample duplicates as standard deviations with Bessel's correction.

The corrosion rates in CW were plotted against the corrosion rates in concrete in Figure 5. A time span of approximately 275 h between 225 and 500 h of exposure time was chosen. The uncertainties were calculated as standard deviations with Bessel's correction from the sample duplicates. A linear trend with  $R^2 = 0.98$  was fitted to highlight the linear dependency of the corrosion of the R2 alloy in both media.
