THESIS FOR THE DEGREE OF LICENTIATE OF ENGINEERING

Corrosion of AlMg3.5 alloy from Studsvik R2 reactor under
simulated cementitious repository conditions

Technical report no 2025:10

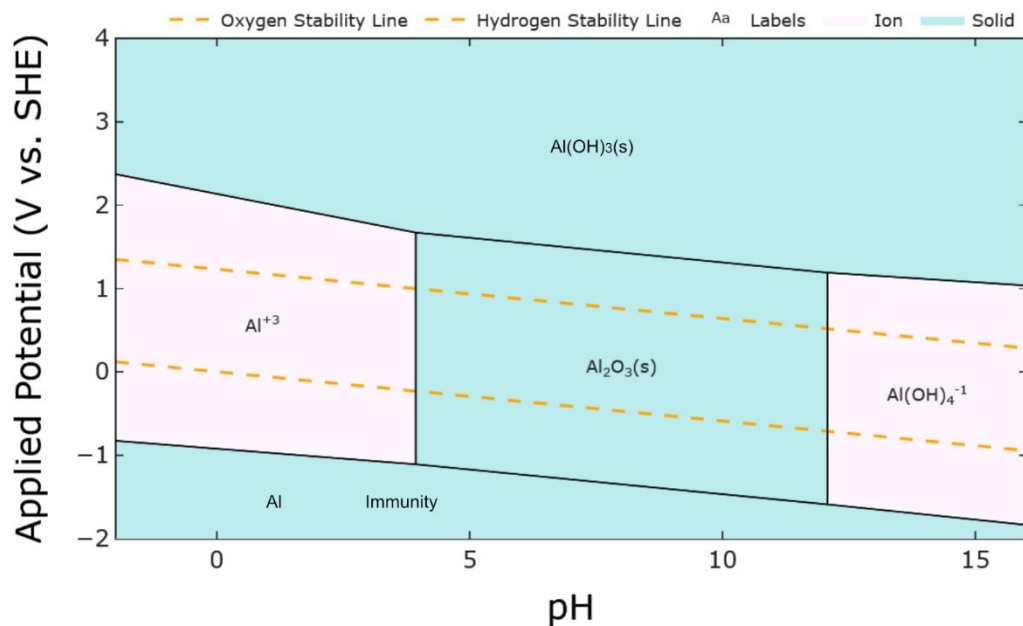
Figure 1: Pourbaix diagram of aluminum with a concentration of 10^{-3} mol, pH ranging from 0 - 16 and potential from -2 to 4. Ions are shown in grey, solid products in green. Dashed lines show the oxygen stability (top) and hydrogen stability lines [30-33].

$\text{Al}(\text{OH})_3$ (Eq. 1-3) [1, 6-9, 23]. A Pourbaix diagram of aluminum is shown in Figure 1. The main driver of the eventual dissolution of the oxide layer under high pH conditions is believed to be the $[\text{Al}(\text{OH})_4]^-$ ion (Eq. 4) which also works as the main phase of the aluminum corrosion product under repository conditions [23]. Metallic aluminum is only stable at highly reducing conditions. This is also clear from Figure 1.

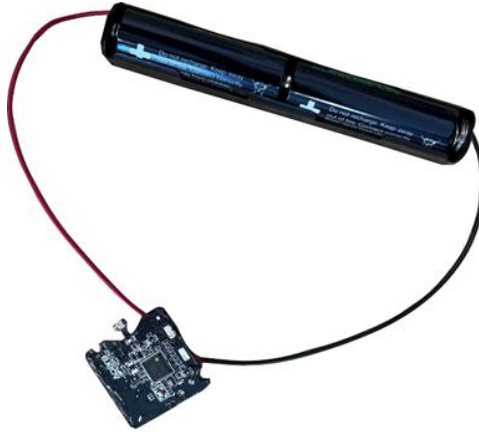
Figure 3: Pressure, humidity and temperature sensor board with attached battery pack [7].

For further studies, the pressure bottle setup will be used, along with the pressure vessels, to study corrosion characteristics for different materials. To improve the bottle setup, the sensor system was replaced by a temperature, humidity and pressure sensor (BME280, Bosch, Germany) on a sensor board (Seeed, China) and connected to a single board computer (ESP32-WROOM-32E, Espressif Systems, China) that sends data points for given time spans.

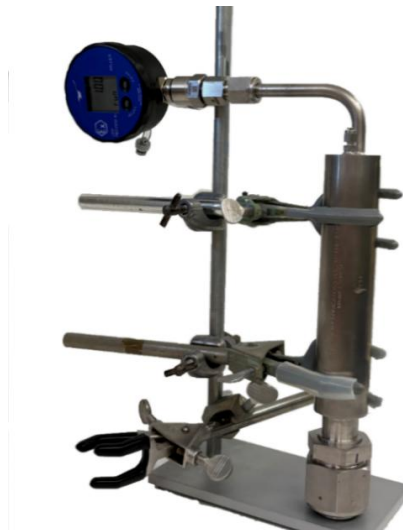
Figure 4: Pressure vessel setup for hydrogen pressure measurements [8].

The samples were immersed in 20 ml of concrete using the same process as for the pressure bottle experiments. The sample tubes were inserted in 165 ml pressure vessels (Precision Fabrication LLC, USA) as seen in Figure 4. The pressure measurements were performed with a pressure gauge designed for hydrogen use (LEO-Record-H₂Ei, Keller, Switzerland). The size of the sample was chosen accordingly to the operating pressure of the vessels of 3447 kPa (test pressure 6895 kPa). Experiments were conducted at room temperature.

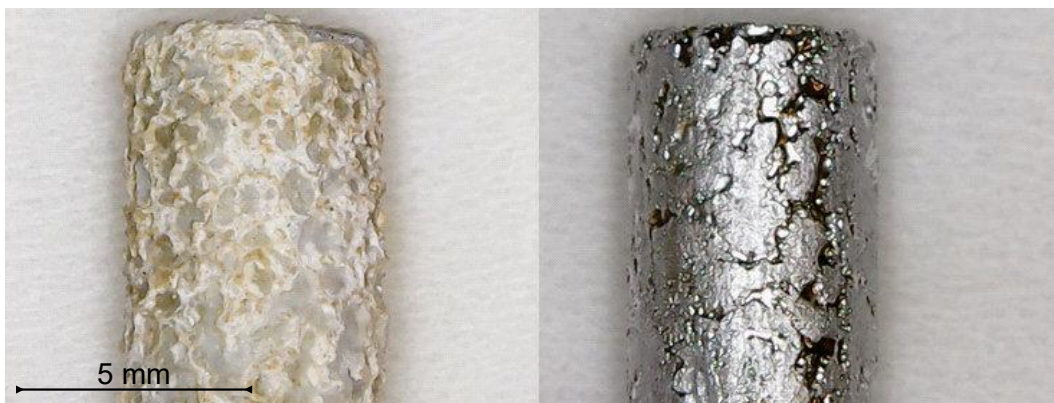
Figure 5: Corroded sample after 1 year exposure time (left) and sample after fully removing concrete residues and oxide (right) [8].

Separate metal samples were placed in unpressurized plastic cups immersed in concrete and CW and exposed until undergoing destructive examination after months up to years of exposure. For destructive measurements, the containers were removed, and the concrete was cracked open. To remove concrete residues and the produced oxide, the samples were pickled for 20 minutes in 20 % nitric acid using an ultrasonic bath (Thermo Fisher Scientific, USA). Afterwards, they were soaked in silicon oil for approximately 24 hours to soften and loosen residues of the oxide layer. The layer was carefully scraped off and the pickling procedure was repeated. These steps were repeated until no mass loss was registered anymore. Full removal of the oxide was also confirmed with a portable microscope. Microscope pictures before (left) and after the removal of the oxide layer (right) are shown in Figure 5.

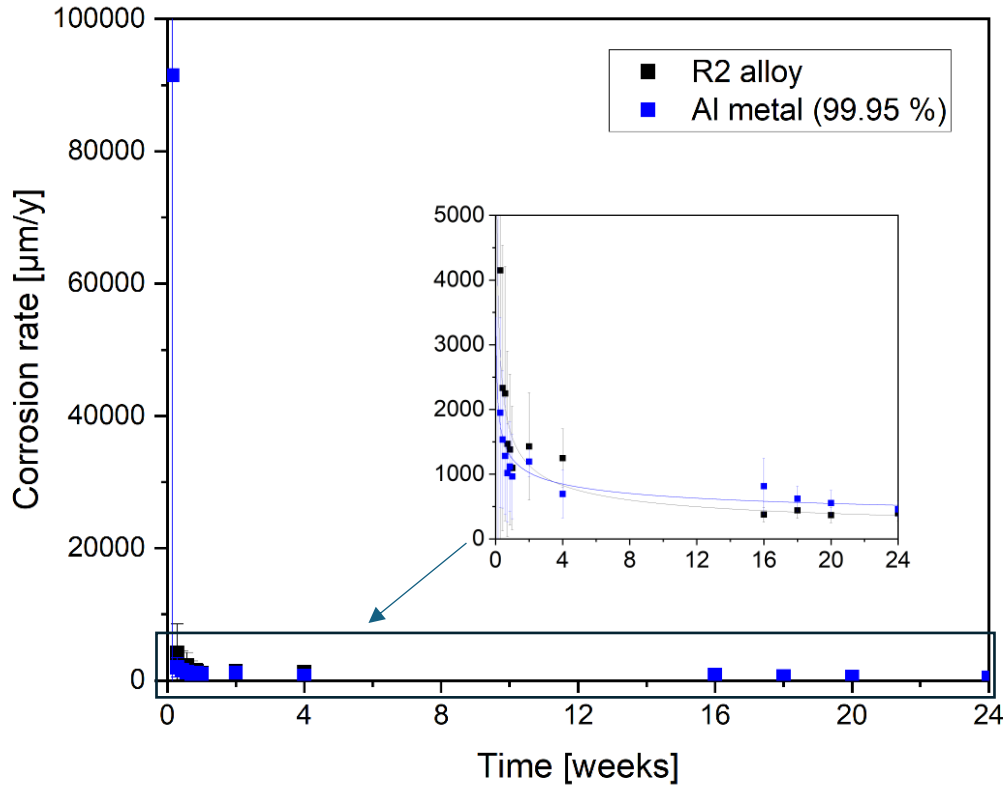
Figure 8: Corrosion rates in $\mu\text{m/y}$ of R2 alloy and aluminum metal in CW. Data measured up to 24 weeks. Cutout to lower corrosion rate and shorter time span [7]. Power fit of hydrogen pressure data according to [44].

The corrosion rates of the R2 alloy in artificial CW also showed extremely high initial values with high uncertainties as seen in Figure 8. Missing data between weeks 4 and 16 was caused by a change of the battery system. The R2 alloy showed corrosion rates of $397 \pm 114 \mu\text{m/y}$ while the pure aluminum corroded faster at $458 \pm 127 \mu\text{m/y}$ after 24 weeks. On long-term, the power fit also suggests that the aluminum metal corrodes slightly faster than the R2 alloy.

Long-term corrosion rates in concrete (shown in Figure 7) slowed down less rapidly compared to CW (shown in Figure 8) and long-term trends for the R2 alloy in concrete suggest slower

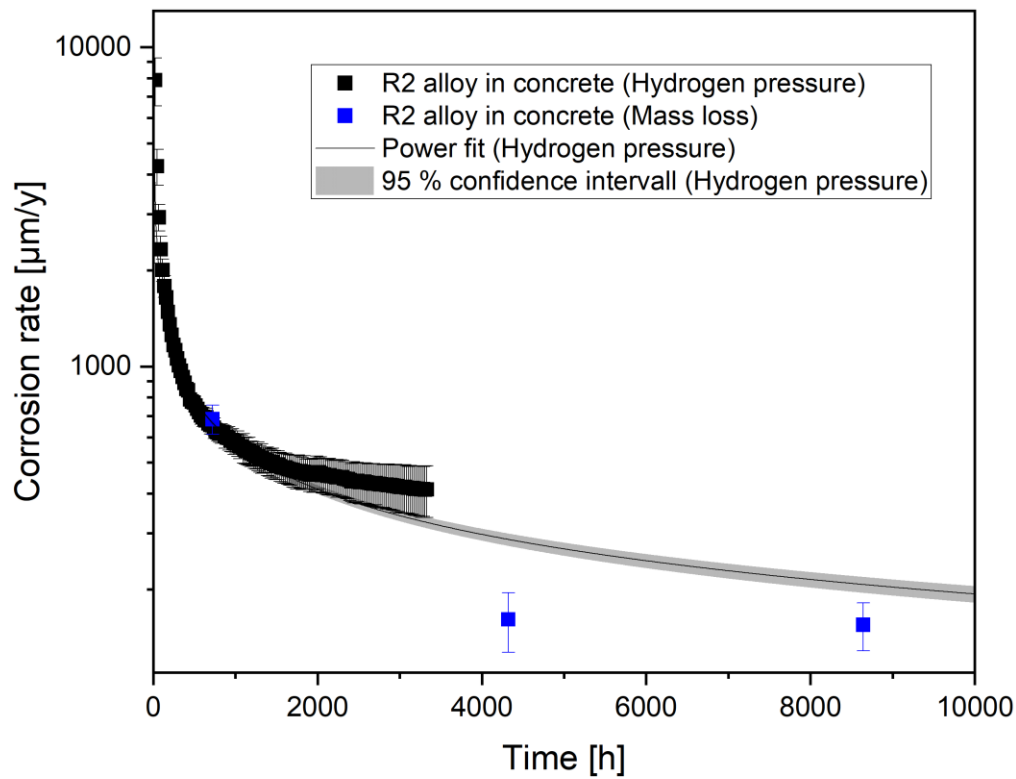
Figure 9: Corrosion rate of R2 alloy in concrete over a time period of 3300 hours calculated by H₂-induced pressure (black). Uncertainties calculated from samples duplicates as standard deviation with Bessel's correction. Corrosion rate of R2 alloy in concrete calculated by mass loss evaluation (blue). Power fit of hydrogen pressure data with 95 % confidence interval according to [44] (continued data from [8]).

Corrosion rates in $\mu\text{m/y}$ over a time span of 3300 hours of the R2 alloy in concrete measured by H_2 -induced pressure and mass loss evaluation are shown in Figure 9. The rates were initially very high exceeding 10000 $\mu\text{m/y}$ and then dropped significantly after a few days. After 2000 hours, the corrosion rate was below 500 $\mu\text{m/y}$ and after 3300 hours it was 400 $\mu\text{m/y}$. Mass loss evaluation showed rates of 684 ± 73 $\mu\text{m/y}$ after 1 month, 166 ± 34 $\mu\text{m/y}$ after 6 months and 155 ± 26 $\mu\text{m/y}$ after 1 year. A cutout is showing a logarithmic scale and a power fit to highlight the comparability of the results of the respective methods.

The corrosion rates were measured during a time span of 2000 hours as shown in Figure 9. High corrosion rates of up to 10000 $\mu\text{m}/\text{y}$ in concrete were consistent with the early formation of the oxide layer in acute corrosion [1, 6-9]. The corrosion rates in the pressure bottle setup were much higher, which can be explained through the faster preparation time of the sample. An initial fast, and with passing time, more constant decrease of the corrosion rates was also consistent with the pressure bottle setup and previous studies [1, 6, 7, 9]. The high initial corrosion rates in both setups were consistent with the early formation of gas-pressure-induced channels in the concrete as seen in Figure 6. These could become pathways for radionuclides [1, 2, 4, 6-8, 10, 28].

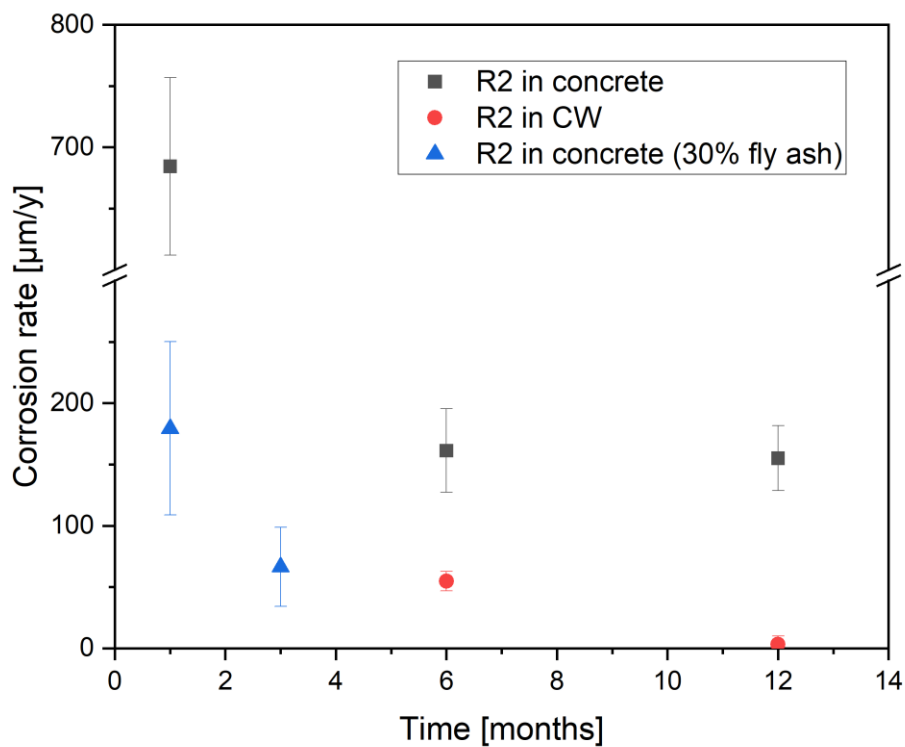
Figure 12: Corrosion rates of R2 alloy in ordinary concrete (black), with 30 % fly ash replacement (blue) and in CW (red) after 1, 3, 6 and 12 months discovered via mass loss evaluation. Uncertainties by standard deviation of triplicates.

The corrosion rate of the R2 alloy in ongoing experiments after 1 month exposure in concrete with Portland cement replaced 30 % by fly ash (CEM II/B-V) is shown in Figure 12. It is compared to the rates of R2 alloy in concrete with Portland cement without fly ash replacement and in CW. The rates were obtained from mass loss evaluation. It could be seen that corrosion rate of the R2 alloy in ordinary concrete was at $684 \pm 73 \mu\text{m/y}$ after 1 month whereas with a 30 % fly ash replacement, it was at $179 \pm 71 \mu\text{m/y}$. Containing fly ash, the rate decreased to $66 \pm 32 \mu\text{m/y}$ after 3 months. This value is slightly higher than the rate in ordinary concrete after 6 and 12 months.

Ongoing experiments in concrete with 30 % fly ash replacement of the cement showed much lower corrosion rates of the R2 alloy as seen in Figure 12. This can be explained by inhibited alkali carbonate reactions in the concrete, and therefore a decreased concentration of K^+ and Na^+ , causing a decreased pH compared to regular Portland cement concrete [41]. The decreased compressive strength of this alternative concrete composition might be negligible considering a reduced expansion cracking through the decrease of alkali carbonate reactions [41]. Another factor for the decreased pH is the limited carbonation through partial cement replacement by fly ash [43].
