## **Study of Corrosion Characteristics of AlMg3.5 Alloy by Hydrogen-Induced Pressure and Mass Loss Evaluation Under Simulated Cementitious**

Schobel, M., Ekberg, C., Retegan Vollmer, T. et al (2025). Study of Corrosion Characteristics of AlMg3.5 Alloy by Hydrogen-Induced Pressure and Mass Loss Evaluation Under Simulated Cementitious Repository Conditions. Corrosion and Materials Degradation, 6(3): 27-. <http://dx.doi.org/10.3390/cmd6030027>

# Study of Corrosion Characteristics of AlMg3.5 Alloy by Hydrogen-Induced Pressure and Mass Loss Evaluation Under Simulated Cementitious Repository Conditions

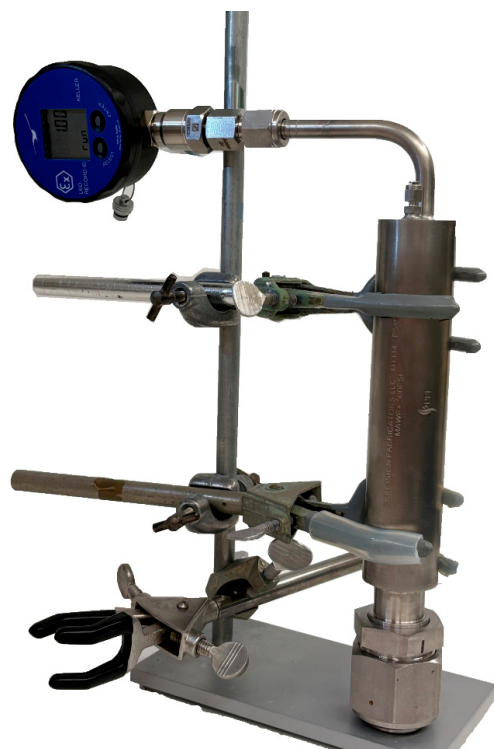
**Figure 1.** Pressure vessel setup for hydrogen pressure measurements. Customized steel autoclave with pressure gauge designed for hydrogen use.

**Pressure measurements.** Samples were immersed in 20 mL of concrete in plastic test tubes and stored in 165 mL pressure vessels (Precision Fabrication LLC, Ligonier, IN, USA) (Figure 1). Leak tests were repeatedly performed with a semi-conductor hydrogen detector (Multitec 540, Sewerin, Gütersloh, Germany), with no indication of leakages. The pressure was measured with a pressure gauge designed for hydrogen use (LEO-Record-H2Ei, Keller, Basel, Switzerland). The measured pressure was observed in PressureSuite (Keller, Switzerland). The sample size was selected so that the possible pressure of full corrosion of the samples would not exceed the operating pressure (3447 kPa) of the vessels (design pressure 6895 kPa). The experiment was conducted in duplicates at room temperature (ca. 19 °C).

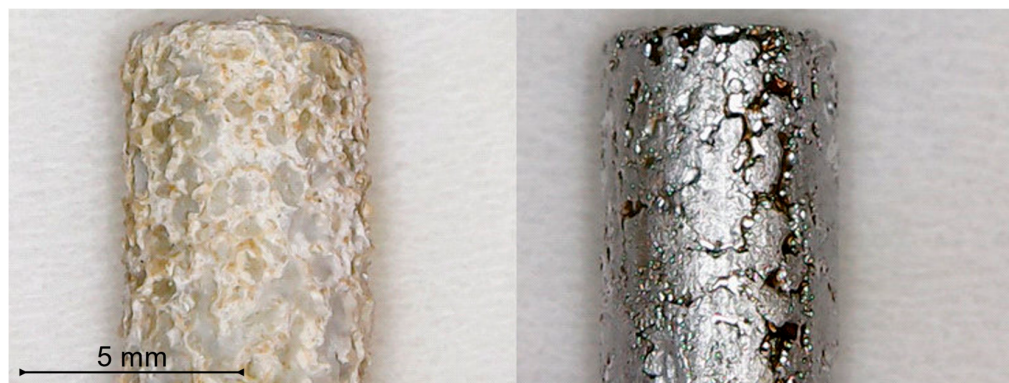
**Figure 2.** Retrieved R2 alloy sample after one year of exposure embedded in concrete (left) and sample after fully removing concrete residues and oxide (right).

**Mass loss evaluation.** Separate samples in triplicates were immersed in concrete and CW in unpressurized containers at room temperature and were exposed for one to twelve months. Afterwards, destructive measurements were conducted by cracking open the concrete and pickling the samples. Full removal of the concrete and oxide layer was performed by pickling the samples in an ultrasonic bath (Thermo Fisher Scientific, Waltham, MA, USA) for 20 min in 20% nitric acid. Thereafter, the samples were soaked in silicon oil for about 24 h to soften and loosen residues of the oxide layer. The residues were carefully scraped off and the samples were pickled in 20% nitric acid again. This process was repeated until no further mass loss was registered. The samples were cleaned in acetone, dried, and weighed, and the mass loss was determined by weighing. Figure 2 shows a sample after one year of exposure in concrete (left) and after fully removing the concrete and oxide layer (right).
