Damage and defects in railway materials:

Influence of mechanical and thermal damage on crack initiation and propagation

CASEY JESSOP

CHALMERS UNIVERSITY OF TECHNOLOGY

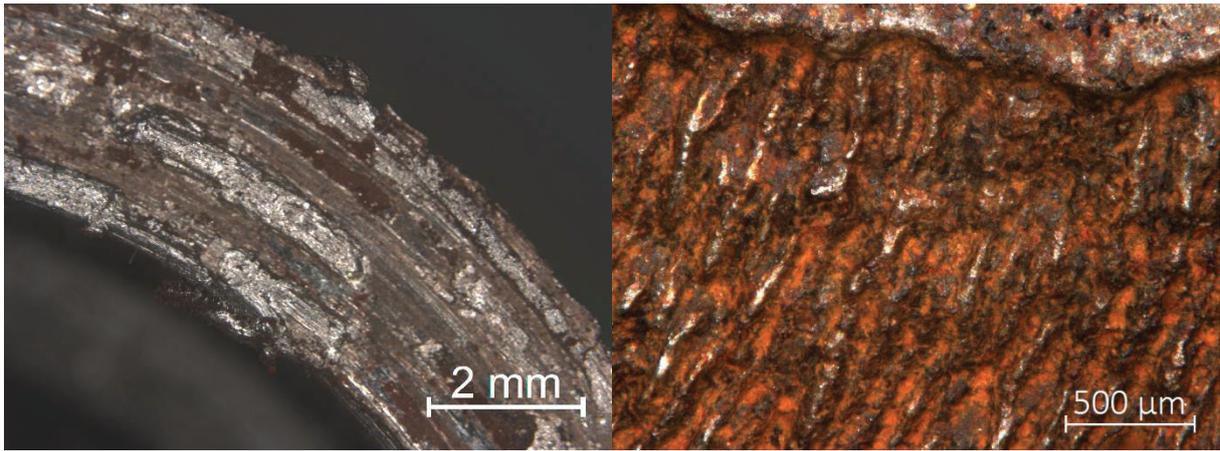
The most significant findings from the friction experiments were related to the deformation of the surfaces, and the effect of adding water to the contact. The ridges on the deformed surfaces are similar to those seen on the squat crack faces, Figure 28. The addition of water in the contact between the two surfaces reduces the coefficient of friction, from approximately 0.63 to 0.38. The reduction of the friction coefficient is accompanied by a reduction in deformation and wear on the surfaces, as seen in Figure 29.

Figure 28. Surface of test bar after friction experiments (left), resembling detail of ridges on squat crack face (right).
Modified from [63]

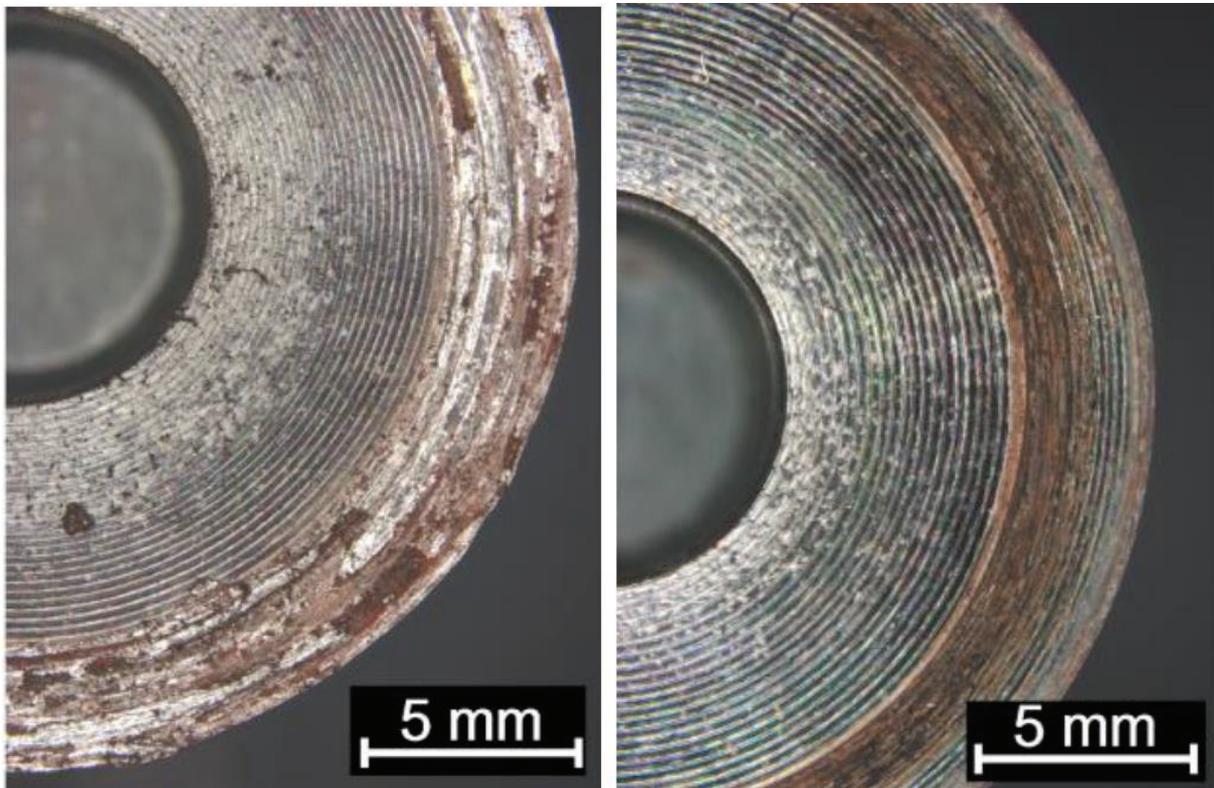
Figure 29. Surfaces of test bar after testing in (left) dry and (right) wet conditions. The more pronounced deformation and wear in the dry conditions is apparent and a reflection of the larger coefficients of frictions calculated. The periphery of the contact surface in the wet tests remains in original condition, while the inner radius is worn and corroded. [63]

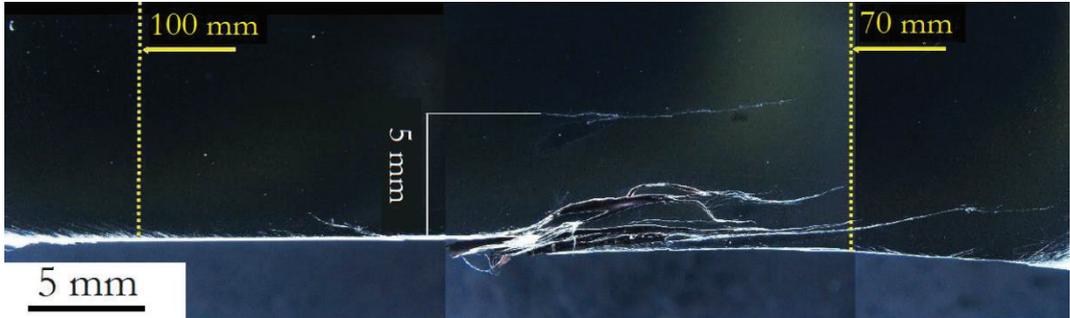
The RCF3 zone in Figure 32 showed a different crack morphology; the cracks are much deeper than in the RCF1 zone, extending to a depth of more than 7 mm, and crack branching is present. It is seen that the RCF3 cracks in the transverse section (Figure 33) are very pronounced, and the majority of the network

extends approximately 2 mm into the wheel. Furthermore, a crack is seen at a depth of 5 mm from the surface. This confirms that dominant cracks extend to at least to this depth, as seen in the longitudinal section, since each section only represents a 2-dimensional image of the whole crack network. It can be concluded that the main damage mechanism is RCF3.

Figure 33. Transverse section through the RCF1 and RCF3 zones. Dotted lines indicate distances of 70 mm and 100 mm from the flange side. These distances correspond to the longitudinal sections of RCF3 and RCF1, respectively.

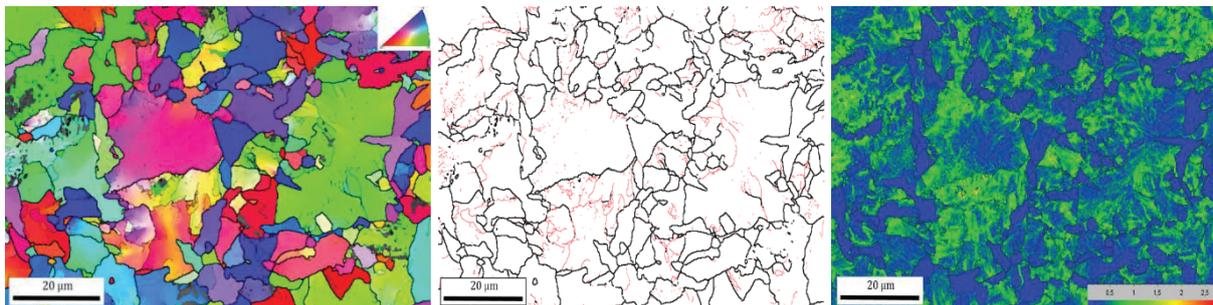
Both methods offer advantages, and a combination of them allows for a good understanding of the behaviour of the material. Using EBSD, it is possible to index the ferrite grains and the pearlitic colonies, and to obtain information from the surface of the sample about local misorientation. The orientation variation in the pearlite colonies is larger than that in the ferrite grains, due to the formation of the lamellar structure of the pearlite. With increasing temperature and annealing time, the misorientation in the ferrite grains decreases. An example of the obtained maps is shown in Figure 35, for the sample annealed at 500 °C for 4h.

Figure 35. Maps from EBSD (R8T sample annealed at 500 °C for 4h). Modified from Paper 5. [72]

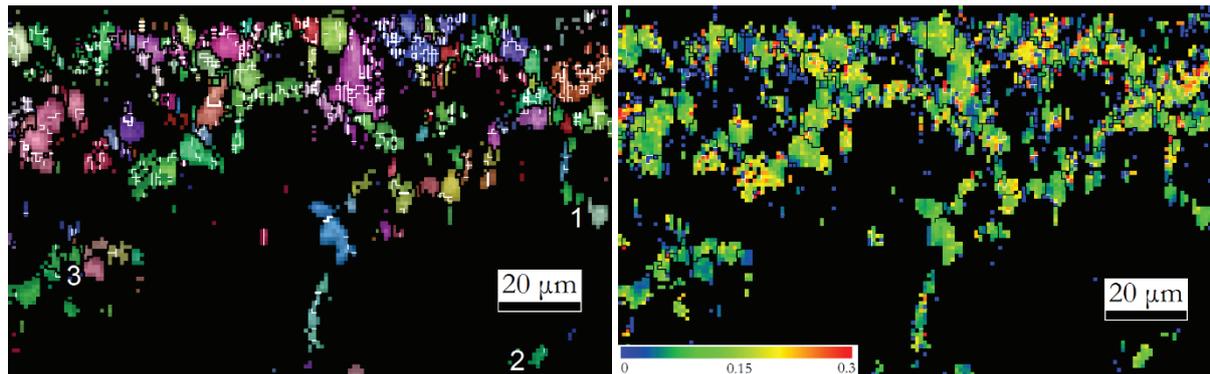
average misorientation. The maps for the sample annealed at 500 °C is shown in Figure 36. The legend corresponds to the distribution of local misorientation angles in the KAM map. There is limited indexing using this method, and due to the larger orientation variations within pearlite colonies that cannot always be indexed, and we are left with a large portion of unresolved points. It was observed, however, that when the sample is fully spheroidized a larger portion of the plane is indexed. Annealing at 690 °C for 96h results in a fully spheroidized microstructure, as shown in Figure 6b. Lower local misorientation is observed after full spheroidization, and more ferrite grains are indexed, as can be seen from the IPF and KAM maps in Figure 37. This suggests that the method works better when indexing the microstructure without cementite plates, since the cementite is no longer present as lamellas within the pearlite grains, but rather as large spheres or carbides within a ferrite matrix.

Figure 36. R8T sample annealed at 500 °C for 4h. (a) IPF, and (b) KAM showing misorientation below 0.3° within the grains. (Sample surface at top)

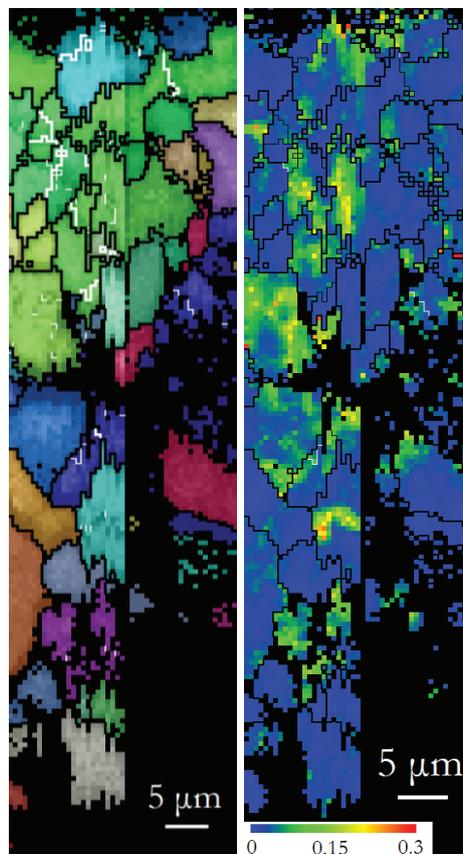
Figure 37. SEM micrograph of R8T sample annealed at 690 °C for 96h, and corresponding IPF and KAM maps showing better indexing when cementite is spheroidized versus lamellar. (Sample surface at top)

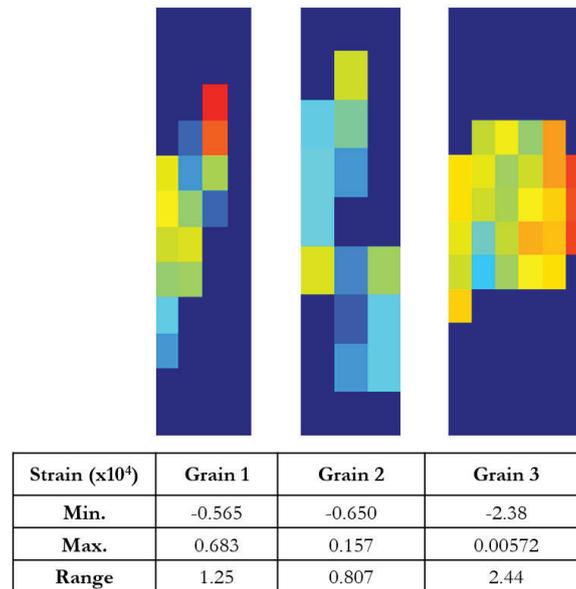
Moreover, the use of monochromatic beams allows for the determination of relative strain within single ferrite grains using DAXM. Figure 38 shows the grains (numbered in Figure 36) in which strains were measured based on calculated strain-free lattice parameters for the sample annealed at 500 °C for 4 hours. It can be seen that the range of residual strains, 3×10^{-4} (-2 to 0.7×10^{-4}), is nearly zero, showing that temperature releases most residual strains within single grains, and the variation is decreased with increased annealing temperature.

Figure 38. Range of strains measured in 3 ferrite grains in the sample annealed at 500 °C for 4h. The grains are numbered in Figure 36.
