## **Deterioration in brick buildings: hygrothermal performance and measures to save them**

Pär Johansson<sup>1,\*</sup> and Paula Wahlgren<sup>1</sup>

<sup>1</sup>Chalmers University of Technology, Department of Architecture and Civil Engineering, SE-412 96 Gothenburg, Sweden

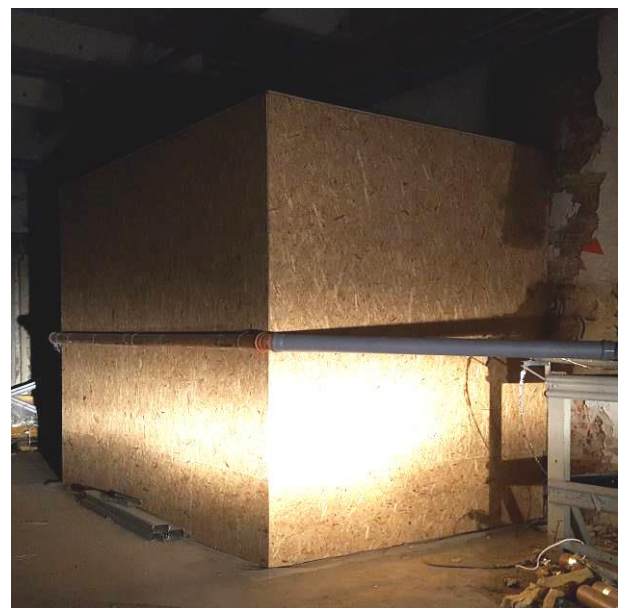
**Fig. 2.** Small test room inside the building.

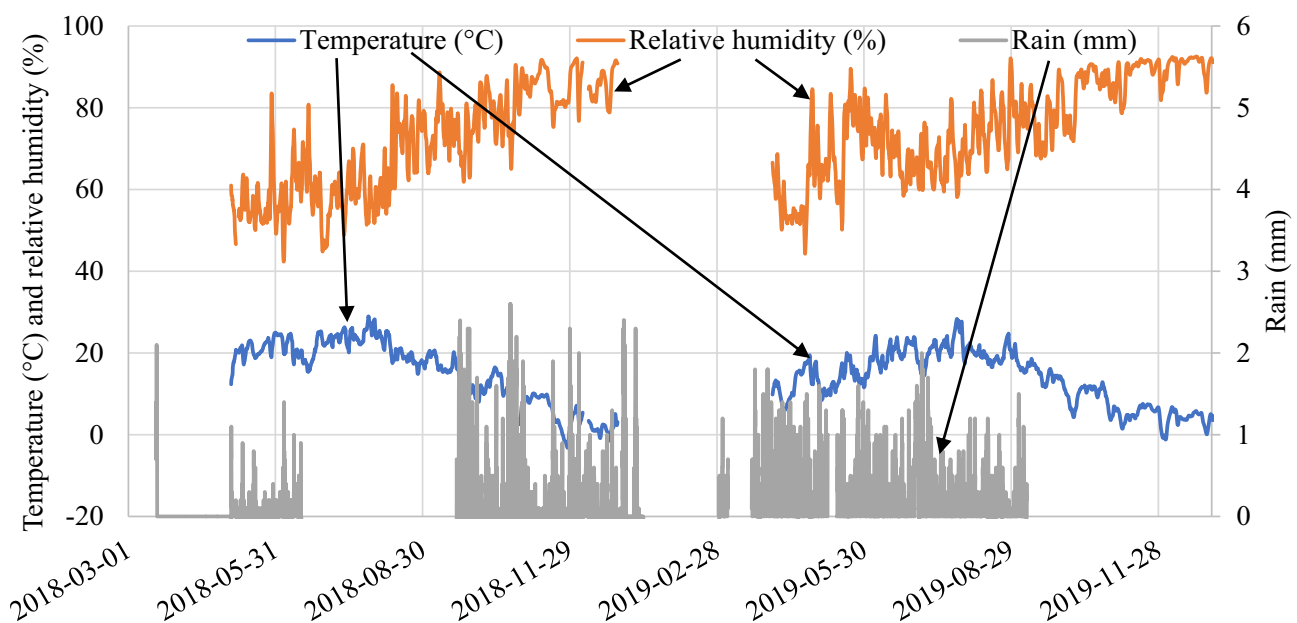
**Fig. 4.** Outdoor temperature, relative humidity and rain load on the wall from March 2018 to January 2020, sliding 24-hour average.

The measurements of the outdoor and indoor temperature, relative humidity and rain load are presented in Fig. 4 and Fig. 5. The measurements inside the test room and building started in March 2018, while the weather station and the outdoor climate were monitored from May 2018.

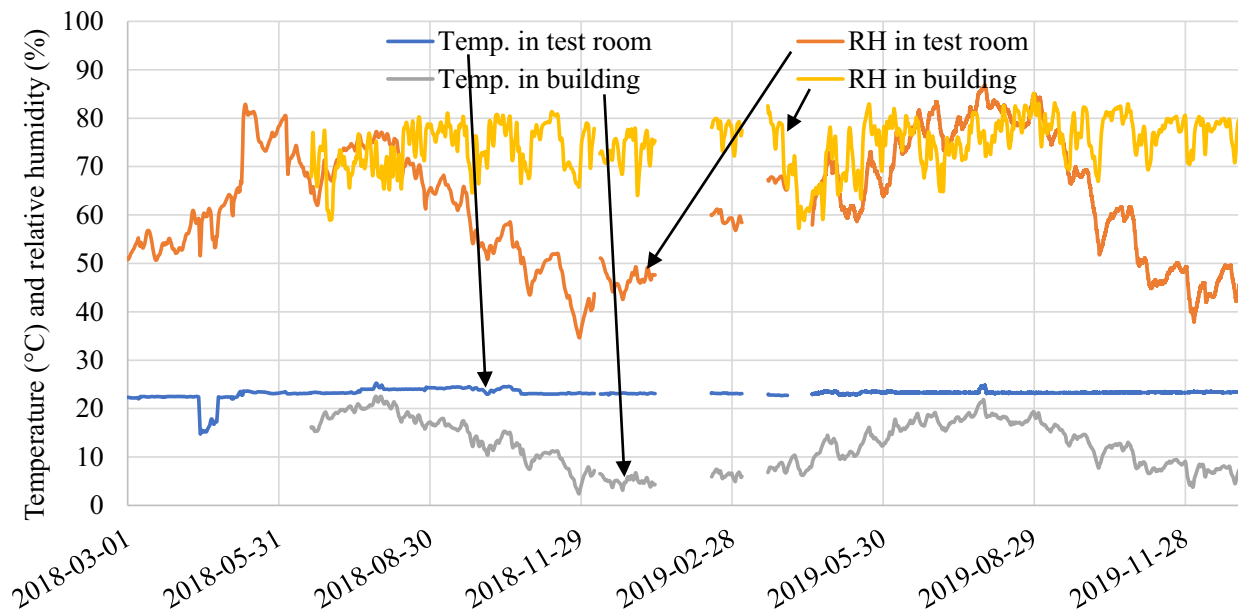
**Fig. 5.** Temperature and relative humidity in test room and in building, from March 2018 to January 2020, sliding 24-hour average.

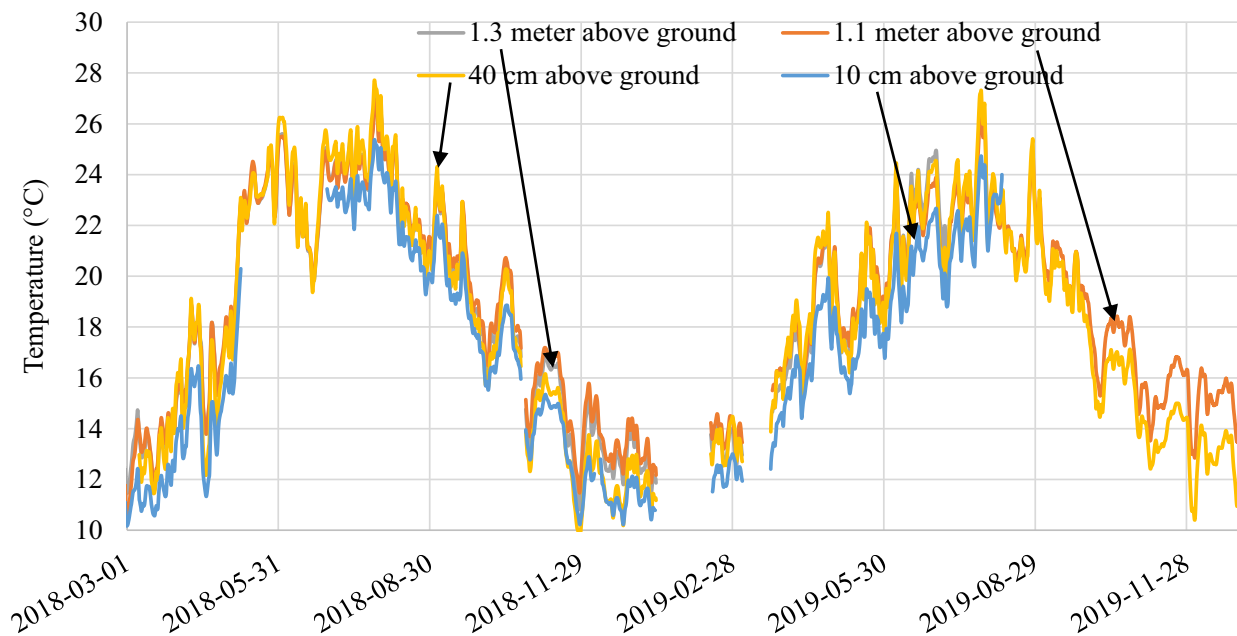
**Fig. 6.** Temperatures in the middle of the wall on different heights, from March 2018 to January 2020, sliding 24-hour average.

According to the measurements, the temperature is highest further up in the wall, where it can be expected that the impact of the surrounding ground is smaller. The relative humidity is above 100% in the measurements. This is due to the interpretation of the measurement results in the sensor itself. The relative humidity is highest close to the slab while it varies between the measurement positions in the upper part of the wall. This could be caused by a crack in the mortar or bricks, as well as whether the sensor is in contact with brick or mortar inside the wall.
