# Deterioration in brick buildings: hygrothermal performance and measures to save them

Pär Johansson<sup>1,\*</sup> and Paula Wahlgren<sup>1</sup>

<sup>1</sup>Chalmers University of Technology, Department of Architecture and Civil Engineering, SE-412 96 Gothenburg, Sweden

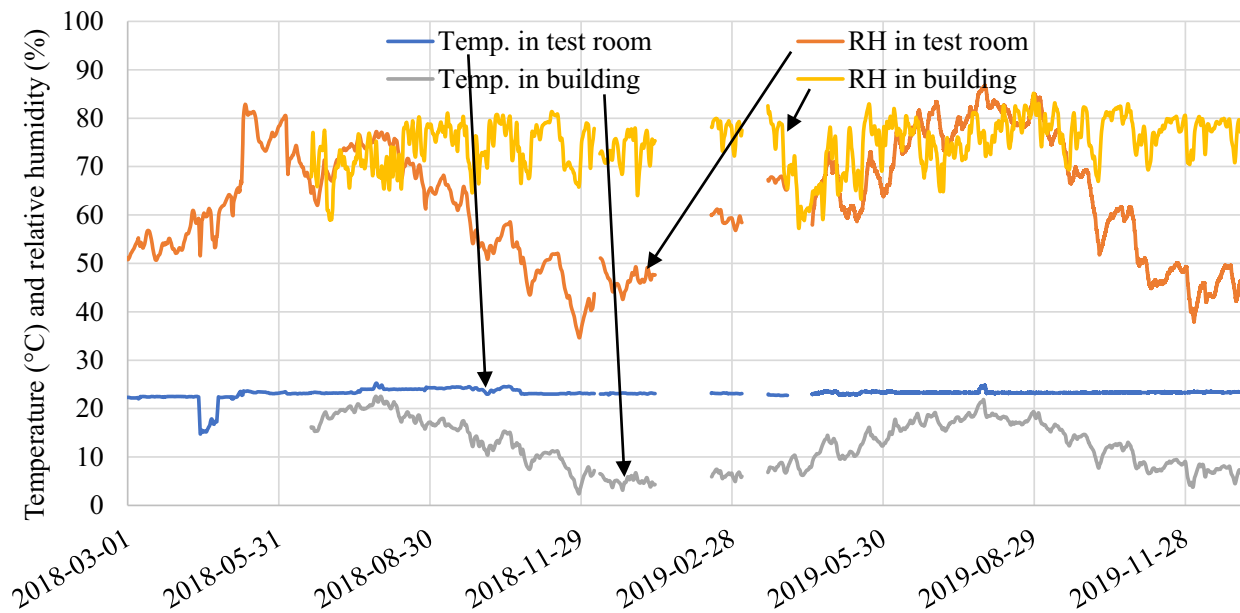
**Fig. 5.** Temperature and relative humidity in test room and in building, from March 2018 to January 2020, sliding 24-hour average.

The measurements of the outdoor and indoor temperature, relative humidity and rain load are presented in Fig. 4 and Fig. 5. The measurements inside the test room and building started in March 2018, while the weather station and the outdoor climate were monitored from May 2018.
