# Concluding destructive investigation of a nine-year-old marine-exposed cracked concrete panel

Geiker, M., Robuschi, S., Lundgren, K. et al (2023). Concluding destructive investigation of a nine-year-old marine-exposed cracked concrete panel. Cement and Concrete Research, 165. http://dx.doi.org/10.1016/j.cemconres.2022.107070

This study undertaken on a nine-year-old cracked concrete panel further investigates the impact of cracks on the corrosion performance of conventional steel reinforcement in marine-exposed concrete to explain observed monitoring data. The present data covers seven 1.80 m long (12.6 m) reinforcing bars embedded in good quality concrete (w/b = 0.40 and cover >75 mm). Each bar was crossed by two horizontal cracks (surface crack widths 0.20–0.30 mm). The investigation showed no corrosion on the surface of the reinforcing bars, in either cracked or uncracked areas. Two of the seven reinforcing bars were instrumented in the vicinity of the cracks. Extensive corrosion was found in the interior of all instrumented parts of these bars. This may explain the monitoring data despite the lack of corrosion on the exterior surface of the two instrumented rebars. However,

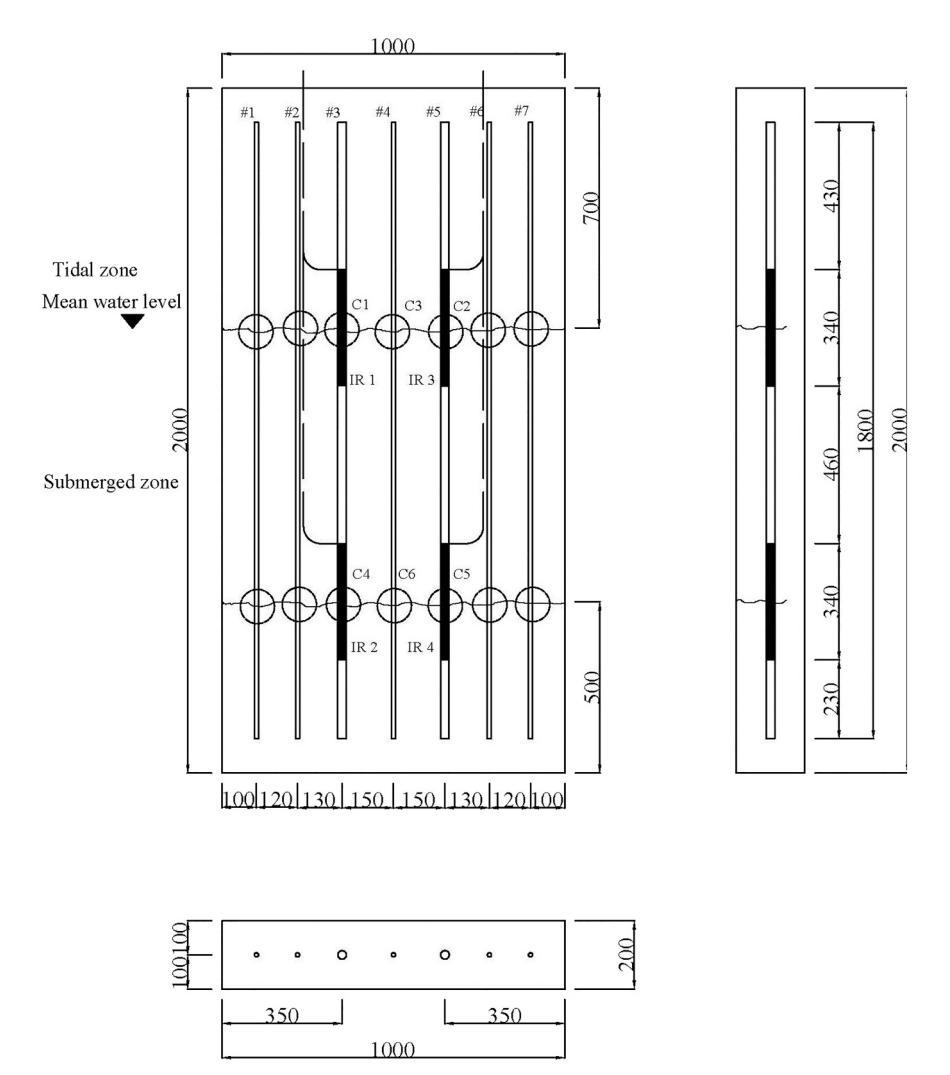
Subsequently and before exposure, two cracks were mechanically introduced in the panel by means of three-point bending. The cracks were located approximately 0.70 m (Crack 1, tidal exposure) and 1.50 m (Crack 2, submerged exposure) from the top of the panel, see Fig. 1. A DEMEC Mechanical Strain Gauge was used to measure crack width in both locations (for three pairs of measuring points along the crack path) both during the cracking and after 1.5 years. Upon cracking, two recesses of approximately  $10 \text{ cm} \times 5 \text{ cm} \times 5 \text{ cm}$  (length  $\times$  width  $\times$  depth) were cut at the edges and along the crack path of the panel. Subsequently, the recesses were filled with fast-hardening repair mortar to retain induced crack widths (see Table 3). The repair mortar was allowed to cure sealed for 24 h before maintaining the applied load and, thus, the crack widths. Then the specimen was stored for seven months onsite still sealed in plastic until exposure.

Fig. 1. Dimensions of the panel, location of mean water level, the two horizontal cracks, and cores extracted for this study: Series 1: cores C3 and C6 include parts of conventional reinforcing bars, cores C1, C2, C4 and C5 include parts of instrumented reinforcing bars; Series 2: numbering of cores. #1–7, numbering of rebar sections: IR 1–4, instrumented rebars: #3 and #5. All measures in mm.

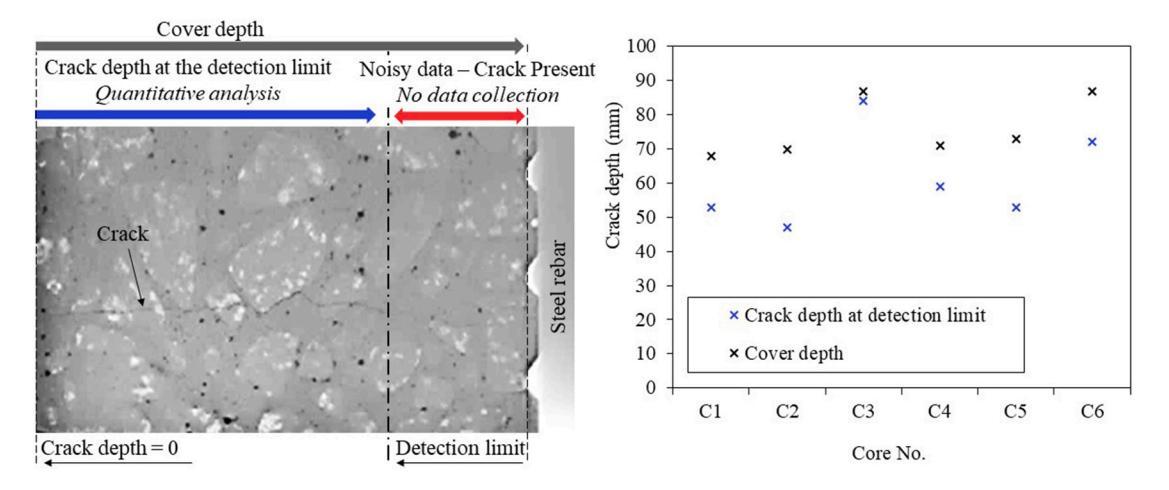
Fig. 4. Schematic illustration of detection limit for quantitative analysis of  $\mu$ -CT scans due to low resolution and image noise, artefacts associated with scanning near rebars. Left: a representative crack with identification of limit for image segmentation. Right: the crack depths at the detection limit and the cover depth for all six cores (Series 1) investigated.

All the cracks were positioned almost perpendicular to the exposed surface, and visual observation of  $\mu$ -CT images near the steel rebar confirmed that the cracks had fully penetrated the concrete cover. However, due to the detection limit, the cracks could not be quantified in the vicinity of the rebars (see Fig. 4). The quantification given below therefore only covers part of the cracks. As supplementary material, crack volume 3D profiles are also given.--

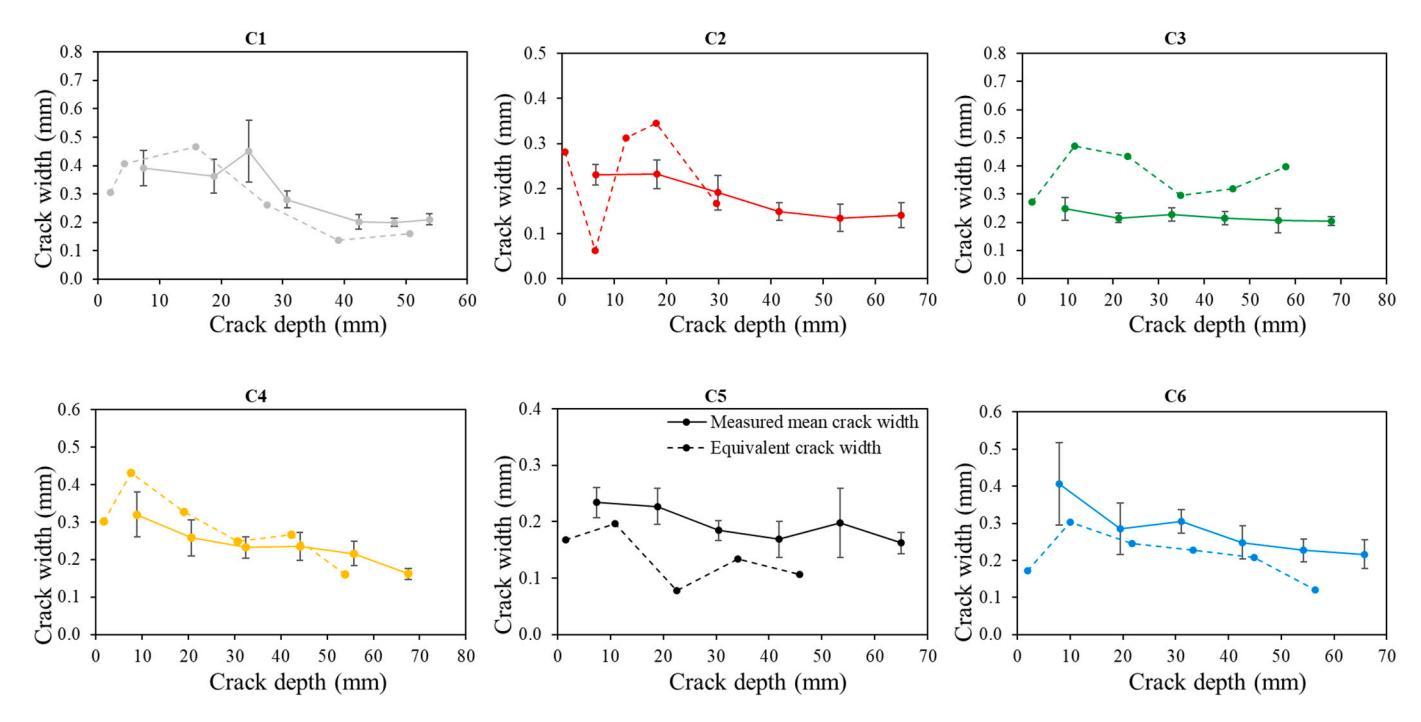
The results enable a comparison of the crack geometry between all six cores investigated, cancelling the effect of crack location in the core. Except for core C2, an increase in equivalent crack width is observed during the transition from the exposed surface down to 10 mm of crack depth, which agrees with the results shown in Fig. 7. While fluctuations are also present, a general trend of decreasing crack width values is observed beyond 10 mm crack depth. Fig. 8 compares the two different methodologies adopted. Good agreement can be observed, considering the limitations related to the resolution.

Fig. 8. Comparison between the two methodologies adopted to quantify crack widths from  $\mu$ -CT scans.

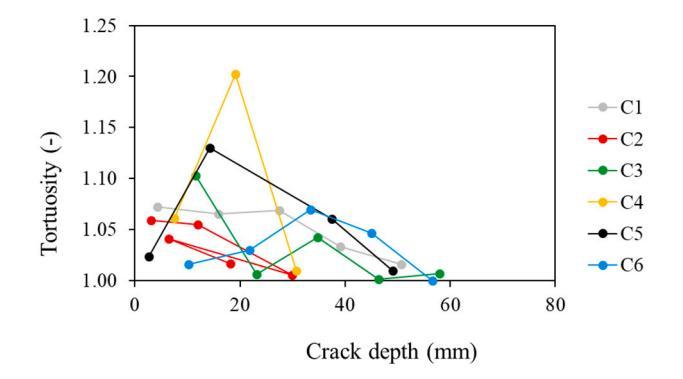
Finally, crack tortuosity was also investigated using the available  $\mu$ -CT image dataset. Representative 2D XY plane projections (five per core) were used to calculate the effective and the nominal crack length (Section 2.4) in the XY plane. The results are illustrated in Fig. 9. Numbers close to 1.00 might be explained by self-healing, closing part of the crack and reducing the effective crack length.

Fig. 9. Crack tortuosity distribution across crack depth for all six cores investigated using  $\mu$ -CT. (For interpretation of the references to colour in this figure legend , the reader is referred to the web version of this article.)

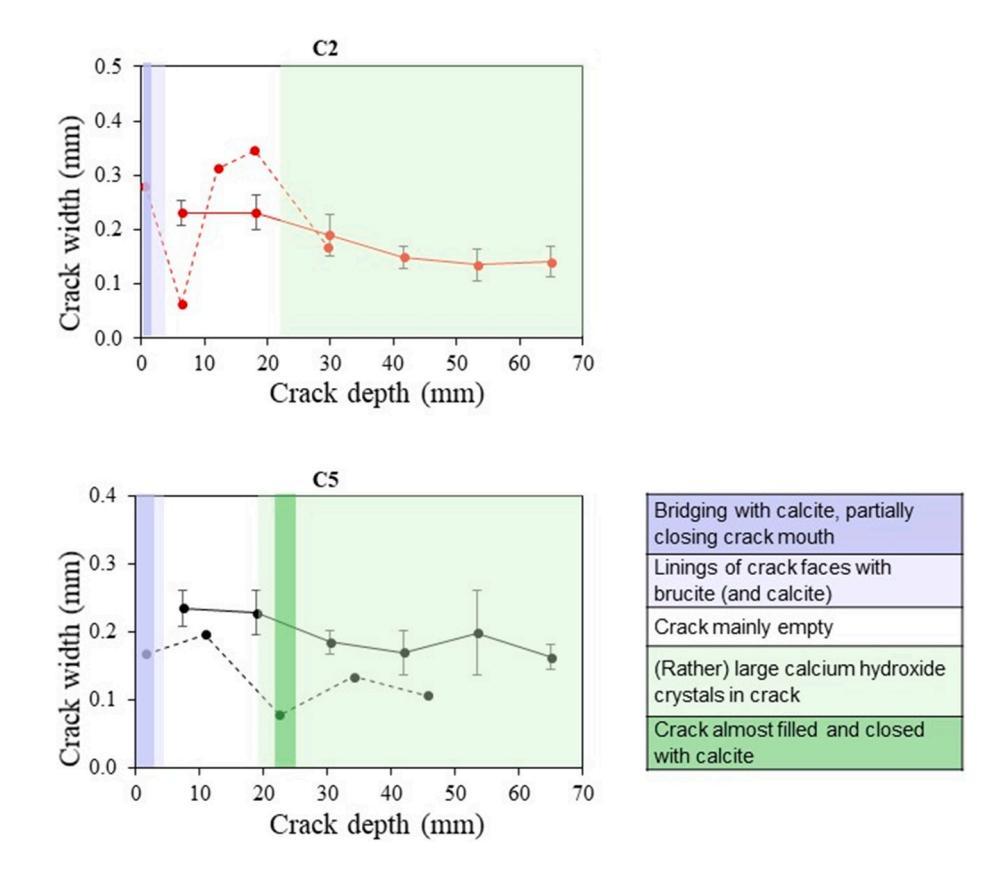
Fig. 12 gives a comparison between results obtained from  $\mu$ -CT and petrography data for cores C2 (tidal exposure) and C5 (submerged exposure).

**Fig. 12.** Comparison of crack characterization using  $\mu$ -CT (equivalent crack width (dotted line) and measured mean crack width (solid line), data from Fig. 8) and zones identified using petrography (data from Table 8) for cores C2 (tidal exposure) and C5 (submerged exposure). (For interpretation of the references to colour in this figure legend, the reader is referred to the web version of this article.)

surface. After nine years of submerged marine exposure, the observation a of reduced crack area can be explained by the precipitation of calcite, brucite and portlandite crystals, partly closing the crack near the exposed surface. If we generalize the findings from this study and consider a vertical surface, it should be noted that horizontal cracks (as in this study) are expected to have a greater ability to self-heal than vertical cracks [21].

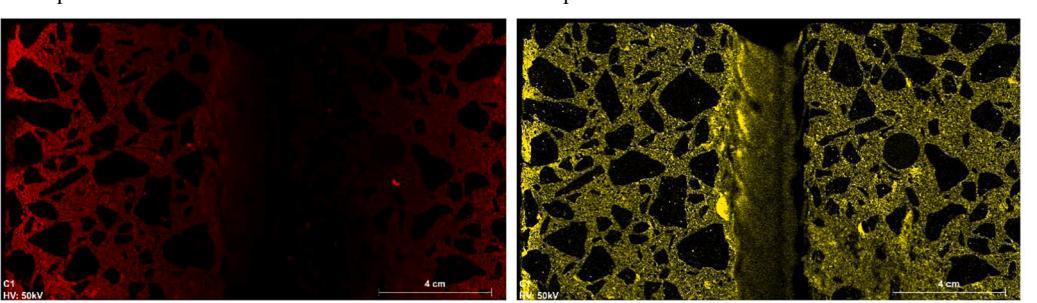
Fig. A1. Elemental overview maps of core C1, with the cracked surface of the panel to the left.

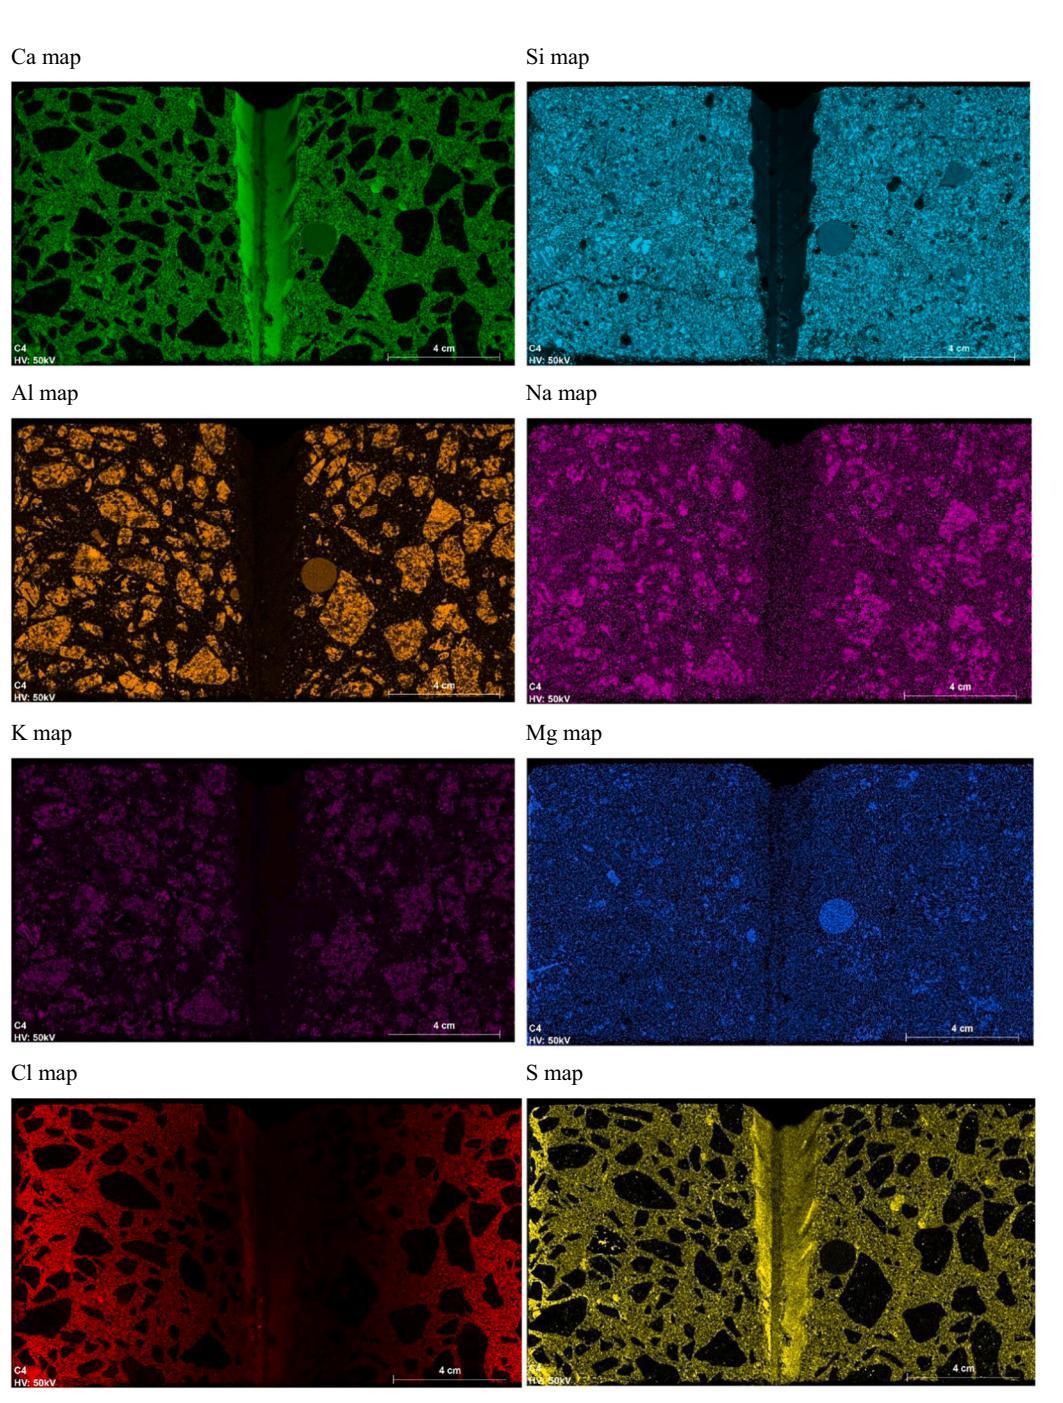
Fig. A2. Elemental overview maps of core C4, with the cracked surface of the panel to the left.
