## **Investigation on Pollution-Induced Flashovers of In-Service Insulators in Ethiopian Power Transmission Lines**

# Investigation on Pollution-Induced Flashovers of In-Service Insulators in Ethiopian Power Transmission Lines

Berhanu Zelalem Desta <sup>1,2,\*</sup>, Mengesha M. Wogari <sup>2</sup> and Stanislaw M. Gubanski <sup>3</sup>

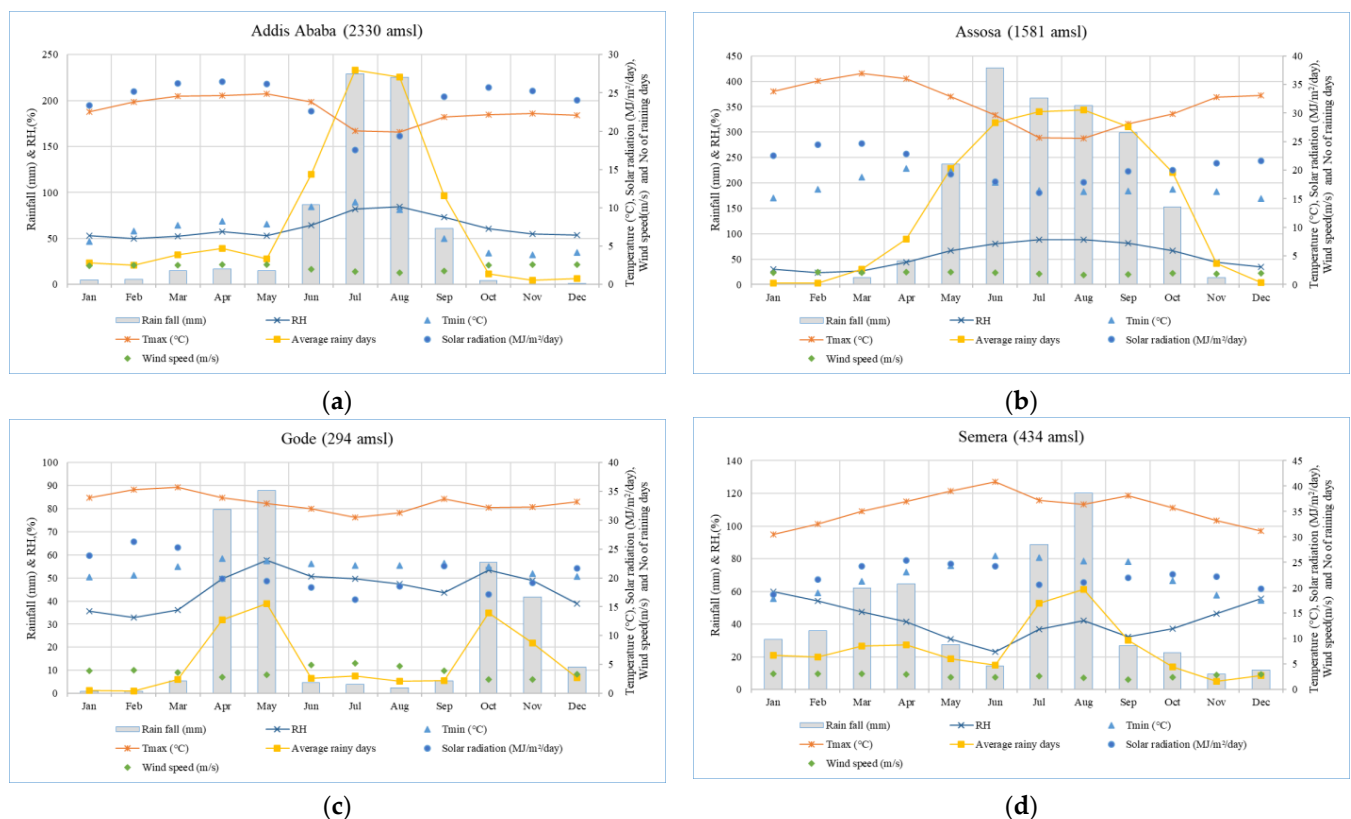
**Figure 2.** Illustrations of annual variations in meteorological parameters (derived from 30 years of data [28]) for four representative sites in Ethiopia. (a) Addis Ababa; (b) Assosa; (c) Gode; (d) Semera.

The meteorological conditions for Group 1 areas, as shown in Figure 2a, are predominantly dry from October to February of the next year, while the period from March to

As shown in Figure 2b, the period spanning from October to February of the next year is mainly dry. The average monthly rainfall during this period is 6.7 mm. Moreover, periods with less than 20 mm rain are in March and November, whereas periods with less than 10 mm rain begin in December and continue to the end of February. During the primary rainy season from March to September, the monthly average rainfall reaches 200 mm and secures natural washing of insulator surfaces.

As shown in Figure 2c, the main dry season in regions of Group 3 is from June to September and from December to February of the next year, while from October to November there is a short rainfall season. During the former periods, the average monthly rainfall is low, respectively, 17 mm and less than 10 mm. During March to May (the main rainy season), the weather is moist, and the average rainy days and average monthly rainfall reach 10 days and 44 mm. The natural washing of insulators by rain increases in this period.

As shown in Figure 2d, the periods from October to February of the next year and from March to May are the main dry seasons. During these periods, the average monthly rainfall is low, around 27 mm. Moreover, less than 20 mm rain periods are during January and June, and less than 10 mm rain periods begin in November and December. During June to September (the main rainy season), the weather is moist, but the rainfall is usually light. Most of the rainy days are continuous drizzle or scattered rains, and the average monthly rainfall reaches 45 mm. Hence, the washing effect during this period is minimal.

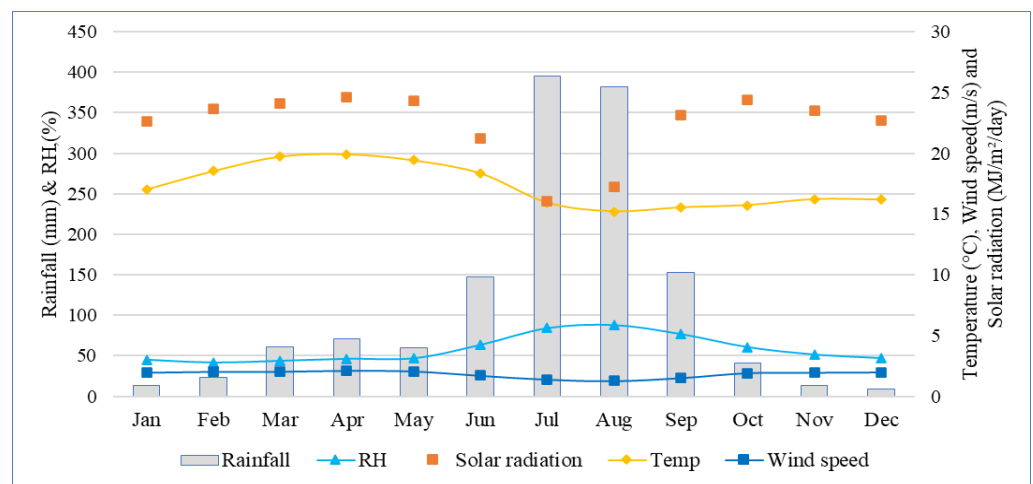
The Bahir Dar II—Debre Markos—Sululta 400 kV line spans 410 km, extending from the northwestern highlands of Ethiopia to Addis Ababa, crossing subtropical highland and tropical savanna climatic conditions. The environmental conditions along the route of the line are characterized by a mixture of desert, industrial, and agricultural pollutants. The main sources of pollution in the area are from transportation, construction, quarry sites, naturally occurring dust from local soils, cement factories, and agricultural activities such as ploughing, fertilizers, crop spraying, and harvesting. The line is insulated with glass-cap and pin strings. The line is known for having a high number of unexplained outages, and the performed analysis identified a total of 72 pollution induced faults on it for the period between 2015 to 2022, an average of 9 faults per year. Figure 14 shows the monthly average meteorological parameters across the entire length of the line. The line receives an average rainfall of about 270 mm from June to September and an average relative humidity above 58%, temperature above 17 °C and windspeed 1.8 m/s for the whole year.

**Figure 14.** Monthly average meteorological parameters across the entire length of the Bahir Dar II—Debre Markos—Sululta 400 kV line [28].
