Cyclic Corrosion and Chlorination of an FeCrAl Alloy in the Presence of KCl

Abstract The KCl-induced corrosion of the FeCrAl alloy Kanthal[®] APMT in an $O_2 + N_2 + H_2O$ environment was studied at 600 °C. The samples were pre-oxidized prior to exposure in order to investigate the protective nature of alumina scales in the present environment. The microstructure and composition of the corroded surface was investigated in detail. Corrosion started at flaws in the pre-formed α -alumina scales, i.e. α -alumina was protective in itself. Consequently, KCl-induced corrosion started locally and, subsequently, spread laterally. An electrochemical mechanism is proposed here by which a transition metal chloride forms in the alloy and K_2CrO_4 forms at the scale/gas interface. Scale de-cohesion is attributed to the formation of a sub-scale transition metal chloride.

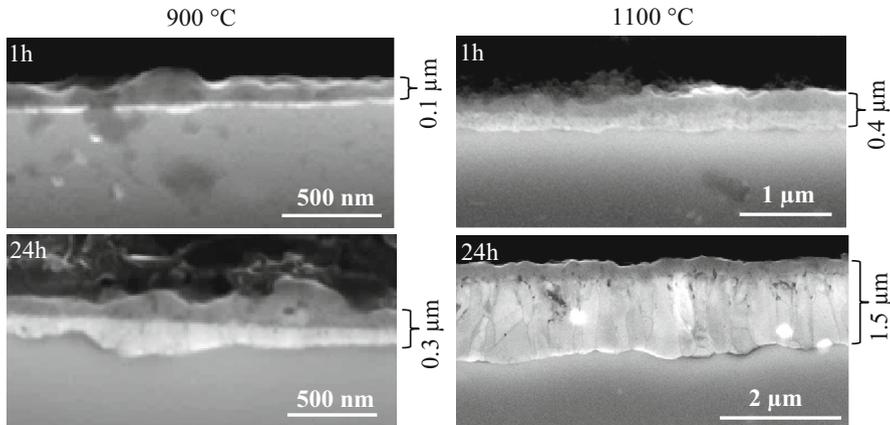
A well adherent alumina scale had formed after all pre-oxidation treatments, scale thickness ranging from 0.1 to $1.5 \mu\text{m}$ depending on oxidation time and temperature (Fig. 1). Both samples oxidized at 1,100 °C and the sample oxidized for 24 h at 900 °C clearly exhibited a two-layered oxide scale. The bottom scale

Fig. 1 SEM-SE micrographs of cross-sections of the pre-formed alumina scales in O_2 at 900 and 1,100 °C for 1 and 24 h, published in [18, 19] by Hellström et al

layer was barely visible after 1 h at 900 °C (Fig. 1). A TEM investigation by Hellström et al. confirmed the presence of a two-layered $\alpha\text{-Al}_2\text{O}_3$ scale after oxidation at 900 °C, the inward growing alumina layer was however not continuous over the entire surface [18]. Analysis using XRD showed that $\alpha\text{-Al}_2\text{O}_3$ was present on all pre-oxidized samples. There was no evidence of metastable forms of alumina.

This study investigated the ability of a pre-formed external alumina scale to prevent KCl-induced corrosion. The scale cross sections in Fig. 1 and the XRD analysis showed that all four pre-oxidations (1 and 24 h at 900 and 1,100 °C in $O_2 + N_2$) generated continuous α -alumina layers. The oxidation behaviour is in line with literature reports on the ability of alloy APMT and other FeCrAl alloys to form highly protective α -alumina scales in the presence of O_2 at 900 °C and higher [22–24].

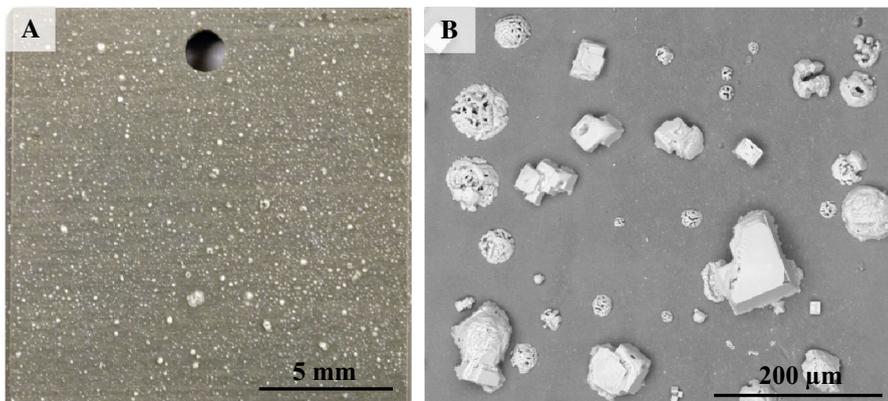
Figure 2 shows the distribution of KCl on the sample surface before exposure, with salt crystallites and aggregates ranging in size from a few μm to $\sim 100 \mu\text{m}$. While the surface between the salt particles appears to be free from KCl, it was shown previously [17, 20] that small amounts of KCl were present also in these areas.

Fig. 2 Optical image (a) and SEM-BSE micrograph (b) of the salt distribution on the alumina scale prior to corrosion exposure

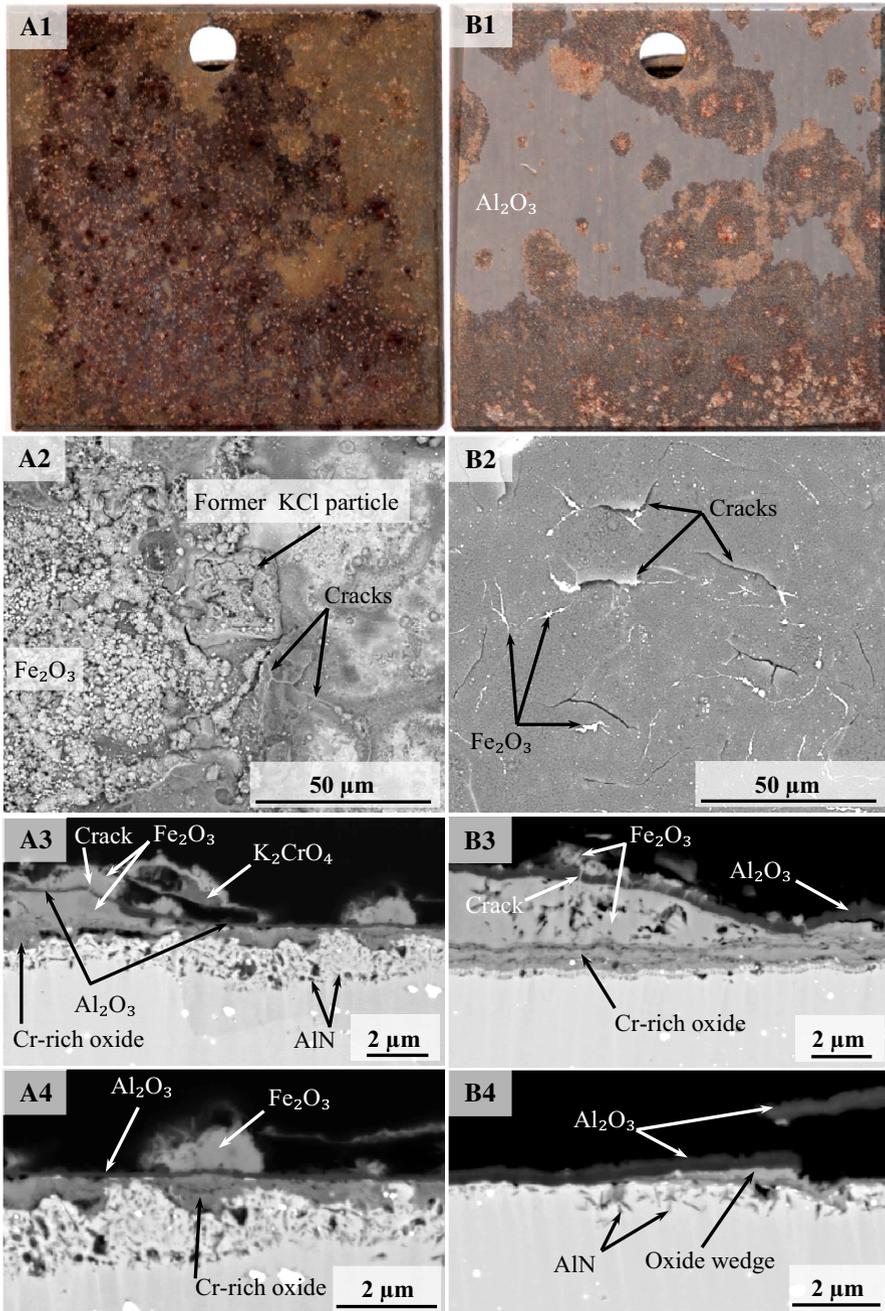
The alumina scales formed during 1 h pre-oxidation at 900 °C failed during the first corrosion exposure (Fig. 3a1), i.e., the entire surface suffered breakaway oxidation. This is illustrated in the SEM-BSE top view micrograph in Fig. 3a2, which shows a representative area of the corroded surface with a former KCl particle in the middle of the micrograph, surrounded by a cracked alumina scale. During the first corrosion exposure, iron-rich oxide had grown on top of the alumina scale, covering most of the sample surface. Analysis using XRD after the corrosion exposure showed the presence of potassium chromate (K_2CrO_4) and hematite ($\alpha-Fe_2O_3$) in addition to $\alpha-Al_2O_3$, which was present after pre-oxidation (Table 2). SEM imaging at higher magnification revealed numerous 1–2 μm -size particles on the surface (not distinguishable in Fig. 3a2). Analytical analysis using SEM/EDX confirmed the presence of K, Cr and O and it was concluded that they consisted of K_2CrO_4 .

The one-sided cross-section in Fig. 3a3 and a4 (a4 is an enlargement of a part of a3) shows a layered oxide scale. The alumina layer from the pre-oxidation stage contains several cracks and relatively thick layers of iron-rich oxide have formed in connection to these cracks, both above and below the alumina. The K_2CrO_4 particles detected in the top view can also be seen in the cross section (Fig. 3a3), and are always found on top of the cracked alumina layer, being associated with iron oxide. Below the iron oxide/alumina/iron oxide sandwich a chromium-rich oxide layer is present (Fig. 3a3). Just beneath the chromium-rich oxide layer there is an Oxidation Affected Zone (OAZ) in the alloy substrate containing small needle-like particles. EDX point analyses showed that the particles are enriched in nitrogen and aluminium and their needle-like shape is consistent with aluminium nitride (AlN), which suggests the presence of AlN in the OAZ.

Corrosion of Samples Pre-oxidized 1 h at 1,100 °C Pre-oxidation for 1 h at 1,100 °C also failed to be protective during the first corrosion exposure, with more than half of the sample surface exhibiting breakaway oxidation (Fig. 3b1). The SEM-BSE top view micrograph in Fig. 3b2, shows a relatively lightly corroded area (corresponding to the grey area in Fig. 3b1) consisting of an alumina scale containing several cracks and fissures. SEM/EDX point analysis showed that the bright areas associated with the cracks are dominated by iron oxide. Similar to the samples pre-oxidised at 900 °C for 1 h (see above), K_2CrO_4 particles were detected on the surface using SEM/EDX. In addition to the $\alpha-Al_2O_3$ formed during pre-oxidation, XRD analysis detected $\alpha-Fe_2O_3$ and potassium chromate (Fig. 4).

The one-sided cross-section in Fig. 3b3 was prepared from an area corresponding to the top view image in Fig. 3b2, which shows a cracked alumina layer with a thickness of about 0.4 μm . In contrast to the previous case (900 °C, 1 h pre-oxidation), the iron-rich oxide is mainly found beneath the alumina layer (compare Fig. 3a3, b3). A chromium-rich oxide is present underneath the iron-rich oxide and there is an OAZ containing needle like aluminium nitride precipitates in the substrate. There is less nitride formation compared to the sample pre-oxidized for 1 h at 900 °C, which indicates that the alumina scale was more protective in this

Fig. 3 Optical images and SEM-BSE micrographs of top-view and cross-sections of the pre-oxidized samples **a1–a4** (1 h, 900 °C) to the left and **b1–b4** (1 h, 1,100 °C) to the right exposed for one corrosion exposure ($O_2 + H_2O + N_2 + KCl$ at 600 °C for 24 h)

case (compare Fig. 3a3, b3). The image of the cross-section in Fig. 3b4 shows the early stage of a corrosion attack, at a location where the alumina scale has cracked. A wedge-shaped layer consisting of iron-rich oxide (SEM/EDX) has formed underneath the protective alumina scale, accompanied by nitride formation in the alloy substrate.

As shown in Results, corrosion and the associated break-up of the alumina scale were initially highly localized and much of the surface was seemingly unaffected. Repeated KCl corrosion exposures caused corrosion to spread over the sample surface (Figs. 3, 5 and 8). The lateral movement of the “corrosion front” is associated with the spreading of cracks in the alumina scale (Figs. 3, 8). The absence of signs of corrosion e.g., de-cohesion of the scale/substrate interface, penetration of Cl in the areas where the alumina scale is not cracked (Fig. 11), indicates that the preformed alumina scale is inherently protective in this environment. Thus, this study implies that KCl-induced corrosion is initiated at flaws in the alumina layer, because an intact alumina layer is impermeable to attack. It is inherently difficult to investigate how corrosion starts using “*post-mortem*” investigations. However, it is suggested that the periphery of the corroded areas corresponds to early stages of corrosion. More specifically, this applies to the end of the laterally growing cracks in the alumina scale where the alumina layer has not yet separated from the alloy substrate. It is argued that investigation of those areas can help elucidate, not only how the “corrosion front” moves but also the initiation of corrosion (Figs. 5, 6, 7, 8, 9, and 10).

According to observations, the products of Reaction (2) accumulate at the scale/gas interface (K_2CrO_4) and at the scale/alloy interface (FeCl_2) (see Figs. 3a3, 6, and 7). It is argued that, although all the reactants are present at their respective positions, Reaction (2) cannot run if the α -alumina scale is intact because the alumina scale constitutes an effective barrier to the diffusion of ions (Fe^{2+} , Cl^{-}). Once the scale cracks, the situation is fundamentally changed. It is proposed that, when a crack forms during the exposure, KCl immediately enters it by means of surface diffusion, forming an adsorbed layer on the freshly exposed alumina in the crack. This is illustrated in Fig. 13, steps I and II. This is supported by the observation of KCl in a newly formed crack, close to the scale/alloy interface after exposure (Fig. 7). It is proposed that KCl in the crack provides the medium for the ionic current i.e., transport of chloride ions, which is necessary for Reaction (2) to run. Moreover, it is proposed that the corresponding electronic current is carried by alumina (Fig. 13, step III).

After scale failure, the alloy suffered nitridation, especially in the case of the samples pre-oxidized for 1 h (Fig. 3). Once again, the corrosion behaviour was similar to that reported for the same alloy without pre-oxidation [15]. The needle-like nitride precipitates were analysed in detail in [15] and it was concluded that they consisted of AlN. Nitridation of the investigated alloy was not detected in the absence of KCl [17]. Nitridation implies that the oxide scale is permeable to N₂ molecules. It is argued that the corrosion attack connected to the formation of K₂CrO₄ and to alloy chlorination (Reaction (2)) creates pathways/cracks through which N₂ molecules to penetrate the oxide scale. N₂, subsequently, dissociates at the metal surface and dissolves into the alloy. Nitridation is expected to make it more difficult for the alloy to form a new protective external alumina scale because it depletes the alloy substrate in aluminium. It may be noted that in the present study, nitride particles were not observed in the cross sections prepared from regions close to the alumina crack tips (Fig. 7). This is not unexpected in an area where the alumina scale has recently failed, because the processes of N₂ diffusion, dissolution and nitride nucleation are not instantaneous.

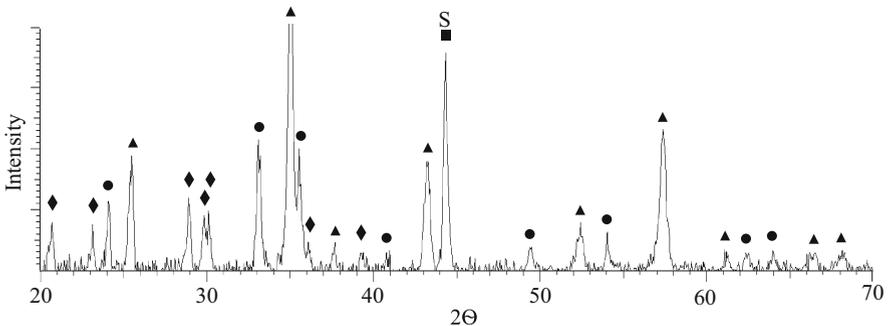
Fig. 4 XRD diffractogram of pre-oxidized APMT (1 h, 1,100 °C) exposed for one corrosion exposure (O₂ + H₂O + N₂ + KCl at 600 °C for 24 h). The *symbols* indicate: K₂CrO₄ (filled diamond), α -Fe₂O₃ (filled circle), α -Al₂O₃ (filled triangle), and substrate (filled square)

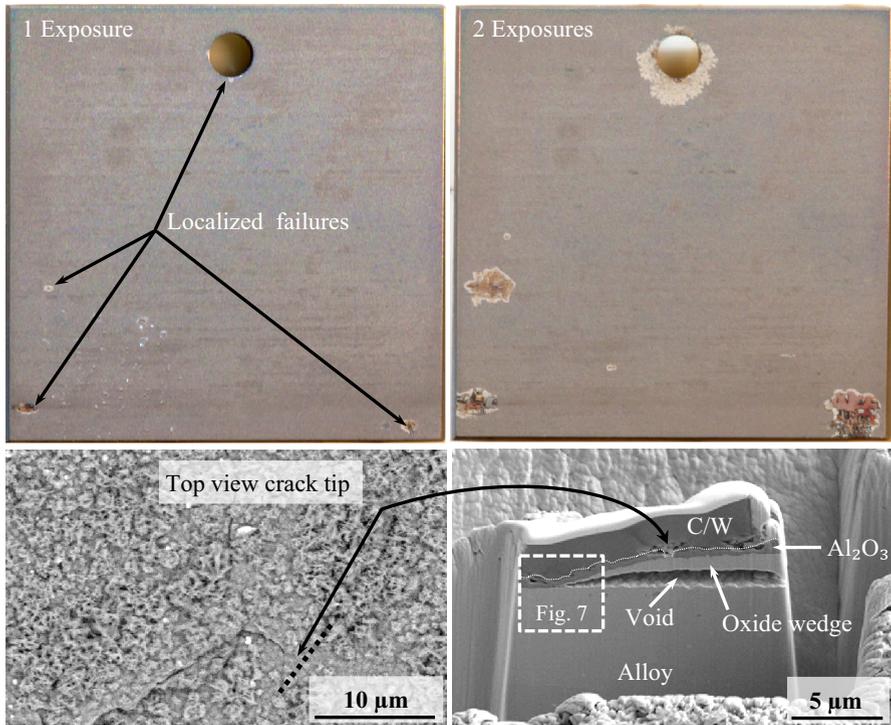
Corrosion of Samples Pre-oxidized 24 h at 900 °C The samples pre-oxidized 24 h at 900 °C were much less corroded after the first corrosion exposure compared to both 1 h pre-oxidations (compare Figs. 5, 3). Nevertheless, the alumina scale had failed at a few locations. The failures were located both on the polished surface (1 μ m diamond suspension) and close to the ground edges (320 SiC paper). The second corrosion exposure resulted in lateral growth of the areas that suffered localised attack during the first corrosion exposure. The areas exhibiting localized corrosion were similar to the ones described above (1 h pre-oxidations). Thus, cracks can be seen in the alumina layer, and are associated with iron-rich oxide and K₂CrO₄ particles (Fig. 6). It can be noted that K₂CrO₄ was also observed at a distance from the cracks in the alumina scale. The presence of α -Fe₂O₃ and K₂CrO₄ was corroborated using XRD (Table 2).

The top view SEM-BSE image of an area at the corrosion front in Fig. 5 (lower left), far away from the iron-rich oxide, shows the end of a crack in the alumina scale. Iron-rich oxide was not detected in imaging from top view. In order to investigate the early stages of alumina scale failure, a TEM specimen was prepared at the crack tip

Fig. 5 Optical images of pre-oxidized APMT (24 h, 900 °C) exposed for one and two corrosion exposures ($O_2 + H_2O + N_2 + KCl$ at 600 °C for 24 h). The SEM-BSE top view micrograph (*left*) and SEM-SE image on the right-hand side shows the corrosion front with a visible crack tip after two corrosion exposures

normal to the direction of the crack (see dotted line). An image of the TEM sample before the final thinning is shown in Fig. 5 (lower right), and reveals a wedge-shaped oxide underneath the alumina layer. SEM/EDX analysis showed that the oxide wedge is iron-rich. Figure 5 shows that the alumina/iron oxide scale is partly detached from the alloy. The point where the alumina scale is detached from the alloy coincides with the tapered end of the iron rich oxide wedge and is considered to correspond to the corrosion front. A comparison of the top view and cross section images in Fig. 5 reveals that the crack tip, seen in top-view, does not coincide with the corrosion front as captured by the cross-section image. Figure 7 shows a STEM micrograph of the corrosion front, complemented by STEM/EDS elemental maps. The analysed TEM foil had a thickness of about 100 nm and carbon and tungsten were deposited for protection of the surface during sample preparation. The interface between the carbon/tungsten deposit and the alumina scale is illustrated with the dotted line in Fig. 5. During final sample thinning, part of the iron-rich oxide wedge was milled away by gallium ions, thus enlarging the void seen in Fig. 5. The void was also affected by re-deposition. Therefore, the STEM/EDS analysis was performed at the far left in the micrograph (boxed area in Fig. 5).

A typical case is shown in Figs. 5, 6 and 7 (24 h pre-oxidation at 900 °C, one and two corrosion cycles). The cracks in the alumina scale are associated with potassium chromate and iron-rich oxide at the scale/gas interface (Fig. 6). Below the alumina, a layered iron-rich oxide had formed as a result of corrosion. It may be noted that the crack in the alumina scale seen in the top-view (Fig. 5 lower left) corresponds to de-cohesion of the alumina/alloy interface (Figs. 5, 7). Significantly, chlorine was detected at the alumina/alloy interface in front of the crack tip, in a region where the Al₂O₃ layer remained seemingly intact and in contact with the alloy substrate (Fig. 7). The same image shows that chlorine penetrated far ahead of potassium, which indicates that transition metal chlorides (FeCl₂ and/or CrCl₂) were present at the alumina/alloy interface. Chlorination with HCl(g) (generated by Reaction (1)) is not considered to be the source of subscale chloride in this case because the HCl generated by Reaction (1) will form at the gas/scale interface and will be transported away from the sample by the flowing gas.

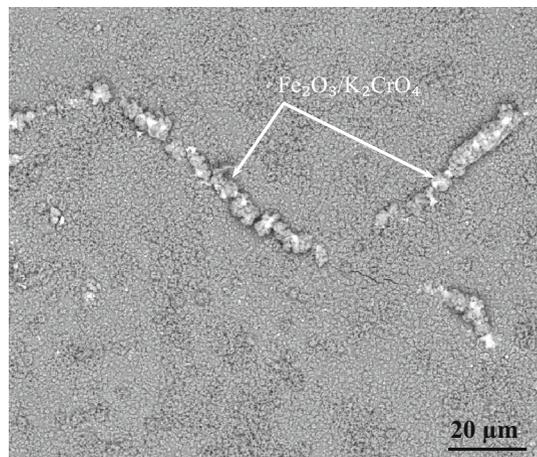
Fig. 6 SEM-BSE micrograph of pre-oxidized APMT (24 h, 900 °C) exposed for two corrosion exposures ($O_2 + H_2O + N_2 + KCl$ at 600 °C for 24 h) showing the cracked alumina scale. Iron oxide and K_2CrO_4 have formed in the cracks

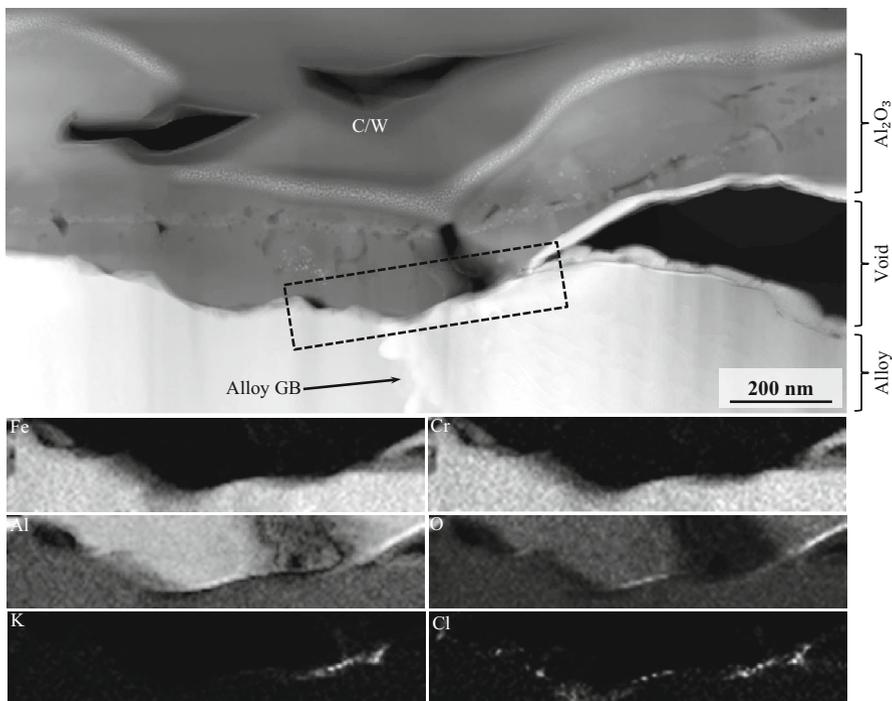
Figure 7 depicts a High Angle Annular Dark Field (HAADF)-STEM micrograph of the area where the alumina scale detached from the alloy substrate

Fig. 7 Elemental maps of the boxed area in the STEM-HAADF micrograph of pre-oxidized APMT (24 h, 900 °C), exposed two corrosion exposures ($O_2 + H_2O + N_2 + KCl$ at 600 °C for 24 h)

(corresponding to the corrosion front). To the left of the corrosion front, the alumina scale is well adhered to the alloy substrate, i.e., no porosity was detected in the alumina/alloy interface. The boxed area in Fig. 7 was subjected to STEM/EDS mapping. The corresponding elemental maps for iron and chromium indicate that a Fe, Cr oxide is present just to the right of the corrosion front, to the far right in the boxed area. This corresponds to the remains of the iron-rich oxide wedge in Fig. 5. Gallium was detected together with the Fe, Cr oxide to the far right in the boxed area, showing that this area had been affected by sample preparation. The remaining part of the boxed area was not affected by the re-deposition. Potassium was enriched in the interface between the alumina scale and alloy close to the corrosion front while chlorine was detected throughout the whole alumina/alloy interface (Fig. 7). In addition STEM/EDS analyses (not shown) showed that the alloy grain boundary in Fig. 7 was enriched in Mo while the alloy grains were depleted in Mo. It should be noted that Mo is homogeneously dispersed in the alloy matrix in the as-delivered

Thus, in the presence of a KCl “salt bridge” across the scale, the anodic formation of FeCl_2 at the scale/alloy interface becomes coupled to the formation of potassium chromate at the scale/gas interface (step IV in Fig. 13). Close to the scale/alloy interface, the anodic formation of FeCl_2 (Reaction (2), Fig. 7) causes charged chloride ion vacancies to form in the adsorbed KCl. Simultaneously, at the scale/gas interface, the cathodic reaction consumes K^{+} ions, thus generating an excess of chloride ions in KCl.

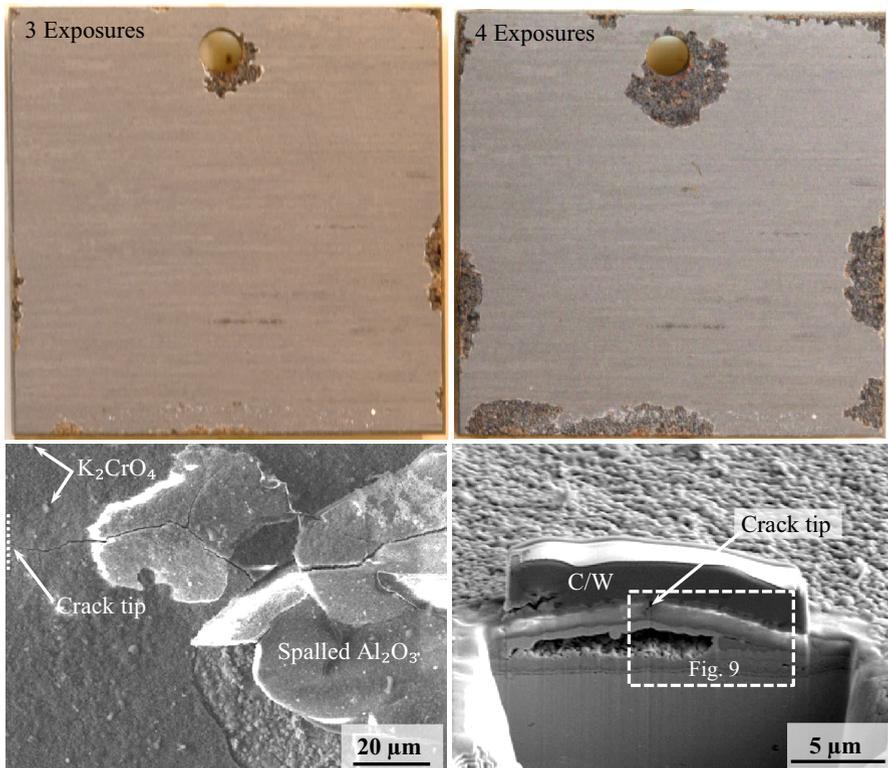
Fig. 8 Optical images of pre-oxidized APMT (24 h, 1,100 °C) exposed for three and four corrosion exposures ($O_2 + H_2O + N_2 + KCl$ at 600 °C for 24 h). The SEM-SE top-view micrograph (*lower left*, four corrosion exposures) of the periphery of a corroded area shows the cracked and partly spalled alumina layer. The cross section was obtained at a crack tip in the alumina layer as indicated by the *dotted line*

Corrosion of Samples Pre-oxidized 24 h at 1,100 °C The samples subjected to 24 h of pre-oxidation at 1,100 °C showed no signs of corrosion after two consecutive corrosion exposures (not shown). However, the third corrosion exposure caused the alumina scale to fail locally, the corrosion morphology was similar to the one described for the other pre-oxidized samples (Fig. 8). In this case, the corrosion started at the sample edges. This is in contrast to the samples pre-oxidized for 24 h at 900 °C where corrosion sometimes started on the polished surface, far away from the edges. After initiation, the corroded areas grew laterally over the surface (Fig. 8). Similar to the other pre-oxidized samples, iron-rich oxide and K_2CrO_4 were detected in association with the cracks in the alumina layer and on areas where the alumina scale had spalled (see Table 2; Fig. 8). It may be noted that K_2CrO_4 particles were detected, not only in association with cracks in the alumina layer but also on top of the intact alumina surface, far away from cracks. It is believed that the chromate had formed through Reaction (1) (see “Discussion” section). It is suggested that the chromia needed for the reaction to occur originated from the transient oxide from the pre-oxidation.

A TEM specimen was prepared from the area at a crack tip, see dotted line in Fig. 8 (top view image, lower left). Figure 8 shows an image of the TEM sample before thinning (lower right), in which the cracked alumina layer with a thick oxide scale can be seen underneath. The STEM micrograph in Fig. 9 was complemented by the STEM/EDS line scan from A to B and by point analyses.

A TEM sample was prepared from an area far away from the corrosion front on the sample shown on the upper right in Fig. 8 (after 4 corrosion cycles). In this area

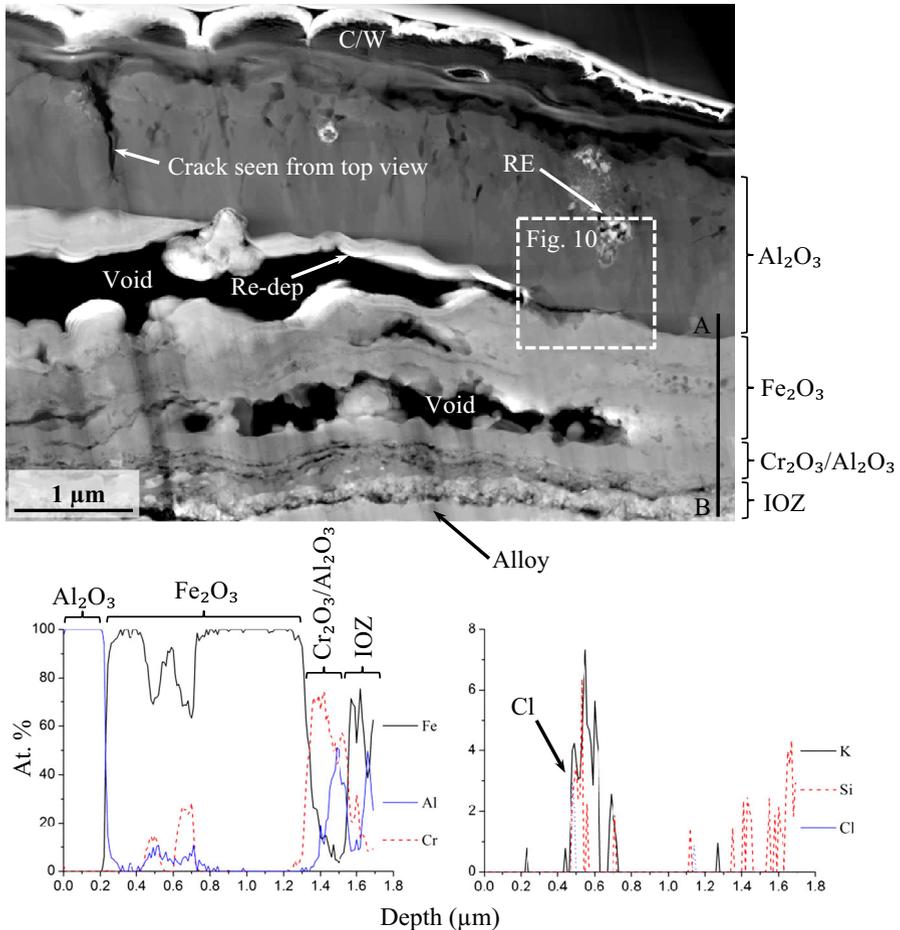
The STEM-HAADF image of the cross-section in Fig. 9 reveals that the crack seen in the top view image (Fig. 8) does not reach all the way through the alumina scale. It may be noted that it is difficult to prepare a TEM foil specimen exactly at the crack tip because the TEM foil is only about 100 nm thick. The crack is believed to run through the entire alumina layer at some location close to the region represented by the obtained TEM foil. The area sampled by the TEM foil shows a relatively advanced stage of corrosion attack, with a rather thick ($\sim 1.5 \mu\text{m}$) oxide present underneath the alumina layer. It can be seen that the oxide scale is partly cracked and contains several large voids. At the bottom of the scale an Internal Oxidation Zone (IOZ) seems present (see below).

In the vicinity of the voids on the left-hand side in Fig. 9, there are signs of re-deposition from sample preparation (mostly Ga). Consequently, the EDS analysis was conducted on the right-hand side of the micrograph. The RE particle indicated in the alumina layer contained low amounts of Ta and Zr together with alumina. The EDS line-scan (A to B in the micrograph) probed the bottom part of the alumina layer, the oxide underneath it and the OAZ in the alloy. The top 4/5 of the oxide below the alumina layer was dominated by iron oxide but also exhibited Al- and Cr-rich bands containing small amounts of K, Si and Cl. Below the iron oxide there was a ~ 200 nm thick layer which consisted of chromia and alumina, and where the alumina component was closest to the alloy. The XRD (Table 2; Fig. 4) analyses did not result in any diffraction from Cr_2O_3 and it is believed to be due to the

Fig. 9 STEM-HAADF micrograph of pre-oxidized APMT for (24 h, 1,100 °C), after four consecutive corrosion exposures ($\text{O}_2 + \text{H}_2\text{O} + \text{N}_2 + \text{KCl}$ at 600 °C for 24 h). The micrograph shows the area at the crack tip in Fig. 8. The EDS line profile from A to B probes the bottom part of the original alumina scale, the oxide underneath it and the corresponding IOZ

relative thin layers that are present in the scale. EDS point analysis indicated that the area immediately below the chromia/alumina layer had been partly oxidized. This ~ 200 nm thick layer is interpreted as an IOZ.

The STEM/EDS line profile in Fig. 9 shows that the oxide underneath the failed alumina layer essentially consisted of iron oxide, most likely hematite. In the middle of this layer, the iron oxide was mixed with considerable amounts of chromium and aluminium oxide together with small amounts of chlorine, potassium and silicon. It is argued that this region corresponds to the alloy immediately below the scale/alloy interface, before the failure of the alumina scale. This implies that the iron oxide layer had grown both outward and inward. Below the iron-rich oxide is a layer of relatively pure chromia. The lower part of this chromia layer, at the new scale/alloy interface, is enriched in alumina. It may be noted that the oxide underneath the failed alumina scale is very similar to the scale formed when the same alloy has been exposed to this environment without pre-oxidation [15].

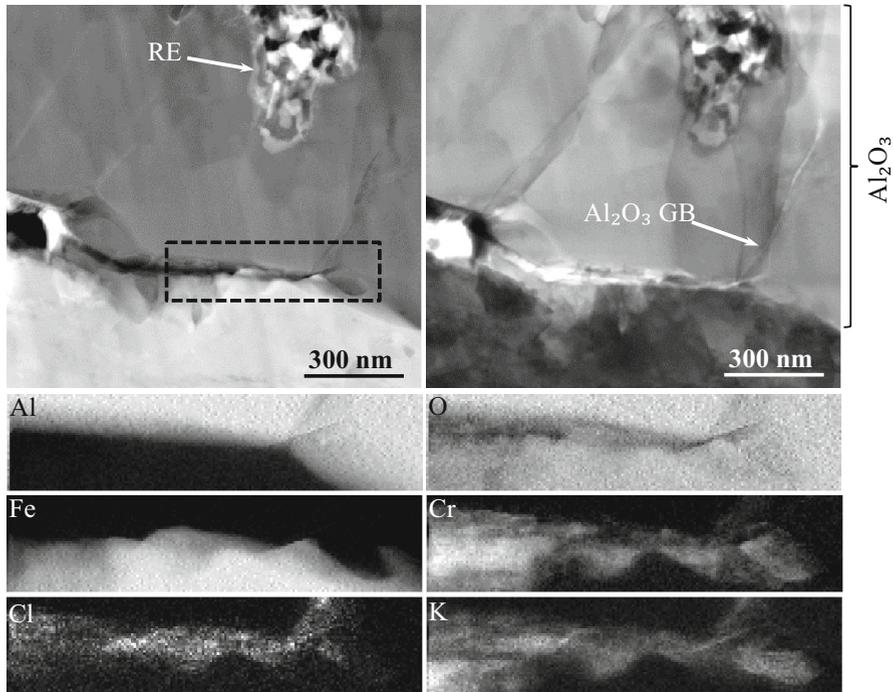
The lateral crack between the alumina and the iron-rich oxide layer (boxed area in Fig. 9) was investigated further with STEM/EDS elemental mapping (Fig. 10). The analysis showed that the crack was enriched in Cr, K and Cl. It may be noted that potassium and chlorine (corresponding to KCl) were also present in a grain boundary in the alumina layer (to the right in Fig. 10).

Fig. 10 EDS Elemental maps of the boxed area in the STEM-HAADF micrograph in Fig. 9 of pre-oxidized APMT (24 h, 1,100 °C), exposed two corrosion exposures ($O_2 + H_2O + N_2 + KCl$ at 600 °C for 24 h). A alumina grain boundary is indicated in the STEM-BF image

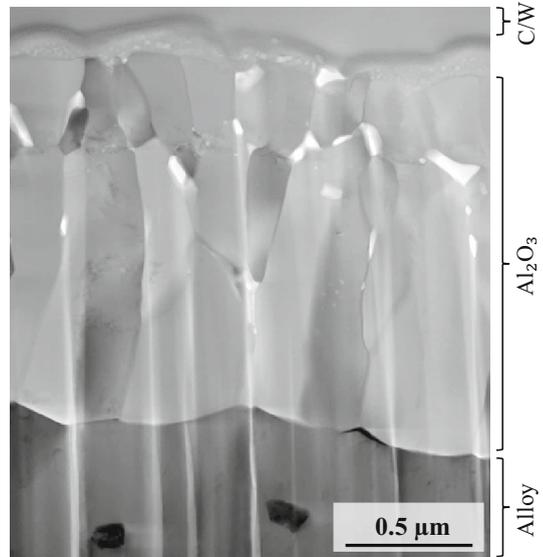
top-view imaging revealed no cracks in the alumina scale. Figure 11 shows a STEM-BF image of the cross-section with an adherent alumina layer. No corrosive species e.g. Cl or K were detected using EDS point analyses and elemental mapping (not shown) either in the alumina scale/alloy interface or in the oxide grain boundaries. On top of the alumina scale there was a layer consisting of K, Si, O and Al. Because no crystalline corrosion products were found other than alumina, this layer is suggested to consist of potassium aluminium silicate glass. Previously, crystalline $KAlSiO_4$ was identified on Kanthal[®] APMT after pre-oxidizing at 700 °C for 24 h in O_2 and then exposed to an $O_2 + H_2O$ environment in the presence of KCl at 600 °C [17].

Fig. 11 STEM-BF micrograph of pre-oxidized APMT (24 h, 1,100 °C), exposed four corrosion exposures ($O_2 + H_2O + N_2 + KCl$ at 600 °C for 24 h). The TEM specimen was obtained far away from the corrosion front

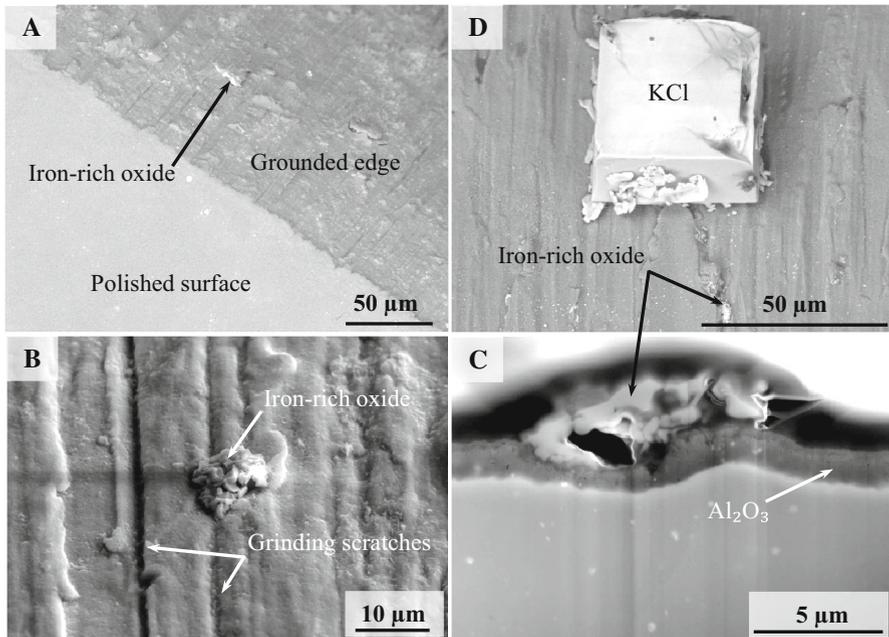
The observation that the KCl-induced corrosion of the pre-oxidized samples always began at the sample edges prompted an investigation of the alumina scale formed by pre-oxidation for 24 h at 1,100 °C. While SEM/EDX top-view imaging of the polished surface showed a very smooth alumina scale, the ground sample edges revealed small ($\sim 5\text{--}10\ \mu\text{m}$ in size) iron-rich oxide nodules (Fig. 12a). It was estimated that about 200 of these iron-rich oxide nodules were present at the sample edges after pre-oxidation. Figure 12b and c shows top-view and cross-section SEM images of one of the iron-rich oxide nodules. The top-view image shows the scratches from grinding. The cross-section shows that a continuous alumina layer

Fig. 12 SEM-BSE images (a, d) and SEM-SE (b, c) of top view and cross section of one grounded edge (320 SiC paper) of pre-oxidized APMT (24 h, 1,100 °C) showing iron-rich oxide nodules. d shows an image of the pre-oxidized edge with added KCl before exposure

was present underneath the iron-rich oxide although it was thinner than the alumina layer formed next to the nodule. Figure 12d illustrates the situation at the edge of a sample before the corrosion exposure, showing a KCl particle in the vicinity of an iron-rich oxide nodule. KCl was also detected on top of some of the iron-rich protrusions before exposure.

absent on the polished surface (Fig. 12). In the cross section of an iron-rich nodule shown in Fig. 12c, the iron oxide is separated from the alloy by an alumina layer which is significantly thinner than the alumina scale in general. It can be speculated that the alumina scale had been damaged at the oxide nodules and that the corrosion started there which would explain the tendency for corrosion to start at the edges. With the information at hand, the initiation of alumina scale failure and corrosion in the presence of KCl may be explained by either cracks caused by thermal mismatch stresses or by the iron oxide nodules at the edges.

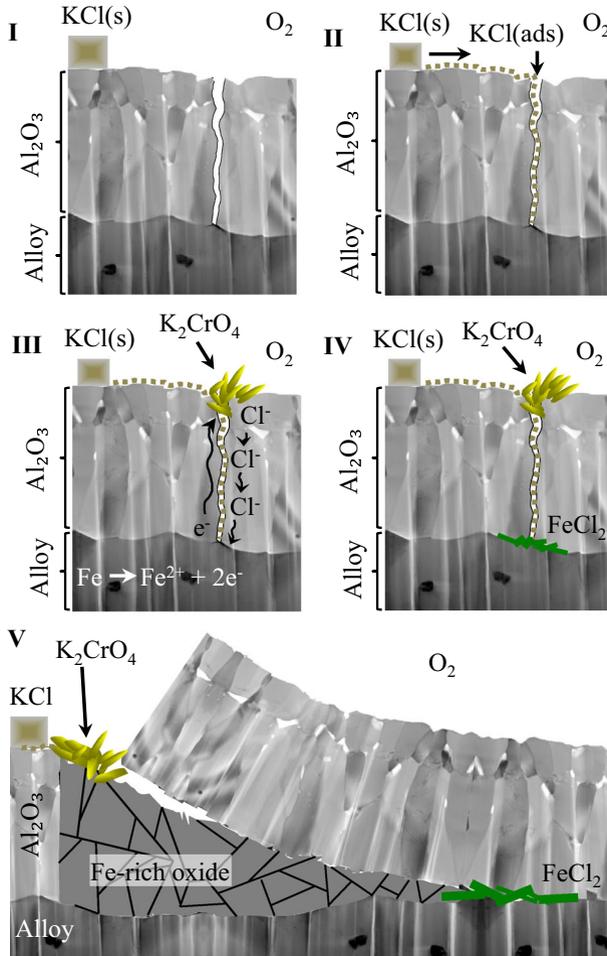
Fig. 13 Schematic illustration of the initiation of the corrosion attack coupled to Reaction (2)
