Laboratory study of driving rain resistance of four façade systems with window fittings - Experimental results of leakage flows

LABORATORY STUDY OF DRIVING RAIN RESISTANCE OF FOUR FAÇADE SYSTEMS WITH WINDOW FITTINGS – EXPERIMENTAL RESULTS OF LEAKAGE FLOWS

Lars OLSSON^{a,b}

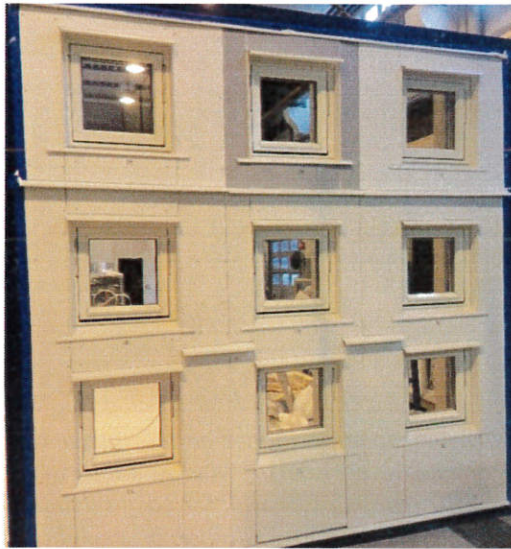
Fig. 2 Front façade of wall 1

1. Façade boards (polymer composite board), outdoor air gap, 300 mm mineral wool insulation (with drainage ducts), plywood and plastic foil (**Fig. 2**). Exterior window sills (metal) were about 100 mm wider than the windows on each side. Connections at the windows were sealed with sealing compound. Rubber strips were fitted behind the façade board joints to metal battens. The bottom of the wall had a waterproofing mat (base flashing) to channel water away. Exterior window sills were sealed to windows with sealing compound.

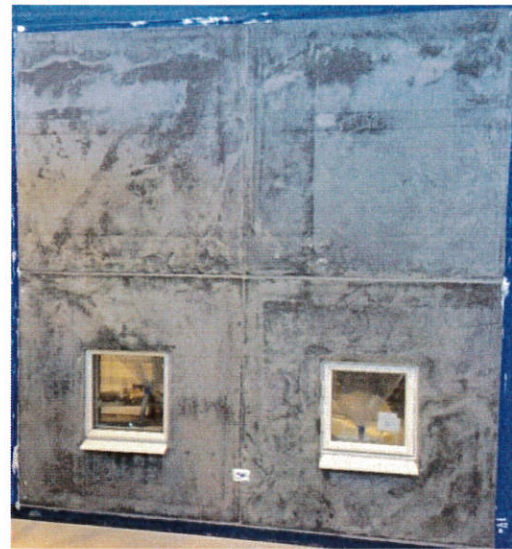
Fig. 3 Front façade of wall 2

2. 15 mm prefabricated high-performance concrete element (**Fig. 3**), 15 mm of mineral wool insulation, 100 mm XPS-insulation. Element joints and connections to windows were sealed using sealing compound. No backer rod was fitted to the vertical joints or to the horizontal joints in the bottom wall. Gaps around the windows were filled with the sealing foam. Additionally, a sealing strip was fitted to the outer section of the space between the sealing foam and sealing compound, around the window, apart from at the bottom of the window connection.
