Manufacturing of Valve Bridge Component Utilizing Lean Alloyed Powders and Vacuum Sintering

Shvab, R., Vattur Sundaram, M., Karlsson, H. et al (2018). Manufacturing of Valve Bridge Component Utilizing Lean Alloyed Powders and Vacuum Sintering. Powder Metallurgy Progress, 18(1): 31-39. <http://dx.doi.org/10.1515/pmp-2018-0004>

R. Shvab, M. V. Sundaram, H. Karlsson, D. Chasoglou, S. Berg, E. Hryha, L. Nyborg

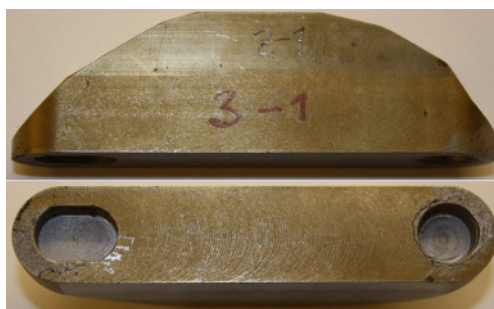
Fig.1. „Side“ (up) and „bottom“ (down) view of the valve bridge component prototype for heavy duty engine application.

Abovementioned powder mixes were pressed into cylindrical blocks, vacuum sintered and machined to receive a valve bridge component shape, see Figure 1.

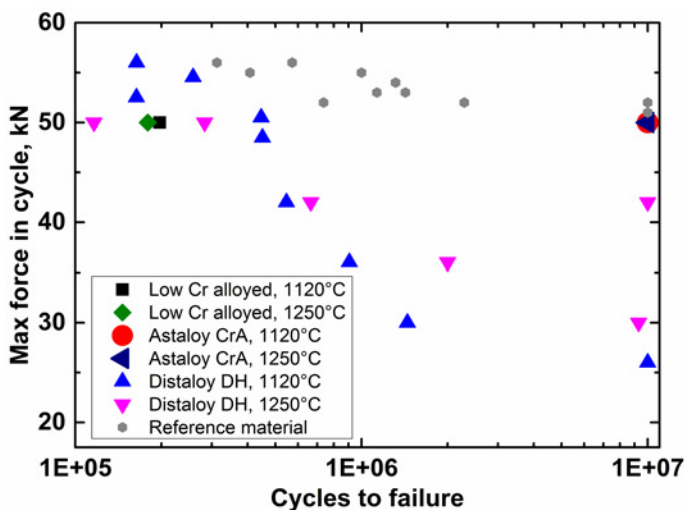
Fig.3. Fatigue tests results for investigated materials in comparison to the reference material.

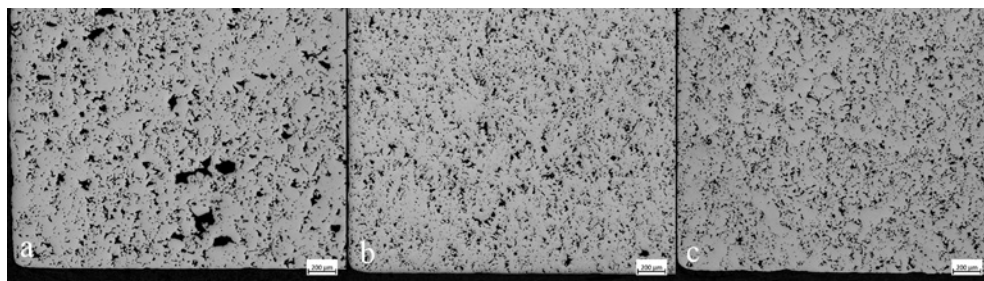
The example of pores structure of investigated materials sintered at 1120°C presented in the Figure 4. In all cases pores are well distributed in the material. Low Cr alloyed material contains large pores, most probably due to admixed Cu powder.

Fig.4. None-etched microstructure of low Cr alloyed steel (a), Astaloy CrA (b) and Distaloy DH (c) materials sintered at 1120°C.

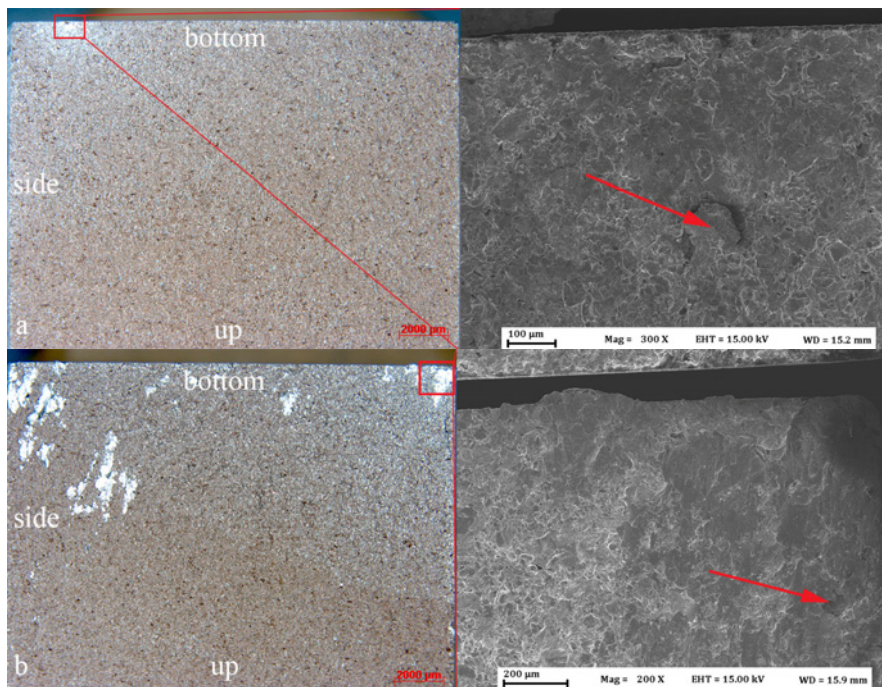
In order to find the crack initiation sites, identify the fracture mechanisms and check the quality of the sintering, the fracture surface analysis was performed for the broken samples. In the case of low Cr alloyed powder sintered at both 1120 and 1250°C, crack initiations were detected close to the sample surface. For material sintered at 1120°C the initiation site was found at the „bottom“ of the sample, see Figure 8a, while for 1250°C sintered material it was closer to the „side“ of the sample, see Figure 8b.

Fig.8. Crack initiations for low Cr alloyed material samples sintered at a) 1120, b) 1250°C.

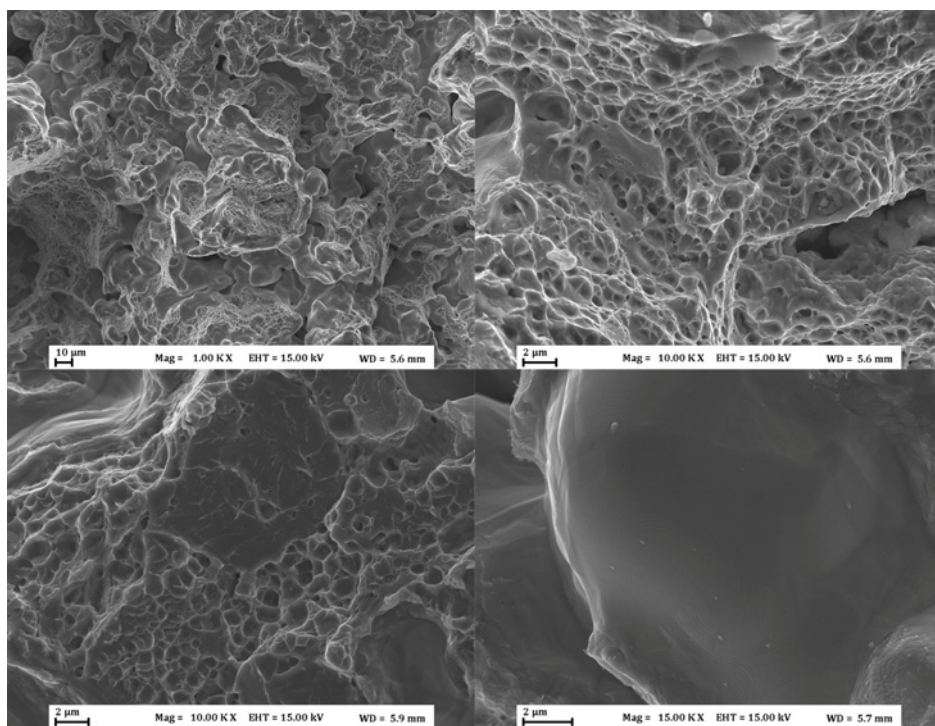
Inter and transparticle ductile fracture was found to be the main failure mechanism for low Cr alloyed material sintered at both 1120 and 1250°C temperatures, see Figure 9. Some areas with cleavage were also observed. No significant oxide residues were detected, indicating good sintering.

Fig.9. Fracture surface of low Cr alloyed material sintered at 1120°C.

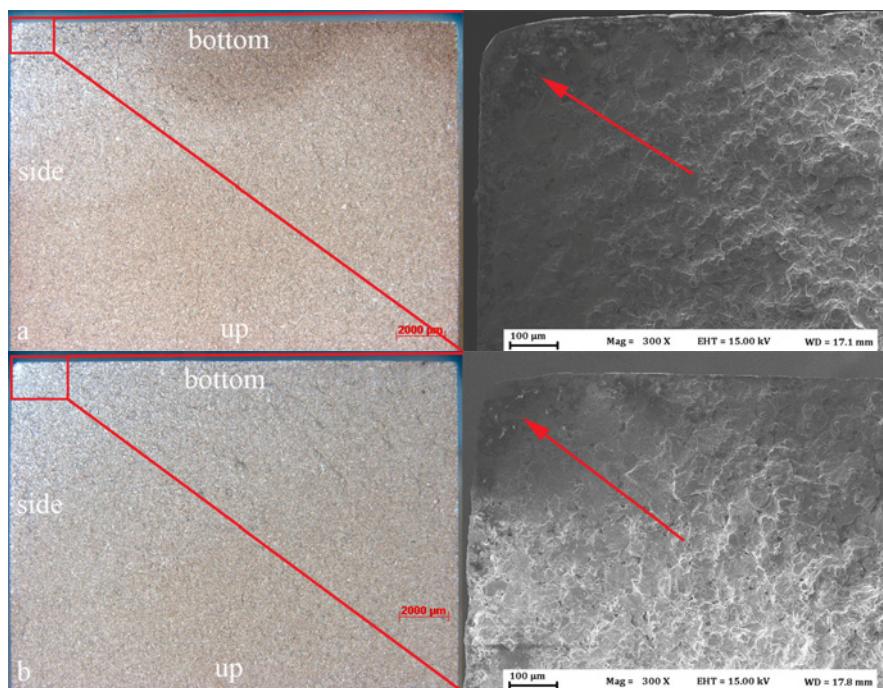
For the valve bridges made of Distaloy DH powder material and sintered at both 1120 and 1250°C, crack initiation sites were found at the bottom edges of the component, see Figure 10.

Fig.10. Crack initiations for Distaloy DH powder samples sintered at a) 1120, b) 1250°C.
