Effect of Powder Recycling on Defect Formation in Electron Beam Melted Alloy 718

Gruber, H., Luchian, C., Hryha, E. et al (2020). Effect of Powder Recycling on Defect Formation in Electron Beam Melted Alloy 718. Metallurgical and Materials Transactions A: Physical Metallurgy and Materials Science, 51(5): 2430-2443. <http://dx.doi.org/10.1007/s11661-020-05674-8>

HANS GRUBER, COSMINA LUCHIAN, EDUARD HRYHA, and LARS NYBORG

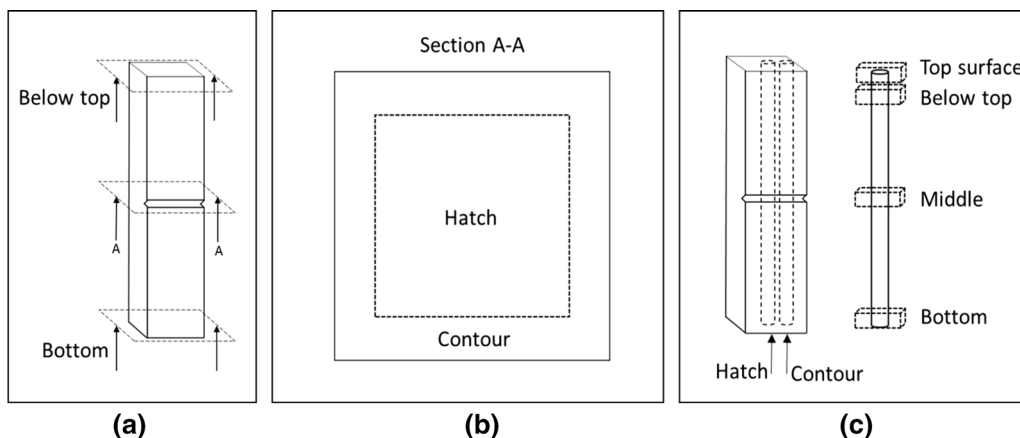
Fig. 1—Positions within the solid EBM samples evaluated in terms of (a) and (b) metallographic image analysis and (c) oxygen and nitrogen measurements. Cross-section A-A in (a) presented in (b).

The extent to which non-metallic inclusions accumulate in certain positions within the material was measured in terms of metallographic image analysis as well as oxygen analysis, see Figure 1(a). The results for a set of three B30 samples are shown in Figure 12. As already indicated in Figure 5, image analysis shows that the defect density in the contour region is continuously higher than in the hatch, see Figure 12(a). In the same figure, it is also shown that image analysis could not detect a clear difference in defect density between the bottom and top part, neither in the contour nor in the hatch region. The oxygen measurements presented in Figure 12(b), on the other hand, suggest a slight increase in oxygen level along the build direction of the hatch material. Especially, the top surface clearly shows

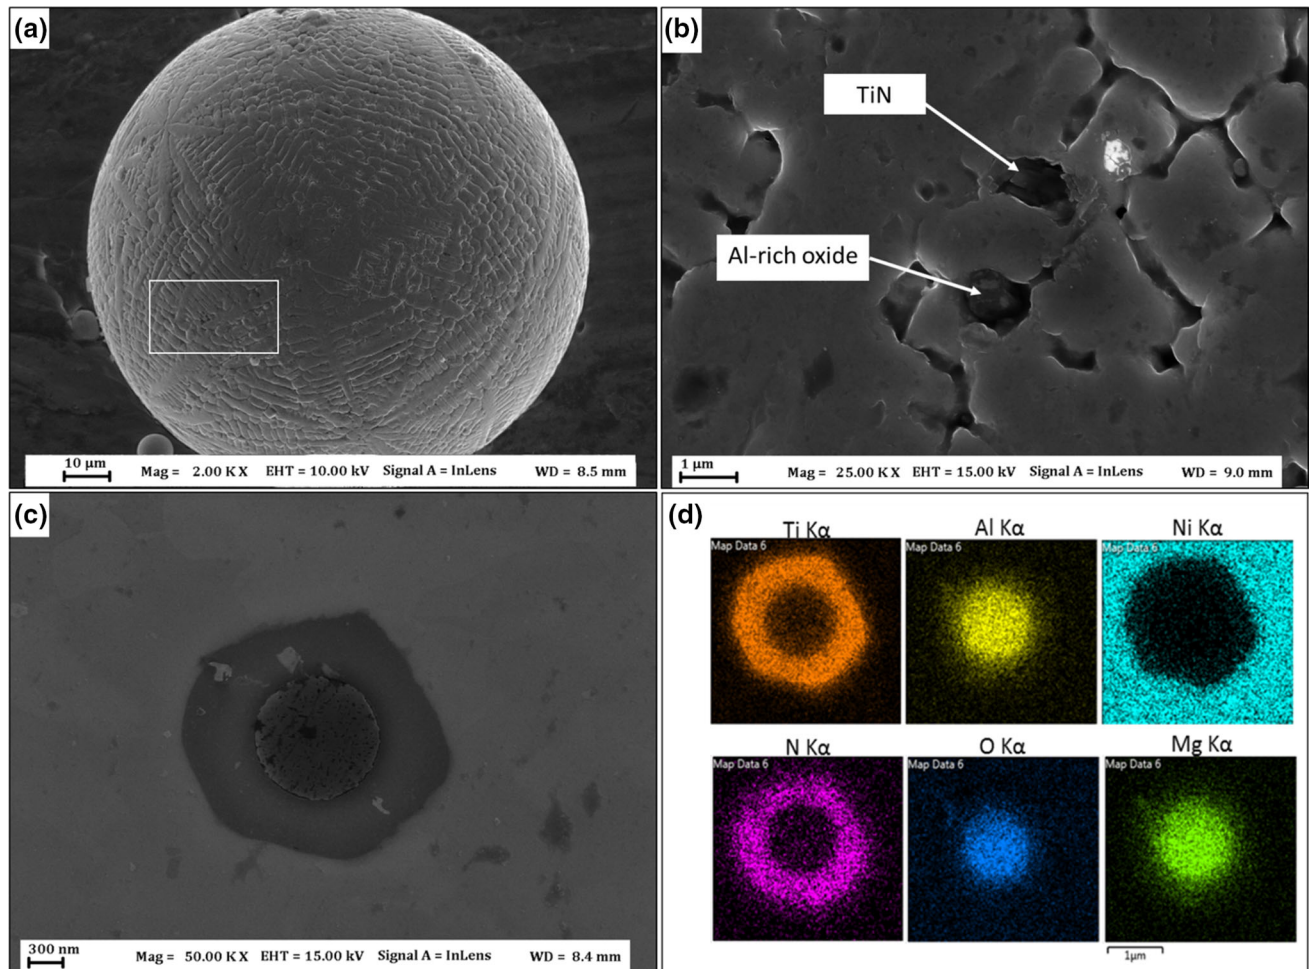
Fig. 2—Scanning electron images of the virgin powder; (a) secondary electron micrograph of the powder surface; (b) surface at higher magnification showing non-metallic inclusions; (c) secondary electron micrograph of a composite TiN/Al-rich oxide inclusion on a powder cross-section; (d) EDS map of the inclusion in (c).

Scanning electron micrographs of the virgin-state Alloy 718 powder are shown in Figure 2. As seen in Figure 2(a), this powder generally has a clean surface appearance that is visually free from non-metallic phases. Even though being fairly few in number, non-metallic inclusions with an equivalent diameter of around 1–10 μm can be observed in the powder when studied at higher magnifications. Powder cross-section analysis shows that they often consist of a dual-phase structure comprising a nucleus and an outer rim, see Figure 2(c).

A close coincidence between the outer rim and the Ti and N images in the EDS map in Figure 2(d) identifies it as TiN. Similarly, a high amount of Al and O in the

nucleus identifies it as Al-rich oxide. The strong oxide forming element Mg, which is a trace element in the studied material (see Table I), was also occasionally detected in the oxide nuclei, see Figure 2(d). Single phase oxide and nitride particles were observed as well. Similar non-metallic inclusions were observed on the cross-sections of the recycled powder.

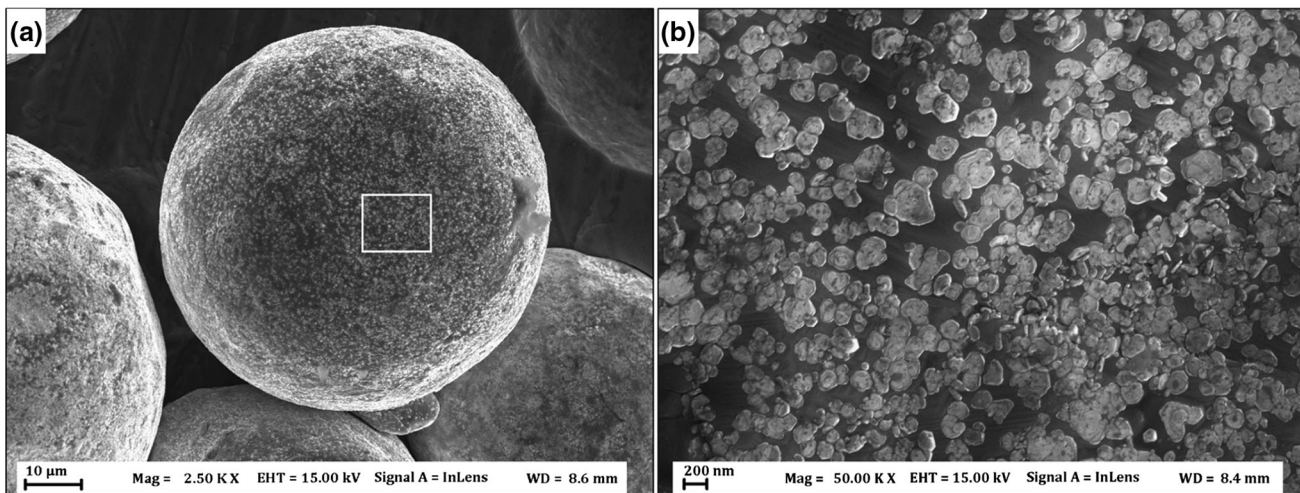
Fig. 3—(a) Secondary scanning electron image of the powder before build cycle 30; (b) Al-rich oxide particulates on the surface at higher magnification.

Figure 3 shows the surface of a powder sample collected before build cycle number 30. As was already described in previous research,^[23,24] a significant part of the re-used Alloy 718 powder surface is covered by Al-rich oxide particulate features that have formed during exposure of the powder to the process and the environment in the EBM build chamber. In Reference 24, it was also shown that the oxide particulates are confined to the powder surface. A more detailed

a continuous melt pool when melting the re-used metal powder under such conditions, the oxide particulates on its surface are not given the opportunity to agglomerate. Instead, as shown in Figures 13(a) and (b), they are finely dispersed on the interior surfaces of the LOFD in a configuration similar to that as seen on the powder surface, see Figure 3.

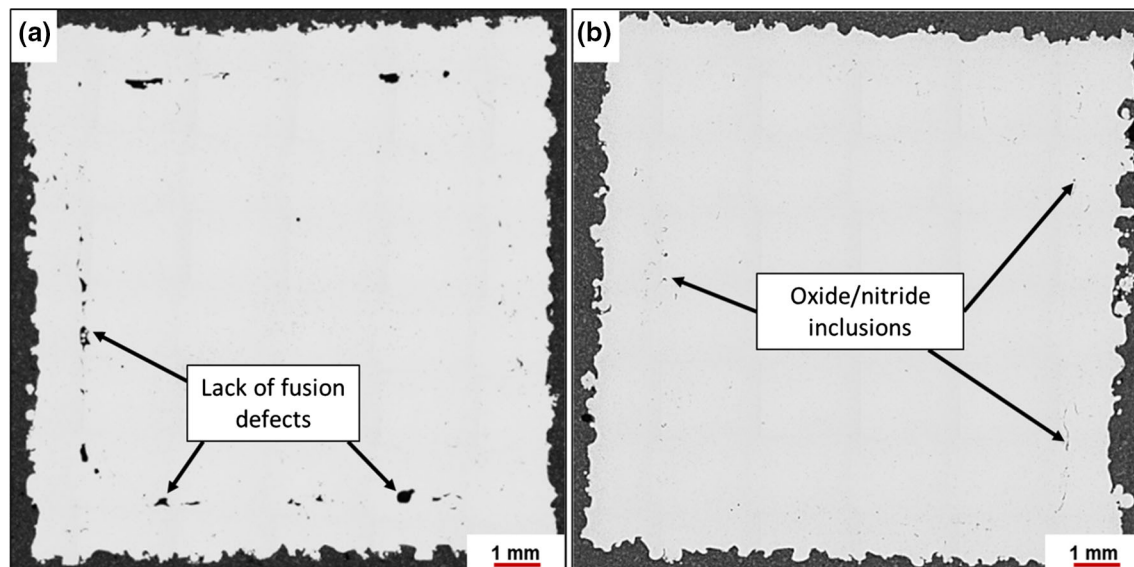
Fig. 4—Light optical micrographs of B30 CVN specimens showing typical distribution of defects on cross-section transversal to the build direction; (a) as-printed condition; (b) as-HIP condition.

Cross-section transversal to the build direction of a B30 specimen in as-printed condition as well as after HIP treatment is shown in Figures 4(a) and (b), respectively. In both cases, larger sized lack of fusion defects and non-metallic inclusions are mainly found along the interface between the contour and hatching regions at around 1 mm from the outer surface. This defect distribution is representative for samples produced from both virgin and re-used powder.

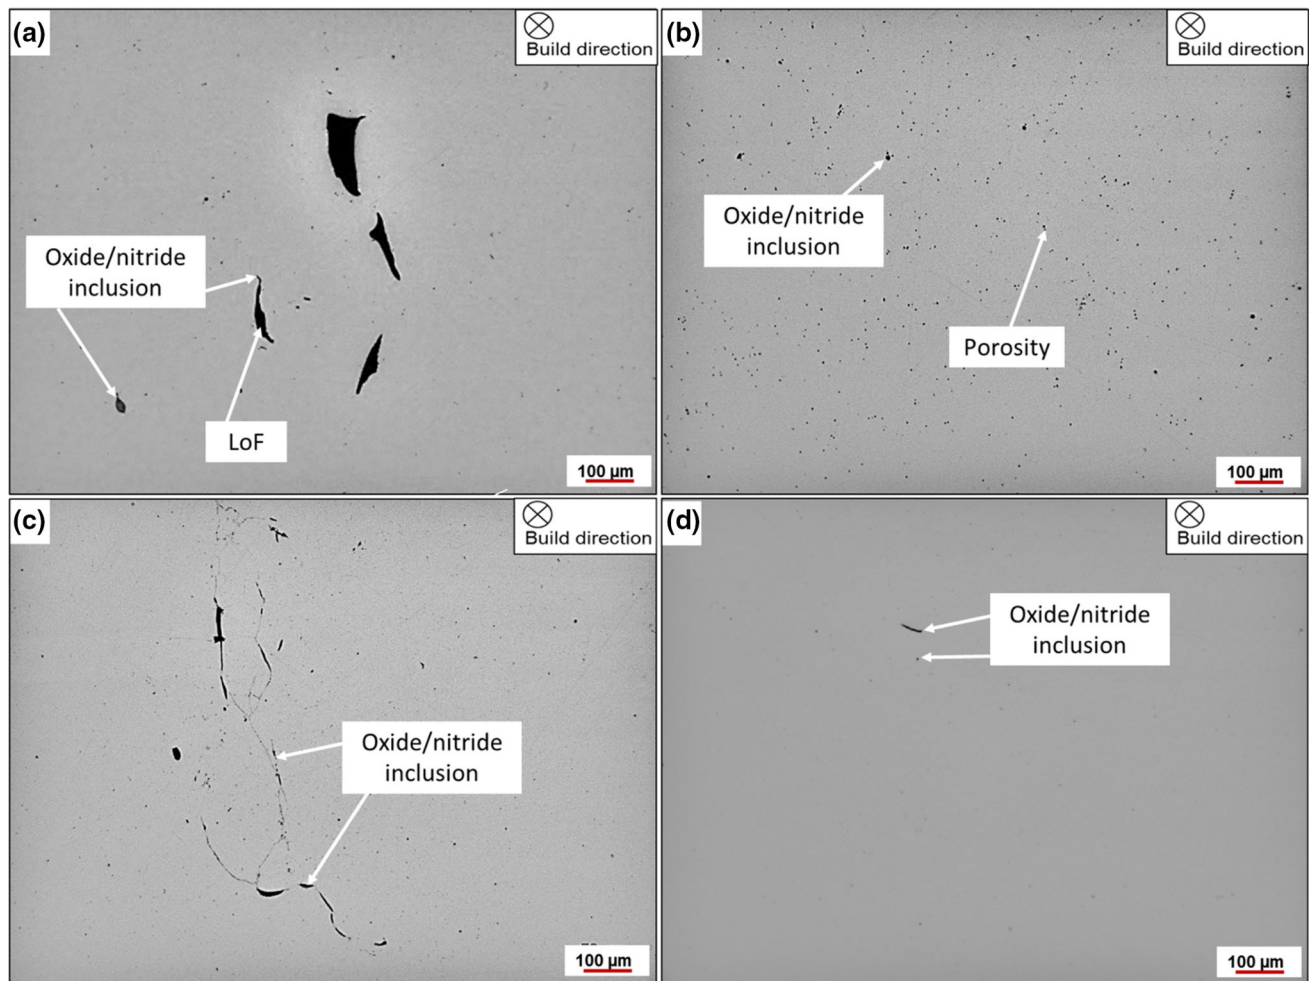
Fig. 5—Light optical micrographs showing defects in the B30 samples; (a) as-printed, contour region, (b) as-printed, hatch region (c) as-HIP, contour region, (d) as-HIP, hatch region.

In as-printed condition, the contour region often contains lack of fusion defects (LOFDs) with in-plane dimensions up to several hundred micrometers. Oxide/nitride inclusions often appear inside LOFDs, as shown in Figure 5(a). TiN inclusions are easily observed due to their yellow tinge and blocky shape in the LOM. Similarly, the oxide has a gray, shiny appearance which makes it distinguishable from porosity and LOFDs. The hatch region mainly contains large amounts of pores, see Figure 5(b). As shown in Figures 5(c) and (d), the defect density after HIP is significantly lower due to elimination of enclosed LOFDs and porosity. Except for voids connected to the outer surface, only non-metallic inclusions remain in the samples after HIP. Also in this case, the largest inclusions, with in-plane dimensions up to several hundred micrometers, are found close to the contour region, Figure 5(c). As seen in the electron images in Figure 6, as a consequence of LOFD consolidation, a network of non-metallic inclusions is left behind, both in the form of individual oxide particulates and as agglomerated oxide and nitride phases. Defects in the hatch region usually consist of discrete TiN and clusters/agglomerates of oxide and Ti-rich nitride inclusions, see Figure 7. As will be shown below, the amount

Also after HIP, there is a steady increase in defect density in the contour region with respect to progressive powder re-use, see in Figure 9(b). This is in line with the increased amount of inclusions in consolidated LOFDs, but also other large oxide agglomerations, as shown in Figure 5(c). A much more modest increase in defect density is seen in the hatch region, in agreement with the result presented in Figure 5(d).

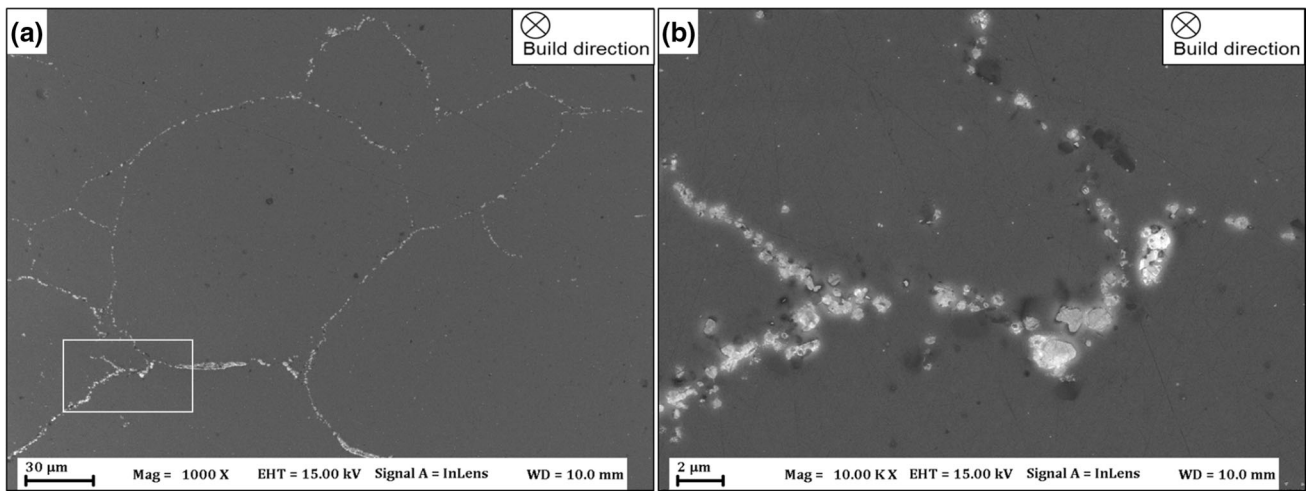
Fig. 6—(a) and (b) Secondary scanning electron images of a B30 sample in as-HIP condition showing non-metallic inclusions in a densified LOFD on a cross-section transversal to the build direction; higher magnification in (b).

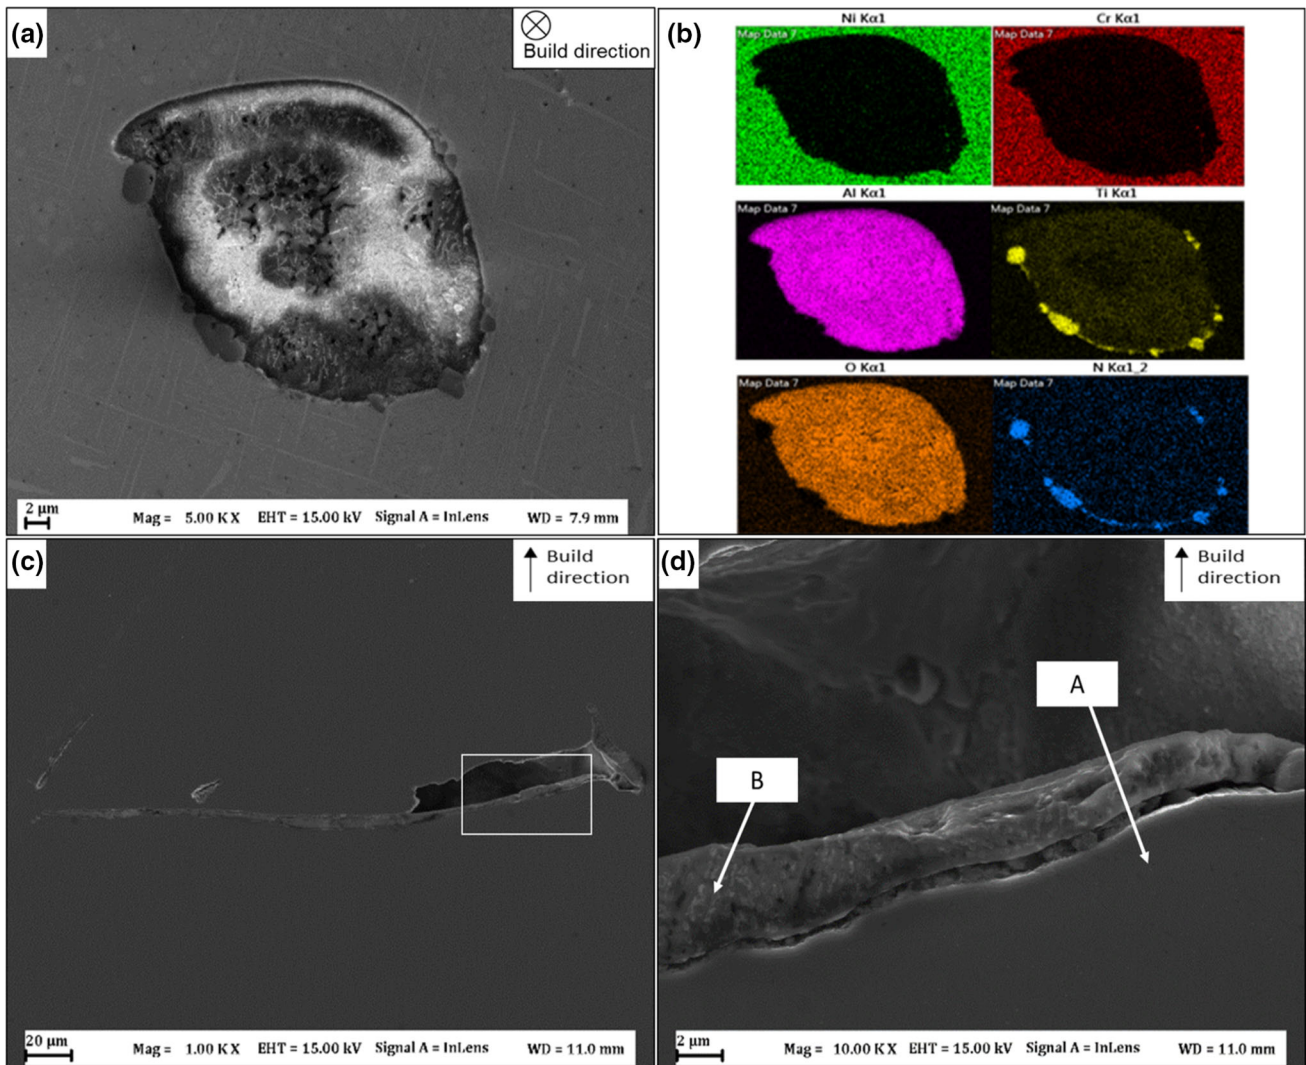
Fig. 7—Non-metallic inclusions observed in the hatch region of samples in as-printed condition; (a) oxide/nitride defect on a cross-section transversal to the build direction in a sample built from virgin powder; (b) corresponding EDS map; (c) large, planar oxide inclusion on a cross-section parallel to the direction in a B30 sample; (d) inclusion in (c) at higher magnification with EDS point analysis regions.

Typical morphologies of non-metallic agglomerated defects in the hatch region are shown in Figure 7. In the plane transversal to the build direction, they have a random orientation and shape, see Figure 7(a). When studied on cross-sections parallel to the build direction, they often have an elongated shape, with the major axis orientated perpendicular to the build direction, see Figure 7(c). In this direction, they can reach a few hundred micrometers. Larger sized inclusions are found in samples produced from re-used powder. Their thickness is usually in the range of a few microns, see Figures 7(c) and (d). As seen in the EDS map in Figure 7(b), the inclusions mainly consist of agglomerated Al-rich oxide, decorated with titanium nitride particles at the rim between the matrix and the defect. The EDS point analysis in the oxide-rich areas, such as point B in Figure 7(d), often gives a chemical composition close to that of pure alumina, see Table III. These findings have been confirmed from chemical analysis of a large number of inclusions in many different samples.

clearly reveals that samples produced from re-used powder often contain large, planar oxide inclusions. Thus, together with the typical oxide morphology on cross-sections parallel to the build direction, see Figures 7(c) and (d), it can be concluded that most large inclusions have a flake-like shape. It is important to note that such inclusions in the material fabricated from virgin powder are considerably fewer and smaller. Figure 8 shows the fracture surface of the hatch region in a B30 sample with the presence of a large planar Al-rich oxide inclusion, which has suffered from extensive cracking. Its homogeneous appearance and the cracks that span across its whole length indicate that it consists of a continuous phase that has formed from accumulation of melted oxide. A representative chemical composition of such flake-shaped inclusions, obtained from EDS analysis, is presented in Table III.

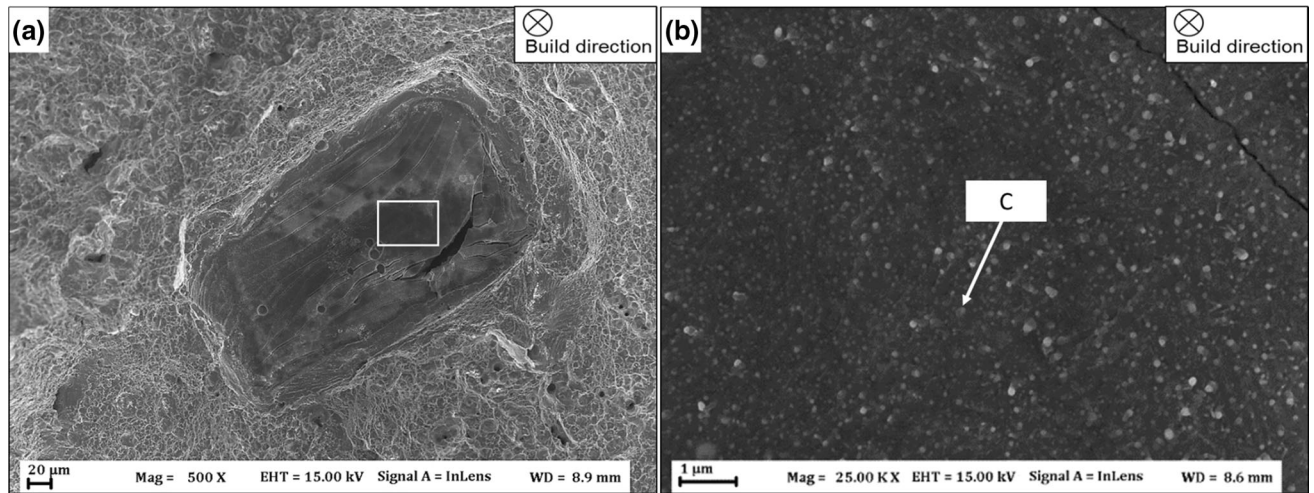
Fig. 8—(a) Non-metallic inclusion in the hatch region of a fractured B30 sample in as-printed condition; (b) higher magnification image showing its homogeneous structure. Chemical composition measured in point C is presented in Table III.

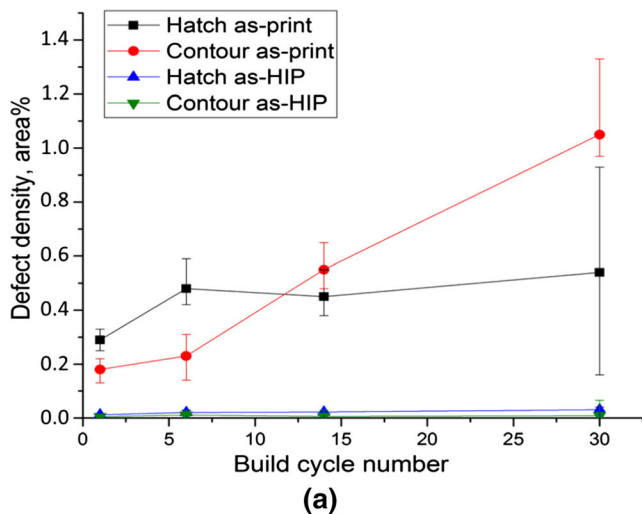
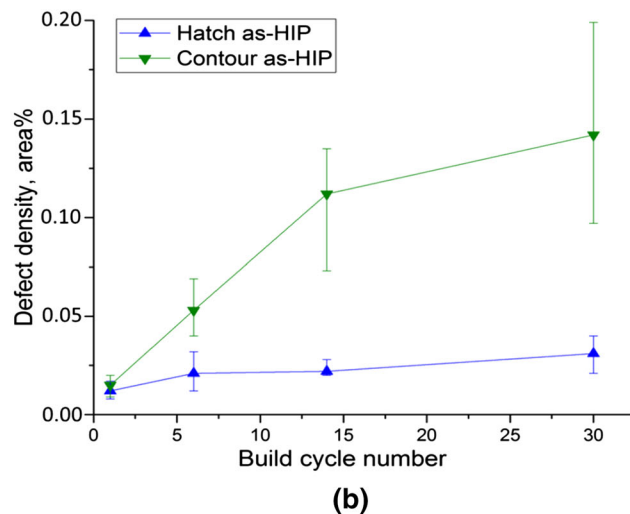
Fig. 9—Defect density in the hatch and contour region measured in (a) as-printed and as-HIP condition (b) as-HIP condition. The error bars indicate the actual measurement range. All data points are average values obtained from measurements in the cross-sections “bottom” and “below top”, as indicated in Fig. 1(b).

The defect density in solid samples produced from virgin and progressively re-used powder, in as-printed and as-HIP condition, is presented in Figure 9(a). As seen here, only as small portion of the defects present in

as-printed condition remain after HIP, which, for improved visualization, is presented separately in Figure 9(b). As seen in Figure 9(a), there is a steady increase in defect density in the contour region with respect to progressive powder re-use. This is mainly due to an increasing amount of LOFDs, which is considerably lower in samples built from virgin powder.

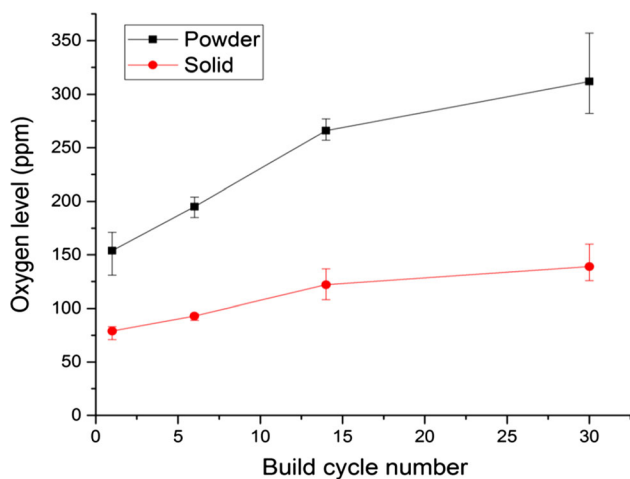
Fig. 10—Oxygen level in powder and solid samples with respect to progressive powder re-use. The oxygen level in the solid samples is measured in the middle hatch position, see Fig. 1(c). The error bars indicate the actual measurement range.

The increasing amount of oxide phases in powder and solid samples as a result of powder re-use is also detected when measuring the oxygen level in progressively re-used powder and corresponding hatch regions of the solid samples, as shown in Figure 10. Clearly, there is a steady increase in oxygen in both powder and solid samples as a consequence of powder re-use. A lower oxygen level (around half) is seen in the solid sample bulk compared to their parent powder material. The nitrogen level, on the other hand, is relatively stable at around 150 ppm in both power and solid

samples irrespective to the condition of the powder and is therefore not included in the graphs. This indicates that the amount of nitrogen-containing phases (mostly TiN) is stable during both powder recycling and electron beam melting.

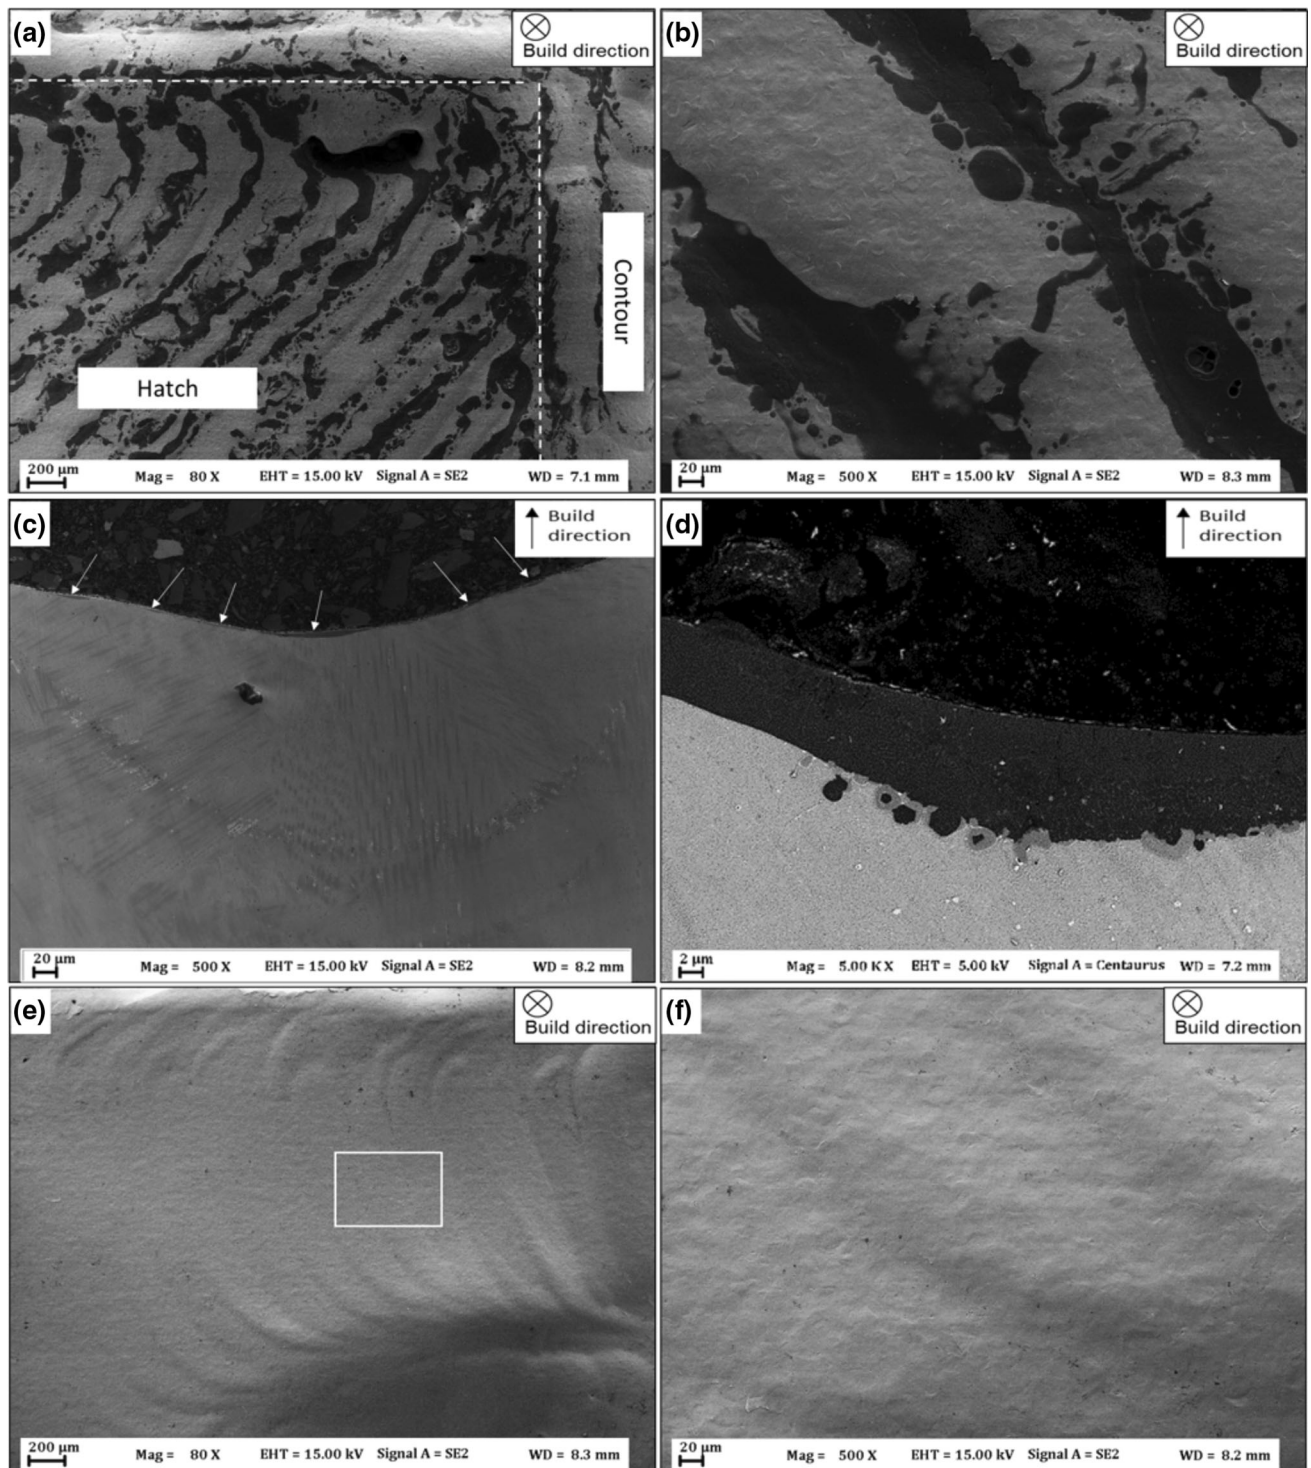
Fig. 11—Scanning electron micrographs showing the top layer of the EBM-fabricated samples; (a) top view of a B30 sample; (b) top view of oxide strings at higher magnification; (c) top layer of a B30 sample observed on a cross-section parallel to the build direction with oxide strings indicated with arrows; (d) cross-section of an oxide string at higher magnification; (e) and (f) top view of a B1 sample.

Figures 11(a) and (b) show the sample top surface (last melted layer) of a B30 sample, which contains a large amount of Al-rich oxide. EDS point analysis on the dark regions in Figure 11(b) gives a similar composition as from the oxide inclusions present in the bulk of the samples (see Table III). The oxide is arranged as strings in a regular pattern aligned along the electron beam scan direction and is often positioned close to the

center of the melt pool top surface. This is also seen when studying the cross-section of the top surface, see Figure 11(c), where the oxide strings have been indicated with arrows. In the higher magnification image in Figure 11(d), a string of oxide which smoothly follows the top of the melt pool in the last solidified layer is shown. As can be seen here, clusters of TiN particles are commonly present together with the oxide. Moreover, from Figure 11(a) it is clear that accumulation of oxide especially takes place at the end of the hatch lines. This observation further explains the large amount of oxide impurities at the interface between the hatch and contour region, as was shown in Figure 9. As compared to the clean appearance of the B1 sample top surface, shown in Figures 11(e) and (f), it is clear that the top surface of samples produced from re-used powder contain much more oxide than their virgin powder counterparts. As the amount of oxide in Figure 11(a) and (b) is much larger than what is observed inside the bulk material, see for example Figure 5(d), it is reasonable to expect that oxide is transported upwards towards the top surface during the melting process.

consistently higher oxygen levels, in agreement with the observed accumulation of oxide on the top surface, as shown in Figure 11. Also in this case, the continuously higher oxygen level in the contour (middle contour) as compared to the hatch (middle hatch) confirms the accumulation of non-metallic phases in the contour region as shown in Figure 12(a).

directions^[30] and the extremely fast solidification times involved in EBM. Nevertheless, during melting of the subsequent layers, the oxide may be transported upwards layer by layer and at the same time agglomerate with more oxide. Finally, it may reach the top surface as shown in Figure 11.

oxide layers are especially seen at the interface between the hatch and contour region, see Figure 11. This indicates that oxide is pushed along the solidification front and accumulates at the end of the scan tracks, where the electron beam changes direction. Consequently, the amount of LOFDs in the contour region increases with progressive powder re-use (Figure 9). Furthermore, since upwards transportation of oxide relies on layer re-melting, this also explains the small difference in defect density between the bottom and top parts of the contour region (Figure 12). The larger amount of oxide on the surface of the re-used powder may also lead to a reduced energy absorption and/or increased electrical resistivity between the powder particles. This may have a negative effect on the sintering behavior which may lead to an increased risk of “powder smoking” (ejection of powder from the powder bed), with the formation of LOFDs in the subsequent layer as a result.^[1,31]

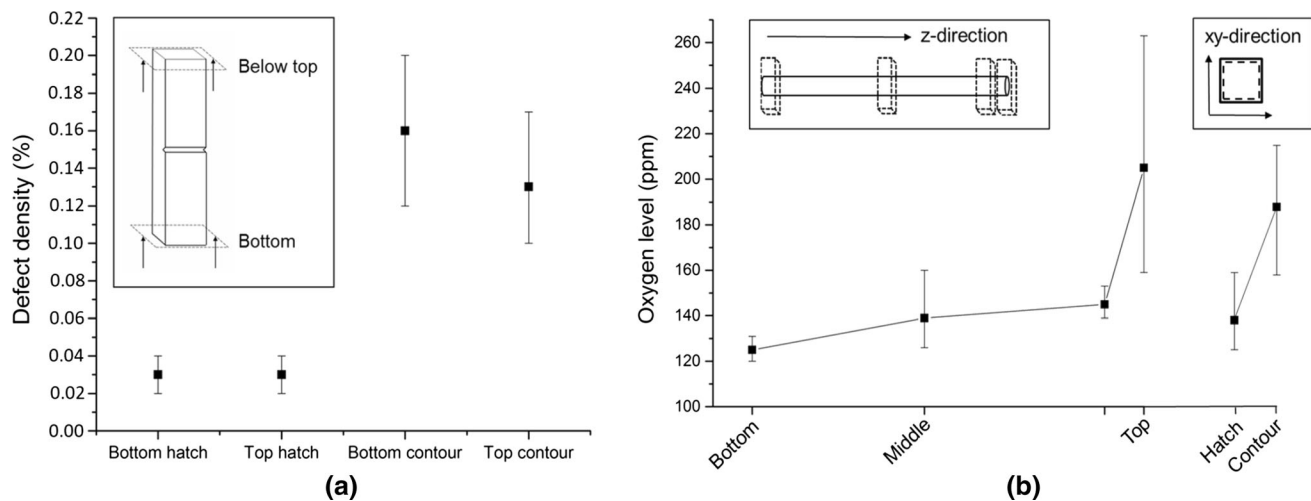
Fig. 12—(a) Defect density and (b) oxygen measurements along the build direction and in the hatch and contour regions in as-HIP B30 samples. The oxygen level in the middle hatch in (b) is the same as the value presented in Fig. 10. The error bars indicate the actual measurement range.

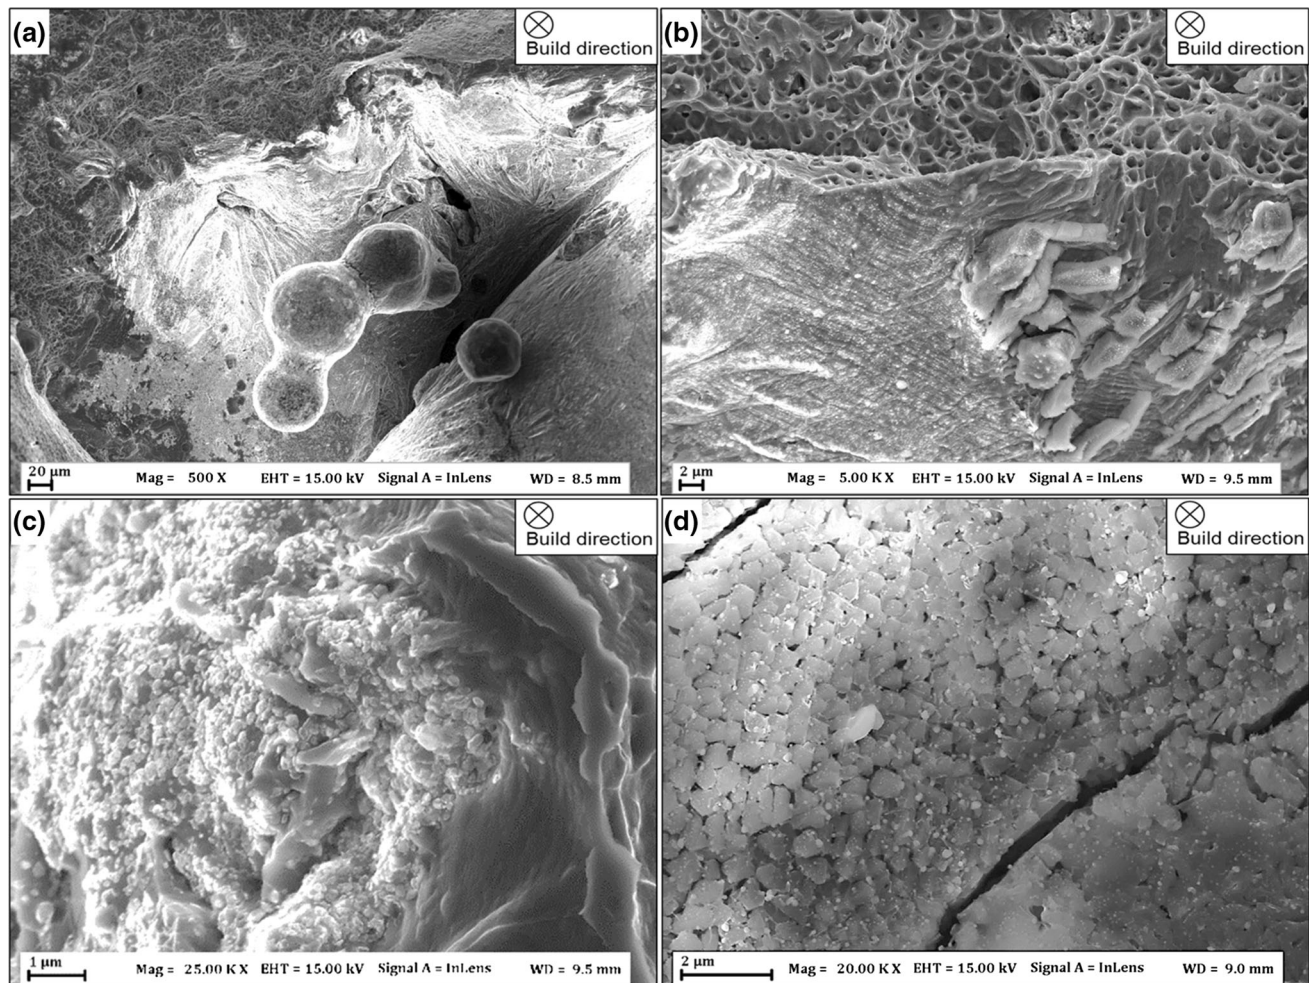
Fig. 13—(a) and (b) Interior of a LOFD as observed from a fracture surface of a B30 sample; higher magnification in (b); (c) cluster of nano-sized oxide inclusions; (d) partially melted oxide inclusions.

However, the situation seems to be different for the present EBM material fabricated from heavily re-used powder. As summarized in Figure 13, the oxide defects in the as-printed B30 samples can be divided into three main morphologies: dispersed inclusions, inclusion clusters, and flake-shaped inclusions. Dispersed inclusions are especially found together with oxidized, un-melted metal particles in areas where the feedstock material has not been fully melted, *i.e.*, in LOFDs. Due to the lack of

The presence of clusters of such small oxide inclusions, shown in Figure 13(c), can be justified by a higher energy input compared to the previous case. In this case, the energy input has been high enough to fully melt the metal, and hence, the particulates from the powder surface have been able to agglomerate to form clusters.

Frequent appearance of oxide clusters that are partially melted together, as shown in Figure 13(d), indicates that the energy input is locally high enough for initial melting of the oxide inclusions. Partially melted oxide inclusions are often seen in the vicinity of large, homogeneous oxide flakes, as shown in Figure 8. Even though very high temperatures may be reached, these large amounts of accumulated oxide are most likely not dissolved in the liquid metal since the solubility of oxygen is very limited.^[11] Instead, when the energy density is high enough, the oxide melts and subsequently solidifies into the flake-shaped morphology as commonly observed in the samples produced from re-used powder.
