On the early stages of localised atmospheric corrosion of magnesium–aluminium alloys

M. Shahabi-Navid¹, Y. Cao², J. E. Svensson³, A. Allanore⁴, N. Birbilis⁵, L. G. Johansson³ & M. Esmaily⁴✉

The surface film on pure magnesium and two aluminium-containing magnesium alloys was characterised after 96 h at 95% RH and 22 °C. The concentration of CO₂ was carefully controlled to be either 0 or 400 ppm. The exposed samples were investigated using X-ray photoelectron spectroscopy, Fourier transform infrared spectroscopy, X-ray diffraction, and electron microscopy. The results showed that when the alloys were exposed to the CO₂-containing environment, aluminium cations (Al³⁺) was incorporated into a layered surface film comprising a partially “hydrated” MgO layer followed by Mg(OH)₂, and magnesium hydroxy carbonates. The results indicated that aluminium-containing magnesium alloys exhibited considerably less localised corrosion in humid air than pure magnesium. Localised corrosion in the materials under investigation was attributed to film thinning by a dissolution/precipitation mechanism.

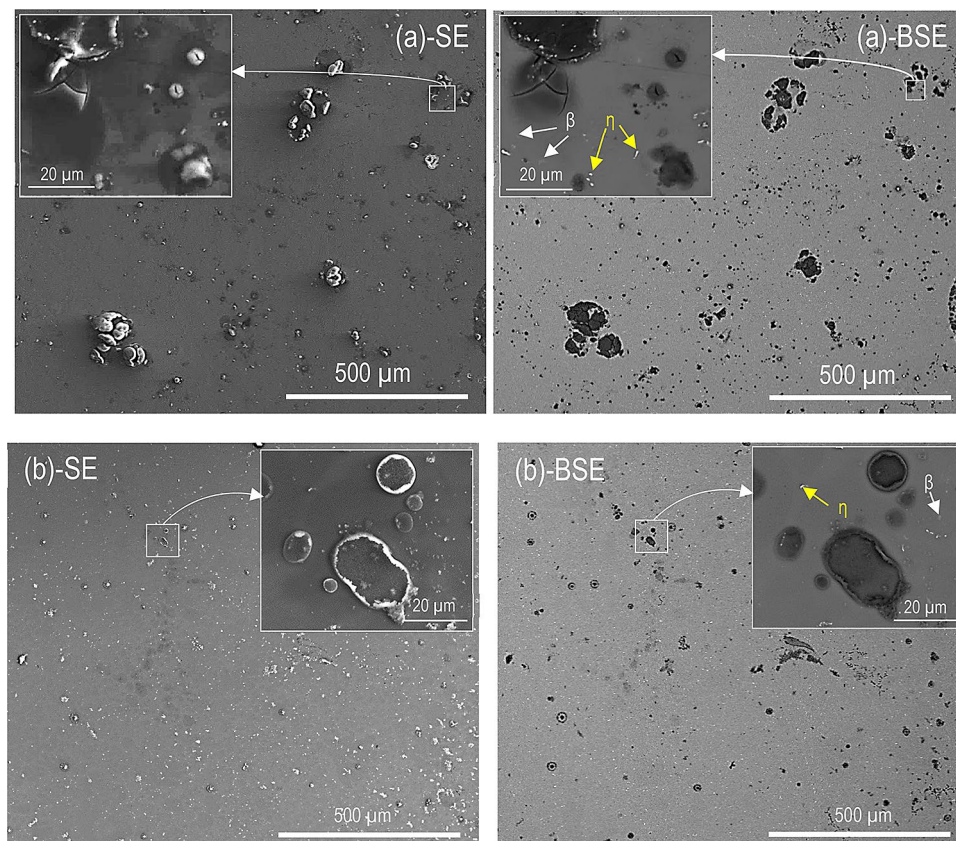
Figure 2. SE and BSE micrographs showing the surface morphology after 96 h exposure at 95% RH and 22 °C. (a) AM50, 400 ppm CO₂, (b) AM50, no CO₂.

Figure 2 depicts alloy AM50 exposed in the presence and absence of 400 ppm CO₂, showing corrosion product nodules of different sizes, similar to those observed on CP Mg. However, the filiform corrosion was not observed on alloy AM50. The corrosion product nodules were often associated with η - and β -phase particles in the alloy matrix (see BSE images in Fig. 2). Similar to CP Mg, the corrosion products formed in the presence of CO₂ contained cracks. The main effect of CO₂ on the corrosion morphology of alloy AM50 was clusters of large corrosion product nodules that only appeared in the presence of CO₂ (compare Figs. 1 and 2).

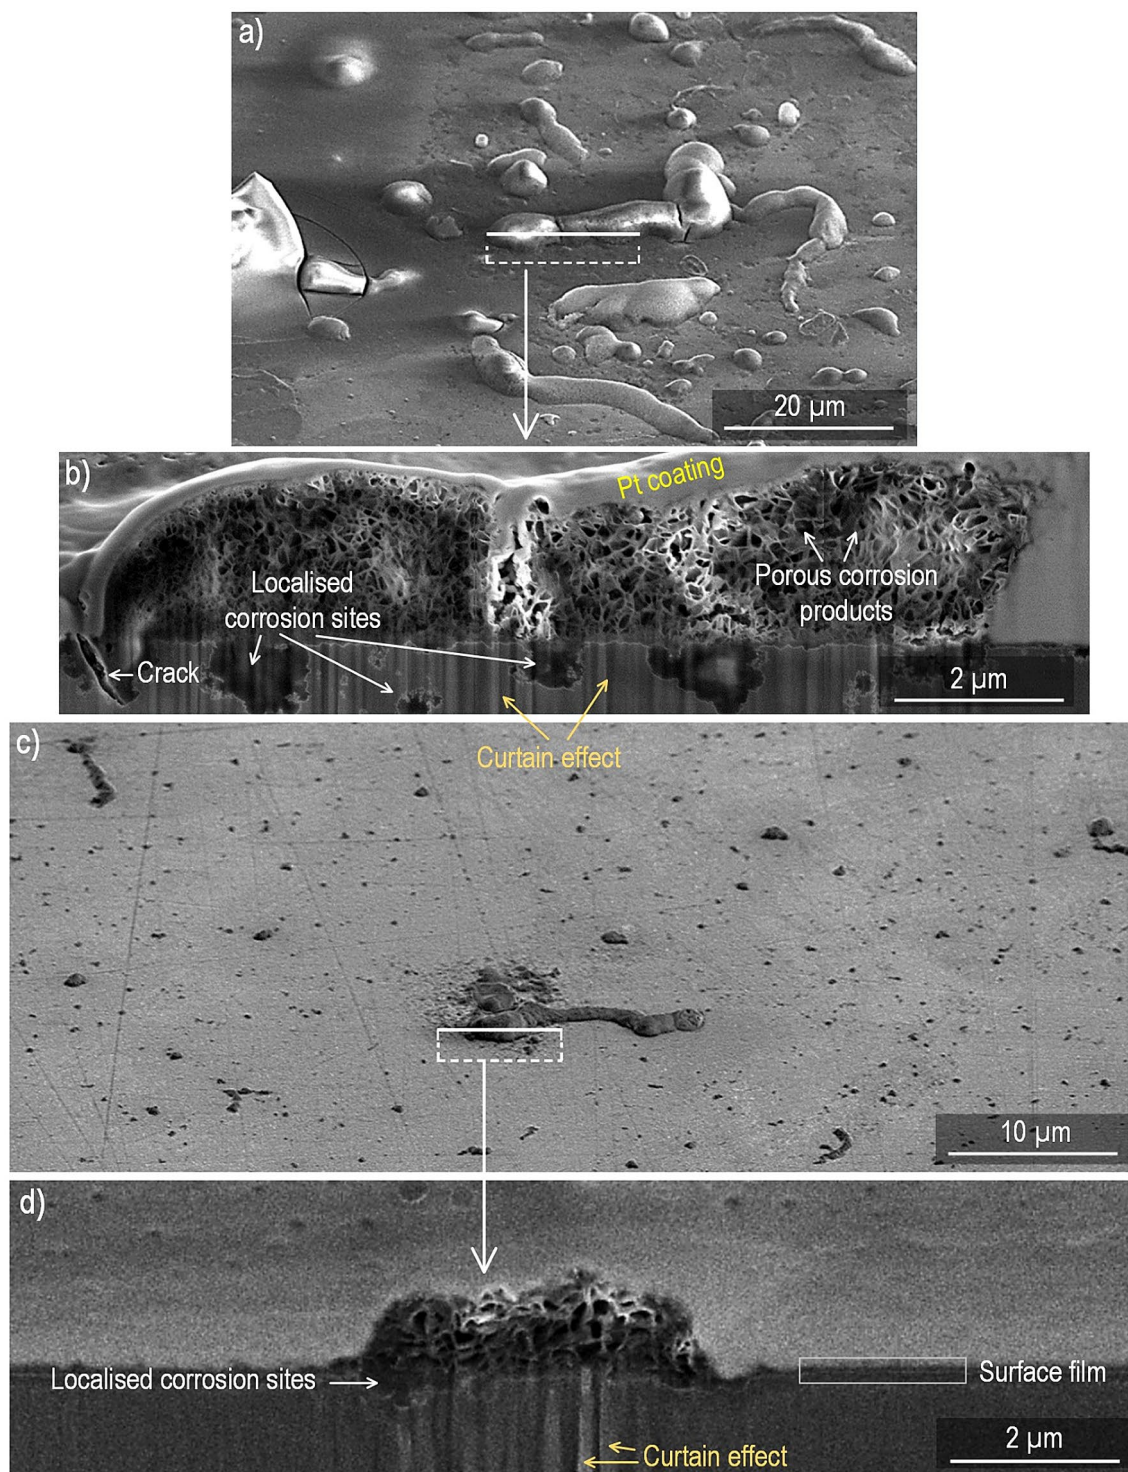
Figure 4. Micrograph of CP Mg exposed at 95% RH and 22 °C for 96 h. **(a)** 52° tilted surface–400 ppm CO₂. **(b)** Cross-section of the selected area–400 ppm CO₂. **(c)** 52° tilted surface–no CO₂. **(d)** Cross-section of the selected area–no CO₂.

Cross-section analysis. Figure 4 shows cross-section SEM images of CP magnesium exposed for 96 h at 95% RH and 22 °C. The overview image (at 52° tilt angle) in Fig. 4a (400 ppm CO₂) shows the characteristic filiform corrosion features. Figure 4b presents a cross-section close to the “head” of a filament, (marked in Fig. 4a), showing the internal structure of the filament and the corrosion pits below it. The filament is very porous, consisting of plate-like crystallites. In contrast, the corrosion product within the pits appears denser. At the left edge of the picture; i.e. at the filament’s head, there is an open crack that extends into a corrosion pit.

Figure 4c shows an overview image (at 52° tilt angle) of a CP magnesium sample after exposure in the absence of CO₂, showing a corrosion product filament at the center. The corresponding cross-section is shown in Fig. 4d, revealing the porous filament interior and the associated corrosion pits in the metal.

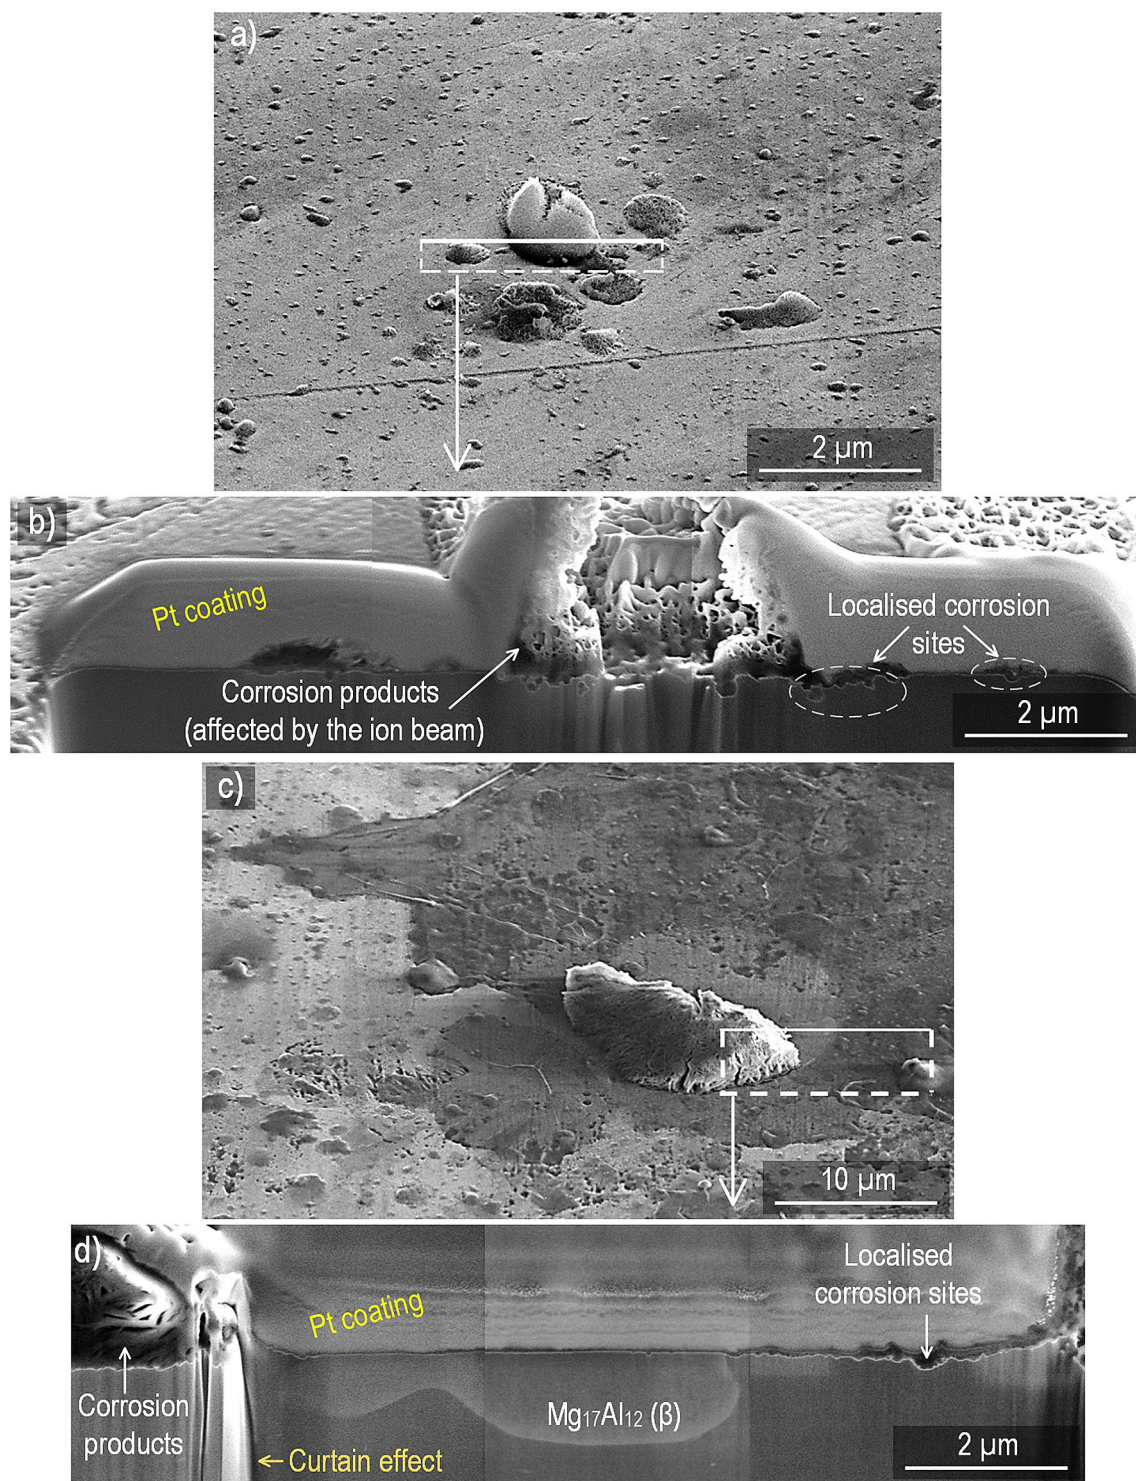
Figure 5. Micrograph of alloy AZ91 exposed at 95% RH and 22 °C for 96 h. (a) 52° tilted surface–400 ppm CO₂. (b) Cross-section of the marked area–400 ppm CO₂. (c) 52° tilted surface–no CO₂. (d) Cross-section of the selected area–no CO₂.

The cross-section images of alloy AZ91 in Fig. 5 shows corrosion product nodules overlying corrosion pits in the alloy. Similar to CP Mg, corrosion product nodules are porous. Although the corrosion product in Fig. 5b was partly destroyed by the ion beam, its plate-like crystallites can still be discerned. Figure 5d shows a β -phase

region in the middle of the image with a relatively thick corrosion product on its left side and some localised corrosion on the right side. Alloy AM50 exhibited similar cross-section morphologies (not shown).

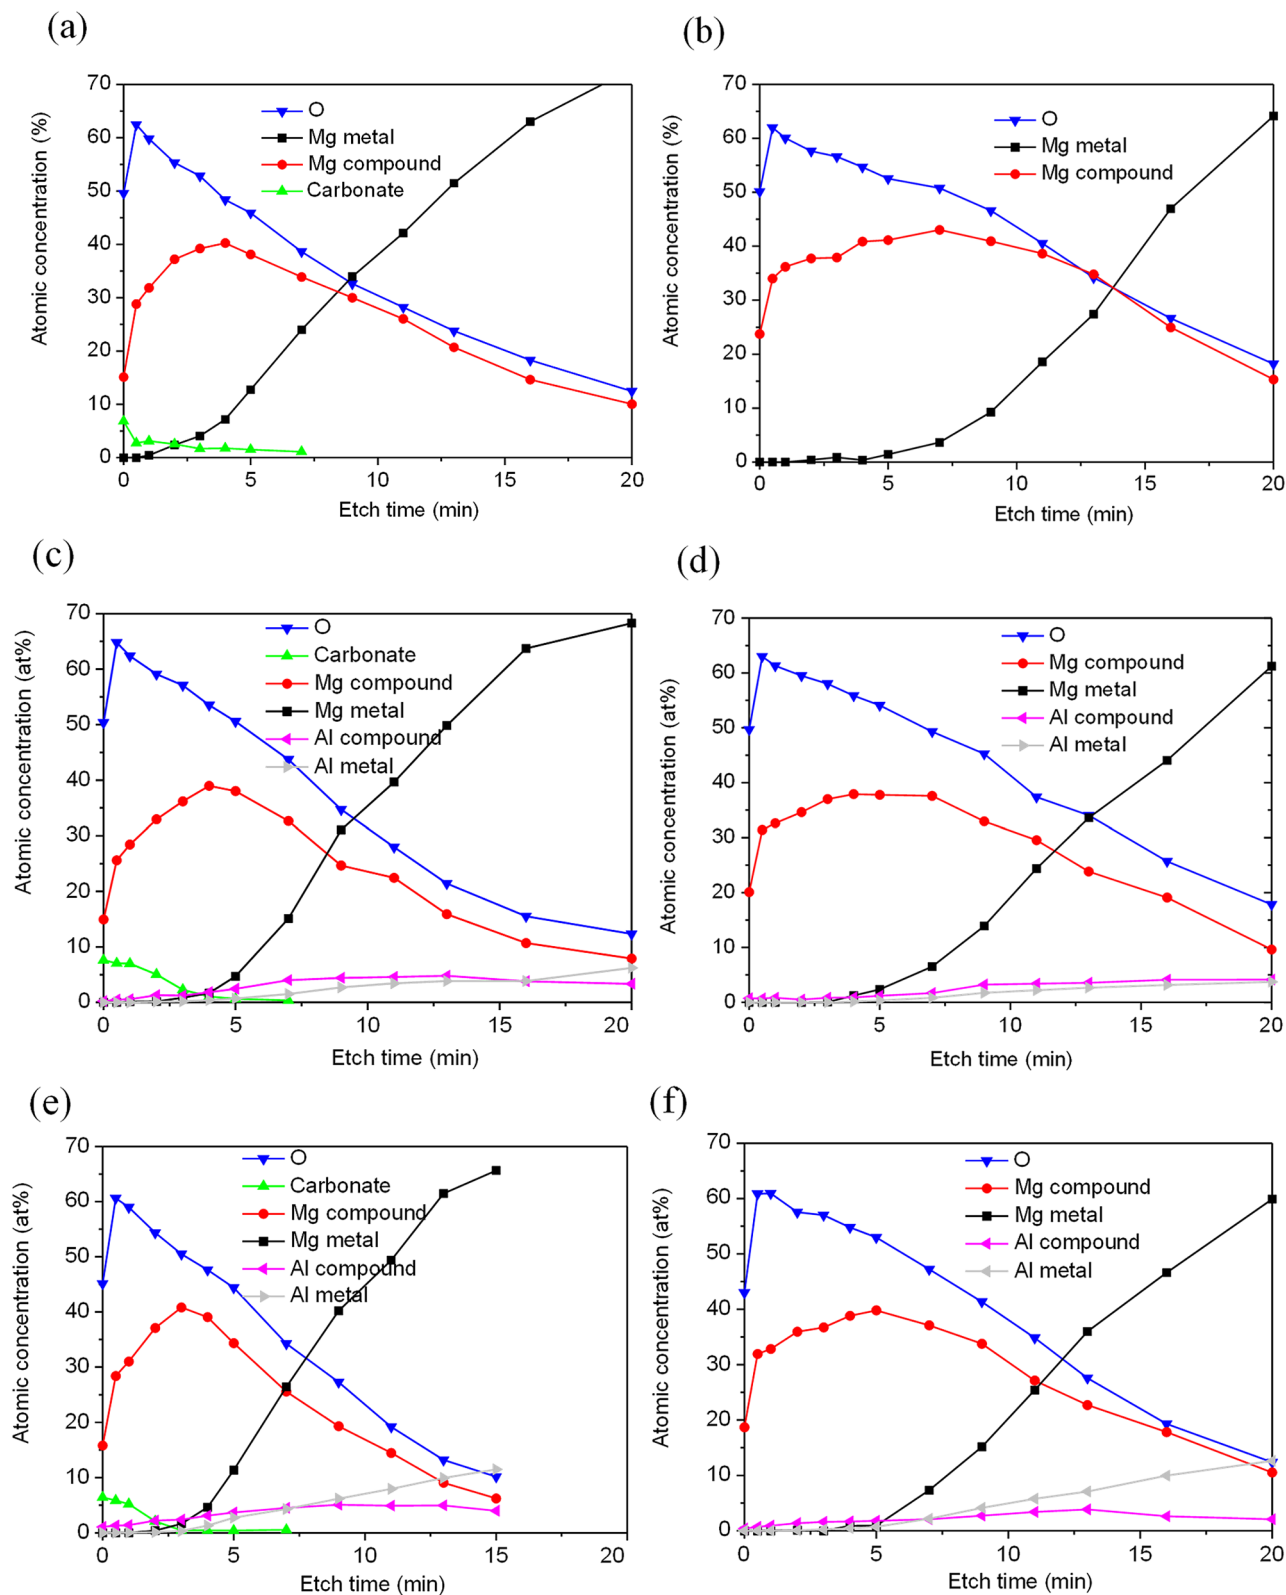
Figure 9. XPS depth profiles for (a) CP Mg, (c) AM50 and (e) AZ91 exposed in the presence and (b) CP Mg, (d) AM50 and (f) AZ91 exposed in the absence of CO₂ (Adventitious carbon was excluded from the analysis).

Figure 9 shows the XPS depth profiles that were performed on the surface of CP Mg, AM50, and AZ91 after 96 h in the CO₂-free and CO₂-containing environments. The recorded XPS C 1s, Mg 2p, and Al 2s photoelectron peaks were curve-fitted using the PHI Multipak software in order to identify the chemical states of these elements. The C 1s component representing adventitious hydrocarbon contamination was excluded from the depth profiles. Carbonate was only detected after exposure to CO₂ and was confined to a very thin surface layer. The variation of magnesium and aluminium in metallic and ionised forms (Mg²⁺ and Al³⁺) was studied with respect to the etch time. For CP Mg, the atomic fraction of Mg²⁺ at the surface was expectedly somewhat lower in the presence of CO₂ than in the absence of CO₂, corresponding to the presence of magnesium hydroxy carbonates and brucite in the presence and the absence of CO₂, respectively. A similar trend was seen for the two alloys. As the analysis probed deeper strata of the film, the Mg²⁺ signal increased, reaching a maximum of 40–45% at about the depth where the magnesium metal peak appeared.

In the case of the samples exposed to 400 ppm CO₂, the signals for metallic magnesium and aluminium appeared after a few minutes of ion etching. The samples exposed in the absence of CO₂ needed about twice as long etching times to detect metallic signals, indicating that the surface film was thicker in those cases.

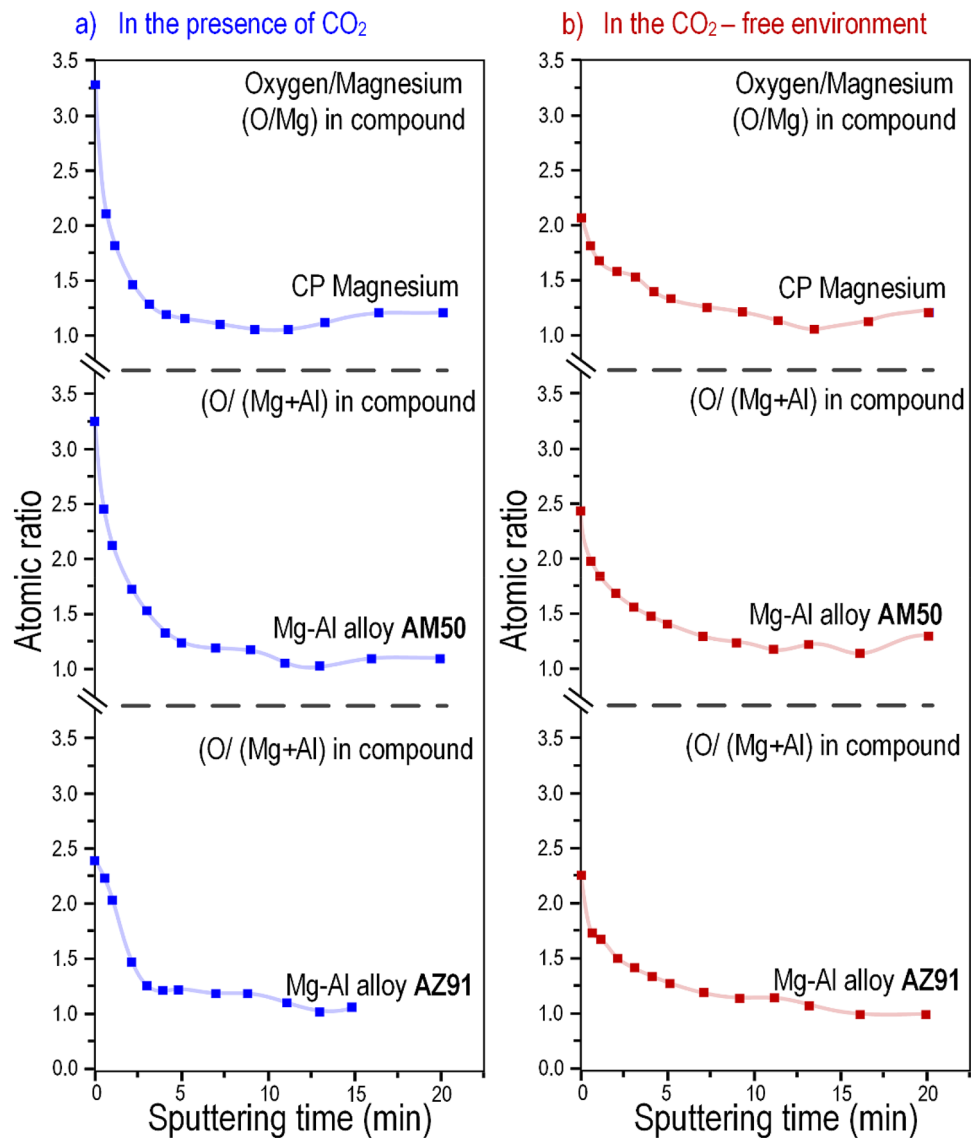
Figure 10. O/Mg²⁺ and O/(Mg²⁺ + Al³⁺) ratios for CP Mg, AM50 and AZ91 after 96 h exposure in 95% RH air (a) in the presence of 400 ppm CO₂ and (b) in the absence of CO₂.

Figure 10 shows the O/Mg²⁺ and O/(Mg²⁺ + Al³⁺) atomic ratios for CP Mg, AM50 and AZ91, in the presence and in the absence of CO₂, calculated from the XPS data. It may be noted that the O/Mg²⁺ atomic ratio in hydromagnesite is 3.6 while it is 2 in brucite and 1 in MgO. In accordance with the identification of brucite by both XRD and FTIR (see above), the O/Mg²⁺ ratio at the top of the surface film formed on CP magnesium in the absence of CO₂ was about 2. The observation that alloys AM50 and AZ91 showed O/(Mg²⁺ + Al³⁺) ratios of about 2 after exposure in the absence of CO₂ indicates that the surface film was dominated by magnesium hydroxide also in those cases.

The higher O/(Mg²⁺ + Al³⁺) ratios detected at the surface in the presence of CO₂ are attributed to the presence of carbonate (compare with Fig. 10). For all three materials (i.e. CP Mg, AM50 and AZ91) and in both environments (i.e. with 400 ppm CO₂ and no CO₂) the O/(Mg²⁺ + Al³⁺) molar ratio decreased rapidly when sputtering started, stabilising at a level slightly above 1. This indicates that the deeper levels of the surface films are dominated by MgO.

The observation that the XPS O/Mg²⁺ and O/(Mg²⁺ + Al³⁺) ratios within the film are slightly higher than 1 (see Fig. 10) is attributed to the presence of magnesium hydroxide in the bulk of the film. In the case of the alloys,
