# Self-healing properties of Ce/Co-coated stainless steel under simulated intermediate temperature solid oxide fuel cell conditions

Solid oxide fuel cell  
Interconnect  
Corrosion  
Ce/Co coating  
Cr-evaporation  
Self-healing

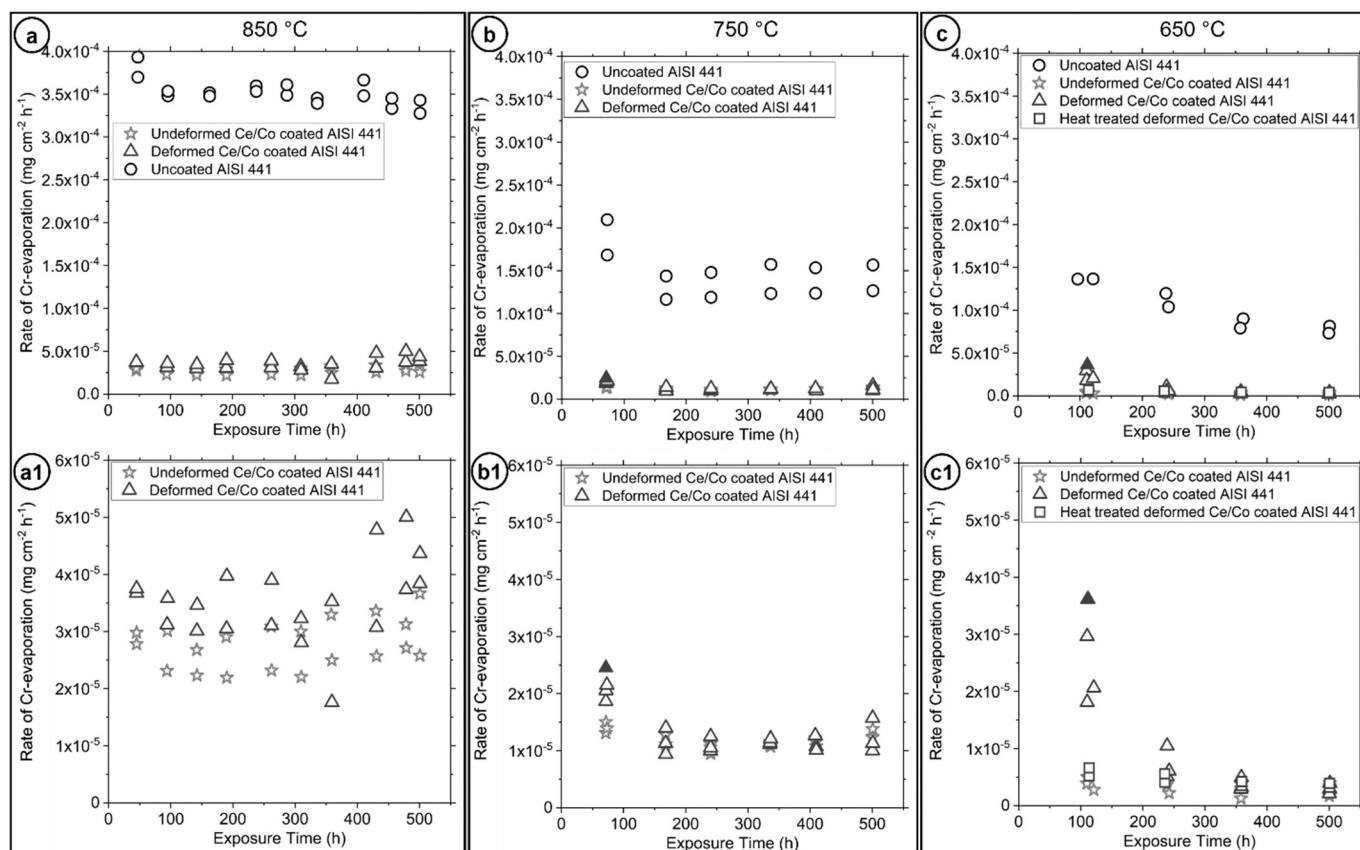
The Cr evaporation rates of all investigated samples are depicted as a function of exposure time in Fig. 1. To understand the development of the Cr evaporation rate over time, the bottom row (Fig. 1a1, b1, c1) shows the same results as the top row, but with a magnified y-axis. All exposures were carried out for 500 h, except for the Cr evaporation rates depicted as filled symbols, which were run for the intermediate times, i. e. 71 h at 750 °C and 111 h at 650 °C. The reason different time intervals had to be employed for the two different temperatures was the rather

Figure 1a and a1 show the results for AISI 441 exposed to air at 850 °C. The Cr evaporation rate for the uncoated material decreased slightly in the beginning, but after roughly 90 h of exposure, no further change in rate was visible, and an average rate of  $3.5 \cdot 10^{-4} \text{ mg cm}^{-2} \text{ h}^{-1}$  was found. The Cr evaporation rates for Ce/Co-coated AISI 441 decreased by roughly a factor of 10 compared to the uncoated AISI 441, and the average rate was around  $3.2 \cdot 10^{-5} \text{ mg cm}^{-2} \text{ h}^{-1}$ . Undeformed and deformed Ce/Co-coated AISI 441 showed a significant scatter in Cr evaporation rate at 850 °C, but no clear trend could be detected between the deformed versus undeformed material.

The Cr evaporation rate at 750 °C is shown in Fig. 1b and b1. The rate for uncoated AISI 441 at this temperature was on average  $1.4 \cdot 10^{-4} \text{ mg cm}^{-2} \text{ h}^{-1}$ . The first data point is not included in this average value because a decrease in rate was visible in the beginning. A slight difference in the Cr evaporation rate behavior was visible between the undeformed and deformed Ce/Co-coated AISI 441 that was exposed to air at 750 °C. The Cr evaporation rate was nearly constant with an average rate of  $1.2 \cdot 10^{-5} \text{ mg cm}^{-2} \text{ h}^{-1}$  for the undeformed material. On the other hand, the initial average Cr evaporation rate for the deformed Ce/Co-coated AISI 441 was  $2.1 \cdot 10^{-5} \text{ mg cm}^{-2} \text{ h}^{-1}$ , however, this rate quickly decreased by a factor of 1.75, and both the deformed and undeformed Ce/Co-coated AISI 441 showed similar Cr evaporation rates after only 168 h.

Fig. 1c and c1 depict the Cr evaporation rate for AISI 441 exposed to air at 650 °C. The Cr evaporation rate for the uncoated material decreased in the beginning, and a plateau seemed to be reached after more than 360 h of exposure. The rate after the decrease was around  $7.8 \cdot 10^{-5} \text{ mg cm}^{-2} \text{ h}^{-1}$ . Ce/Co-coated AISI 441 exhibited much lower Cr

Fig. 1. Cr evaporation rates for uncoated and Ce/Co-coated AISI 441. Samples were exposed to air at 850 °C (a and a1), 750 °C (b and b1), and 650 °C (c and c1). The bottom row depicts zoomed in versions of the top row. Filled symbols mark samples that were taken out after 71 h or 111 h of exposure at 750 °C or 650 °C, respectively.

While the formation of a thin Cr rich surface oxide in the of cracked areas occurred in a matter of hours at 850 °C (see Fig. 1a and a1), the process was much slower at lower temperatures and can, thus, be clearly seen in the development of Cr evaporation rates over time (see Fig. 1b, b1, c, and c1). This matches well to data by Grzesik et al. [29], which suggest that the diffusion coefficient drops by 1–2 orders of magnitude when the temperature is lowered from 850 °C to 650 °C. Nevertheless, even though the self-healing process was slower at 750 °C and 650 °C

than at 850 °C, the Cr evaporation data shown in the present work strongly suggest that the Ce/Co coating has self-healing capabilities also at these lower temperatures. Additionally, the initial Cr evaporation rates of the deformed Ce/Co-coated AISI 441 at those low temperatures were substantially lower than the rates for the uncoated material because most of the surface was still covered with undamaged coating. To what extent the initially higher Cr evaporation is acceptable or not is difficult to establish due to the lack of studies correlating Cr evaporation to stack degradation. At 650 °C the additional Cr evaporation is estimated to be  $3 \cdot 10^{-3} \text{ mg cm}^{-2}$  based on the data presented in Fig. 1. According to an estimate by Stanislawski et al. [21] this would correspond to less than 1% cell degradation in the stack Research Centre Juelich build around 2006. This shows further studies are needed to elucidate the relationship between Cr evaporation and cell and stack degradation. A detailed discussion of the behavior of the deformed Ce/Co-coated AISI 441 at 750 and 650 °C is given below.

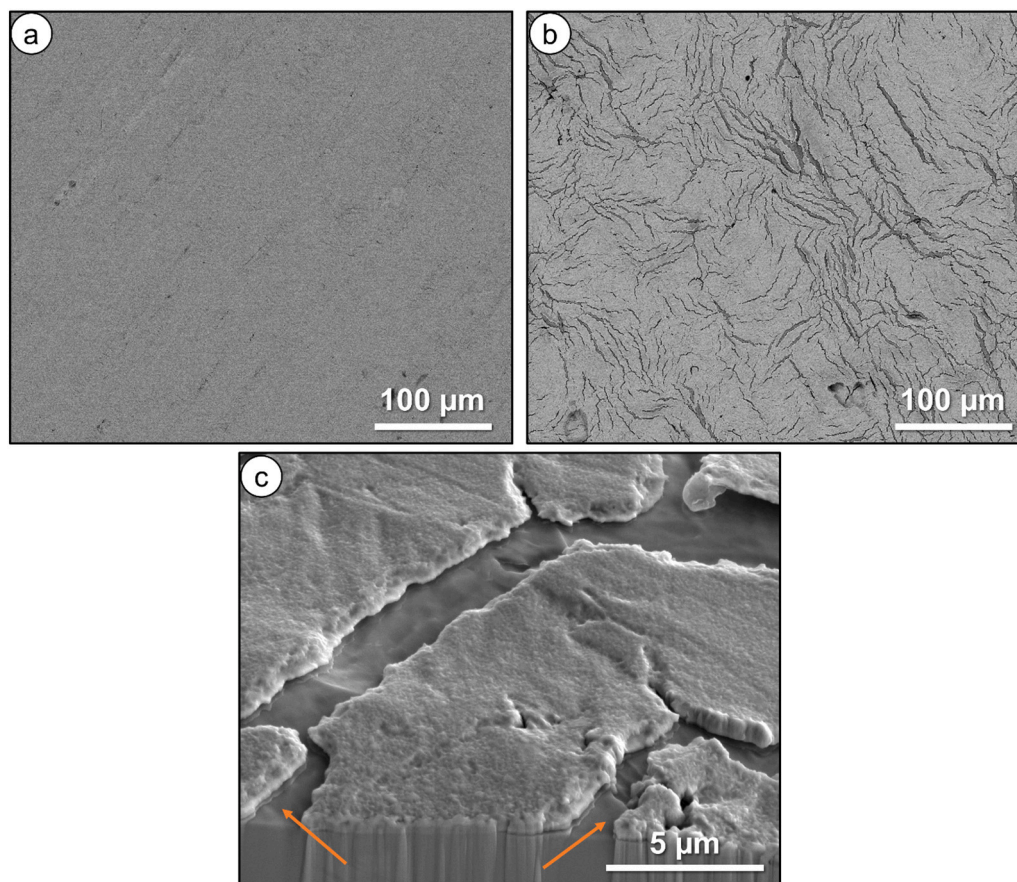
SEM micrographs of unexposed Ce/Co-coated AISI 441 are depicted in Fig. 2. For the undeformed material, Fig. 2a, the surface was homogenous and no cracks in the coating were found. However, the rolling direction of the underlying steel was visible. In contrast cracks were clearly visible on the entire surface of the deformed material, shown in Fig. 2b. The FIB-milled cross-section of the biaxially deformed Ce/Co coated AISI 441 confirmed that cracks (indicated by arrows in Fig. 2c) had formed in the coating.

**Fig. 2.** Backscattered SEM micrograph for unexposed Ce/Co-coated AISI 441. The samples were either undeformed (a), or biaxially deformed (b and c). A) and b) correspond to top-view micrographs of the respective samples, and b) corresponds to a FIB-milled cross-section of a biaxially deformed sample. The arrows in c) indicate the location of cracks in the coating.

The present study showed that when Ce/Co-coated ferritic stainless steels were deformed, cracks appeared in the coating (see Fig. 2). However, Cr evaporation data showed that these cracks quickly healed at 850 °C, because the Cr evaporation rate for the deformed material did not greatly differ from the rate for the undeformed material within the limits of the measurement technique (see Fig. 1a and a1). This self-healing process is consistent with previously reported data by Falk-Windisch et al. [23,27]. Their studies have shown that a Co-rich oxide forms on the entire surface of deformed Ce/Co-coated FSS at 850 °C after only 24 h of exposure. Additionally, their Cr evaporation data showed no difference between the pre-coated deformed Ce/Co-coated FSS and the undeformed Ce/Co-coated FSS, similar to the present study. Their assumption was that cracked regions first form a  $(\text{Cr,Mn})_3\text{O}_4$  top layer and a subsequent interdiffusion of Co between this spinel in the cracked areas and the thick  $\text{Co}_3\text{O}_4$  spinel in the non-cracked areas leads to the formation of a  $(\text{Co,Cr,Mn})_3\text{O}_4$  spinel in the cracked areas with low levels of Cr. In Falk-Windisch et al.'s [23,27] studies the outer layer was uniformly covered by a pure  $(\text{Co,Mn})_3\text{O}_4$  layer after 336 h of exposure, and

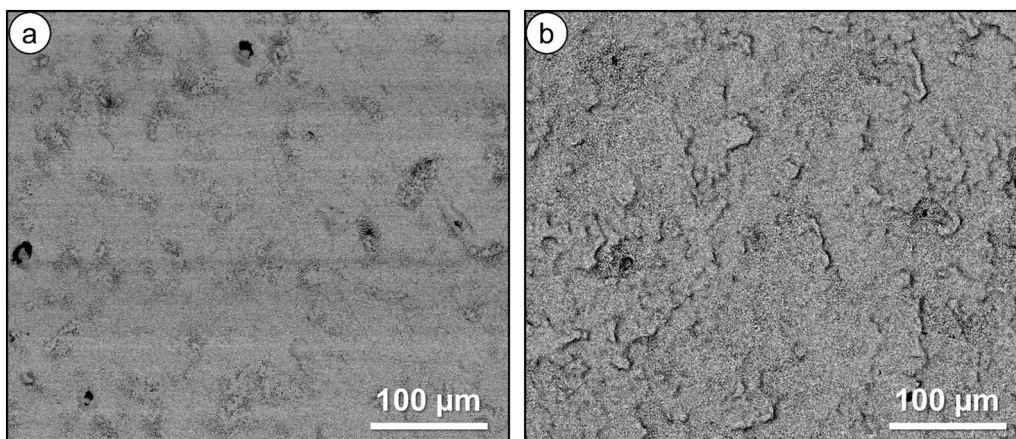
AISI 441 are shown in Fig. 3. They confirm that even after 500 h of exposure, the homogeneity and uniformity of the surface morphology for undeformed Ce/Co-coated AISI 441 was similar regardless if the material was exposed at 750 °C (Fig. 3a) or at 650 °C (Fig. 3b). Additionally, the rolling direction of the underlying steel was no longer visible after 500 h of exposure.

Fig. 3. Backscattered SEM micrograph of undeformed Ce/Co-coated AISI 441 that was exposed to air for 500 h either at 750 °C a) or at 650 °C b).

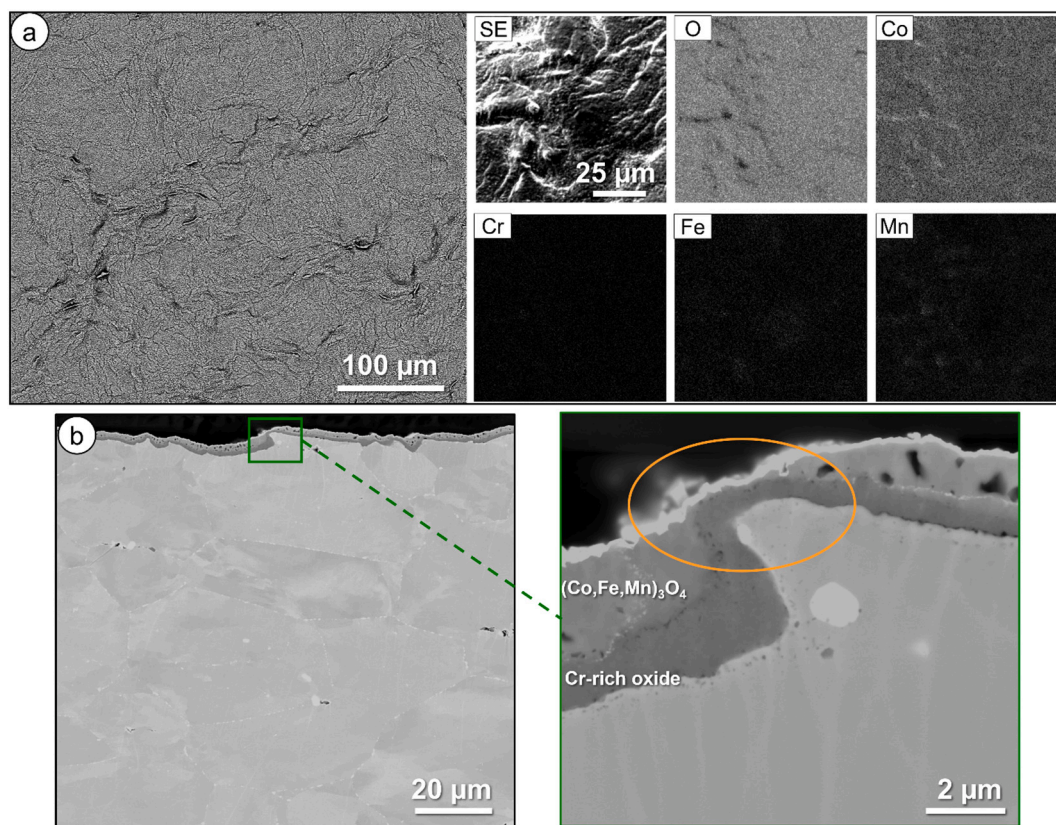
SEM micrographs of the deformed Ce/Co-coated AISI 441 that was exposed at 750 °C are shown in Fig. 4. The cracks that had formed during the biaxial deformation of Ce/Co-coated AISI 441 are still very clearly visible on the surface of the samples in the figure, even after 500 h of exposure (see Fig. 4a). However, the corresponding EDX maps showed that the entire surface was already covered with Co, and no Fe or Cr signal was recorded from the underlying steel. This indicates that a thick Co oxide had formed also inside the cracks of the coating. Locally higher Mn concentrations were also recorded. The BIB-milled cross-section of this sample (see Fig. 4b) showed that in some areas the Cr-rich scale was not yet covered by a thick  $(\text{Co, Fe, Mn})_3\text{O}_4$  scale after 500 h (see orange circle in inset in Fig. 4b).

Fig. 4. SEM micrographs and quantitative EDX maps (at.%) of biaxially deformed Ce/Co-coated AISI 441 that was exposed to air for 500 h at 750 °C. A) corresponds to a top-view of the sample, and b) corresponds to a BIB-milled cross-section of the same sample. The circle in the inset (b) shows the area where the crack in the coating was located and  $(\text{Co,Fe,Mn})_3\text{O}_4$  had not yet formed (in sufficient thickness) on top of the Cr-rich scale.

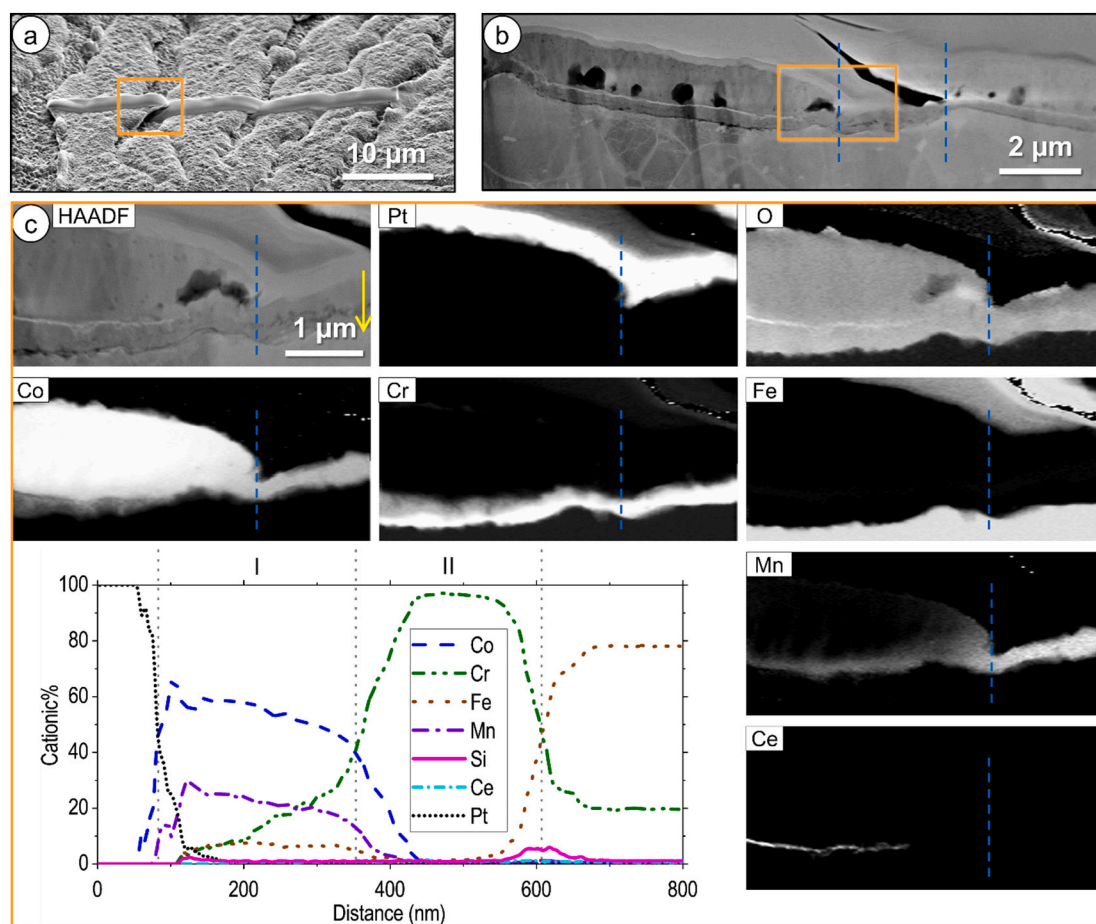
To further understand how quickly Co had diffused into the cracks of deformed Ce/Co-coated AISI 441 at 750 °C, short-term exposed samples, 71 h, were analyzed further. In situ lift-out samples were prepared for this purpose using FIB and were examined using STEM/EDX, and the results are depicted in Fig. 5. The EDX map and line scan for the cracked region are shown in Fig. 5c. Additional line scans performed in multiple places throughout the lift-out in cracked and non-cracked regions were used to determine the cationic% stated below and in Table 2. The line scans were performed using higher magnification than what is depicted in Fig. 5.

approximately 1.2  $\mu\text{m}$ , and roughly 92 cationic% Co, 5 cationic% Mn, and low incorporations of Fe (below 3 cationic%). A thin Ce oxide layer was present below this oxide. The innermost layer consisted of a relatively pure Cr oxide scale ( $\sim 280$  nm) with low amounts of Mn, ranging between 1 and 4 cationic%.

Cracked regions (see Fig. 5) were also completely covered with a Cr-rich oxide (marked as region I in the graph in Fig. 5c), with a thickness ranging between 300 and 400 nm and with 40–60 cationic% Co, 20–30 cationic% Mn, around 7 cationic% Fe, and, towards the inner oxide, increasing levels of Cr, from 0 cationic% at the outermost layer to 40 cationic% at the innermost layer of the Co,Mn-oxide. A pure and continuous, roughly 230 nm thick, Cr oxide (marked as region II in the

graph in Fig. 5c) had formed beneath this Co-rich oxide. Ce was only found in low quantities below 1 cationic% in the cracked region and did not show up at all in the EDX maps for this region.

The Fe, Cr, and O signals detected above the pure and dense Pt deposit are believed to be the redeposition that occurred during the milling process and can thus be ignored.

**Fig. 5.** Electron microscopy of biaxially deformed Ce/Co-coated AISI 441 that was exposed to air for 71 h at 750 °C. The crack marked by the orange box was investigated with STEM/EDX. A) SEM micrograph with Pt deposited on the area chosen for the FIB lift-out; b) HAADF micrograph of lift-out, with the area inside of the blue dashed lines marking the cracked area; c) HAADF micrograph including the corresponding EDX maps in at.% and a line scan through the crack (yellow arrow). The Si map is not shown in the EDX maps, as it was not relevant to the discussion. The cracked area is on the right side of the blue dashed line, while the non-cracked area is on the left side of it. (For interpretation of the references to color in this figure legend, the reader is referred to the web version of this article.)

Composition of the oxides of deformed Ce/Co coated AISI 441 in cationic% based on Figs. 5c and 8c.

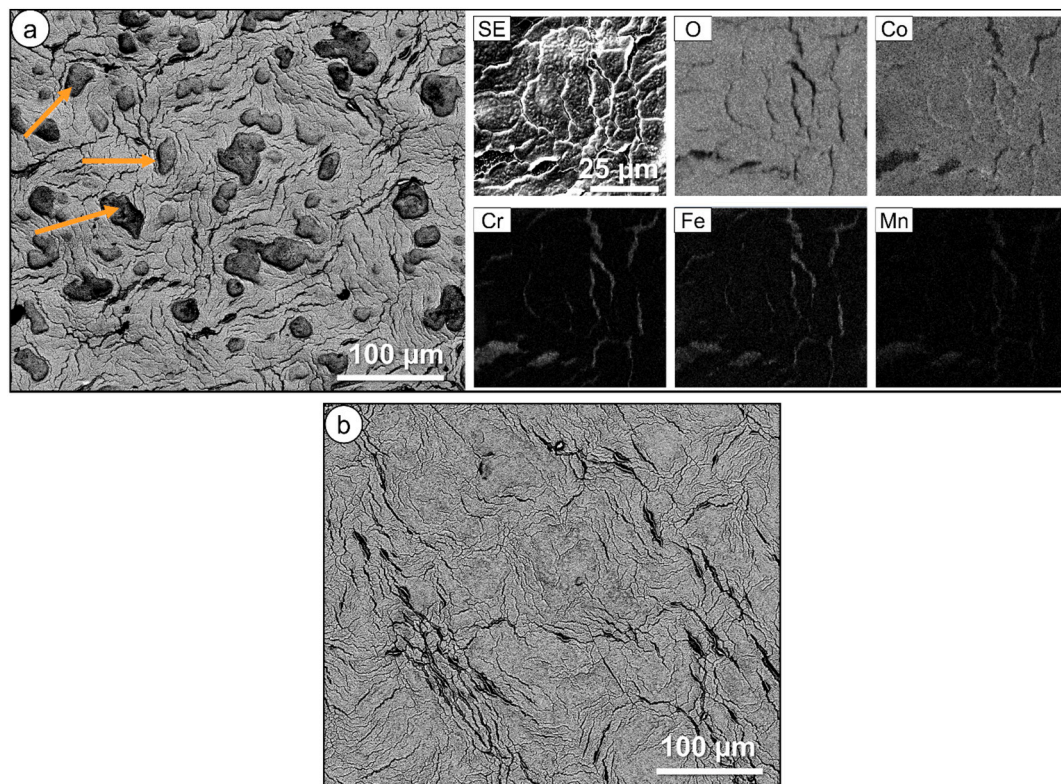
Fig. 6a shows top-view SEM micrographs of deformed Ce/Co-coated AISI 441 that was exposed for 500 h at 650 °C. The cracks were still clearly visible after 500 h of exposure at 650 °C, similar to the samples exposed at 750 °C (see Fig. 4a). However, contrary to the EDX maps recorded for the latter temperature, the EDX maps for samples exposed at 650 °C also still clearly showed the presence of cracks. Nevertheless, a

small concentration of Co had already diffused into the cracks also at 650 °C, according to the Co map shown in Fig. 6. For deformed samples exposed at 650 °C nodules on the sample surface had formed and are indicated by arrows in Fig. 6. Further analysis of these nodules can be found below. Additionally, also heat-treated deformed Ce/Co coated AISI 441 that was exposed for 500 h at 650 °C was analyzed using SEM. The corresponding micrographs are depicted in Fig. 6b. Similar to the non-heat-treated samples, the cracks were still clearly visible after 500 h of exposure for heat-treated samples. However, no nodule formation had occurred in the latter samples.

**Fig. 6.** SEM micrographs and quantitative EDX maps (at.%) of biaxially deformed Ce/Co-coated AISI 441 that was exposed to air for 500 h at 650 °C. A) was not heat-treated prior to exposure, whereas b) was heat-treated for 3 h at 850 °C prior to exposure.

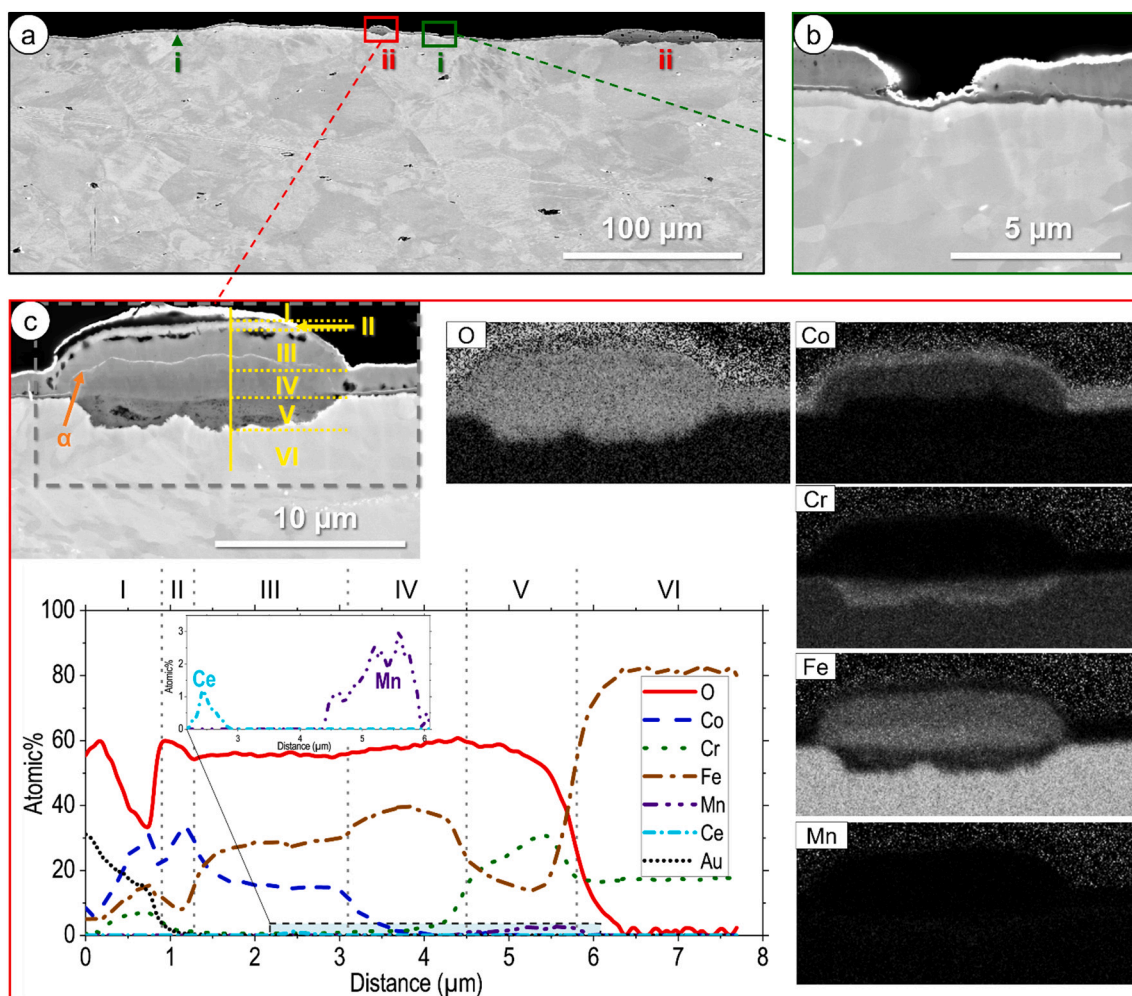
section of biaxially deformed Ce/Co-coated AISI 441, which was exposed at 650 °C, are depicted in Fig. 7. The overview of the entire cross-section (Fig. 7a) shows that besides cracks (marked as i), also nodules (marked as ii) are clearly visible. Magnified micrographs show both areas in more detail (see Fig. 7b and c). The EDX maps of the BIB cross-section of the nodule is shown in Fig. 7c. The figure shows that four different regions were present inside the oxide nodule. An EDX line scan also confirmed this and the compositions of the different regions are given in Table 3. The first region in the EDX line scan (marked as I) showed high Au content, which was used to mark the surface of the cross-section. Region II is the actual surface of the nodule. The EDX line

scan showed that a thin (0.4 μm) Co-rich top layer had formed in this region with roughly 10 at.% incorporation of Fe. First a Fe,Co-rich oxide (marked as III) and then a rather pure Fe oxide (marked as IV) were present below this layer. According to the recorded EDX maps and the corresponding SEM micrograph, the thickness of the former oxide (Layer III) was roughly around 1.5 μm throughout the entire nodule, whereas the thickness of the latter layer (Layer IV) varied throughout the nodule. The bottom oxide scale of the nodule, which consisted of a Cr-rich oxide (marked as V), also showed this variation in thickness, and is assumed to be  $(\text{Cr,Fe,Mn})_2\text{O}_3$  with roughly 10 to 20 at.% of Fe incorporation along with low levels of Mn (up to 3 at.%). The region VI marks the steel substrate. The inset inside the EDX line scan graph (see Fig. 7c) also shows that a thin Ce layer was detected in the cross-section; this layer can also be seen in the corresponding SEM micrograph and is marked as  $\alpha$  (see Fig. 7c).

**Fig. 7.** Backscattered SEM micrographs and quantitative EDX maps (at.%) of BIB milled cross-sections of biaxially deformed Ce/Co-coated AISI 441, which was exposed to air for 500 h at 650 °C. Magnified micrographs for the cracked sections and the nodules found in the overview a) are shown in b) (marked as i) and c) (marked as ii), respectively.

Composition of the regions found in the nodules that had formed on deformed Ce/Co coated AISI 441, which was exposed for 500 h at 650 °C in at.% based on Fig. 7c. Region I was excluded as this region still showed copious amounts of Au, which was used to mark the surface.

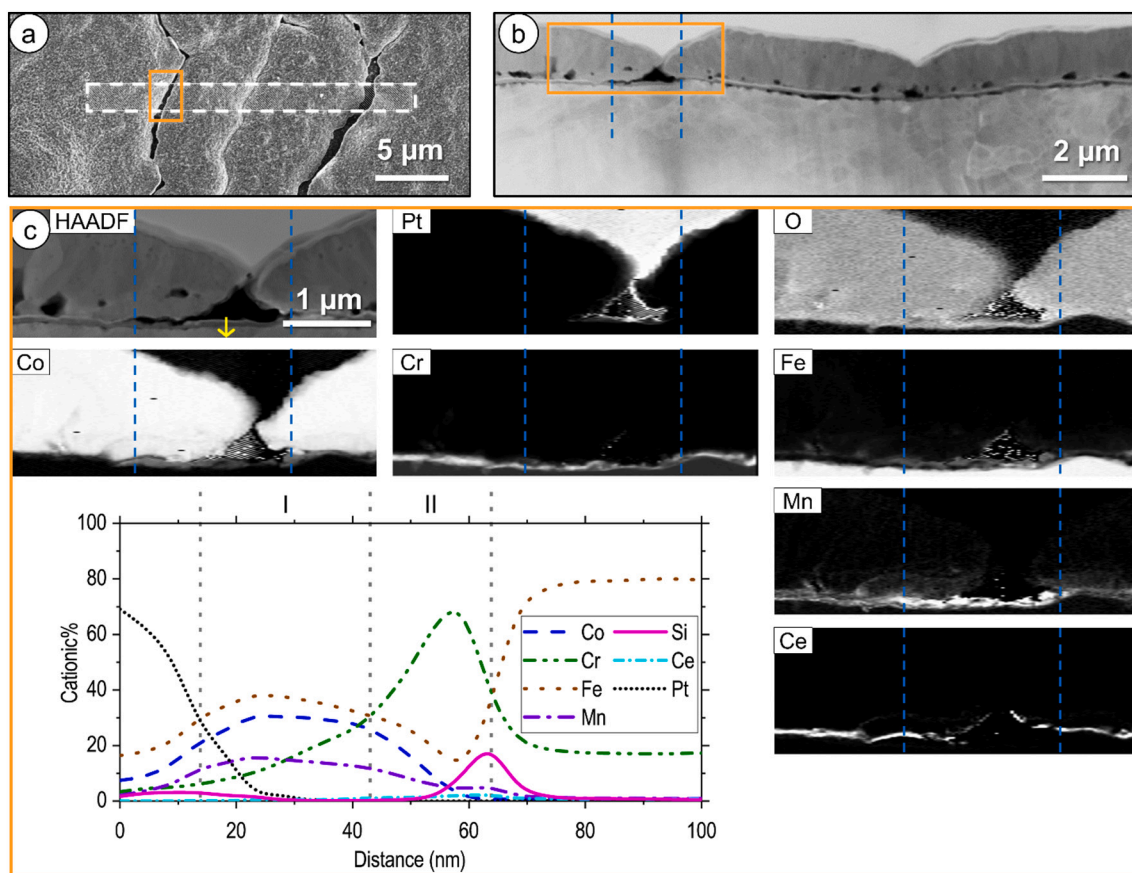
Short-term exposed specimens, 111 h, were also prepared for the deformed Ce/Co-coated AISI 441 that was exposed at 650 °C, and a FIB lift-out was analyzed using STEM/EDX. The results are shown in Fig. 8, and again multiple line scans were performed and form the basis for the cationic% stated below and in Table 2. The line scans were performed using higher magnification than what is depicted in Fig. 8.

The non-cracked region showed a pure Co oxide as the top layer, with a thickness of around 1.2 μm and only minor incorporation of Mn (around 2 cationic%) close to the innermost layer of this oxide. A Ce oxide scale had formed underneath this scale, beneath which a pure roughly 60 nm thick Cr oxide was present.

The Co signal for the cracked region suggests that small amounts of Co had diffused into the crack. A very thin Co oxide layer (marked as region I in the graph in Fig. 8c) had formed (~30 nm) on top of the crack, and up to 30 cationic% Co was found in this layer. Similar to the specimen that was exposed for 71 h at 750 °C, higher amounts of Mn, around 15 cationic%, seemed to be present in the Co-rich oxide covering the cracked area compared to the one covering the non-cracked area.

Additionally, high amounts of Fe, between 35 and 40 cationic%, were found in the Co-rich oxide, and increasing amounts of Cr were found in this oxide, from 5 cationic% in the outermost layer to 30 cationic% in the innermost layer. A Cr-rich oxide (marked as region II in the graph in Fig. 8c) had formed underneath the Co-rich oxide. However, unlike at 750 °C, this Cr-oxide was not pure and comparatively high amounts of Mn, Co, and Fe were present. Due to the thickness of this oxide (around 20 nm), it cannot be excluded that the EDX signal was influenced by the surroundings, i.e. the Co-rich oxide, the substrate, or the area underneath the surface. Again, no Ce signal was detected directly in the crack in the EDX maps, however low amounts were detected using the line scan (below 2 cationic%).

**Fig. 8.** Electron microscopy of the biaxially deformed Ce/Co-coated AISI 441 that was exposed to air for 111 h at 650 °C. The area marked by the orange box was investigated with STEM/EDX and the blue lines mark the crack location. A) SEM micrograph with the area chosen for the FIB lift-out marked by the dashed white box; b) HAADF micrograph of lift-out; c) HAADF micrograph including the corresponding EDX maps in at.% and a line scan through the crack (yellow arrow). The Si map is not shown in the EDX maps, as it was not relevant to the discussion. (For interpretation of the references to colour in this figure legend, the reader is referred to the web version of this article.)
