A method for in-field railhead crack detection using digital image correlation

Knut Andreas Meyer, Daniel Gren, Johan Ahlström & Anders Ekberg

Railway infrastructure managers must decide when and how to maintain rails. However, they often have insufficient information about railhead cracks. Therefore, we propose a new method for rail crack detection using a train-mounted digital image correlation (DIC) camera system. The measurement train's weight cause rail bending, allowing the DIC to measure strain concentrations caused by surface-breaking cracks. In this study, we evaluate the method under laboratory conditions. The detected cracks correlate to the actual crack network in the analysed rail field sample. Furthermore, finite element simulations show the method's high sensitivity to crack depths. Existing methods, such as ultra-sonic and eddy-current, produce damage severity indications. The proposed method complements these techniques by providing a discrete description of the surface-breaking cracks and their depth. This information enables infrastructure managers to optimize rail maintenance. Additionally, such detailed measurements can be valuable for research in railhead da

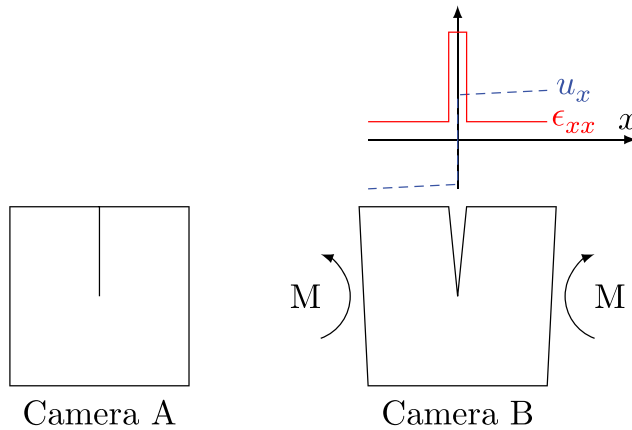
Figure 2. Illustration of the measured strain around a crack mouth in a rail subjected to a positive bending moment.

However, in DIC, the strain is calculated based on displacement between points with a finite spacing. Therefore, the strain illustrated in [Figure 2](#) is not a Dirac delta function. If the point spacing is small enough, a high strain concentration is detected around the crack mouth. This strain concentration is the proposed crack indicator. Finally, we note that the train direction does not matter: the reference image from Camera A can be taken before or after the image from Camera B.

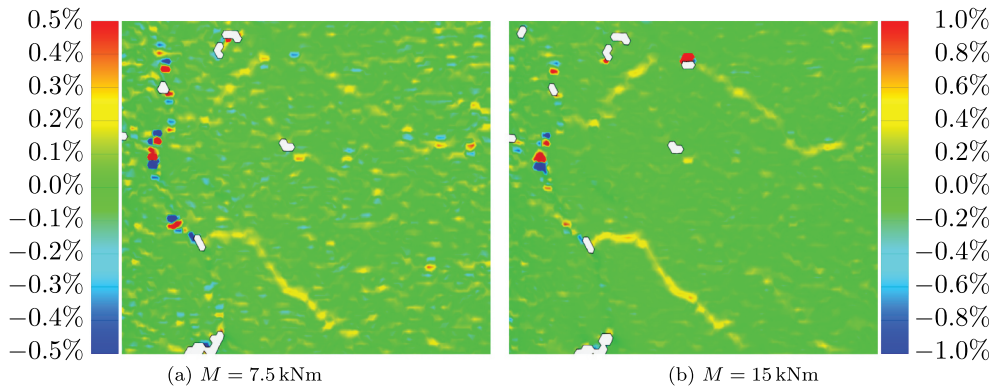
Figure 4. Surface strain distribution along the rail (horizontal in this figure), measured by DIC.

Figure 4 shows that strain concentrations can be observed at a 7.5 kNm bending moment. Increasing the bending moment to 15 kNm improves the Signal to Noise Ratio (SNR) and makes the strain concentrations clearer, see Figure 4(b). The results in Figure 1 only show a 3.8 kNm bending moment. However, this moment can be increased to above 10 kNm following the optimization of train parameters described in Section 5.1.

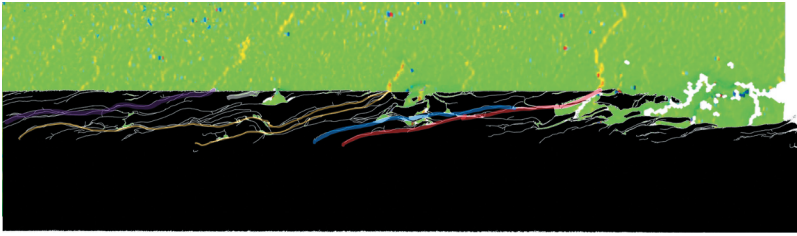
Figure 10. Correlation between cracks and DIC surface strains at $z = -1.51\text{mm}$. More sections are available in the supplementary material 'CracksToDIC_Correlation.pdf'.

The first section, Figure 9(a), was made after a skim pass in the surface grinder and defines $z = 0.00\text{mm}$. Distinct cracks appear as thin white lines against the ground surface appearing black. Depressions due to plastic deformation and material fall-out (spalling) result in larger white areas. Throughout the sections, we will follow five cracks, indicated by purple, yellow, blue, red and white colours. In the supplementary material 'CracksToDIC_Correlation.pdf', the sections are put on top of the results in Figure 7 to facilitate interpretation. As an example, the results for $z = -1.51\text{mm}$ are shown in Figure 10.

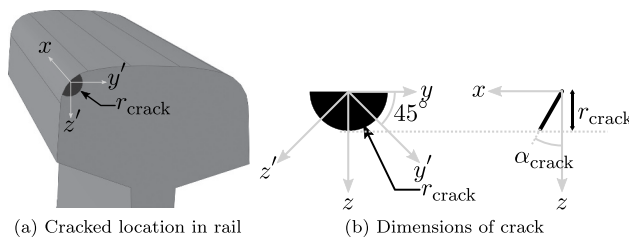
Figure 12. Dimensions of the crack in the finite element model.

Figure 7 shows the heterogeneous surface strain caused by cracks. Figure 9 reveals an intricate crack network with a maximum depth of about 3 mm . To better understand the correlation between surface strains and crack morphologies (Figure 12), we use a linear elastic finite element study of a cracked rail subjected to a 15 kNm bending moment (Figure 13). Specifically, we investigate how different crack inclinations, α_{crack} (Figure 12b), affect the surface strains. Note that the xyz -coordinate system here is only approximately equal to the coordinate system used on the field sample. The crack is further parameterized by the crack depth, r_{crack} . This depth is also the radius of the crack projection onto the yz -plane. As shown in Figure 12a, the crack is located in the middle of the gauge corner on the nominal rail profile. Symmetry boundary conditions are applied on the right side sufficiently far from the crack to ensure homogeneous strains at the boundary.

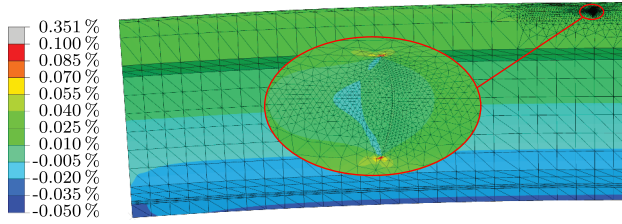
Figure 13. Longitudinal strain for a 5 mm deep crack with $\alpha_{\text{crack}} = 45^\circ$. Displacements are amplified 50 times.

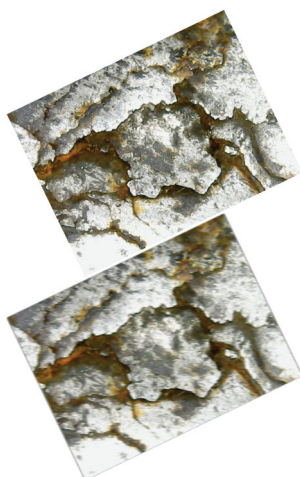
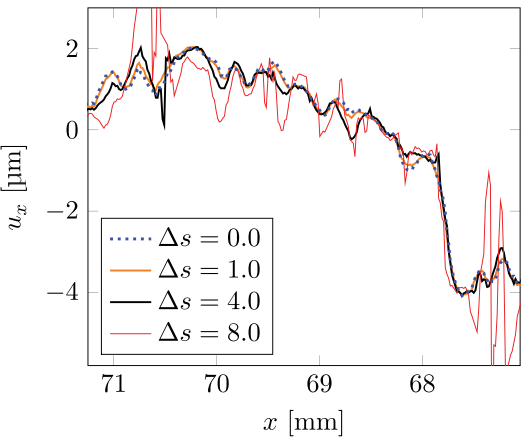
(a) $\Delta s = 0.0$ (upper) and $\Delta s = 8.0$ (lower)

Figure 16. The motion blur effect.

(b) Identified displacements along line in Figure 8b

By applying these filter kernels to raw reference and deformed images like the one in Figure 8a, we simulate a motion blur effect, see Figure 16a. When too much blurring occurs, fewer subsets can be identified in the DIC analysis. Errors are thus introduced in the displacements. Figure 16b shows this effect. In contrast to Figure 8, the image was rotated before the DIC analysis, causing a slightly different result for $\Delta s = 0.0$. Travelling 1 pixel during the exposure time, $\Delta s = 1.0$, has minimal impact on the results. At $\Delta s = 4.0$, the noise increases, but the displacement step around $x = 64.7\text{mm}$ is still distinct. However, for a longer exposure time, $\Delta s = 8.0$, the data noise are at a similar level to the displacement step. In conclusion, an exposure time resulting in 4 pixels traversed provides sufficient measurement accuracy.
