A method for in-field railhead crack detection using digital image correlation

Knut Andreas Meyer, Daniel Gren, Johan Ahlström & Anders Ekberg

Railway infrastructure managers must decide when and how to maintain rails. However, they often have insufficient information about railhead cracks. Therefore, we propose a new method for rail crack detection using a train-mounted digital image correlation (DIC) camera system. The measurement train's weight cause rail bending, allowing the DIC to measure strain concentrations caused by surface-breaking cracks. In this study, we evaluate the method under laboratory conditions. The detected cracks correlate to the actual crack network in the analysed rail field sample. Furthermore, finite element simulations show the method's high sensitivity to crack depths. Existing methods, such as ultra-sonic and eddy-current, produce damage severity indications. The proposed method complements these techniques by providing a discrete description of the surface-breaking cracks and their depth. This information enables infrastructure managers to optimize rail maintenance. Additionally, such detailed measurements can be valuable for research in railhead da

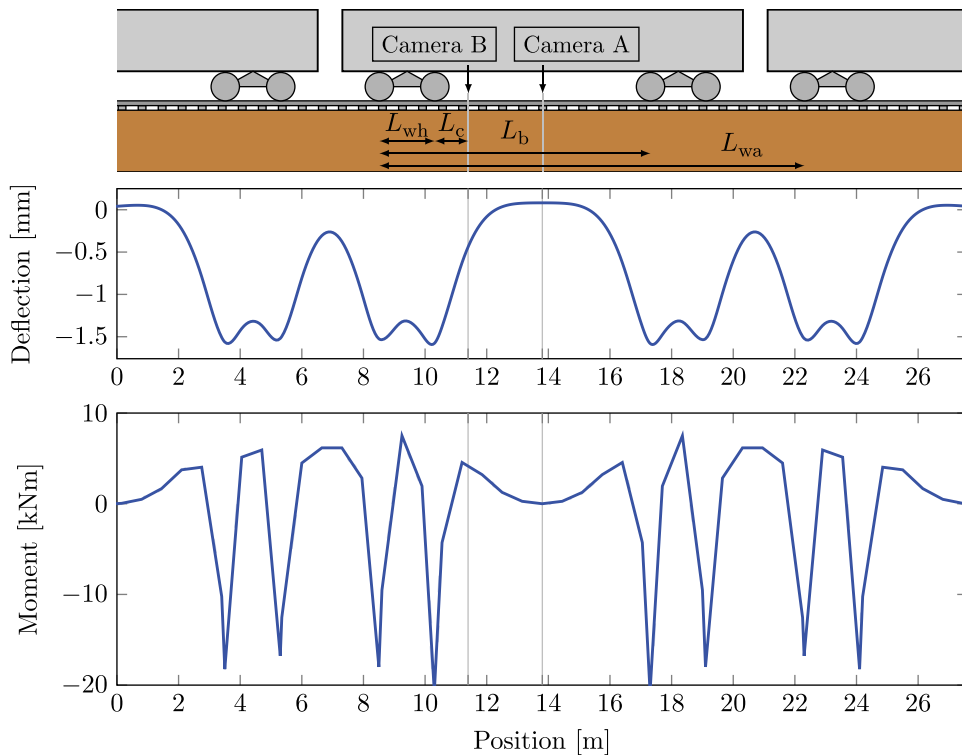
Figure 1. Rail deflection and bending moment due to a train passage. Camera A measures the undeformed rail surface while Camera B measures the deformed surface. The dimensions L_{wh} , L_b , and L_{wa} are described in [Table 1](#), and L_c is the distance from the wheel to Camera B.

Rails, sleepers and the ground deflects when a train rolls over, as illustrated in [Figure 1](#). These results are calculated for a freight train with a 25-ton axle load using the methodology described in [Section 5.1](#). The rail deflections give rise to bending moments in the rail. [Figure 1](#) shows that the bending moment in the middle of each waggon is approximately zero. Camera A can then take a reference image, showing the rail surface without an applied bending moment. When the train has moved so that Camera B is approximately in Camera A's previous position, Camera B acquires an image of the same area as Camera A's reference image. This approximate position is calculated from the train speed. The DIC pattern recognition is then used in an optimization loop to accurately determine the relative position of the images. The image from camera B shows the surface being affected by tensile strains due to a positive rail bending moment. These tensile strains cause the cracks to open, see [Figure 2](#). The crack opening causes a displacement jump over the crack mouth leading to an infinite strain.

zero. However, at Camera B, the moment fluctuates when rolling between two sleepers. To maximize the method's sensitivity for all positions, we must maximize the minimum moment over such a cycle by adjusting the camera position, L_c (see Figure 1 for the definition of L_c). Figure 11b shows how the minimum moment varies with camera position. The maximum moment is also included as a reference. The black dot marks the minimum moment at the position of camera B that maximizes the minimum moment. For the parameters in Table 1, this bending moment is 3.8 kNm. The DIC method can calculate the average surface strain and thereby also the bending moment. Hence, a varying bending moment during rolling does not pose an issue for the proposed method. For shallow cracks, there is no discernible difference between a tensile strain for the entire rail or a bending strain in the railhead. Therefore, the method can account for varying complex static and dynamic loading conditions.

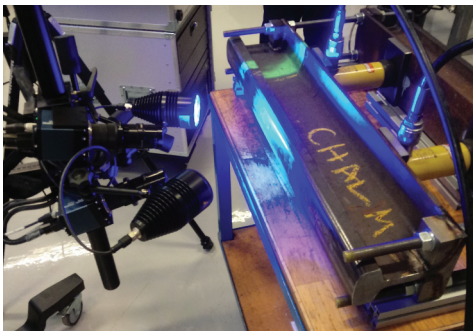
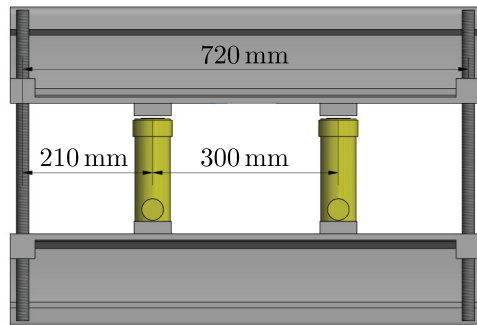
(a) Picture of DIC experiment

(b) Schematic of bending fixture

Figure 3. DIC experimental setup with the yellow hydraulic cylinders exerting a 4-point bending in the rail samples.

Two rail field samples were connected by threaded rods, as shown in Figure 3. Two hydraulically connected cylinders load the samples in 4-point bending. This setup gives a constant bending moment in the part of the rail located between the cylinders. The hydraulic pressure was controlled by a manual pump and measured by an electronic pressure sensor.

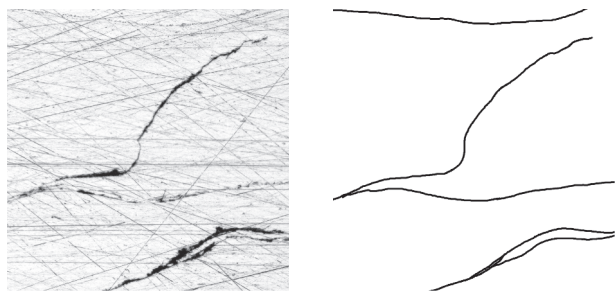
(a) Original grayscale optical microscopy image (b) Processed, binary image

Figure 6. Example of conversion from optical microscopy images to binary images. The shown images are $1.5\text{mm} \times 1.5\text{mm}$.

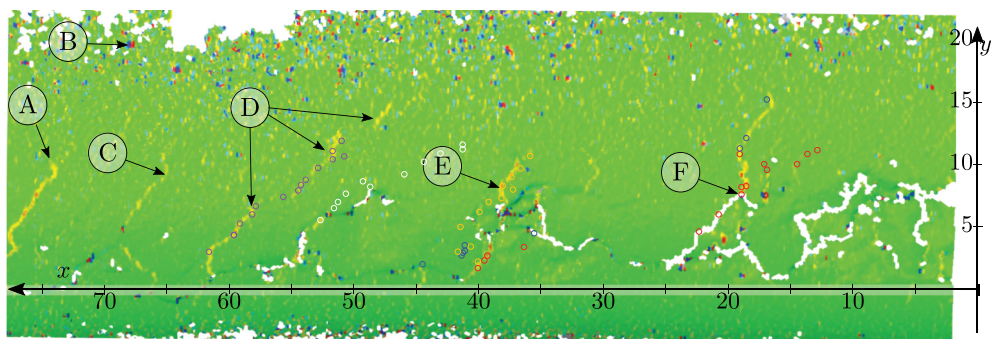
Figure 7. DIC results, viewed from above the microscopy sections. The black rectangle at $x = y = 0$ shows the location of the reference mark, and axes correspond to the axes in Figure 9 with dimensions in mm. The same strain scale as in Figure 4(b) is used. The coloured circles show the end-points of the cracks marked with the corresponding translucent colour in Figure 9

The strain field in Figure 7 is visualized for a 15 kNm bending moment. The reference mark, see Figure 5, is on the right side of the strain field. Furthermore, the reference line in Figure 7 shows the horizontal direction in the section images that is along the rail. Hence, it is perpendicular to the reference mark shown in Figure 5(b).

Two types of artefacts are observed in Figure 7. First, the white areas are places where the DIC algorithm was unable to identify the surface. Typically, these artefacts are caused by severe surface irregularities, for example at crack mouths. At reference mark F in Figure 7, the artefact is located in the lower part of the crack mouth, where the geometry is too irregular to be accurately captured by the DIC system. In the upper part, the strain concentration is visible.

The second artefact is the occurrence of red and blue dots. They typically occur in pairs (see e.g. reference mark B). This result implies that high strains of opposite signs are detected close to each other, and the effect cancels out. When these appear just at points and do not coalesce into

Figure 7 shows the heterogeneous surface strain caused by cracks. Figure 9 reveals an intricate crack network with a maximum depth of about 3 mm . To better understand the correlation between surface strains and crack morphologies (Figure 12), we use a linear elastic finite element study of a cracked rail subjected to a 15 kNm bending moment (Figure 13). Specifically, we investigate how different crack inclinations, α_{crack} (Figure 12b), affect the surface strains. Note that the xyz -coordinate system here is only approximately equal to the coordinate system used on the field sample. The crack is further parameterized by the crack depth, r_{crack} . This depth is also the radius of the crack projection onto the yz -plane. As shown in Figure 12a, the crack is located in the middle of the gauge corner on the nominal rail profile. Symmetry boundary conditions are applied on the right side sufficiently far from the crack to ensure homogeneous strains at the boundary.

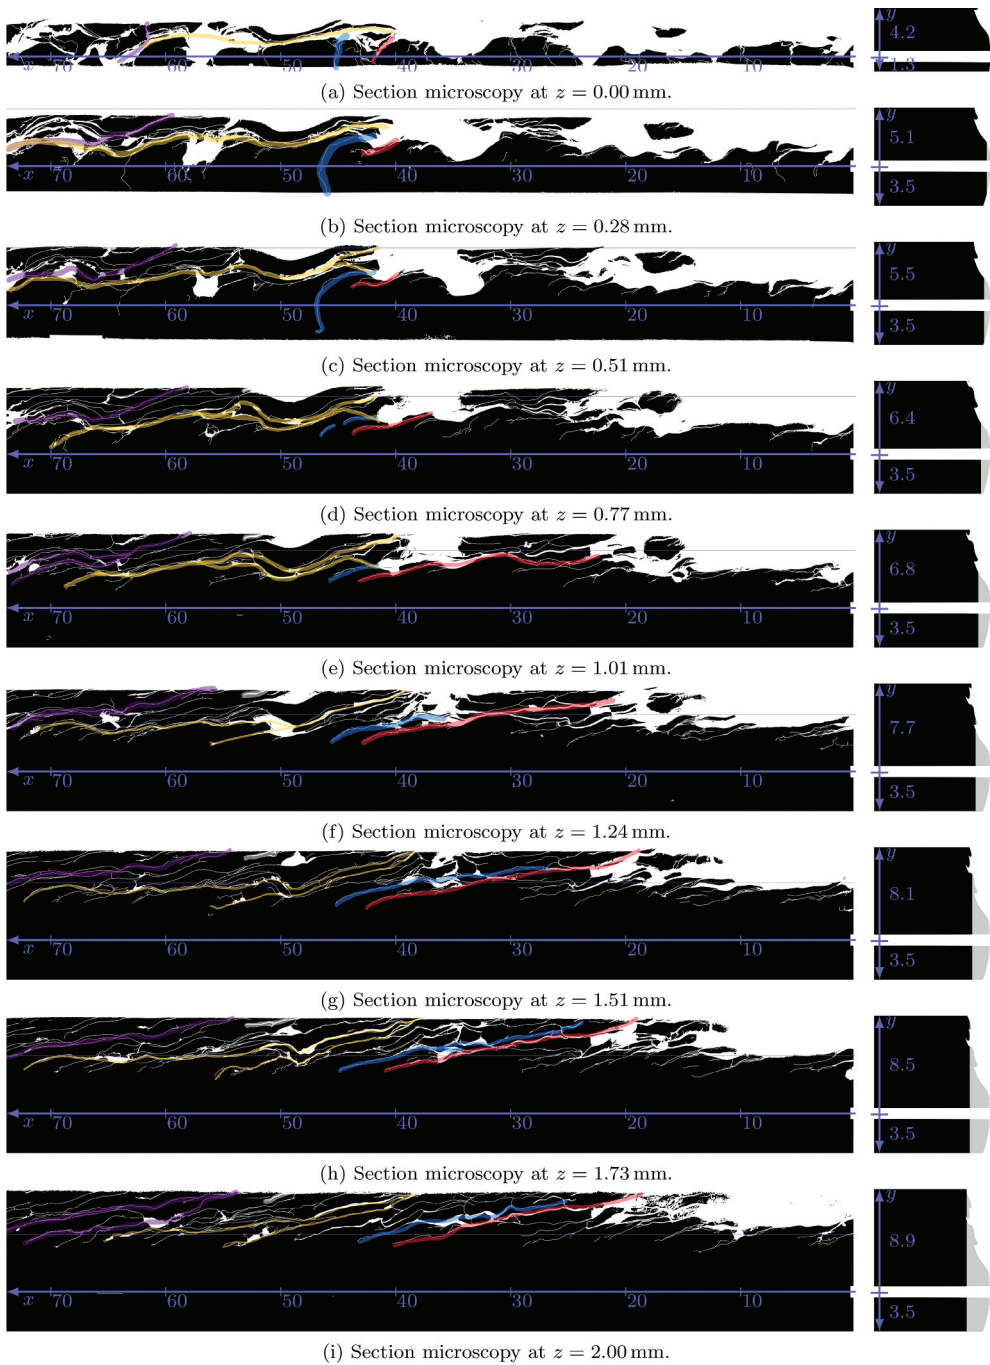
Figure 9. Sections showing the crack patterns with inverted colours compared to Figure 6. All coordinates are in mm. The horizontal lines have 5 mm spacing, the numbers next to the positive and negative y -axes denote the respective axis' length, and the z -coordinate is defined in Figure 5(b). The translucent colours show how different cracks evolve between the sections and their top endpoints are marked by circles of the corresponding colour in Figure 7

Figure 9 shows microscopy sections with approximately 0.25 mm spacing down to $z = 3.26\text{mm}$, as well as the section at $z = 5.00\text{mm}$. On the right side, the side view of the sectioned part's profile is shown for clarity. Ground off material is marked with a grey colour. The upwards arrow indicates the approximate distance from the reference line ($y = 0$) to the end of the ground surface. The sections in Figure 9 were processed further to improve crack visibility and reduce the manuscript's file size.¹ The full-sized images are available as a dataset [23]. These binary images also contain sections at 3.75, 4.5, 7.0 and 9.0 mm, which are not included in Figure 9 due to space constraints. Only cracks close to the surface appear in the sections at $z = 7.0\text{mm}$ and $z = 9.0\text{mm}$.

The first section, Figure 9(a), was made after a skim pass in the surface grinder and defines $z = 0.00\text{mm}$. Distinct cracks appear as thin white lines against the ground surface appearing black. Depressions due to plastic deformation and material fall-out (spalling) result in larger white areas. Throughout the sections, we will follow five cracks, indicated by purple, yellow, blue, red and white colours. In the supplementary material 'CracksToDIC_Correlation.pdf', the sections are put on top of the results in Figure 7 to facilitate interpretation. As an example, the results for $z = -1.51\text{mm}$ are shown in Figure 10.

The purple crack breaks the surface at $z = 0.00\text{mm}$ around $x = 62\text{mm}$. Moving down 0.28mm, it extends quite far along the rail (x -direction), just under the surface. The crack keeps appearing in roughly the same location, slightly shifting in the positive y -direction as the depth increases. Its surface-breaking point also shifts in the positive y -direction which is also observed in the DIC results in Figure 7, indicated by the purple circles. The crack appears to be shallow in Figure 9(n). It is marked further into the material as it likely remains connected in the z -direction, based on observations in the next section at $z = 3.75\text{mm}$ (only included in supplementary materials). Parts of the crack is also visible in Figure 9(o) ($z = 5.00\text{mm}$), and an approximate crack depth of 1.5 mm can be inferred. Note that the z -coordinate does not indicate the crack depth: it is measured perpendicular to the surface (see the profile views on the right in Figure 9.)

We will now consider the near-surface geometry of the blue crack that also break the surface around $x \approx 40$ mm in [Figure 9a](#). From the first 3 sections, the blue crack seems to extend normal to the surface. At its initial surface-breaking point at $x = 44.5$ mm, $y = 2.0$ mm, a slight strain concentration can be observed in [Figure 7](#). Within the first 0.28 mm the crack mouth moves quite a lot to the right, indicating an almost horizontal crack plane, even if the part of the crack around $y = 0$ mm extends downwards. No clear strain concentration occurs in [Figure 7](#) at the first 5 blue dots. This observation indicates that the DIC results are less sensitive in areas with almost horizontal cracks.
