Investigation on Pollution-Induced Flashovers of In-Service Insulators in Ethiopian Power Transmission Lines

Zelalem Desta, B., Wogari, M., Gubanski, S. (2024). Investigation on Pollution-Induced Flashovers of In-Service Insulators in Ethiopian Power Transmission Lines. *Energies*, 17(9). <http://dx.doi.org/10.3390/en17092007>

Keywords: Ethiopian power transmission system; unexplained outages; pollution flashover; outdoor insulators; silicone rubber polymeric insulators; site pollution severity

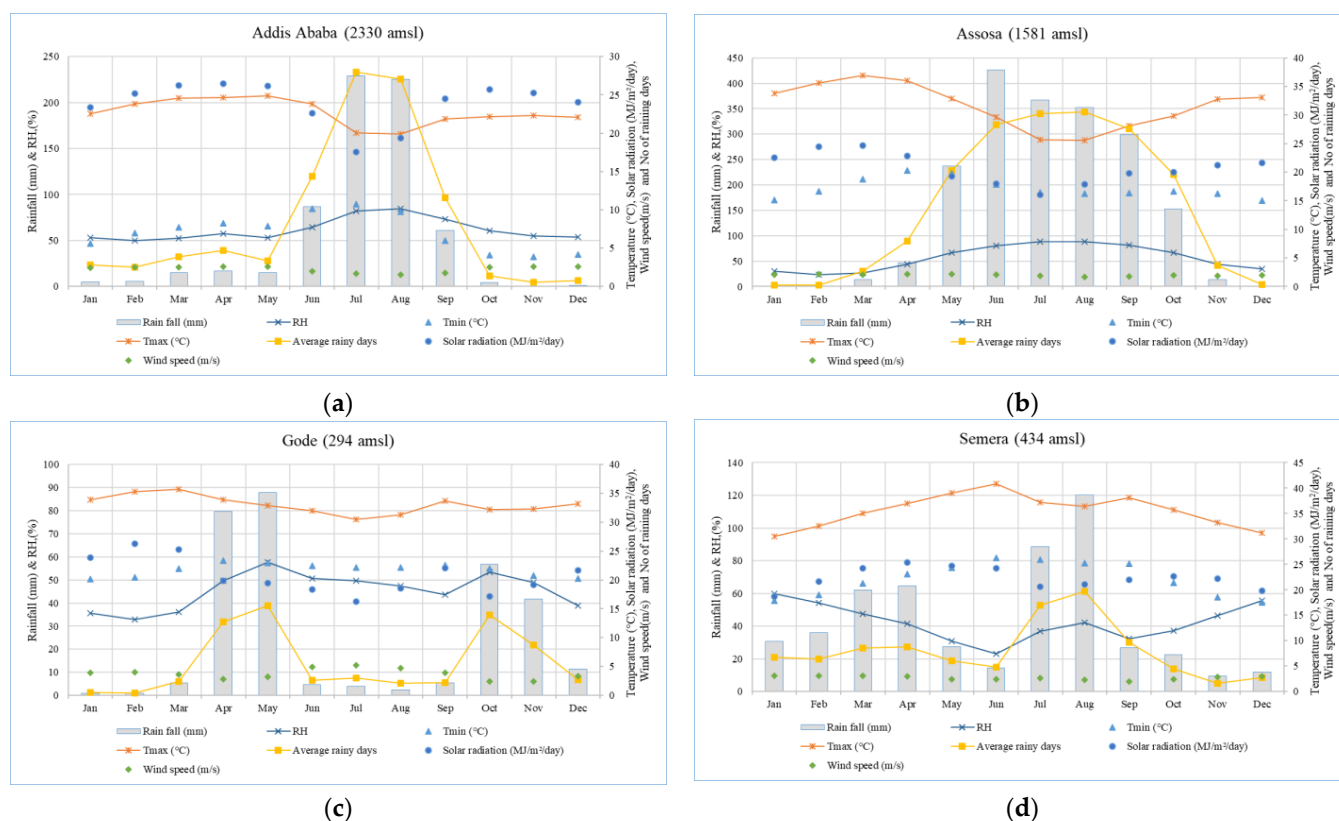
Figure 2. Illustrations of annual variations in meteorological parameters (derived from 30 years of data [28]) for four representative sites in Ethiopia. (a) Addis Ababa; (b) Assosa; (c) Gode; (d) Semera.

The meteorological conditions for Group 1 areas, as shown in Figure 2a, are predominantly dry from October to February of the next year, while the period from March to

As shown in Figure 2b, the period spanning from October to February of the next year is mainly dry. The average monthly rainfall during this period is 6.7 mm. Moreover, periods with less than 20 mm rain are in March and November, whereas periods with less than 10 mm rain begin in December and continue to the end of February. During the primary rainy season from March to September, the monthly average rainfall reaches 200 mm and secures natural washing of insulator surfaces.

As shown in Figure 2c, the main dry season in regions of Group 3 is from June to September and from December to February of the next year, while from October to November there is a short rainfall season. During the former periods, the average monthly rainfall is low, respectively, 17 mm and less than 10 mm. During March to May (the main rainy season), the weather is moist, and the average rainy days and average monthly rainfall reach 10 days and 44 mm. The natural washing of insulators by rain increases in this period.

As shown in Figure 2d, the periods from October to February of the next year and from March to May are the main dry seasons. During these periods, the average monthly rainfall is low, around 27 mm. Moreover, less than 20 mm rain periods are during January and June, and less than 10 mm rain periods begin in November and December. During June to September (the main rainy season), the weather is moist, but the rainfall is usually light. Most of the rainy days are continuous drizzle or scattered rains, and the average monthly rainfall reaches 45 mm. Hence, the washing effect during this period is minimal.

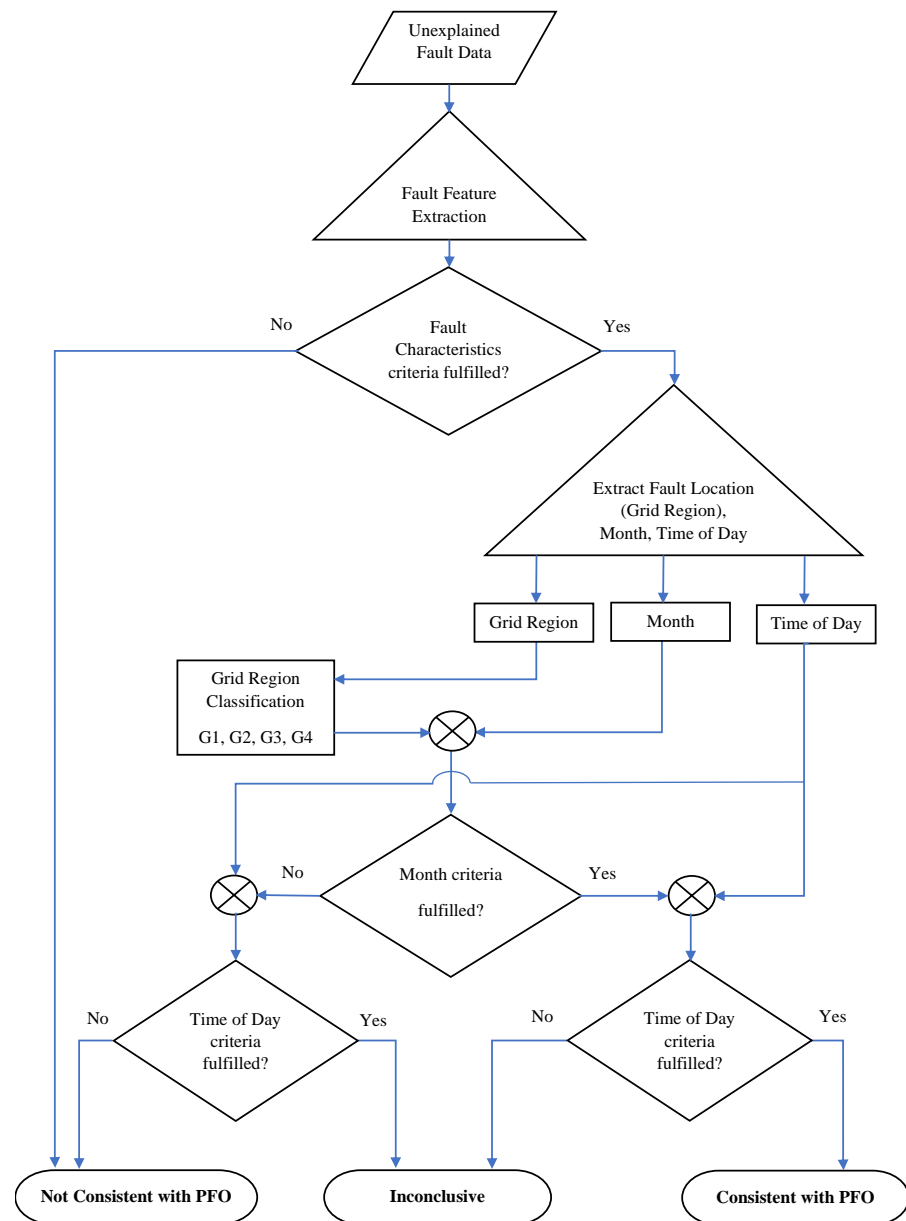
Figure 3. Procedure for application of criteria for identifying pollution flashover-induced faults.

The implementation of these criteria can best be demonstrated through the flowchart depicted in Figure 3. The criteria and the procedure described in the flowchart serve as a general guideline for evaluating the roots of unexplained faults. The first decision block checks whether an unexplained fault fulfils the characteristics criteria outlined in Section 2.1.5. If the unexplained fault does not satisfy this criterion, then this fault is not considered as pollution caused and categorized as “Not Consistent with PFO”. Otherwise, the process continues, and information on the fault location (Grid Region), month, and

time of its appearance is extracted. The subsequent decision blocks in the flow chart use the criteria presented in Sections 2.1 and 2.2 as well as in Table 1.

In the following steps, after assigning the right grid region group to the fault, it is tested for the month and time-of-the-day criteria. If the conditions are fulfilled, then the fault is categorized as “Consistent with PFO”. If only one of the criteria is fulfilled, then it becomes difficult to assign it as PFO because other possible environmentally induced causes of unexplained fault may also exhibit similar characteristics. So, such cases are “Inconclusive” and need further investigations to assign their possible causes. Moreover, if it fails to fulfill both criteria, then it is not considered as pollution-induced flashover and hence assigned as “Not Consistent with PFO”.

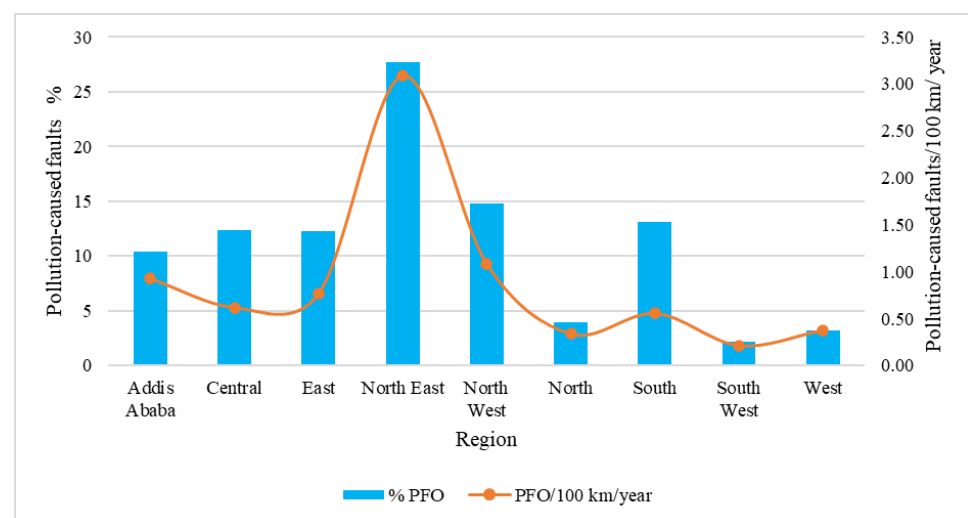
Figure 4. Distribution of pollution-induced flashover faults across EEP grid regions from 2015–2022.

The distribution of pollution-induced faults in each grid region of EEP between 2015 and 2022 is presented in Figure 4. Among these regions, the Northeast region suffered 290 (27.8%) faults, the highest frequency of interruptions with 3.1 faults/100 km/year, followed by the Northwest region which endured 155 (14.8%) faults and 1.1 faults/100 km/year. The Addis Ababa, East, Central and South grid regions also experienced a higher number of interruptions during this period with more than 100 faults and 0.55 faults/100 km/year each. The Southwest region suffered 23 (2.2%) faults, the lowest number of incidents with 0.2 faults/100 km/year.

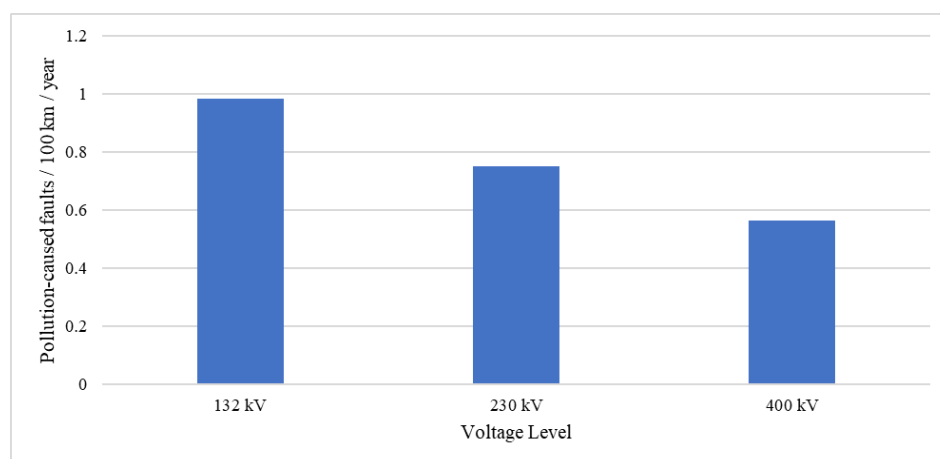
Figure 6. Frequency of pollution-induced faults for 132 kV, 230 kV, and 400 kV lines.

The distribution of pollution-induced fault frequency for the primary-voltage-level lines is illustrated in Figure 6. When the frequency of faults is evaluated separately, 132 kV lines suffered the highest fault frequency at 0.98 faults/100 km/year, and the faults experienced by 230 kV lines amounts to 0.75 faults/100 km/year. These poor performances are in accordance with the service experiences reported by EEP experts. Almost half of the 132 and 230 kV lines were built prior to 2005, and their underperformance could, in addition to the environmental and climatic factors, be attributed to the aging of the line infrastructure. In contrast, 400 kV lines display a lower fault frequency of about 0.57/100 km/year.

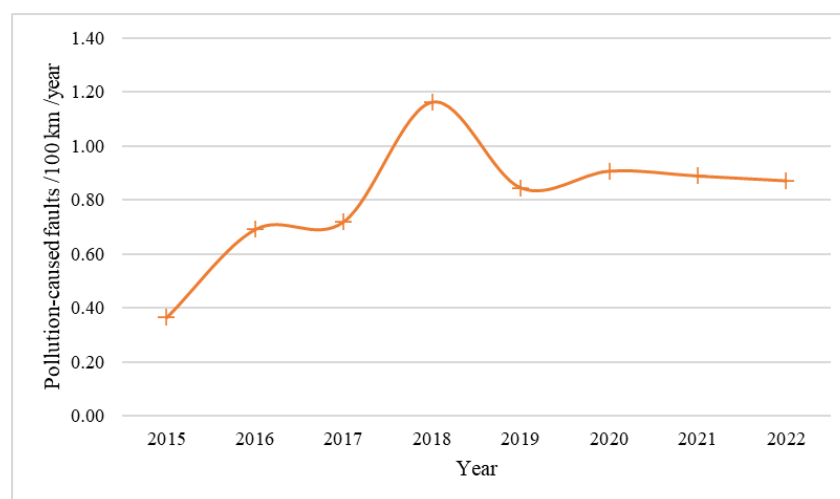
Figure 7. Annual variation in pollution-induced faults in Ethiopian power grid.

Scrutiny of the identified pollution-induced faults revealed that yearly trends in their appearance varied from one year to another—it had an increasing trend, peaking in 2018, as shown in Figure 7. Since 2019, it has become constant due to pollution saturation (an equilibrium condition between the pollution deposit rate and insulator cleaning rate) [1]. The reason for the increasing trend could be attributed to changes in environmental and meteorological conditions, issues related to the selection and dimensioning of insulators, infrastructure aging, and ineffective maintenance procedures. Further study is required to elucidate the reason for this trend and develop strategies to mitigate future fault occurrences.

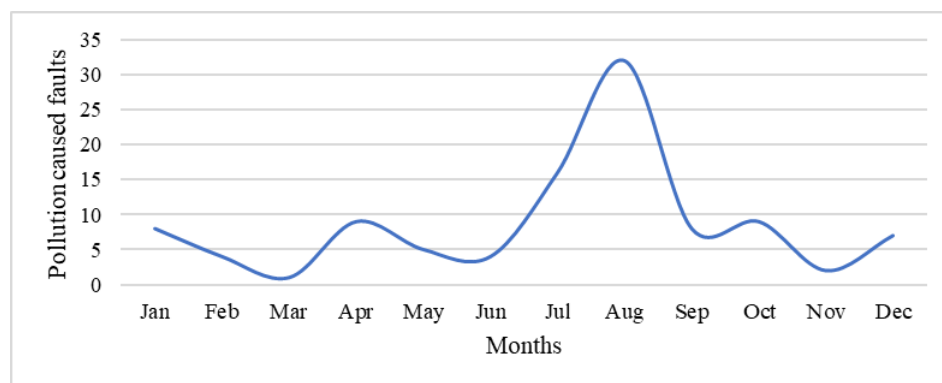
Figure 13. Monthly distribution of pollution-induced faults of the Combolcha II—Semera—Dicheto 230 kV line.

Figures 12 and 13 indicate that the pollution-induced faults mainly occurred on the line during the night from 19:00 to early morning (5:00–6:00), peaking at midnight (23:00–1:00) and especially in April and August. This is the rainy season in the region, having relatively low rainfall levels, when insulator surfaces are wetted by light precipitation during the evening hours and dew formation at sunrise.
