Investigation on Pollution-Induced Flashovers of In-Service Insulators in Ethiopian Power Transmission Lines

Zelalem Desta, B., Wogari, M., Gubanski, S. (2024). Investigation on Pollution-Induced Flashovers of In-Service Insulators in Ethiopian Power Transmission Lines. *Energies*, 17(9). <http://dx.doi.org/10.3390/en17092007>

Keywords: Ethiopian power transmission system; unexplained outages; pollution flashover; outdoor insulators; silicone rubber polymeric insulators; site pollution severity

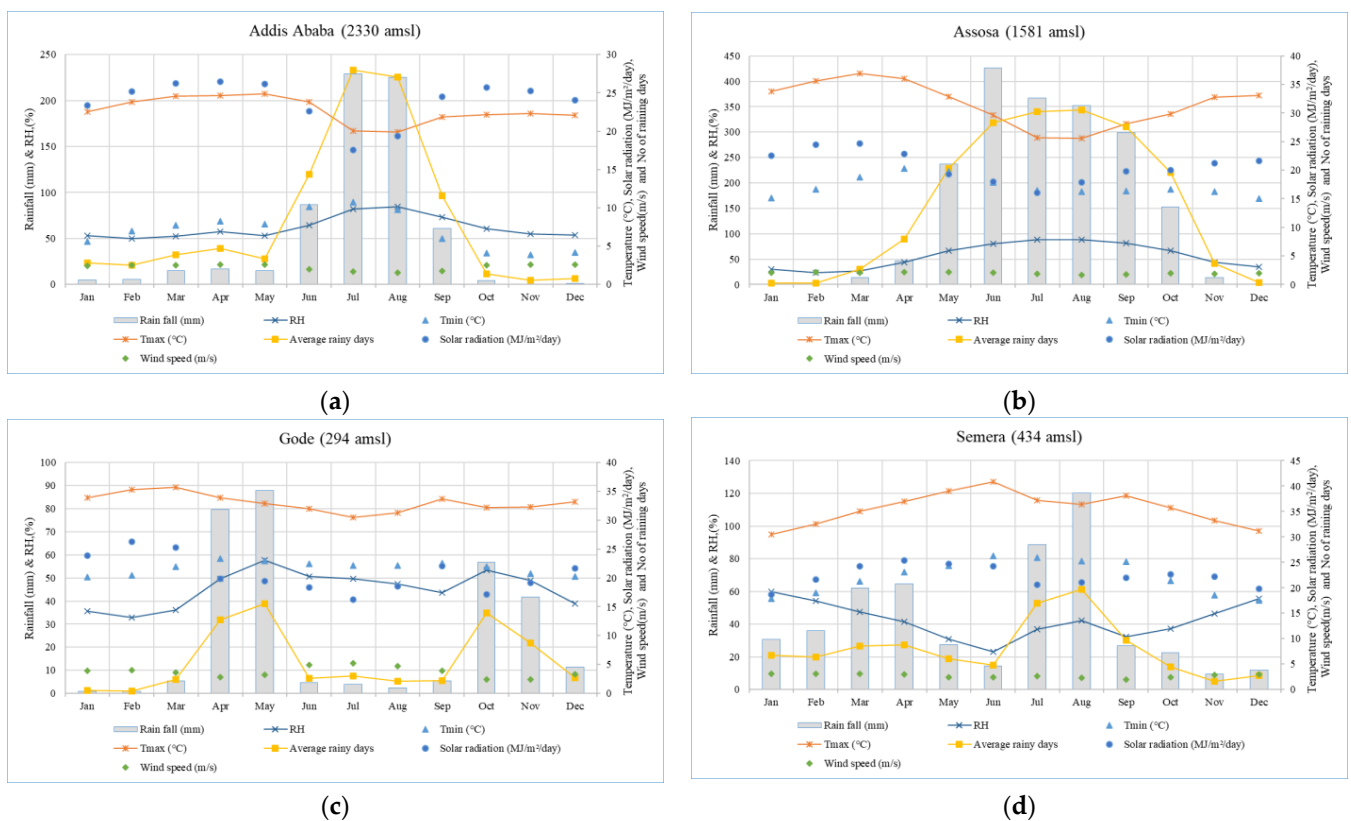
Figure 2. Illustrations of annual variations in meteorological parameters (derived from 30 years of data [28]) for four representative sites in Ethiopia. (a) Addis Ababa; (b) Assosa; (c) Gode; (d) Semera.

The meteorological conditions for Group 1 areas, as shown in Figure 2a, are predominantly dry from October to February of the next year, while the period from March to

As shown in Figure 2b, the period spanning from October to February of the next year is mainly dry. The average monthly rainfall during this period is 6.7 mm. Moreover, periods with less than 20 mm rain are in March and November, whereas periods with less than 10 mm rain begin in December and continue to the end of February. During the primary rainy season from March to September, the monthly average rainfall reaches 200 mm and secures natural washing of insulator surfaces.

As shown in Figure 2c, the main dry season in regions of Group 3 is from June to September and from December to February of the next year, while from October to November there is a short rainfall season. During the former periods, the average monthly rainfall is low, respectively, 17 mm and less than 10 mm. During March to May (the main rainy season), the weather is moist, and the average rainy days and average monthly rainfall reach 10 days and 44 mm. The natural washing of insulators by rain increases in this period.

As shown in Figure 2d, the periods from October to February of the next year and from March to May are the main dry seasons. During these periods, the average monthly rainfall is low, around 27 mm. Moreover, less than 20 mm rain periods are during January and June, and less than 10 mm rain periods begin in November and December. During June to September (the main rainy season), the weather is moist, but the rainfall is usually light. Most of the rainy days are continuous drizzle or scattered rains, and the average monthly rainfall reaches 45 mm. Hence, the washing effect during this period is minimal.

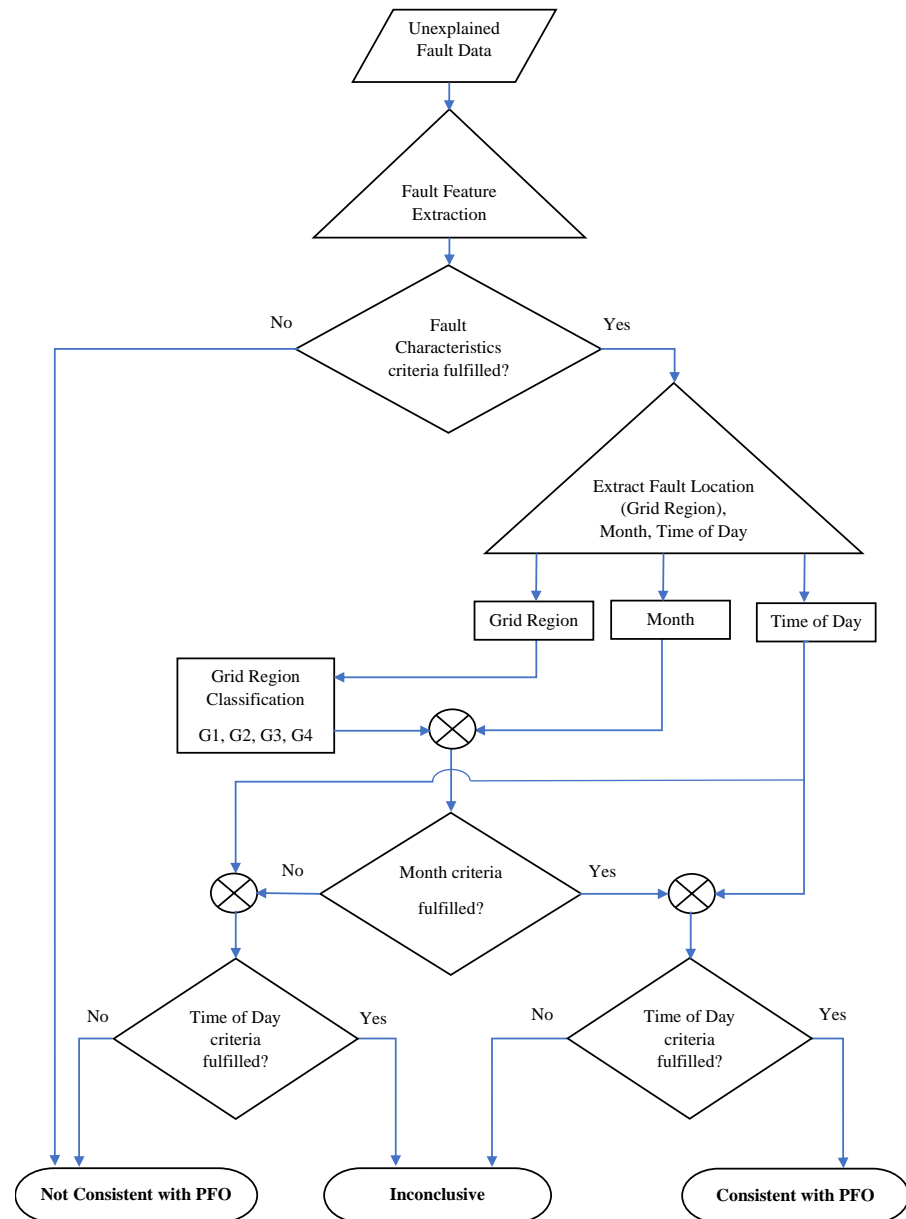
Figure 3. Procedure for application of criteria for identifying pollution flashover-induced faults.

The implementation of these criteria can best be demonstrated through the flowchart depicted in Figure 3. The criteria and the procedure described in the flowchart serve as a general guideline for evaluating the roots of unexplained faults. The first decision block checks whether an unexplained fault fulfils the characteristics criteria outlined in Section 2.1.5. If the unexplained fault does not satisfy this criterion, then this fault is not considered as pollution caused and categorized as “Not Consistent with PFO”. Otherwise, the process continues, and information on the fault location (Grid Region), month, and

time of its appearance is extracted. The subsequent decision blocks in the flow chart use the criteria presented in Sections 2.1 and 2.2 as well as in Table 1.

In the following steps, after assigning the right grid region group to the fault, it is tested for the month and time-of-the-day criteria. If the conditions are fulfilled, then the fault is categorized as “Consistent with PFO”. If only one of the criteria is fulfilled, then it becomes difficult to assign it as PFO because other possible environmentally induced causes of unexplained fault may also exhibit similar characteristics. So, such cases are “Inconclusive” and need further investigations to assign their possible causes. Moreover, if it fails to fulfill both criteria, then it is not considered as pollution-induced flashover and hence assigned as “Not Consistent with PFO”.

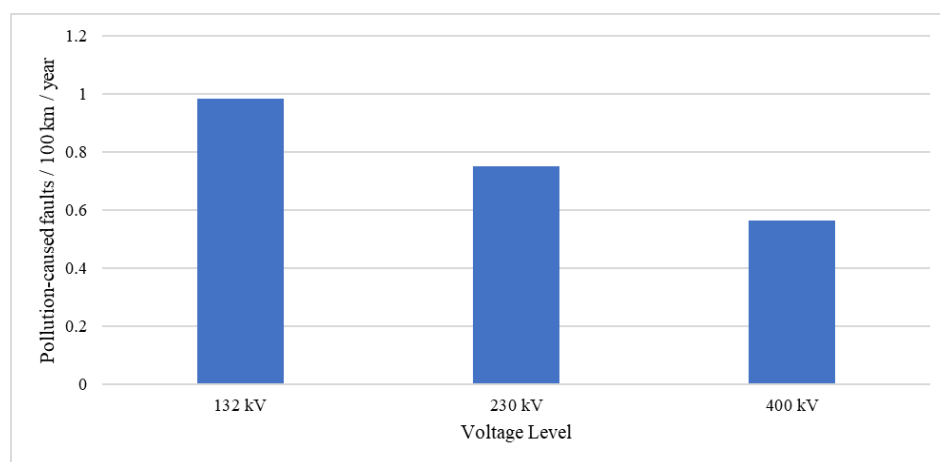
Figure 6. Frequency of pollution-induced faults for 132 kV, 230 kV, and 400 kV lines.

The distribution of pollution-induced fault frequency for the primary-voltage-level lines is illustrated in Figure 6. When the frequency of faults is evaluated separately, 132 kV lines suffered the highest fault frequency at 0.98 faults/100 km/year, and the faults experienced by 230 kV lines amounts to 0.75 faults/100 km/year. These poor performances are in accordance with the service experiences reported by EEP experts. Almost half of the 132 and 230 kV lines were built prior to 2005, and their underperformance could, in addition to the environmental and climatic factors, be attributed to the aging of the line infrastructure. In contrast, 400 kV lines display a lower fault frequency of about 0.57/100 km/year.

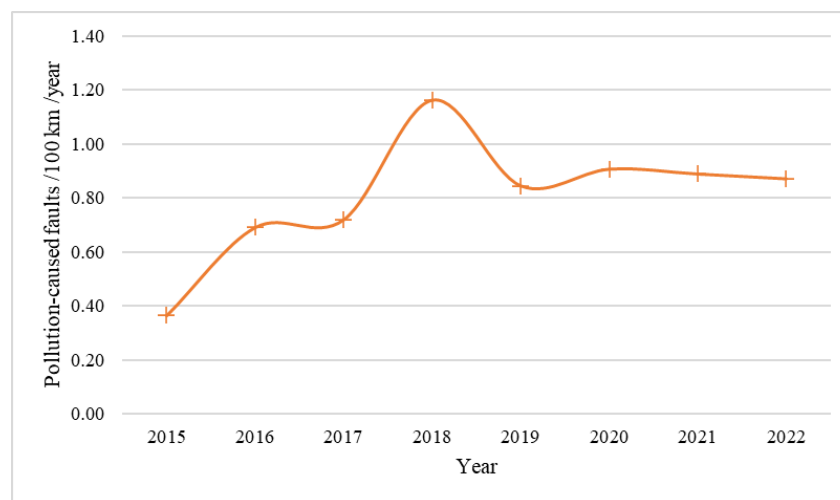
Figure 7. Annual variation in pollution-induced faults in Ethiopian power grid.

Scrutiny of the identified pollution-induced faults revealed that yearly trends in their appearance varied from one year to another—it had an increasing trend, peaking in 2018, as shown in Figure 7. Since 2019, it has become constant due to pollution saturation (an equilibrium condition between the pollution deposit rate and insulator cleaning rate) [1]. The reason for the increasing trend could be attributed to changes in environmental and meteorological conditions, issues related to the selection and dimensioning of insulators, infrastructure aging, and ineffective maintenance procedures. Further study is required to elucidate the reason for this trend and develop strategies to mitigate future fault occurrences.

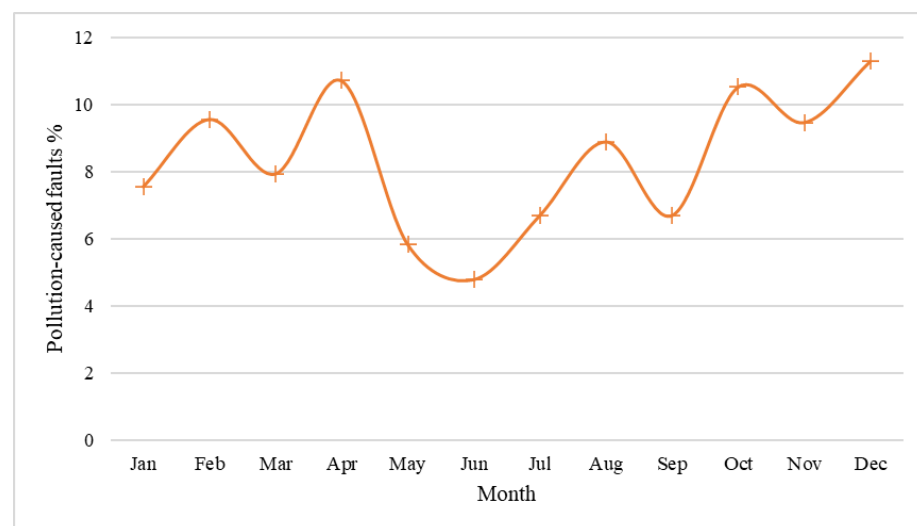
Figure 9. Seasonal trend of pollution-induced flashover faults in the Ethiopian power network.

The seasonal pattern of fault incidence is depicted in Figure 9, exhibiting a maximum fault during the dry months of October to February and March to May, peaking in December and April. A relatively lower number of faults occur from May to September, except for August, which falls during the main rainy season in most parts of Ethiopia. The seasonal trend of fault occurrence follows the rainfall patterns in the country.

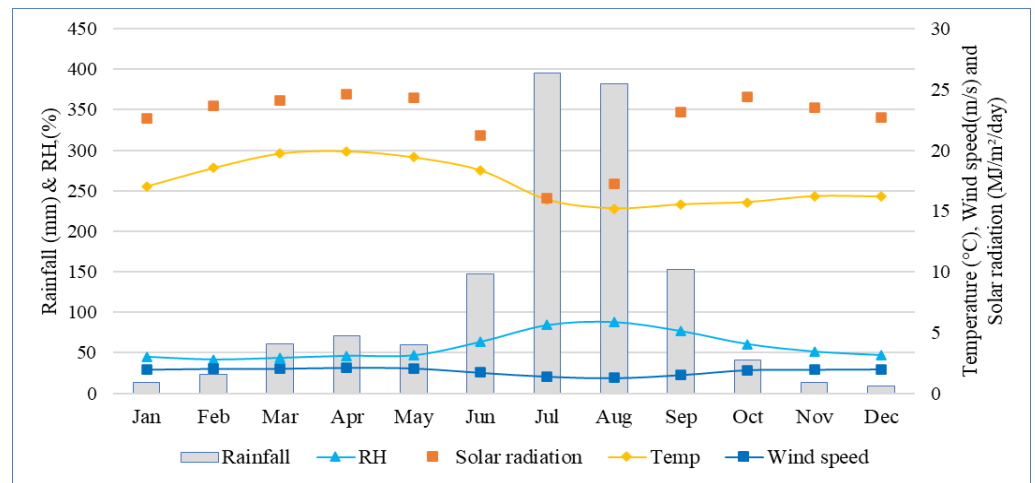
Figure 14. Monthly average meteorological parameters across the entire length of the Bahir Dar II—Debre Markos—Sululta 400 kV line [28].

The Bahir Dar II—Debre Markos—Sululta 400 kV line spans 410 km, extending from the northwestern highlands of Ethiopia to Addis Ababa, crossing subtropical highland and tropical savanna climatic conditions. The environmental conditions along the route of the line are characterized by a mixture of desert, industrial, and agricultural pollutants. The main sources of pollution in the area are from transportation, construction, quarry sites, naturally occurring dust from local soils, cement factories, and agricultural activities such as ploughing, fertilizers, crop spraying, and harvesting. The line is insulated with glass-cap and pin strings. The line is known for having a high number of unexplained outages, and the performed analysis identified a total of 72 pollution induced faults on it for the period between 2015 to 2022, an average of 9 faults per year. Figure 14 shows the monthly average meteorological parameters across the entire length of the line. The line receives an average rainfall of about 270 mm from June to September and an average relative humidity above 58%, temperature above 17 °C and windspeed 1.8 m/s for the whole year.

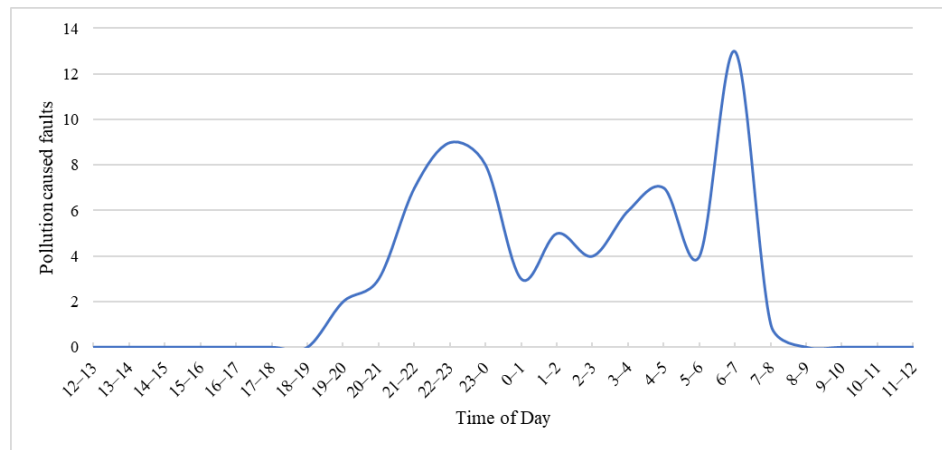
Figure 15. Daily distribution of pollution-induced faults of the Bahir Dar II—Debre Markos—Sululta 400 kV line.

The time-of-the-day curve depicted in Figure 15 reveals that most of these faults occurred close to midnight, from 22:00 to 23:00, and early in the morning, between 6:00 to 7:00. Figure 16 indicates that the majority of faults occurred between November and February, attributed to dew formation on the glass insulator surface, and from March to May (due to light precipitation), respectively, corresponding to the dry and light rainfall seasons in the area. Most faults were concentrated during spring ploughing, winter crop harvesting, and burning. The bird streamer mechanism may contribute to the faults occurring in October and November, during the autumn season. The described conditions are consistent with type A and type B pollution-flashover mechanisms.

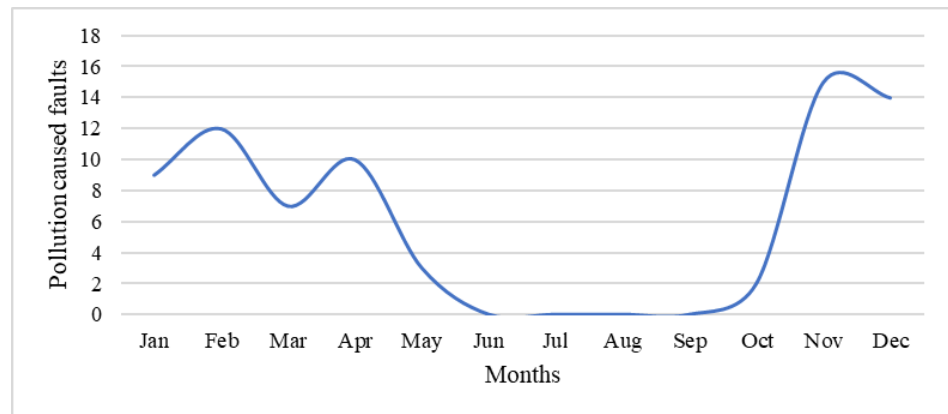
Figure 16. Monthly distribution of pollution-induced faults of the Bahir Dar II—Debre Markos—Sululta 400 kV line.
