Chemical and electrochemical surface modification and fatigue response of PBF-LB/M 316L stainless steel

Swathi Kiranmayee Manchili¹ · Fabio Pezzotti¹ · Erik Dartfeldt¹ · Martina Halmdienst² · Uta Klement³ · Seyed Hosseini^{4,5}

Abstract

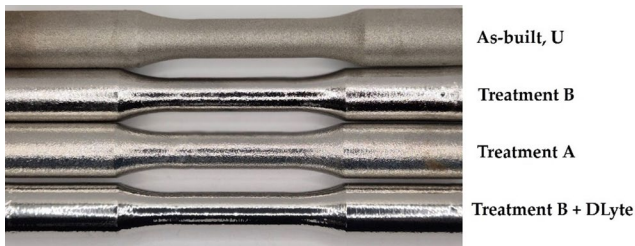
Fig. 5 Qualitative observation of the fatigue samples in the top view illustrating the observable difference in surface quality

Figure 5 shows top-view microscopy images of samples (U, A, B, B+D), revealing clear distinctions in surface morphology due to post-processing. Visual observations confirm roughness measurements.

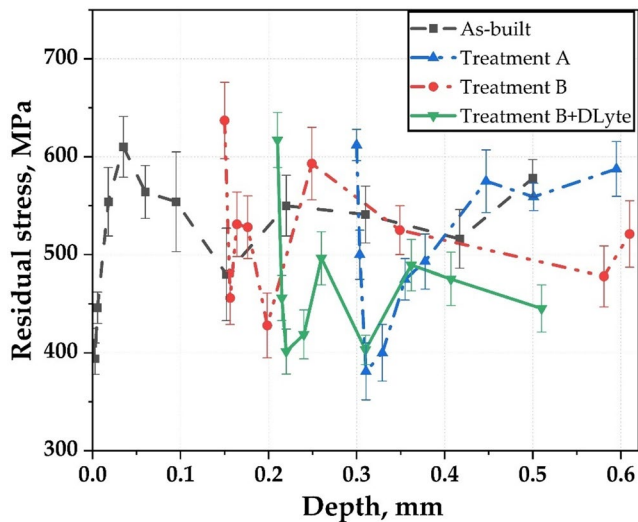
Fig. 7 Residual stress depth profile for different conditions under study

Figure 7 presents individual residual stress (RS) depth profiles for all conditions (U, A, B, B+D). To ensure accurate comparison despite surface variations from post-processing, a geometrically equivalent depth was chosen. For U specimens, surface RS was ~ 400 MPa, decreasing slightly to ~ 385 MPa at $20\ \mu\text{m}$. A peak of ~ 600 MPa was observed at $35\ \mu\text{m}$, after which RS stabilized between 500 – 550 MPa deeper within the material. In contrast to as-built specimens (~ 400 MPa), all post-processed surfaces (A, B, B+D) showed higher tensile residual stresses, averaging ~ 635 MPa. A notable "hook-shaped" residual stress profile characterized these treated specimens: stress initially decreased to ~ 450 MPa at $7\ \mu\text{m}$ (similar to U specimens), but then rose again beyond $7\ \mu\text{m}$, defining the observed profiles for A, B, and B+D. The post-processing treatments do not induce or relieve residual stresses in the bulk material. The small variations observed beyond ~ 0.3 mm result from stress redistribution and the altered surface reference following material removal.

The specimens in this study were intentionally not heat-treated prior to surface finishing, which contributed to the relatively high tensile residual stresses measured at the surface (Fig. 7). Previous studies on PBF-LB/M 316L stainless steel have shown that stress-relief heat treatments significantly reduce near-surface tensile residual stresses

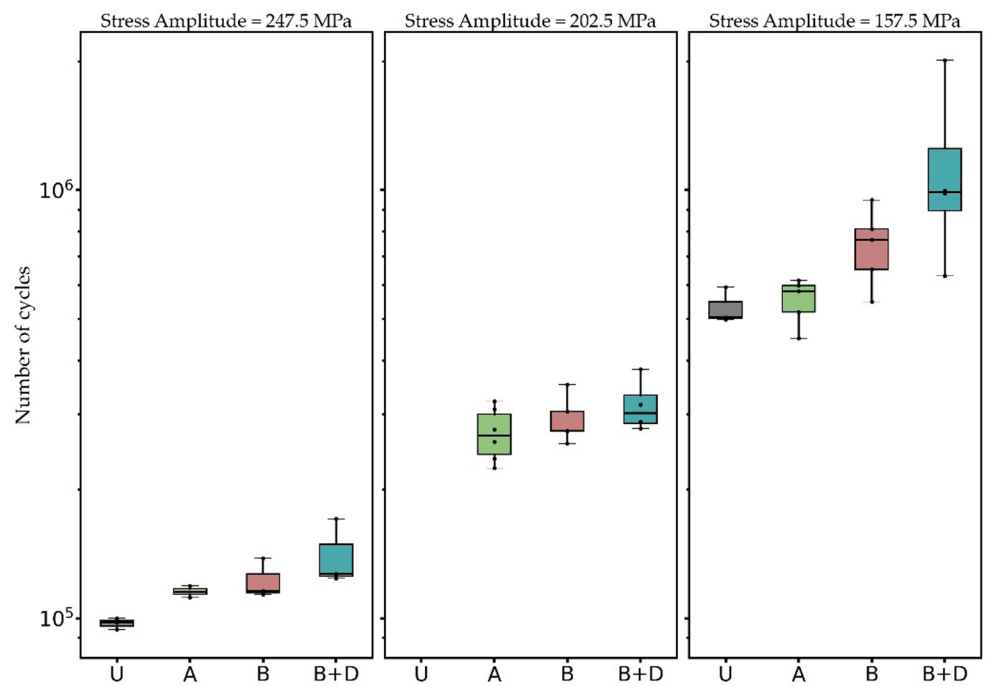
Fig. 12 Fatigue life of each specimen condition at different stress amplitudes. The rectangular boxes represent the range of measured fatigue lives, with the horizontal line inside each box indicating the mean fatigue life (average number of cycles to failure). *Note* Data for the as-built (U) condition at 202.5 MPa are not shown due to premature specimen failure during alignment

Figure 12 presents the average fatigue life and data spread for each surface condition (U, A, B, B+D) and stress amplitude.

All post-processed conditions showed slight improvement in average fatigue life compared to the as-built state, particularly at higher stress amplitudes (247.5 MPa). Here, A and B treatments showed similar improvements (approx. 22–24%), while B+D specimens displayed the most significant enhancement (40% increase). At the intermediate stress (202.5 MPa), despite limited as-built data for direct comparison, B and B+D improved by 12% and 17%, respectively, while A showed the lowest average fatigue life among post-processed conditions. At the lowest stress (157.5 MPa), B exhibited substantial improvement (40%), A showed marginal improvement (4%), and B+D had the most significant enhancement at this level. Notably, the largest scattering was observed in B+D specimens at 157.5 MPa. However, a consistent observation across all tested specimens is that the post-processed specimens performed similar to the as-built specimens.
