# Influence of build rate and post-AM surface treatments on fatigue life of powder bed fusion – laser beam 316L stainless steel

This study investigates the influence of increased build rates on the high-cycle fatigue (HCF) life of PBF-LB manufactured 316L stainless steel by detailed analysis of pore characteristics using X-ray Computed Tomography (XCT) and surface roughness. Furthermore, the effects of post-processing surface treatments by chemical mechanical processing (CMP) and Hirtisation® on surface improvement and fatigue life were studied as well. Although increased build rates led to reduced fatigue life compared to the reference condition, this was related to distinct pore morphologies revealed by XCT. Specifically, the impact of porosity generated by increased hatch distance (PA) exhibited more uniform lack of fusion (LoF) pores, while porosity generated by higher scan speed (PB), displayed larger, more randomly distributed defects, leading to larger scatter in fatigue life. Examination of the fracture surfaces confirmed that crack initiation sites were associated with surface defects in the reference samples, LoF along the hatch lines in the PA samples, and larger, rando

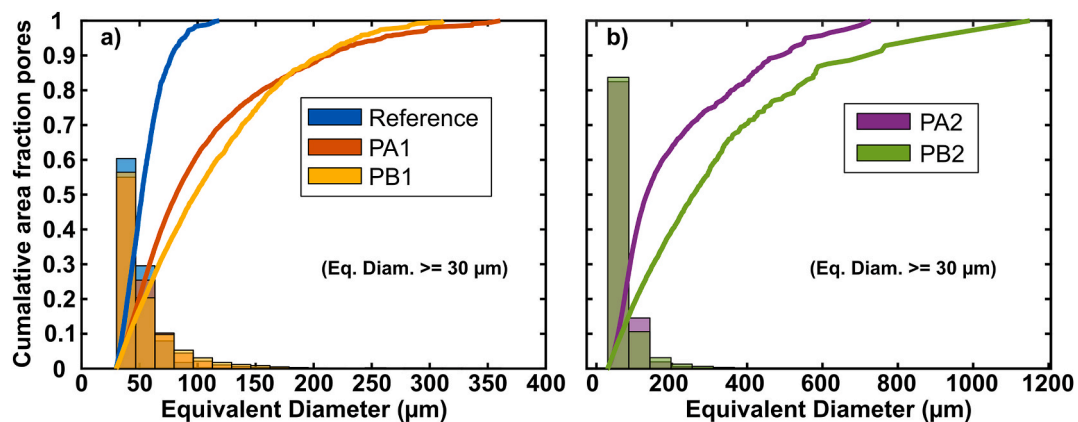
Fig. 4. Statistical analysis of pore characteristics for different as-built conditions: a) cumulative area fraction and size distribution of pores with equivalent diameter  $\geq 30 \mu\text{m}$  for the reference, PA1, and PB1 conditions. Further, in b) the same analysis for PA2 and PB2 at higher build rates with an extended x-axis to reflect larger pore sizes.

Figs. 4 and 5 present a quantitative analysis of pore characteristics focusing on size, distribution, shape, and orientation angle relative to the build direction for the different as-built conditions. With increasing build rate, larger pores occupy a greater proportion of the total pore area. As shown in Fig. 4a and b, the cumulative area fraction curves shift toward higher equivalent diameters, indicating that defects grow both in size and in their contribution to the overall pore fraction. The PB conditions show broader distributions with a greater number of large pores. For the PB2 condition, even at 200 μm, the cumulative area fraction is still relatively low (approximately 0.4), indicating the presence of numerous larger pores, whereas in the reference condition, nearly all pore area is accounted for by pores below 100 μm. This demonstrates that increased scan speed has a stronger influence on pore size than hatch spacing at the same build rate.

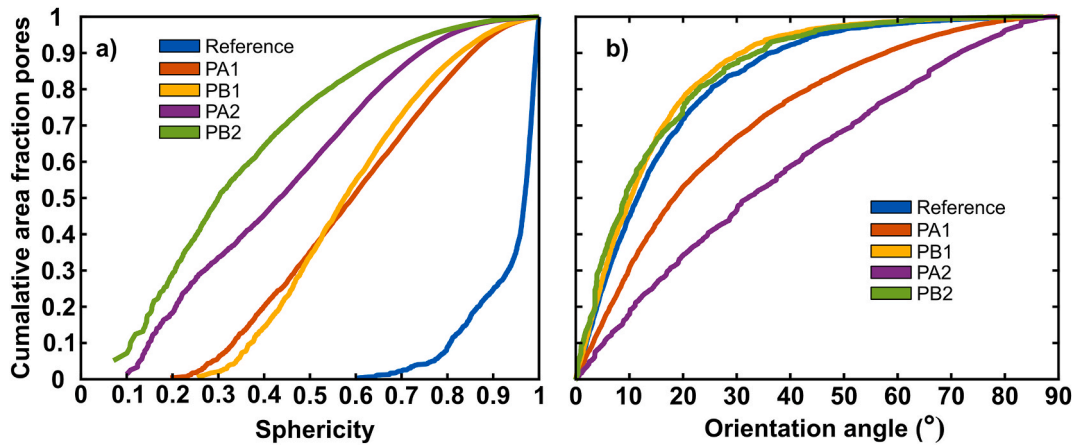
Fig. 5. Statistical analysis of pore characteristics for different as-built conditions: a) cumulative area fraction of pores as a function of sphericity, and b) cumulative area fraction as a function of orientation angle relative to the build direction (0° = perpendicular, 90° = parallel).

The evolution of pore shape and orientation is summarized in Fig. 5a and b. As build rate increases, a reduction in sphericity is observed, specifically in the high build rate conditions, reflecting a shift from rounded gas pores to more irregular, LoF type porosity. It is seen that the

reference condition (Fig. 5a) maintains the highest sphericity values, with no pores below 0.6 sphericity. This is consistent with the presence of small, nearly spherical gas pores captured by XCT (Fig. 3). At an intermediate build rate, PA1 and PB1 display nearly identical cumulative trends in sphericity, suggesting that both increased hatch spacing and scan speed introduce similar levels of shape irregularity. However, at the highest build rates, PB2 shows a pronounced reduction in sphericity compared to PA2, indicating larger irregularity likely linked to unstable melt pool behaviour and the formation of inter-layer LoF pores [25,26].

Regarding pore orientation (Fig. 5b), the interpretation of the reference condition is limited, as the pores are small and nearly spherical, making their orientation difficult to define. Among the process modified conditions, PB1 and PB2 exhibit similar overall orientation profiles, with most pores oriented at small angles, indicating a directional preference perpendicular to the build direction. This suggests that increased scan speed in PB conditions promotes inter-layer LoF pores that preferentially form within the plane between layers. For increased hatch distances the PA conditions show incremental shifts toward higher

orientation angles with increasing build rate, as indicated by the reduced slope at lower angles. This trend suggests a tendency for pores to align more parallel to the build direction, although this is difficult to capture due to the interconnected nature of pores observed in XCT reconstructions (Fig. 3).
