## Fragment impacts into concrete

J. Leppänen

Department of Structural Engineering and Mechanics, Concrete Structures, Chalmers University of Technology, Sweden

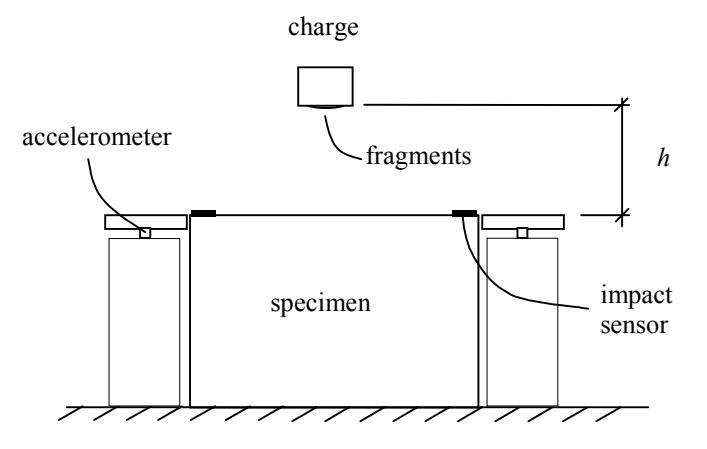
Figure 1: Test set-up for fragment impacts into concrete.

Concrete blocks with dimensions of 750 x 750 x 500 mm<sup>3</sup> were shot with fragments, which were spherical and 4 mm in radius, at a speed of approximately 1,650 m/s. The test set-up is shown in Figure 1. Totally, six blocks were shot, where the charge was placed with varying height over the concrete blocks. Results from three of these are discussed in this paper. Furthermore, single fragments were shot against concrete blocks. However, results discussed in this paper are limited to the multi-fragment impacts. For more details from the experiments, see Leppänen [4].

The charge was made by gluing bearing balls into a convex end of a cylinder. Two different explosives were used: octol and hexotol, with a weight of 1.3 kg. Totally, 7 charges were fired, 5 with octol and 2 with hexotol, and the height varied between 0.6 m and 1.0 m. The fragment velocity was measured with accelerometer and impact sensor. The impact velocity was approximately 1,650 m/s.

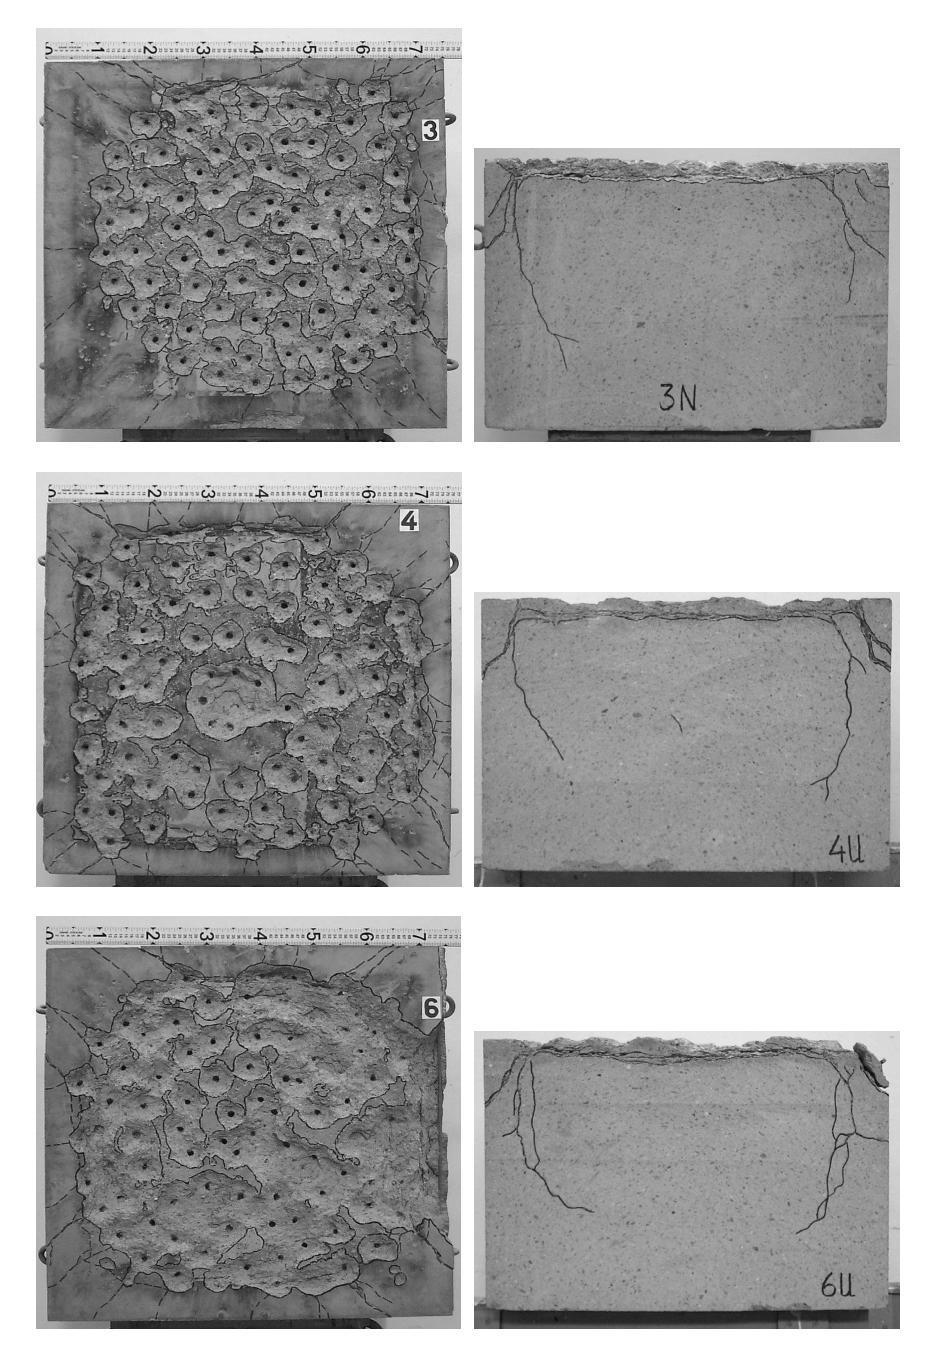
Figure 2: The concrete blocks (3, 4 and 6) after fragment impacts. To left: above, to right: cross section (after cutting the blocks in two halves).

The concrete blocks (numbered 3, 4 and 6), after the shot with fragments are shown in Figure 2. The height of the charge was 0.6 m for blocks 3 and 6, and 0.7 m for block 4. The depth of penetration varied between 30 and 50 mm, and the crater diameter varied between 45 and 60 mm. The concrete blocks were cut in two halves and the crack pattern was observed; it is also shown in Figure 2. All blocks had similar overall crack patterns, with clear spalling; the depth of the damage zone is approximately 50 mm. At the boundaries of the block, a global crack pattern was developed; this is due to reflections of the stress wave.

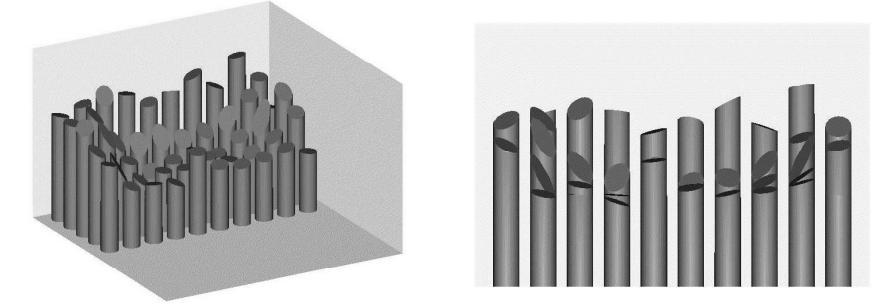
Figure 3: The global cracking (block 3). Drawn from the drilled cylinders.

To study the change in material properties, uniaxial compressive and splitting tensile tests were carried out on drilled cylinders, with a diameter of 50 mm, from the concrete blocks. However, when drilling, most of the cylinders broke in two pieces. The broken cylinders were measured and drawn (for block 3), as seen in Figure 3. The broken cylinders correspond to the global crack pattern (compare Figure 2).

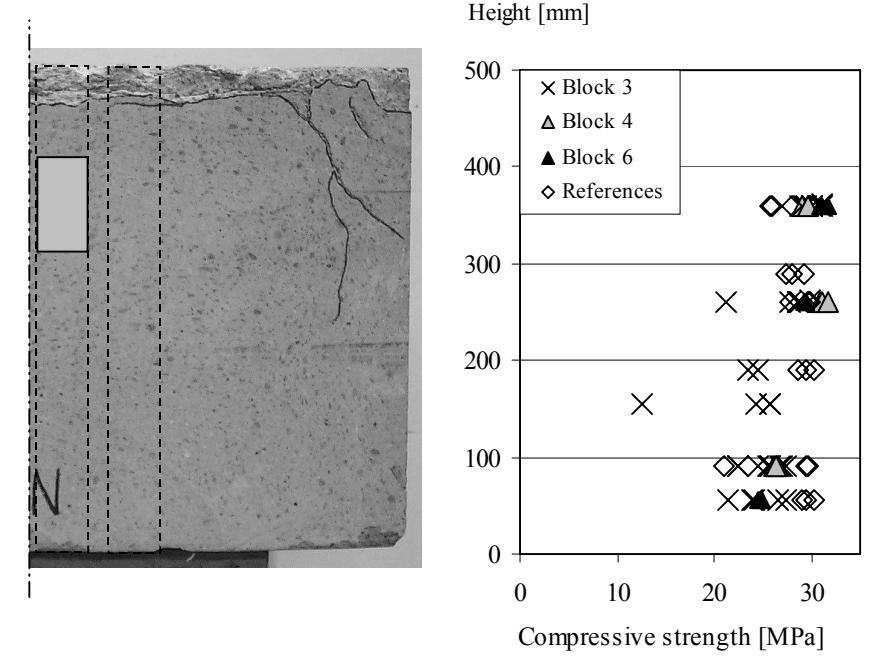
Figure 4: Uniaxial compressive tests from vertical drilled cylinders. The cylinders are taken out from marked areas. Results at different heights correspond to the cylinders' centres of gravity.

For the uniaxial compressive test drilled in the horizontal direction, the strength was hardly affected by the fragment impacts. For the vertical drilled cylinders, at a distance of 140 mm below the surface of the fragment impact, as shown in Figure 4, the uniaxial compressive tests showed somewhat higher concrete strength compared to tests with references (specimen from a concrete block that was not exposed to any loading). This slight increase in strength is probably due to compaction of the concrete. However, the specimen that was taken out near the global crack pattern (as shown in Figure 2), in the middle and in the bottom of the block, had lower strength.

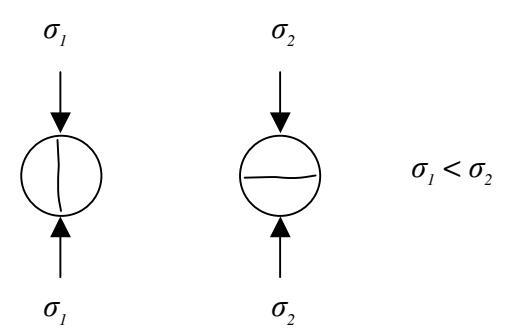
Figure 5: Effect of the orientation of the crack for splitting tensile tests.

For the splitting tensile tests, the orientation when testing is important, as shown in Figure 5. If a specimen is loaded, where the cracks are parallel to the loading, the strength is decreased, and if the crack is orientated perpendicular to the loading, the strength will barely be affected.

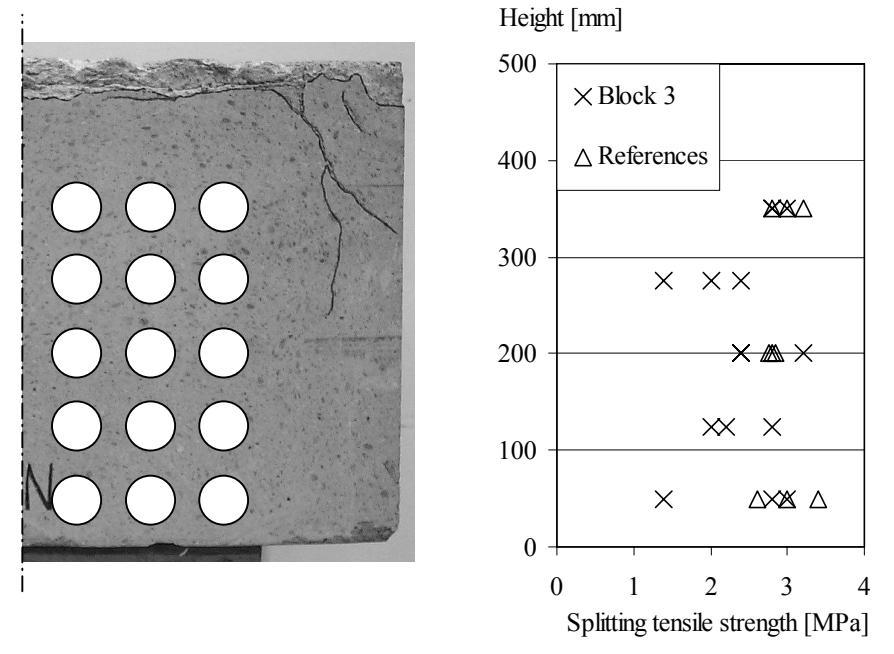
Figure 6: Uniaxial splitting tensile tests (block 3), from horizontal drilled cylinders, orientation unknown. The cylinders are drilled from marked areas.

However, for the first block (block 3), when drilling the cylinders, the orientations of the cracks were unknown. The results from the splitting tensile tests are shown in Figure 6. The strength was not affected at a distance of 150 mm from the impact. For the tests where the cylinders were drilled out near the global crack and in the bottom, the strength was highly reduced in relation to the references (for most of the tests).

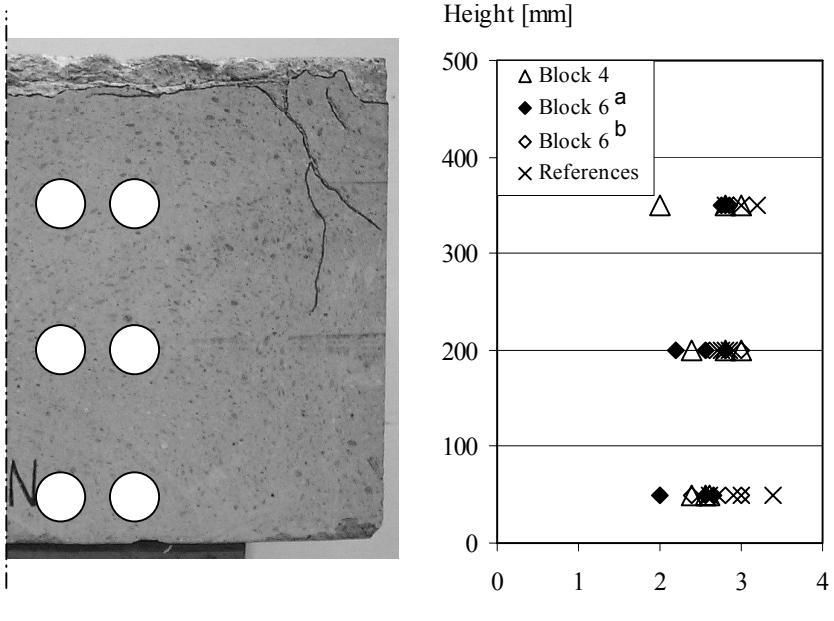
Figure 7: Uniaxial splitting tensile tests (blocks 4 and 6), from horizontal drilled cylinders. The cracks are orientated parallel to the loading direction for blocks 4 and 6<sup>a</sup>. For block 6<sup>b</sup> the cracks are orientated perpendicular to the loading direction. The cylinders are drilled from marked areas.

For the next two blocks (4 and 6), the specimens were marked before they were drilled, so that the orientation of the crack would be known. The test where the crack was orientated perpendicular to the direction of the loading yielded a higher average strength than did tests where the cracks were orientated parallel to the direction of loading. The results from the splitting tensile tests from the horizontal drilled cylinders are shown in Figure 7. The overall behaviour was similar as for block 3. For the tests below at a distance of 150 mm, as for block 3, the strength was not affected by the fragment impacts (except for one test).

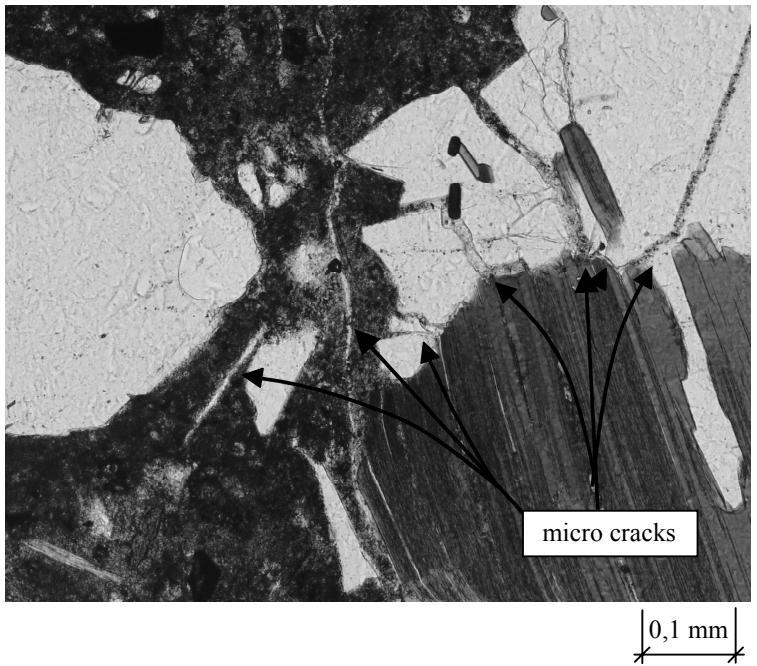
Figure 8: Photograph from the thin-ground specimen.

To study the concrete below the impact zone further, a thin-ground specimen was taken out at a distance between 80 and 170 mm below the surface. From the specimen, micro-cracks could be observed with a microscope. With a camera sited in the microscope, photographs were taken, and an example is shown in Figure 8. In the figure, micro-cracks can be seen, and similar micro-cracks could be found in the thin-ground specimen up to a level of approximately 120 mm below the surface of the fragment impacts. The width of the micro-cracks was up to approximately 0.02 mm.
