Fernandez, I., Gil Berrocal, C., Rempling, R. (2021). Long-term performance of distributed optical fiber sensors embedded in reinforced concrete beams under sustained deflection and cyclic loading. Sensors, 21(19). http://dx.doi.org/10.3390/s21196338

# Long-Term Performance of Distributed Optical Fiber Sensors Embedded in Reinforced Concrete Beams under Sustained Deflection and Cyclic Loading

Ignasi Fernandez <sup>1,\*</sup>, Carlos G. Berrocal <sup>1,2</sup> and Rasmus Rempling <sup>1,3</sup>

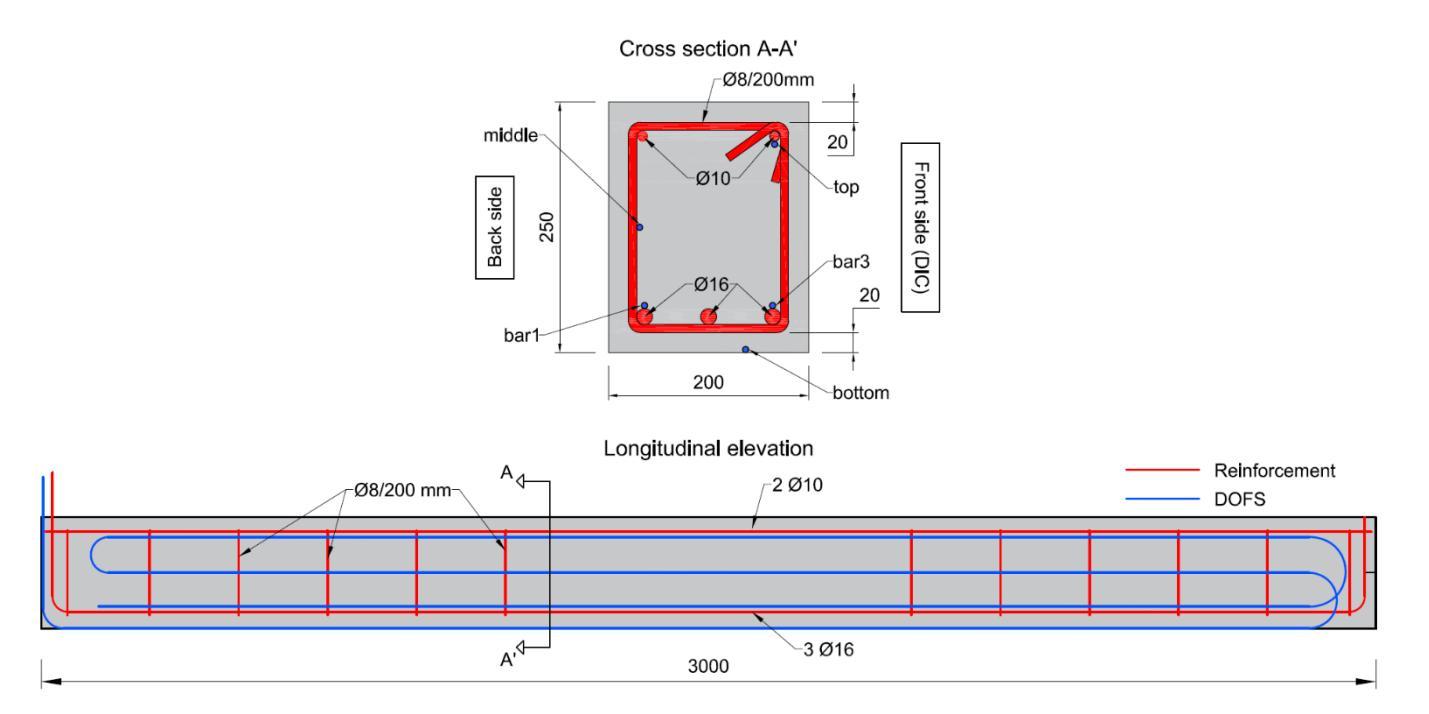
Figure 1. Geometry of the beam specimens, reinforcement layout and DOFS configuration (all measurements in mm).

The specimens used in this work were RC beams with a total length of 3 m and a rectangular cross-section of  $200 \times 250$  mm. Each beam was reinforced with three  $\emptyset16$  mm rebar at the bottom and two  $\emptyset10$  mm at the top. Moreover, six  $\emptyset8$  mm closed-loop stirrups equally spaced at 200 mm were placed on either side of the beams. All reinforcement was made of normal ductility carbon-steel (B500B) with a nominal yield strength of 500 MPa. Plastic spacers were placed between the stirrups and the bottom and lateral sides of the form to ensure a clear concrete cover of 20 mm. The ends of the bottom bars were bent upwards to improve the anchorage. The geometry and reinforcement layout of the beams is presented in Figure 1. Note that at one of the beam ends, the bars protruded from the concrete surface, which was required for a later stage of the experiments in which accelerated corrosion was planned.

For each beam, a single DOFS was installed in a multilayer configuration to monitor the variation of strain along the beam in the region between the supports at five different locations of the beam's cross-section: above the two outer tensile rebars (bar 1 and bar 3); under one of the compressive rebars (top); at mid-height (middle); and at the bottom surface of the beam (bottom). The DOFS were either supported along the longitudinal reinforcement (bar1, bar3 and top), fixed to the stirrups (middle) or resting on the formwork (bottom), using electric tape to fix the sensors in place.

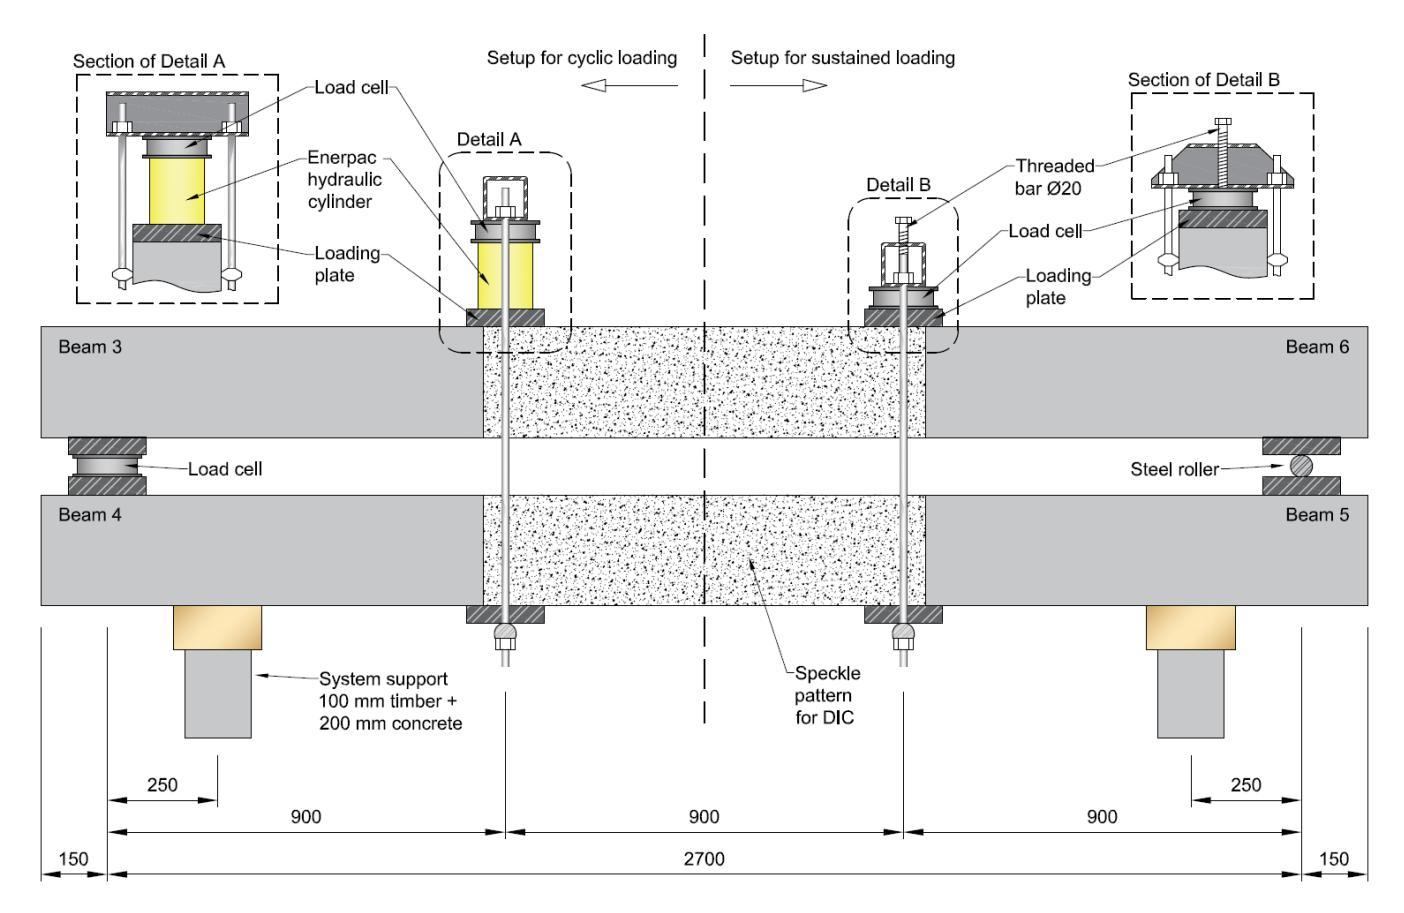
Figure 2. Loading setup for the long-term loading experiments (all measurements in mm).

For the long-term loading, the beams were divided into two groups and the beams in each group were clamped together according to the setup illustrated in Figure 2. In that setup, the bottom beam was turned upside down so that the tension reinforcement was facing upwards. Then, the top beam was positioned onto two sets of support plates resting on the bottom beam, the centers of which were 2700 mm apart. Thereafter, the load was introduced at two loading points, where the clamping devices were mounted, which divided the total span into three equal spans of 900 mm.

For the group of beams subjected to cyclic loading, a hydraulic cylinder was placed between the clamping device and the loading plate of the top beam, cf. Detail A in Figure 2; the imposed deformation on the group of beams subjected to sustained deflection was achieved by tightening a threaded bolt screwed into the clamping device, cf. Detail B in Figure 2. Two load cells were provisioned at the loading points over the top beam and one more between the support plates at one of the ends in order to ensure a symmetric load distribution. The load of the Enerpac hydraulic cylinder was automatically controlled using a close-loop feedback control system retrofitted with the measurement of the load-cells.

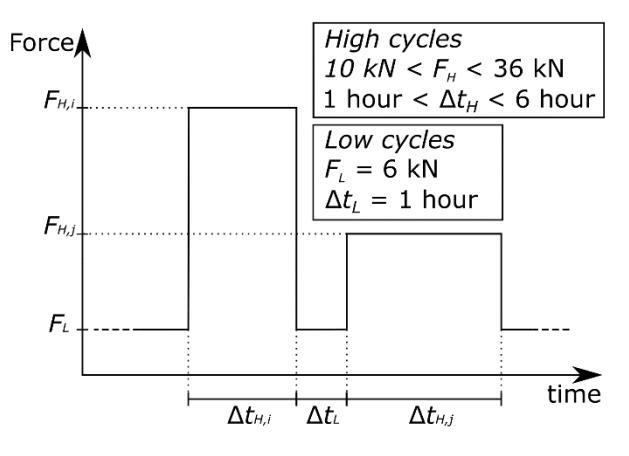
Figure 3. Definition of the loading procedure for the cyclically loaded beams.

The definition of the loading procedure for the cyclically loaded beams in the time domain was performed according to a squared wave signal where both the amplitude and the duration of the pulses were randomly varied within a given interval, as illustrated in Figure 3. A closed-loop feedback system was used to control the load applied by the hydraulic cylinders. The maximum load applied for each cycle varied between 10 and 36 kN (per cylinder) whereas the pulse duration varied between 1 and 6 h. Conversely, both the load and the interval between pulses were kept constant at 6 kN and 1 h, respectively. The beams subjected to sustained deflection were initially loaded to approximately 30 kN (per loading point) and then reloaded after 44 days to compensate the part of the load lost due to creep effects.

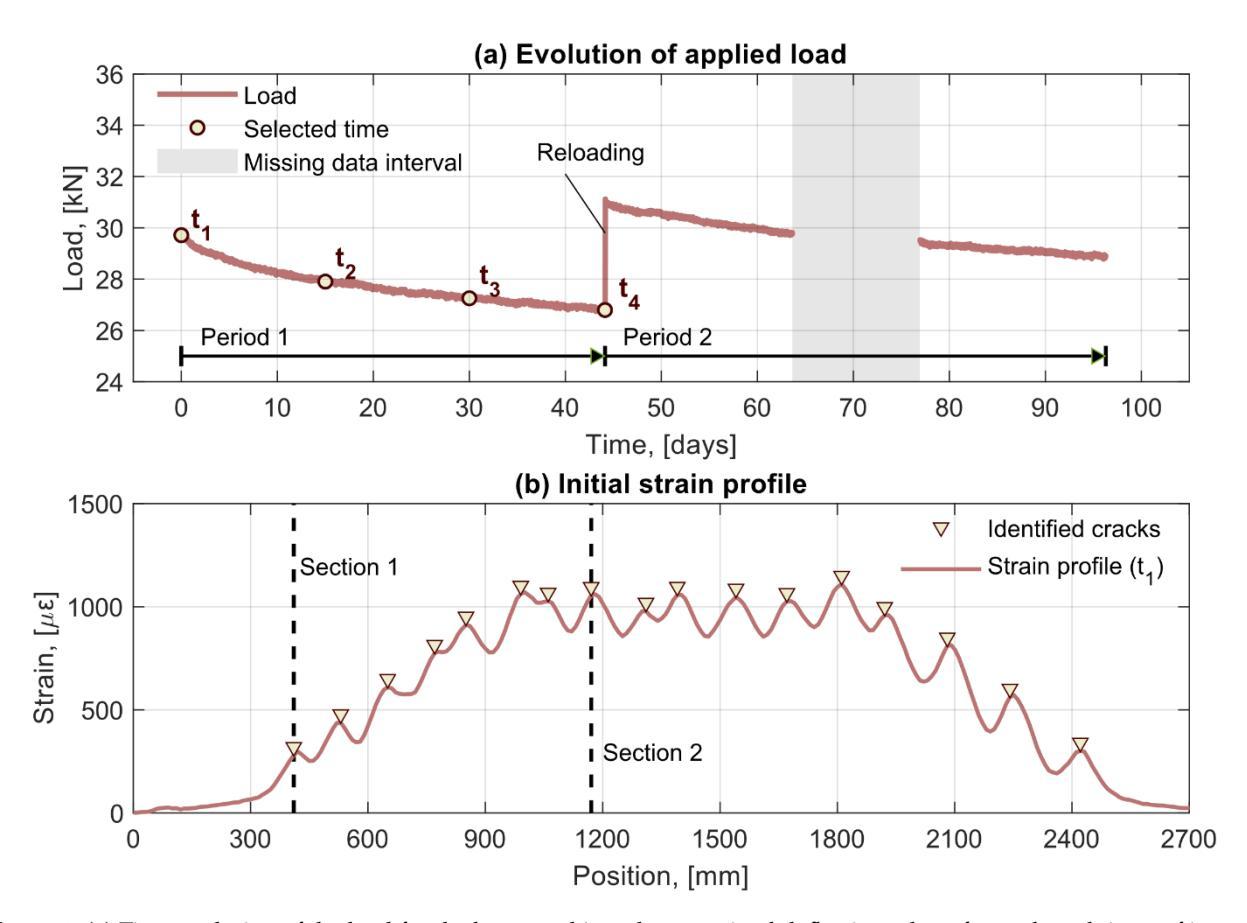
**Figure 4.** (a) Time evolution of the load for the beams subjected to sustained deflection where four selected times of interest  $(t_1, t_3, t_3, t_4)$  are indicated by markers. (b) Strain profile at one of the tensile reinforcement bars of beam 5 at the beginning of the test. Triangular markers indicate the positions of identified cracks and dashed lines highlight the position of two sections of interest, a crack in the shear span (Section 1) and a crack in the constant moment region (Section 2).

The variation of the load in the beams subjected to a sustained deflection as measured by a load cell located over one of the loading plates is presented in Figure 4a. A gradual load decay due to relaxation effects caused by the creep of the concrete can be observed up to the point where the load was manually increased to restore the initial load level. Thereafter, the load continued decreasing following a trend similar to before the reloading. Accordingly, the total monitoring time is divided into two periods, where the beginning of the second period is marked by the reloading of the beams. Four different times in period one, depicted in Figure 4a as circular markers, were selected to investigate variations over time of the spatial distribution of the beam parameters. Note that in period two, a certain region is shaded in grey indicating a period of missing data due to unavailability of the optical fiber interrogator.

Figure 4b shows the initial distribution of strains at the tensile reinforcement in beam 5, where the position of identified cracks, clearly discernible in the strain profile as strain peaks, have been indicated by triangular markers. Two sections of interest were selected to investigate the variation over time of the DOFS measurements, as well as derived magnitudes, for specific locations. The sections corresponded to the position of two different cracks, one located in the shear span (Section 1) and one in the constant moment region (Section 2), as shown in Figure 4b.

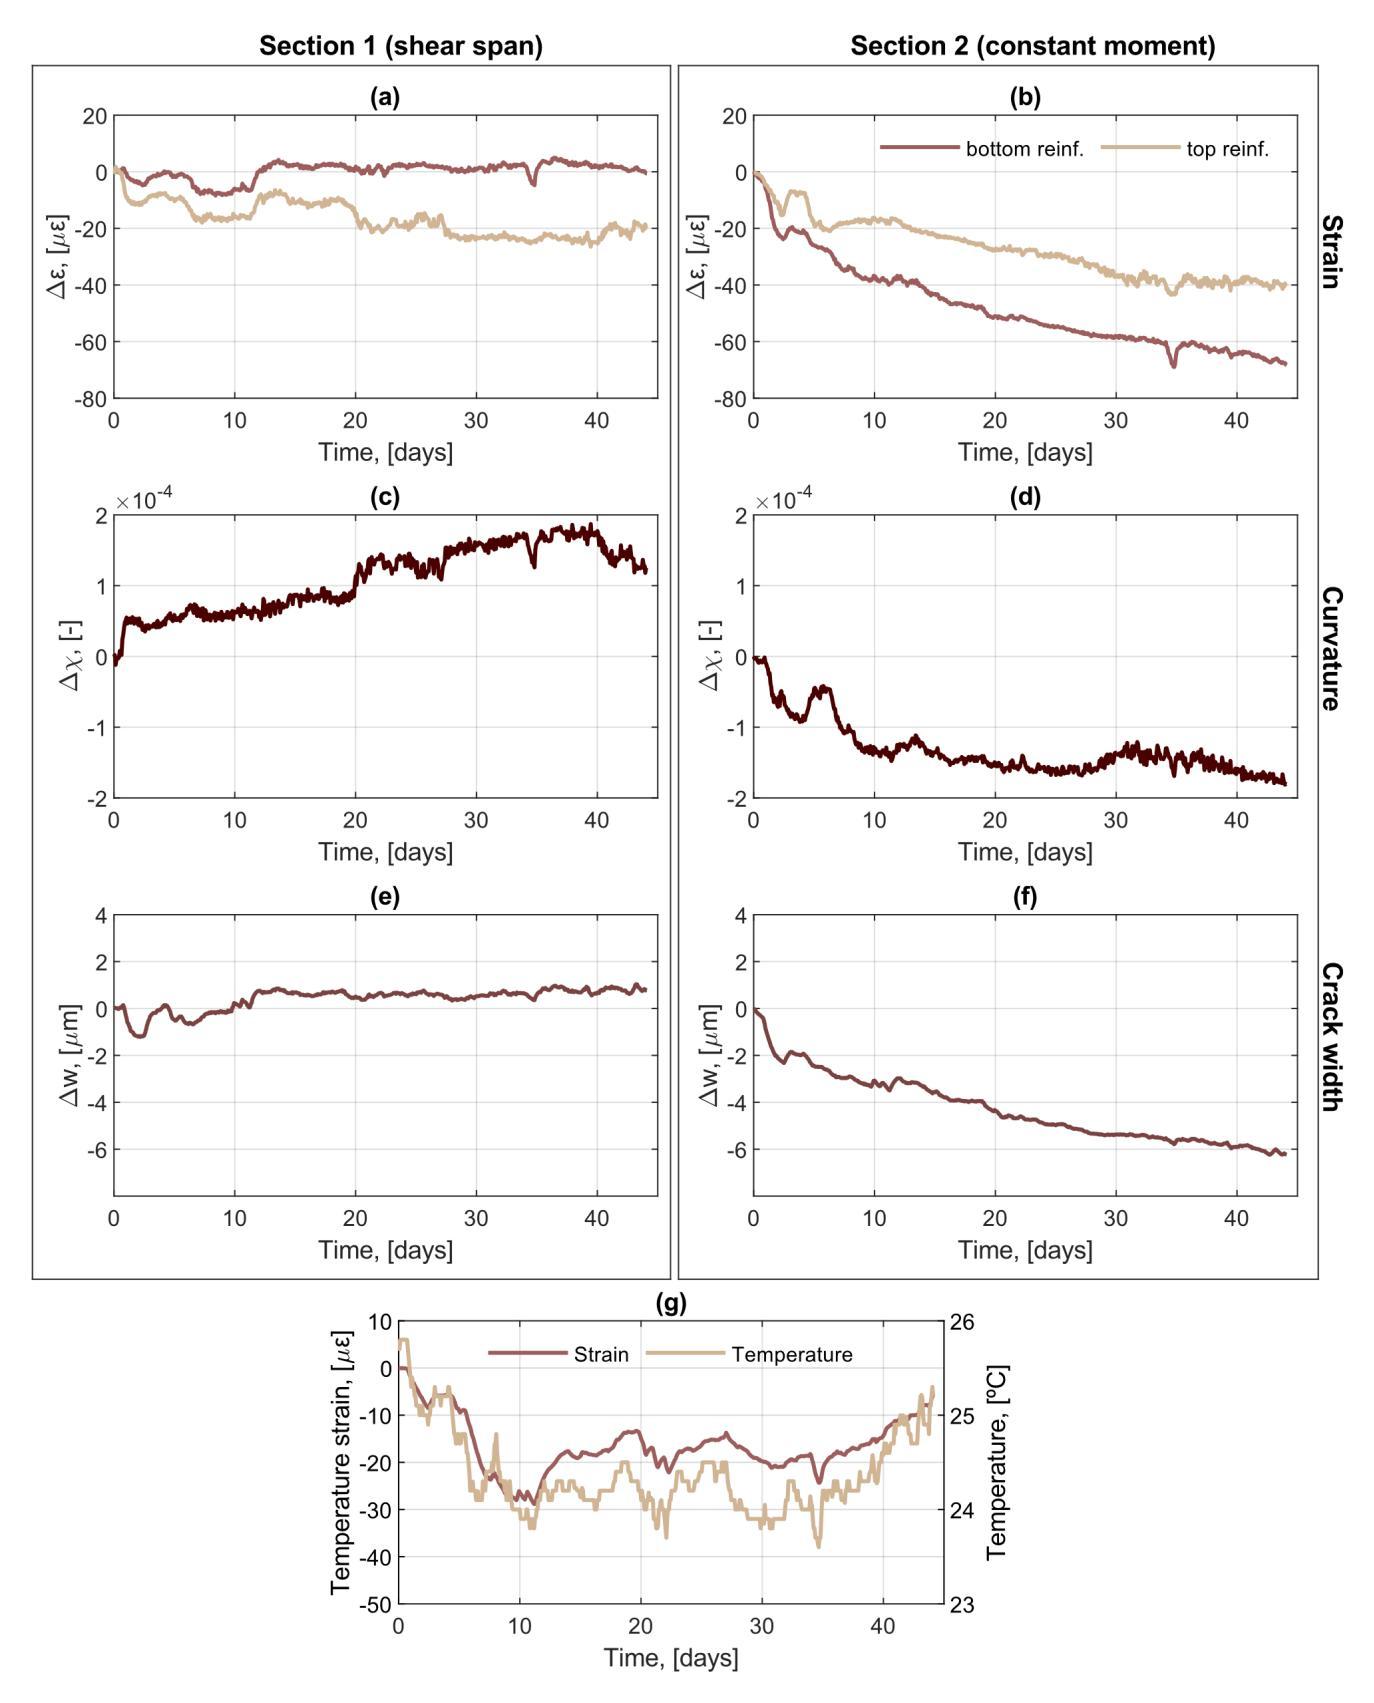
**Figure 5.** Incremental variation of measured and calculated magnitudes in the beam over time for Sections 1 and 2: (**a**,**b**) strain; (**c**,**d**) curvature; (**e**,**f**) crack width. (**g**) Variation of ambient temperature and the corresponding temperature-induced strain.

The increments of strain at the top and bottom reinforcement, the increments of curvature and the increments of crack width during period 1 is presented for Sections 1 and 2 in Figure 5a,c,e and Figure 5b,d,f), respectively. Furthermore, Figure 5g shows the measured ambient temperature and the variation of strain in the concrete attributable to temperature changes. The temperature strain, which is used for temperature compensation, was obtained by analyzing the strain in a section of the fiber optic cable embedded beyond the beam support, hence in a section without mechanically induced strains.

Looking at the results of Section 2, Figure 5b reveals that the strains at the bottom reinforcement suffer a negative increment, i.e., they decrease in magnitude, which can be explained by the progressive loss of load observed, although to a lesser extent, the strains at the top reinforcement also become more negative, i.e., they increase in magnitude, which can be attributed to the concrete creep in the compressive zone of the beam. Note that the increase in magnitude of the compressive strains is not incompatible with the decrease in load since creep-induced strains are not mechanical strains. However, they do contribute to the curvature and deflection of the beam. Accordingly, using the strain at the bottom

Interestingly, the curvature at Section 1, located in the shear span of the beam, follows an opposite trend to that of the curvature at Section 2. In Section 1, the strain at the top reinforcement decreases similar to what was observed for Section 2, which can also be attributed to the effect of concrete creep. Conversely, the strain at the bottom reinforcement does not display any significant change. This seems to indicate that a redistribution of curvature in the beam occurs under conditions of sustained deflection, where the curvature decreases in the most loaded region, where the curvature is initially larger, and it increases in regions where the curvature is lower from the start.

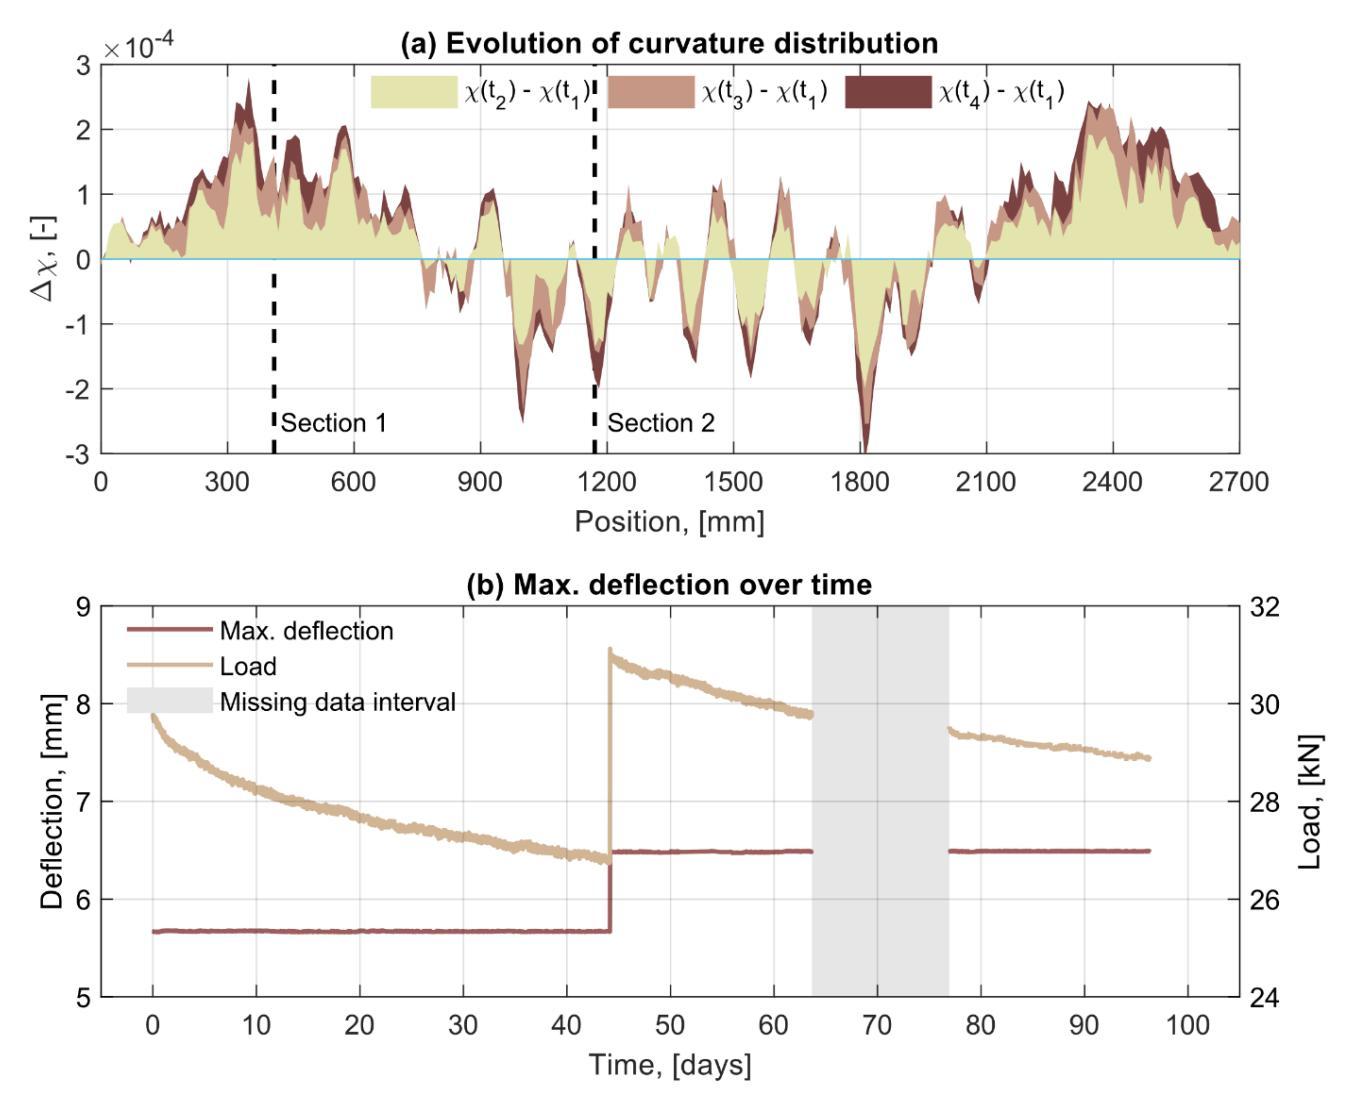
**Figure 6.** (a) Distribution of curvature increment along the beam for the instants  $t_2$ ,  $t_3$  and  $t_4$  with respect to the initial instant  $t_1$ ; (b) evolution of the maximum deflection in beam 5 calculated from the DOFS strain measurements together with the corresponding evolution of applied load.

In order to confirm whether the hypothesis that a redistribution of curvatures exist in the beam under sustained deflection, the distribution of curvature increments along the beam calculated at t<sub>2</sub>, t<sub>3</sub> and t<sub>4</sub> with respect to the initial instant t<sub>1</sub> is presented in Figure 6a. As observed, a decrease in curvature occurs for all the cracked sections located in the constant moment region, and even for those that are outside the region but close to it, whereas for the sections between cracks the curvature generally increased. In the region of the shear spans closer to the support, on the other hand, a consistent but non-uniform increase in the curvature is observed within a distance of between 600 and 700 mm from the support. From Figure 6a it can be also appreciated that the rate of change is faster in the beginning, which indicates that the redistribution of curvature is driven by creep and is likely caused by the differential rate of creep deformation occurring between the most loaded sections (cracked section in the constant moment regions) and the rest of sections.

Last, in Figure 6b, the maximum deflection calculated through the double integration of the curvature distributions defined in Equation (1) is presented. As observed, the maximum deflection remains constant within each of the two periods, and it only increased at the instant when the beams were reloaded to restore the initial load level. These results demonstrate that the DOFS were able to measure correctly during the entire monitoring period and that the variation of strains and the consequent redistribution of curvatures observed in Figure 6a were measured accurately despite their magnitude being very small.

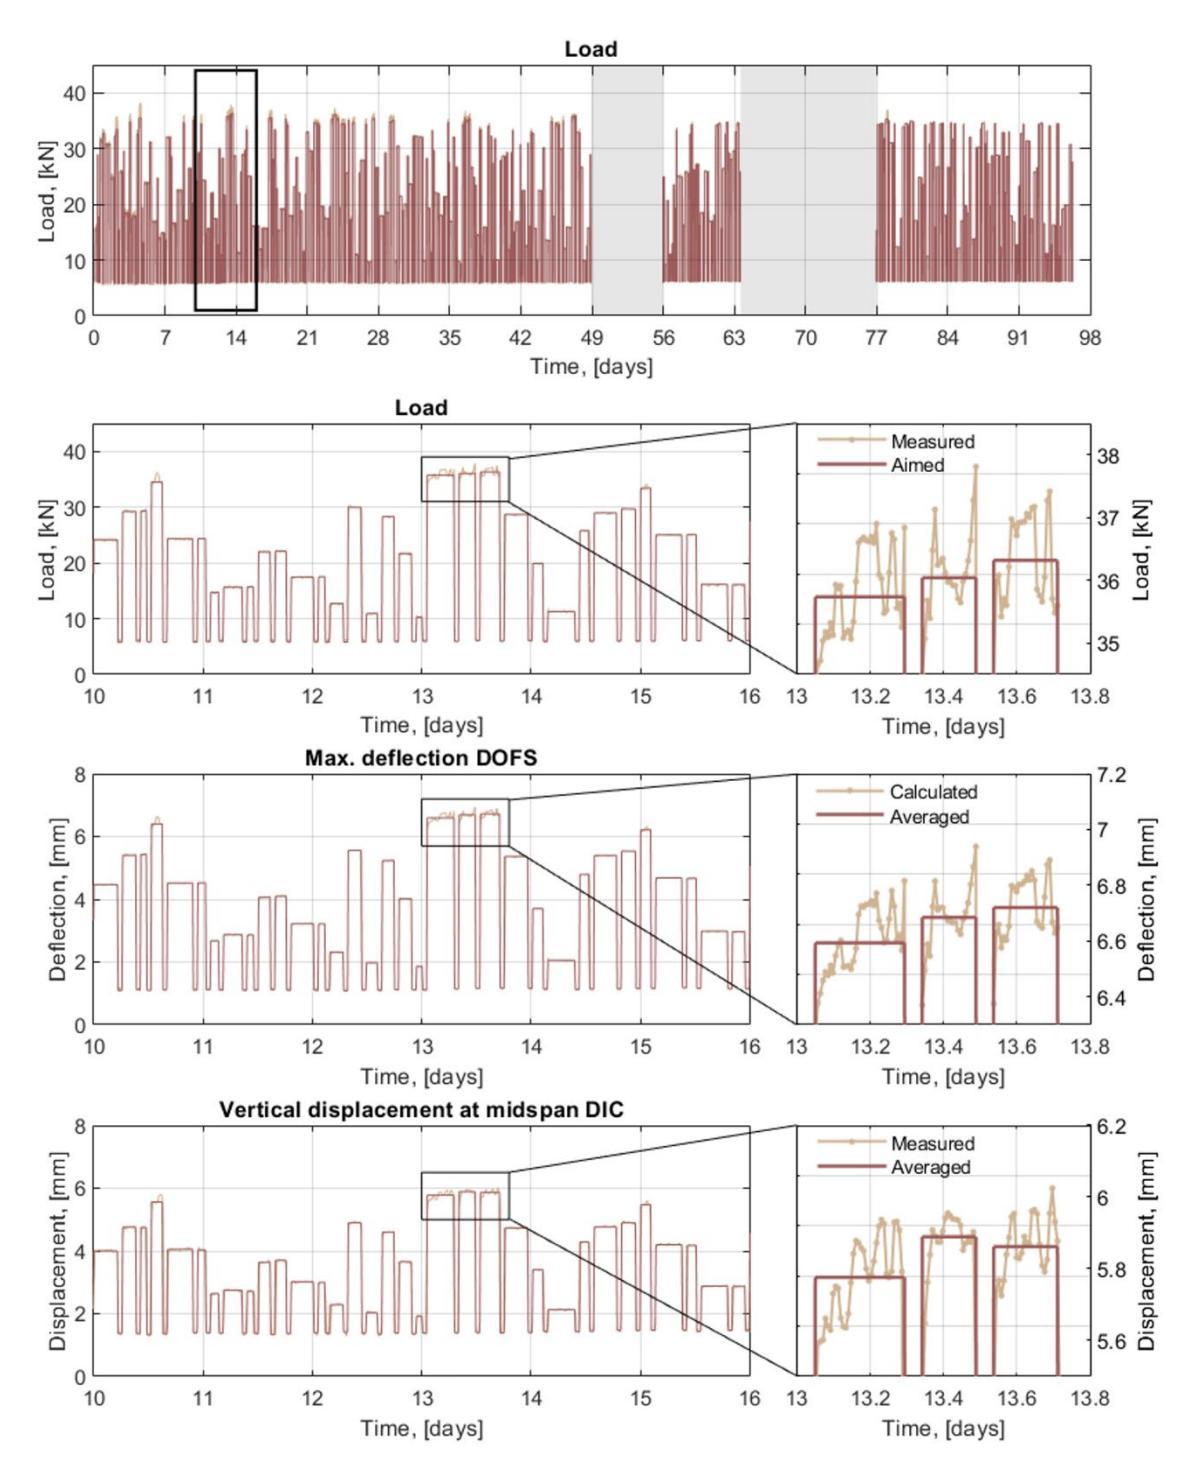
**Figure 7.** Load history of the beams subjected to cyclic loading. A zoomed-in region is presented to show the variability of the load cycles both in load magnitude and pulse duration and how the corresponding measurements of the DOFS and DIC correlate with the applied load. A further zoomed-in region is presented for the load, DOFS deflection and DIC displacement to illustrate the noise of the load-control system and the averaged values used for the analysis of results.

The load history of the beams subjected to cyclic loading is presented in Figure 7 where the more than 400 load cycles applied during the monitoring period are displayed. The additional period of missing data between the days 49 and 56 of the test was caused by a malfunctioning of the hydraulic system used to apply the loads.

A zoom-in of the load history between days 10 and 16 of the test is also presented in Figure 7 to better appreciate the variability of the load cycles, together with the maximum deflection calculated from the DOFS measurements and the midspan displacement measured from the DIC system for the same period. As observed, a good agreement exists between the overall shape of the deflection/displacement measured by both monitoring systems and the shape of the applied load. However, a closer look at the acquired data revealed that the values measured by the load cells differed significantly from the aimed load values due to the inability of the system to accurately stabilize the oil pressure, hence the load, resulting in discrepancies of up to  $\pm 5\%$ . More importantly, due to the slight time shift in the acquisition of data between the different systems (load cells, DOFS and DIC), the comparison of results for a specific load cycle is no longer straightforward. Therefore, in order to minimize the impact of the load signal noise on the comparison of results, an averaging procedure was carried out to obtain mean values of the load as well as deflections and displacements (see Figure 7).

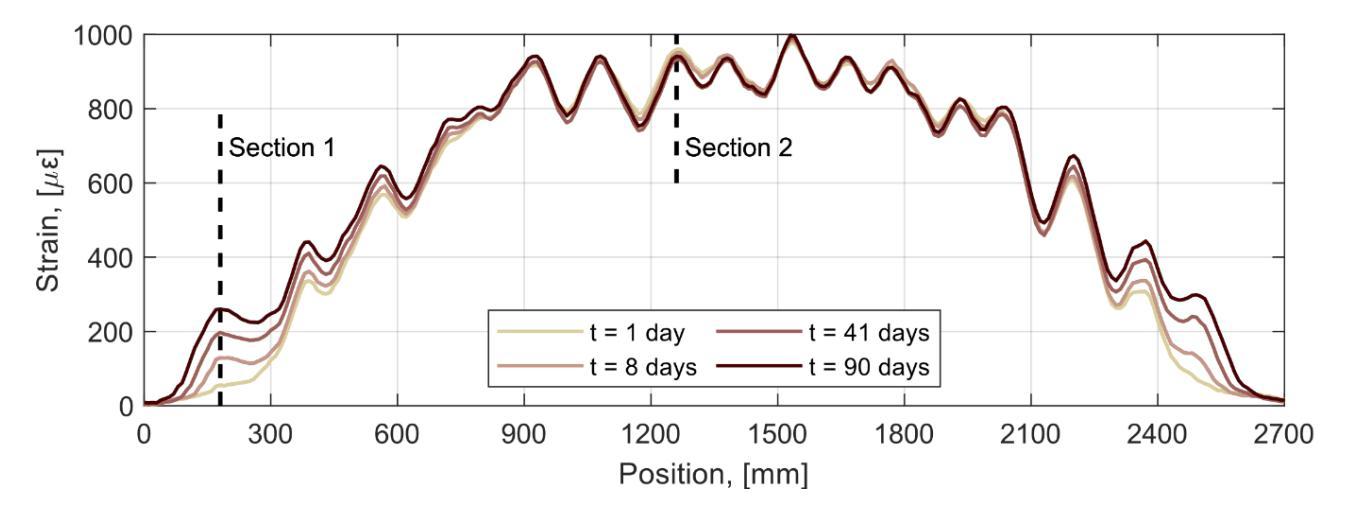
Figure 8. Strain profiles at the tensile reinforcement of beam 4 at different times for a loading cycle of ca. 28.5 kN.

To study how repeated load cycles affect the strain distribution at the tensile reinforcement, the strain profiles measured by the DOFS during the application of a load cycle of similar magnitude (28.5 kN), but occurring at different times during the test, are presented in Figure 8. As observed, the strain remains virtually unaltered in the central 900 mm of the beam with no apparent difference between the strain profile at day 1 and at day 90. This seems to indicate that despite the cyclic loading, no bond degradation occurred between the reinforcement and the concrete at that load level. Conversely, an increasing trend is observed for the strain in the shear span regions, which is more evident near the supports. This effect can be explained by the formation of new cracks and the development of existing incipient cracks in the shear span caused by the higher load levels reached in the cyclic loading compared to the pre-cracking procedure.

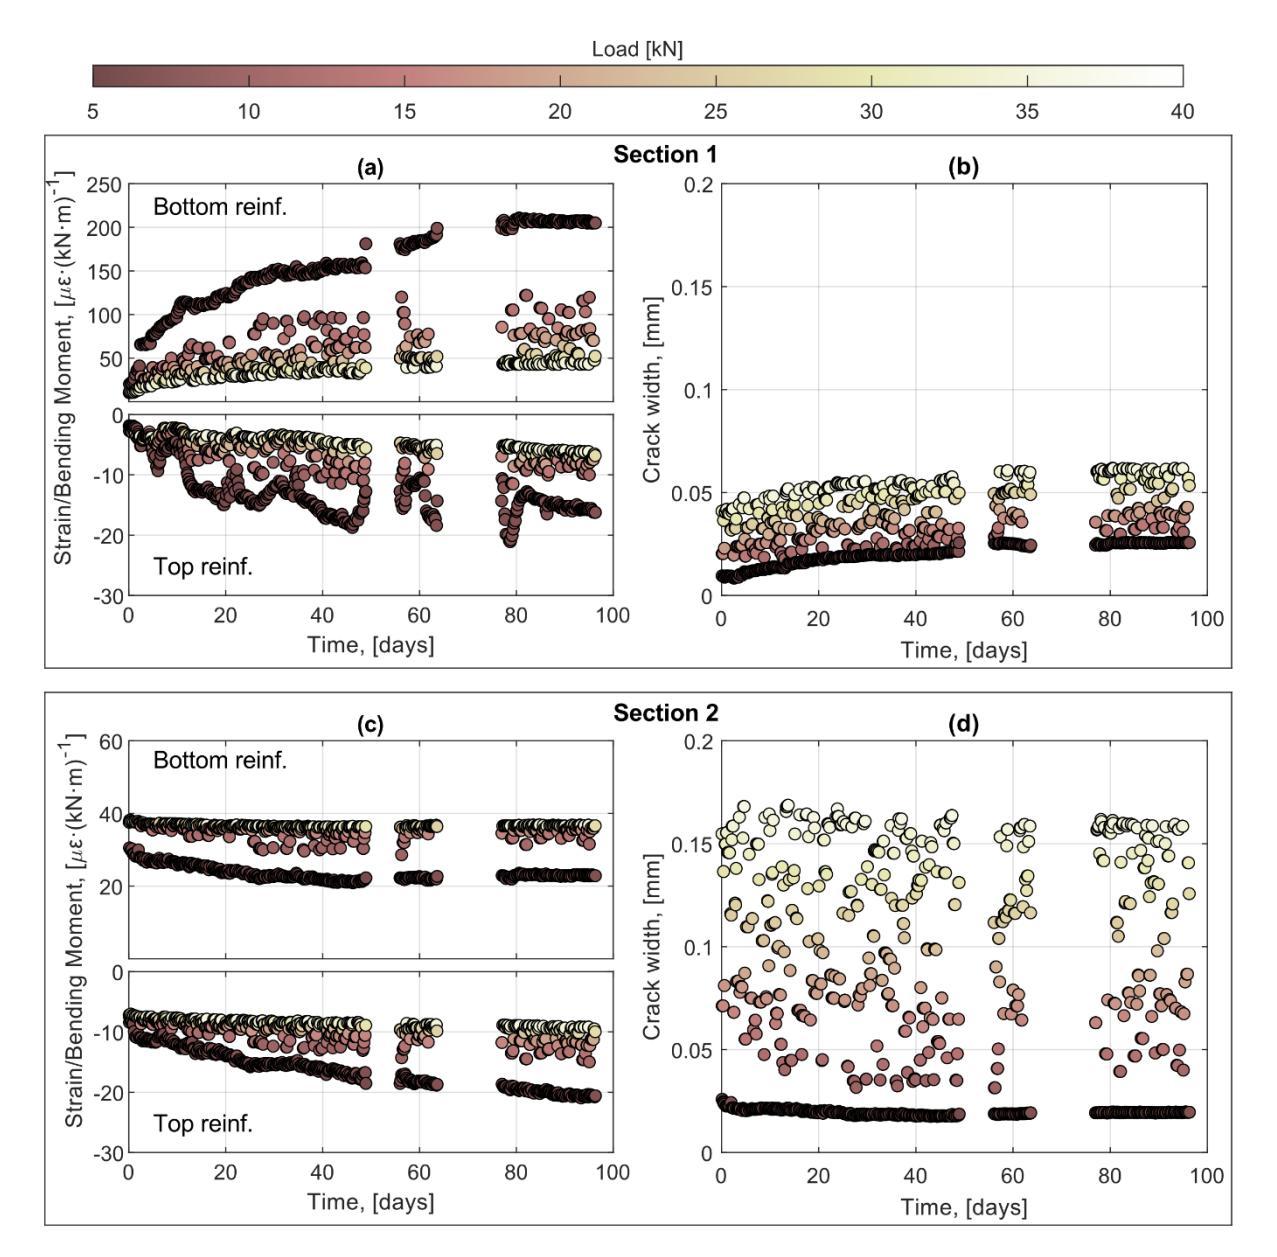
**Figure 9.** Evolution of strains over time represented as the ratio between the DOFS strain measurement and the section bending moment and evolution of crack width for Section 1 (**a**,**b**) and Section 2 (**c**,**d**).

In Figure 9, the evolution of strain at the bottom and top reinforcement of beam 4 is presented for both Sections 1 and 2 (cf. Figure 8) together with the evolution of the crack width for each section. Note, however, that to attain comparable strain results, the impact of the loading cycle and the influence of the section position were removed by normalizing the values of the strain by the corresponding sectional bending moment. An observation common to both sections is the fact that the magnitude of the top reinforcement strain under the low-cycle load increases, proportionally, much faster than the strain at higher loads which in most cases displayed a very limited variation. This can be explained by the development of greater creep strains under the continuously applied low-cycle load compared to the relatively instantaneous loading-unloading of each individual cycle.

The strain measured at the bottom reinforcement, on the other hand, displays a different behavior for the two investigated sections. For instance, in Section 1, the measured strain clearly increases with the number of cycles. This is attributed to the imperfect closure of cracks during the unloading phase of the cycle, which leads to compressive stresses in the cracks and a residual crack opening causing the appearance of steel stresses, hence strains, larger than what would be expected. This effect, which was suggested by Hordijk [41] and later verified experimentally using DOFS by Cantone et al. [34], is supported by the increasing crack width observed in Section 1, see Figure 9b. Conversely, in Section 2, the bottom reinforcement strains decrease with the number of cycles applied, yet the variation of the crack width is almost negligible. This could be explained by a weaker bond between concrete and steel in the unloading phase, which enables the concrete between cracks to recover a greater fraction of its elastic strain. It should be noted that the effect of imperfect crack closure is more pronounced for inclined cracks and stress levels close to zero, which explains why is not observed for the cracks in the region with constant bending moment. Last, it is interesting to note that whereas the residual crack width for Sections 1 and 2 varies over time, the difference between the crack width at minimum and maximum loads seems to remain constant.

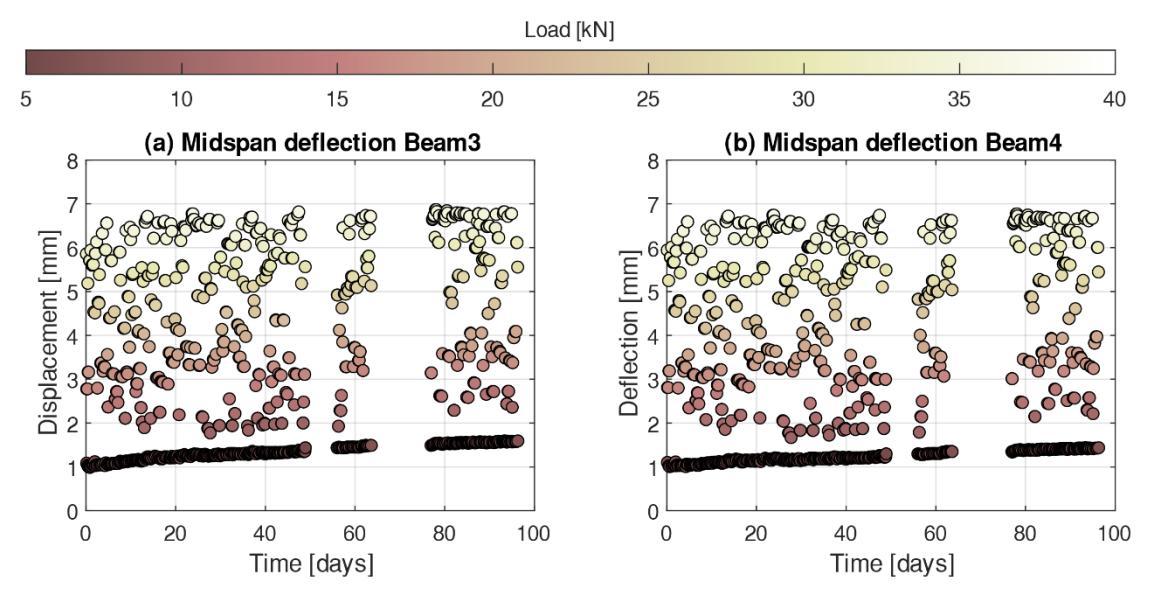
Figure 10. Evolution of the midspan deflection calculated from DOFS strain measurements for (a) beam 3 and (b) beam 4.

for the DIC system. In this study, only the central region of the beam was captured in the pictures taken with the digital camera, which means that any support settlement occurring outside the field of vision of the camera cannot be accounted for in the calculation of the beam deflection. In addition, in the analysis of the DIC results, a progressive drifting in the fixture of the camera was detected, which compromised the accuracy of the DIC results for the calculation of long-term deflections. Therefore, Figure 10 presents the long-term deflection of beam 3 and beam 4 only for the values calculated based on the DOFS strains measurements. As observed, the flexural behavior of both beams is almost identical, describing a slight increasing tendency of the residual midspan deflection over time, which can be attributed to creep effects. The results show only slight differences between the two beams, indicating a minor variation of the stiffness. More importantly, the similarity between the results obtained by two individual DOFS on two separate specimens with the same geometry and subjected to the same load denotes a good repeatability of the presented methodology, hence a robust solution to monitor deflections.

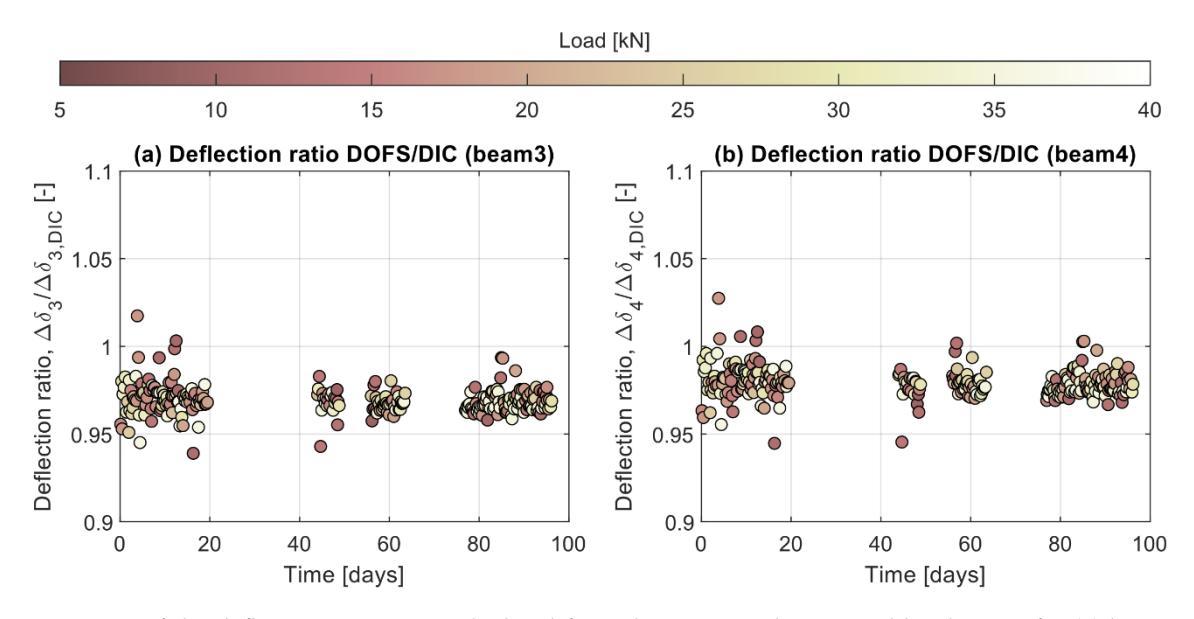
**Figure 11.** Ratio of the deflection increment calculated from the DOFS and measured by the DIC for (**a**) beam 3 and (**b**) beam 4.

positive for beam 3 and negative for beam 4. The comparison of the deflection increments for each individual cycle is presented in Figure 11a,b in the form of deflection ratios between the DOFS and the DIC for beam 3 and beam 4, respectively. As observed, in both cases the mean error is below 5%, which agrees with previous results by the authors [25]. Furthermore, it is worth highlighting that the results show very little scatter and that no apparent influence of the applied load level nor the number of cycles can be observed. These results reveal that the calculation of deflections based on DOFS is reliable over time, even under repeated load cycles, and potentially more robust than non-contact image-based systems since it does not require a fixed external reference for the computation of deflections.

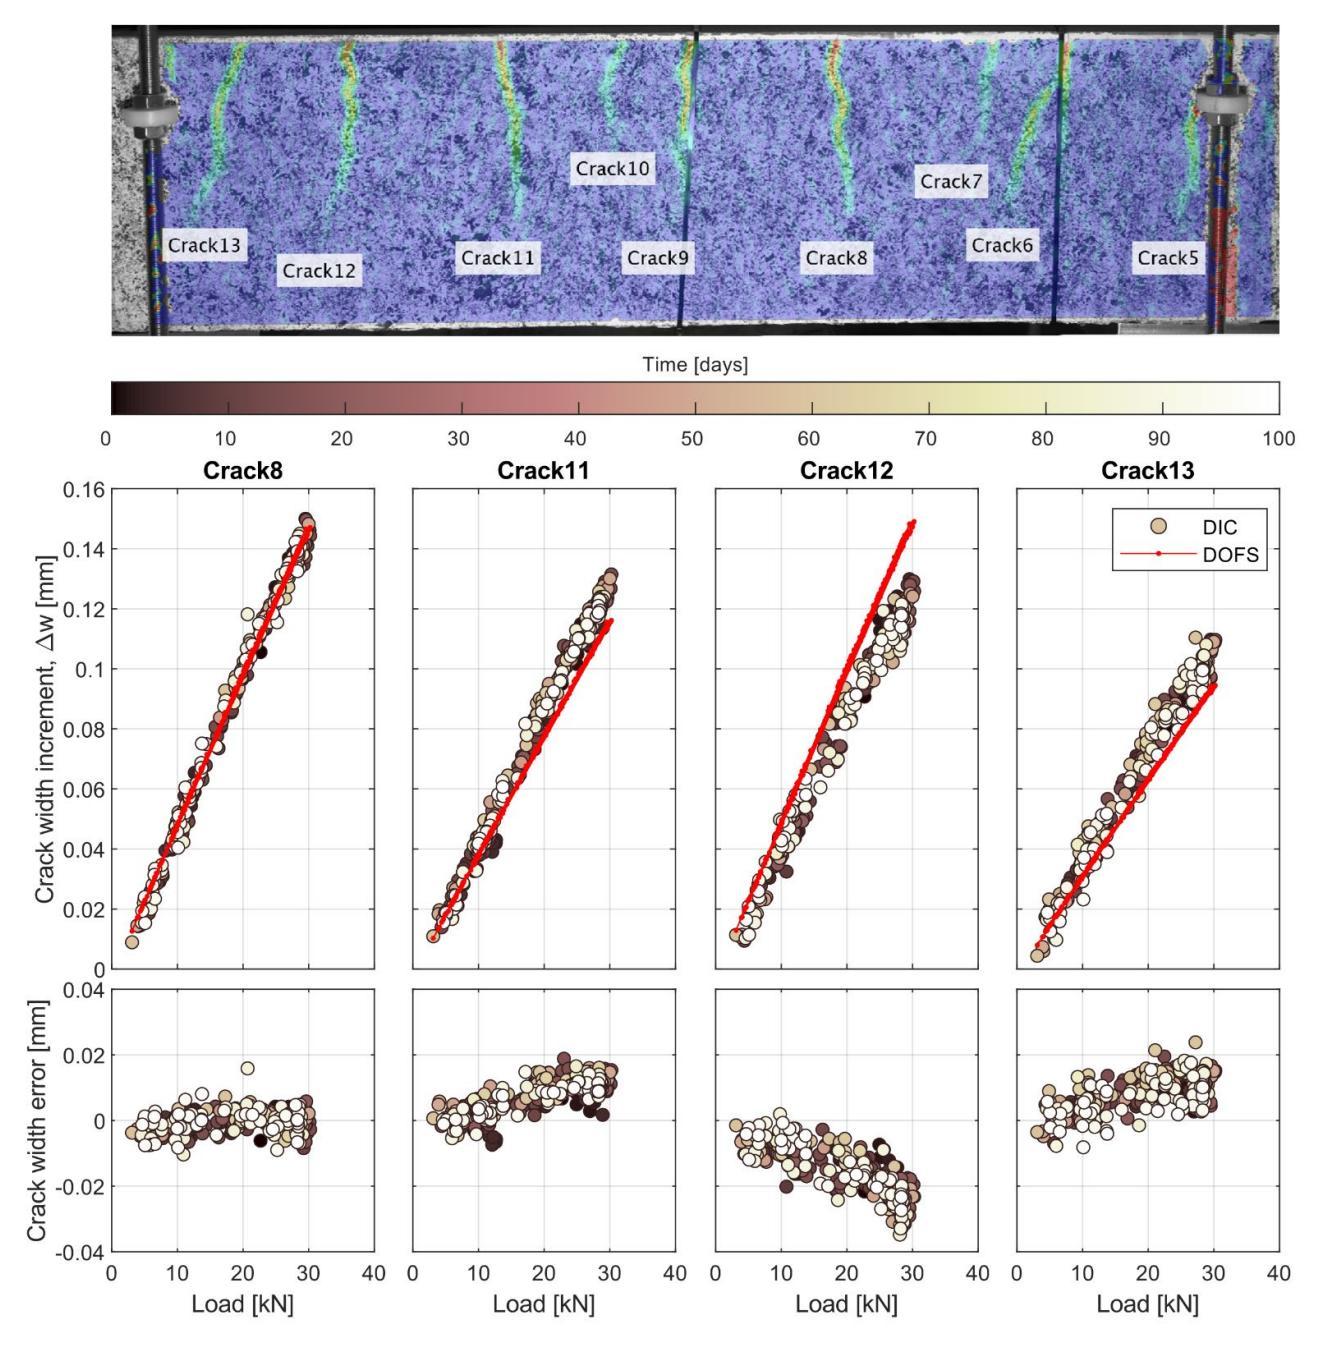
**Figure 12.** Results of the DIC showing the field of principal strains to highlight the position of cracks on the surface of beam 4 along the region of constant bending moment (**top**). Relationship between increment of crack width and applied load for selected cracks (**middle**). Crack width error between the DIC and DOFS measurements (**bottom**).

The results of the comparison are presented in Figure 12 as a function of the cycle load, where each marker corresponds to one cycle and the color of the marker indicates the time, in days, for which the cycle occurred Additionally, the crack width error calculated as the difference between the increment of crack width measured by the DIC and the DOFS is also presented in Figure 12 for each crack. In terms of accuracy, it can be observed that the agreement between the DOFS and the DIC varies from crack to crack but, overall, the maximum error is generally below 0.02 mm, except for one crack where it reaches 0.04 mm at higher loads, which is in accordance with previous results [25]. Moreover, in all

cases the relationship between the increment of crack width and the applied load remains linear for both the DIC and the DOFS. This agrees with the results shown in Figure 9b,d, in which despite a certain variation of the total crack width over time, the variation of crack width between the peak and low cycle loads remained nearly constant. The fact that increment of crack width stayed proportional to the applied load over time suggests that the cyclic loading did not cause any significant bond degradation, which otherwise would be translated into an increased crack width over time. Furthermore, it is worth noting that despite the linearity observed in the results from both systems, the DOFS results exhibit a much lower scatter than the DIC. These results further highlight the potential of DOFS for monitoring of RC structures.
