# Article Increasing Water Absorptivity of an Aerogel-Based Coating Mortar in Subsequent Wetting and Drying

**Abstract:** Aerogel-based coating mortars are energy-efficient composites with thermal conductivities of  $30-50 \text{ mW/(m}\cdot\text{K})$ . They are useful when retrofitting uninsulated building envelopes, particularly in listed masonry buildings, as shown in studies. Meanwhile, the long-term reliability of their hygrothermal properties, typically declared after a single laboratory measurement, is not confirmed. To illustrate the latter and by combining experimental and numerical methods, this study shows that (1) the capillary water absorptivity of a commercially available aerogel-based coating mortar increases after repeated drying and wetting cycles, and (2) leads to a higher moisture content in a masonry wall. After the third cycle, the measured water absorption was more than five times higher than after the first one. Based on numerical simulations, the increasing capillary water absorptivity results in 36% higher relative humidity in the wall if the aerogel-based coating mortar is applied externally and exposed to driving rain. Future research should investigate

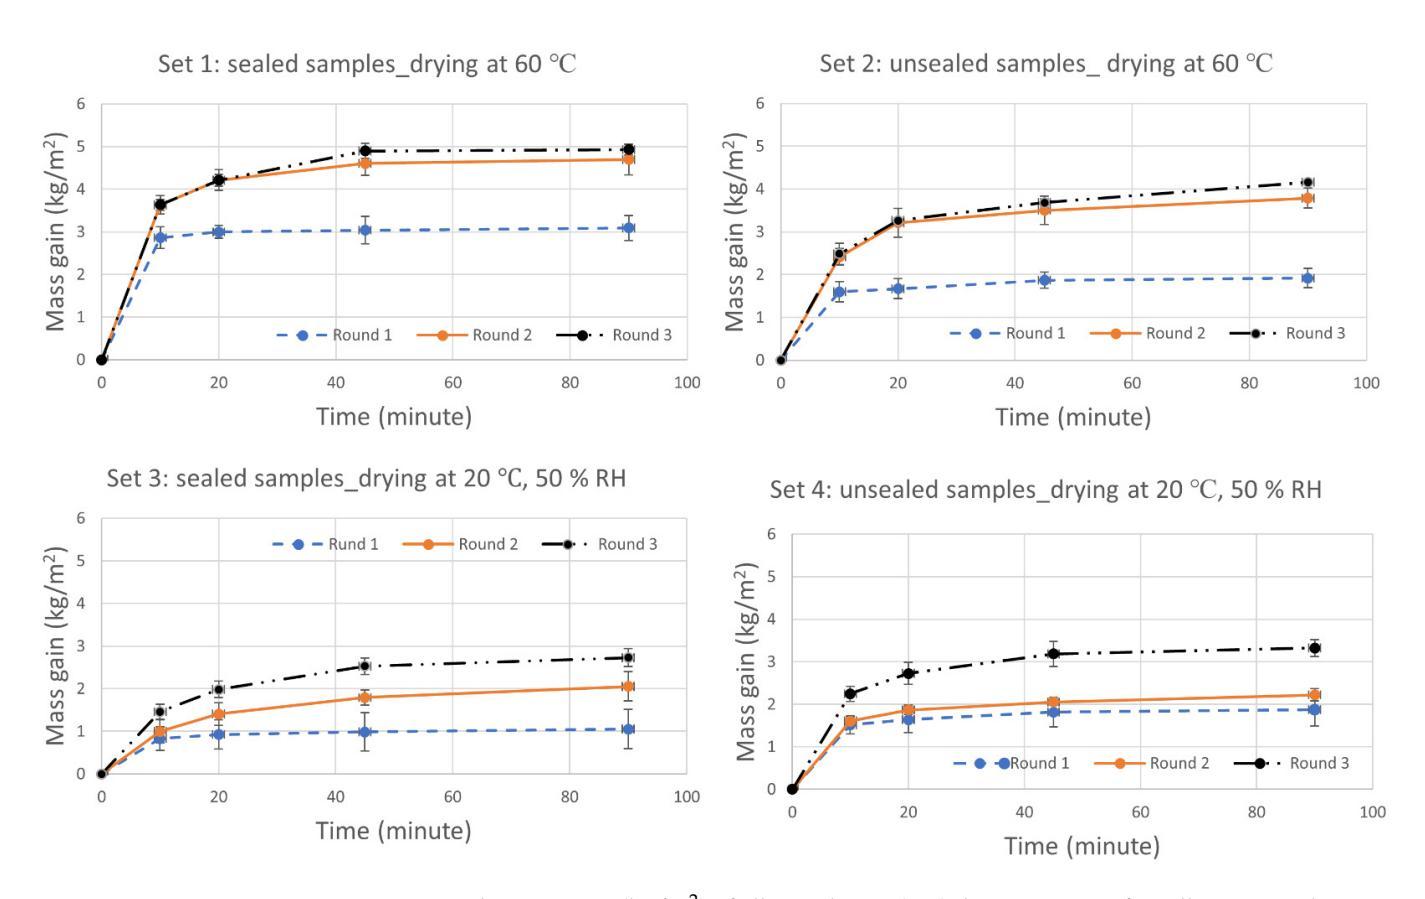
**Figure 1.** The mass gain  $(kg/m^2)$  of all sample sets (1–4) during 90 min of capillary water absorption from free water. Each measurement point represents the mean value of the three samples in each set.

The results showed that the calculated  $A_{cap}$  in the first round was 0.04–0.06 kg/m<sup>2</sup>·min<sup>0.5</sup> for all sample sets, i.e., within the lower range of the declared value of less than 0.2 kg/m<sup>2</sup>·min<sup>0.5</sup>. The value for sample set 1, dried and sealed in accordance with the standard, was 0.04 kg/m<sup>2</sup>·min<sup>0.5</sup>. In the second and third round of the measurements, the  $A_{cap}$  for the same sample set 1 was significantly increased from 0.04 to 0.17 and 0.21 kg/m<sup>2</sup>·min<sup>0.5</sup>, respectively. This means that the measured  $A_{cap}$  in the third round was more than five times higher than the same after the first round. A similar magnitude of change could be observed for the other sample sets as well, see Figure 2.

presented in this section, it is evident that the mass gain and measured A<sub>cap</sub> of the ACM samples already increased significantly after one cycle of wetting and drying. The drying condition and sealing of the samples were investigated as two parameters that could potentially affect the measurements. Regardless of the sealing and drying condition, a similar increasing trend was observed in the measurements. For the unsealed samples, a source of error would be the additional vapor exchange via diffusion with the (humid) surrounding air in the containers. The coefficient of variance ( $CV = \left(\frac{SD}{mean value}\right) \cdot 100$ ) (CV) for the A<sub>cap</sub> of the sample sets varied between 7–22%. These variations could be due to the uncertainties related to the testing method, such as weighting of the samples. It could also be a sign of heterogeneity of the samples with respect to their capillary water absorptivity.

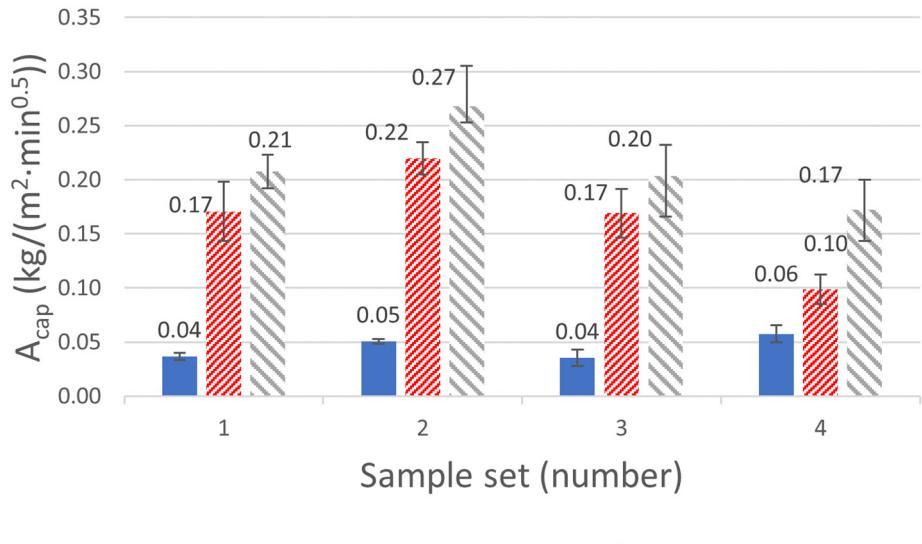
Round 1 Round 2 Round 3

**Figure 2.** The calculated water absorption coefficient,  $A_{cap}$  (kg/m<sup>2</sup>·min<sup>0.5</sup>), for all three rounds of measurement using Equation (1). Each value represents the mean value of three samples in each set. The declared  $A_{cap}$  of the ACM is stated to be less than 0.2 kg/m<sup>2</sup>·min<sup>0.5</sup>.

For the calculated  $A_{cap}$  presented in Figure 2, it has to be mentioned that according to the standard [16], the  $A_{cap}$  should be calculated for the samples dried at elevated temperature (60 °C). As such, the calculated values for sample sets 2 and 4 (dried at 20 °C and 50% RH, respectively) are not following this specification. Consequently, for these two sample sets, it is the trend and actual change in the capillary water absorptivity after each cycling that is of interest rather than the absolute value of the calculated  $A_{cap}$ . With this reasoning in mind, all sample sets are considered in the analyses.

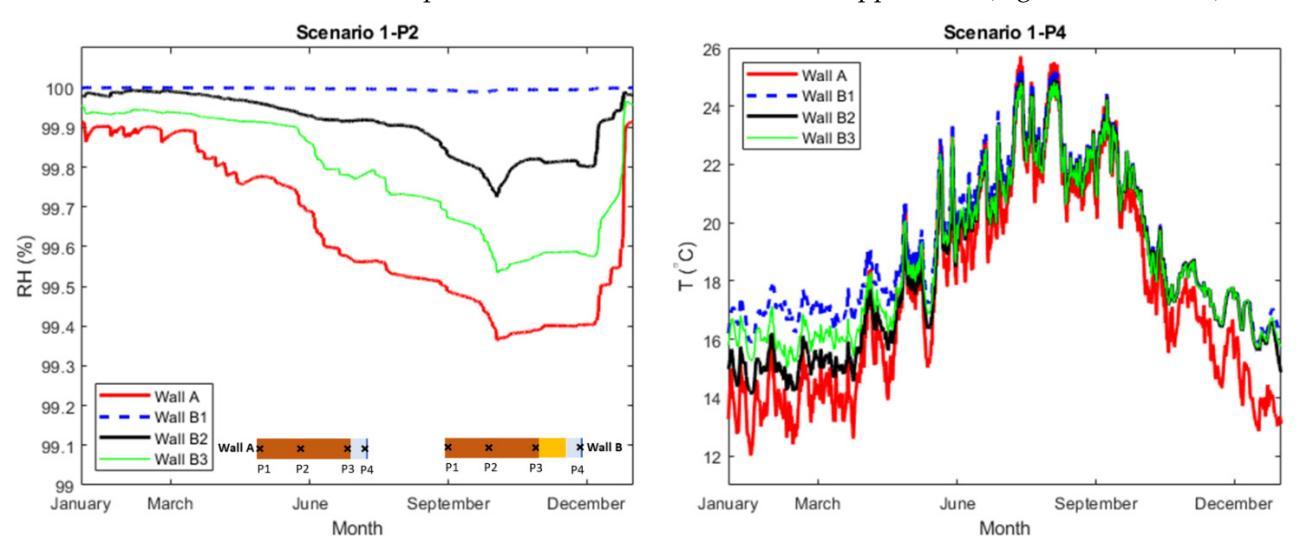
**Figure 3.** (Left): Relative humidity at checkpoints P2 (middle of brick). (Right): Temperature at checkpoint P4 (interior surface).

In scenario 1, the exterior wall surfaces were exposed to rain (Adhering Fraction of Rain, AFR: 0.7) and the drying towards the exterior was highly limited, simulating a case for the locally denser and low permeable bricks in the moisture-damaged reference building. In Figure 3, the RH at checkpoint P2, in the middle of the brick, and the interior surface T at point P4 are plotted. Table 1 presents the yearly average RH at all checkpoints. Furthermore, additional plots on scenario 1 can be found in Appendix B (Figures A3 and A4).

In summary, the simulated cases in scenario 1 showed high levels of RH in the walls, both for the reference wall but also the walls internally insulated with ACM. The high RH-levels in the reference wall, wall A, could demonstrate an extreme case of the moisture problems that exist today in the walls of the reference building. In the case the drying towards exterior is limited, the interior drying may not be sufficient even for the heated indoor environment as demonstrated in the simulations. The results also showed that for the rain-exposed walls, the existing moisture problems would remain after internal insulation by ACM if drying towards exterior is prevented. The differences between the wall B1 and wall B2–B3 were negligible considering the RH-levels at checkpoints P1–P3. At checkpoint P4 at the interior, the average RH in wall B1 ( $A_{cap}$ : 0.04 kg/m<sup>2</sup>·min<sup>0.5</sup>) was 21% lower than the same in wall B2 ( $A_{cap}$ : 0.2 kg/m<sup>2</sup>·min<sup>0.5</sup>) and wall B3 ( $A_{cap}$ : 0.3 kg/m<sup>2</sup>·min<sup>0.5</sup>). Comparing the interior surface temperature at P4, Figure 3 (right), the average temperature was around 17.6 °C in wall A and 19.2 °C in wall B1. The same in wall B2–B3 was around 18.5 °C. This could be an indicator for less transmission heat losses

towards the exterior and better thermal comfort in the interior for the retrofitted walls B1–B3. The higher temperature at P4 in wall B1 compared with wall B2–B3 could be due to the lower moisture content and accordingly lower thermal conductivity of the ACM in wall B1. Considering the risk for freeze-thawing, it only occurred at the exterior of the brick section (P1). A freeze-thaw cycle was defined as one crossing of 0 °C in the respective checkpoint. The number of freeze-thaw cycles was increased from 21 to 25 times (Figure A4) after internal insulation by ACM. Again, this was most likely a consequence of reduced heat losses towards the exterior resulting in lower temperatures in the exterior (P1).

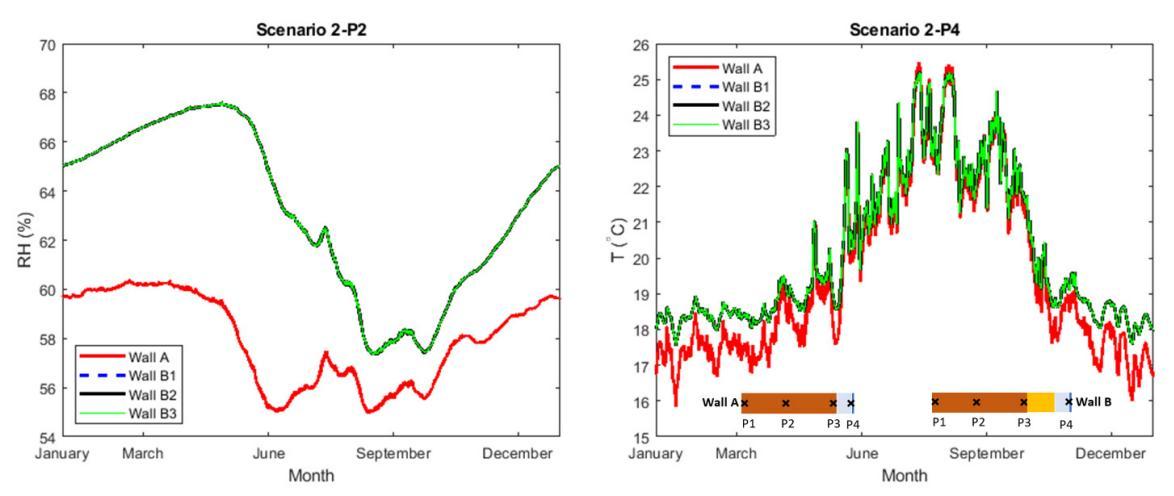
**Figure 4.** (Left): Relative humidity at checkpoints P2 (middle of brick). (**Right**): Temperature at checkpoint P4 (interior surface).

The simulations in scenario 2, represented the same cases as in scenario 1 with the only difference of assuming no capillary water absorption (no rain) at the exterior of the brick walls (AFR: 0). In Figure 4, the calculated relative humidity at checkpoint P2, in the middle of the brick, and the interior surface temperature at point P4 are plotted. Table 2 presents the yearly average RH at all checkpoints. Furthermore, additional plots in scenario 2 can be found in Appendix C (Figures A5 and A6).

In general, and compared to scenario 1, the RH-levels in the walls simulated in scenario 2 were lower. Like scenario 1, a less significant difference between the calculated RH-levels in the walls was observed. The results showed that freeze-thaw cycles occurred only at the exterior part of the brick section (Figure A6), as in scenario 1. The number of cycles at checkpoint P1 was 35 in wall A compared to 41–42 for wall B1–B3. Compared with scenario 1, the number of cycles was increased in scenario 2. Unlike the wet construction and wet ACM in scenario 1, the thermal performance of the dryer construction in scenario 2 would be higher. As such, the heat losses towards the exterior would be less, increasing the probability for minus degrees at the exterior. Considering the interior surface temperatures at checkpoint P4, the average temperature of the reference wall (wall A) was 19.6 °C. The temperature at the same position was increased to 20.2 °C after the internal insulation by ACM (wall B1–B3).

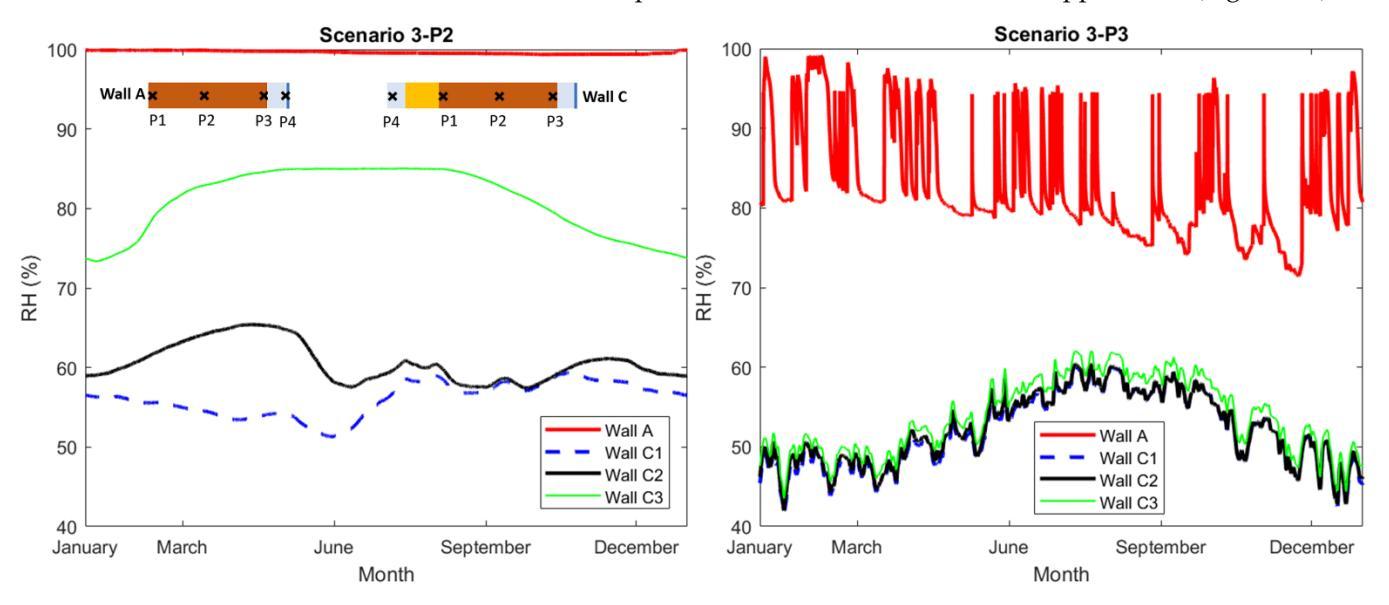
**Figure 5.** (Left): Relative humidity at checkpoint P2 (middle of brick). (Right): Relative humidity at checkpoint P3 (interior of the brick).

In scenario 3, in contrast to scenario 1 and 2, the reference wall was insulated externally by ACM. Similar to scenario 1, the exterior surface was exposed to rainwater (AFR:0.7). The purpose of the simulations in scenario 3 was to study the impact of varying  $A_{cap}$  of ACM on the RH-levels in the walls when the ACM is applied externally. In Figure 5, the calculated RH at checkpoint P2, in the middle of the brick, and at point P3, at the interior side of the brick, are plotted. Table 3 presents the yearly average RH at all checkpoints. Furthermore, additional plots in scenario 3 can be found in Appendix D (Figure A7).

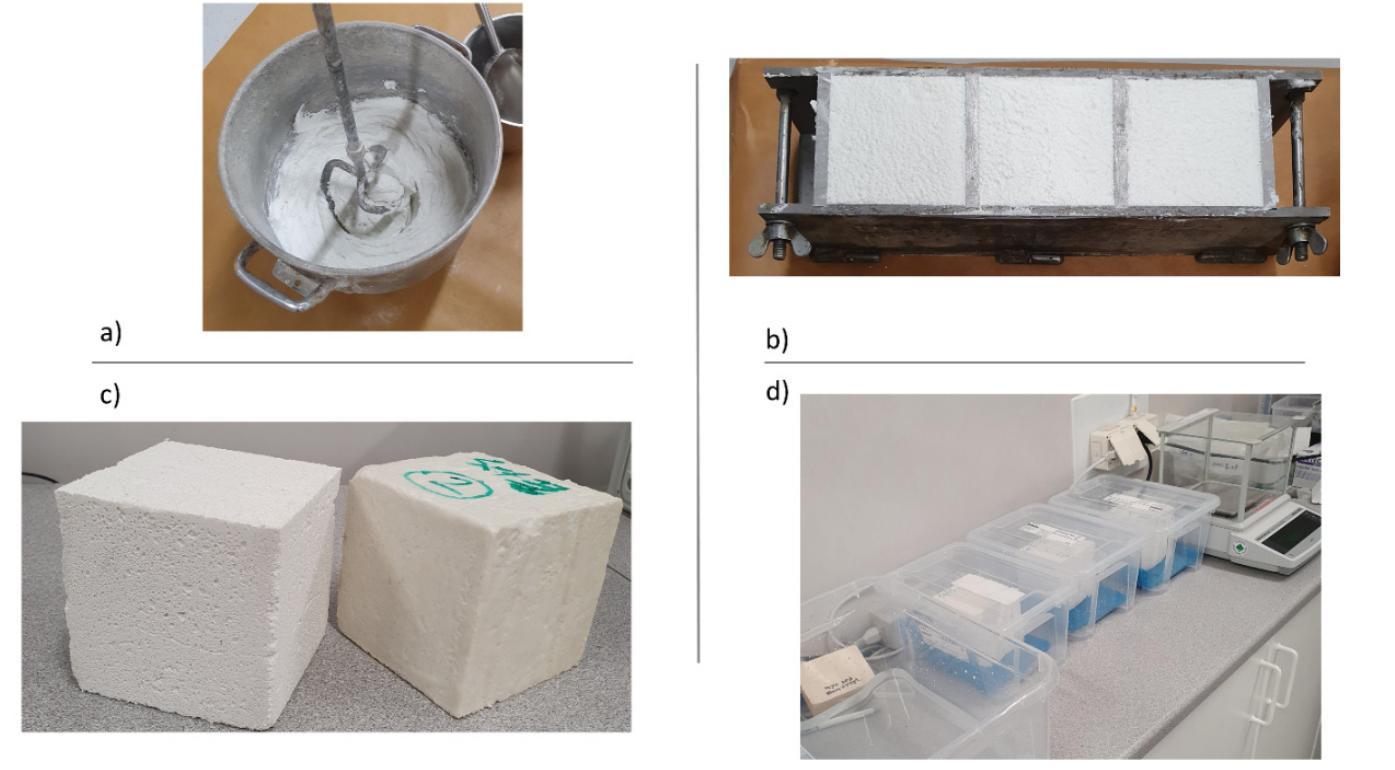
**Figure 6.** (**a**,**b**) Mixing and casting of the cubic samples. (**c**) Hardened sample: unsealed (left) and sealed on the edges by epoxy (right). (**d**) The set up used for the measurements. Continuous surface contact with water was maintained in all containers (minimum water level of 5–10 mm). A high absorbent dishcloth (blue) was placed at the bottom of each container to help maintain constant and even water content on the entire surface area of each sample. Photo: the authors.

Table 5, compiles the sample details and testing conditions implemented. Each sample set consisted of three identical samples, see Figure 6a–c. For each set, three rounds of testing were performed, i.e., three wetting and drying cycles. For sample set 3, an additional fourth round was also carried out for two out of three samples as the third sample was damaged. However, only the results of this additional fourth round are part of the discussion. After each testing round, the tested samples were dried back to the starting weight before a new round of testing was initiated. Sample sets 1 and 2 were dried at an elevated temperature (60 °C), according to the standard [16]. The other two sample sets (set 3 and 4) were dried at ambient climate (20 °C, 50% RH). For two sets (set 1 and 3), the edges of the sample were sealed (Figure 6c) while the other two sets were kept unsealed. These variations among the sample sets were to consider the impact of the drying condition and sealing of the samples on the measurement results. Figure 6d depicts an example of the considered measurement set up. During testing, the samples were kept in closed containers to avoid undesired evaporation into the surroundings. The water in the containers was maintained at the same level (minimum of 5–10 mm). Also, a highly absorbent dishcloth (Wettex) shown in blue in Figure 6d was placed at the bottom of each container to help maintain constant and even water contact with the entire surface area of each sample. The mass gain of the samples was registered after 10, 20, 45 and 90 min, respectively. A scale of the model METTLER TOLEDO PG503-S [31] with a resolution of 0.001 g was used.

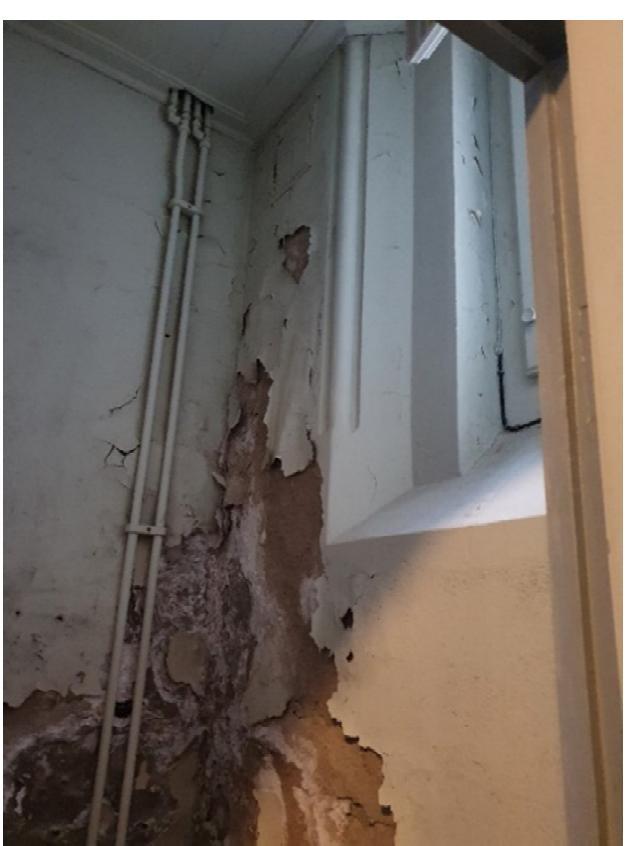
**Figure 8.** Example of the moisture-related damage at the interior of the Örgryte New Church: weathering of the internal coating mortar (plaster) and paint, and salt efflorescence. Photo: the authors.

There have been multiple cases of moisture-related damage in the church for years [32]. In [32], Balksten et al. delivered a comprehensive investigation report on the historical background, current status, and main reasons causing this damage. The first damage was reported in early 1900, approximately 10–20 years after the inauguration of the church. Since then, several retrofitting attempts have taken place to repair only limited parts of the damaged construction, most likely due to economical limitations and limited resources at the time. Consequently, the façades consist today of several types of bricks with various properties considering their vapor permeability. Also, many grout types, with varying age, binder type and porosity, and thus different moisture properties have been used for the repair work of the construction. According to Balksten et al. [32], the low frost resistance of the originally used bricks was a major contributor to the frost damage in the façades. The issue was more severe for those parts facing south and west, due to higher exposure to driving rain combined with the high frequency of freeze-thawing events. Also, the façades of the unheated areas in the church were more damaged than other parts with an internally heated area. The damage has led to weathering of the bricks from the façades with extensive material loss. Internally, the damage can be recognized locally on the weathered coating layers (plaster). Moreover, clear patterns of salt efflorescence can be observed. Figure 8 shows an example of the damage on the interior side of the church. The walls in the church were internally painted with several layers of organic and dense paints, with low vapor permeability. Consequently, drying towards the interior was rather limited. This issue resulted in moisture accumulation and salt crystallization behind the paint as the salt transportation, in dissolved form, towards the interior surface was highly prevented.

According to [32], the main moisture source for the observed damage in the building envelope of the church is the exterior moisture load mainly from driving rain. The material variations in the exterior façades, combined with high exposure to driving rain and freezethawing have resulted in water penetration in several spots. Meanwhile, for the parts with less permeable bricks drying towards the exterior is rather limited. The fact that drying towards the interior was also partly prevented due to the low vapor permeable interior surface coating and paint, increased the magnitude of the observed damage in the building

envelope. These issues have been concluded to be the main reasons for the damage that have occurred in the building envelopes of the church.

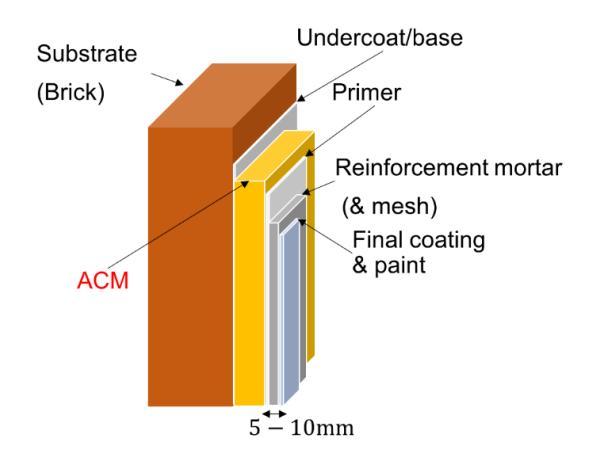
**Figure 9.** Schematic illustrating a multilayer wall system with ACM. To compensate for the low mechanical strength of the ACM, it is applied in a multilayer wall system. On the load-bearing structure, an undercoat layer is applied under the ACM (10–50 mm). To protect the ACM, a primer, reinforcement mortar and layer of coating and paint is applied to the surface. In total, this led to the system being 5–10 mm thicker than the ACM layer.

To compensate for the lower mechanical strength and higher fragility of ACM, it is in practice applied in a multilayer wall system [1], see Figure 9. Each layer of the system is applied separately and dried out before the application of the next one. An undercoat is applied first to increase the adhesiveness and control the water suction to the substrate before the ACM is applied. The thickness of the ACM is normally around 10–50 mm. On top of the ACM, a primer is applied before the application of the reinforcement mortar that provides the necessary mechanical strength to the wall system. In some cases, reinforcement mesh can also be added. Finally, the multilayer wall system can be supplemented by a final layer of coating and a mineral-based vapor open and water-repellent paint to achieve the final desired surface structure and appearance. The total thickness of the wall system is normally increased by 5–10 mm due to the additional layers applied together with ACM.

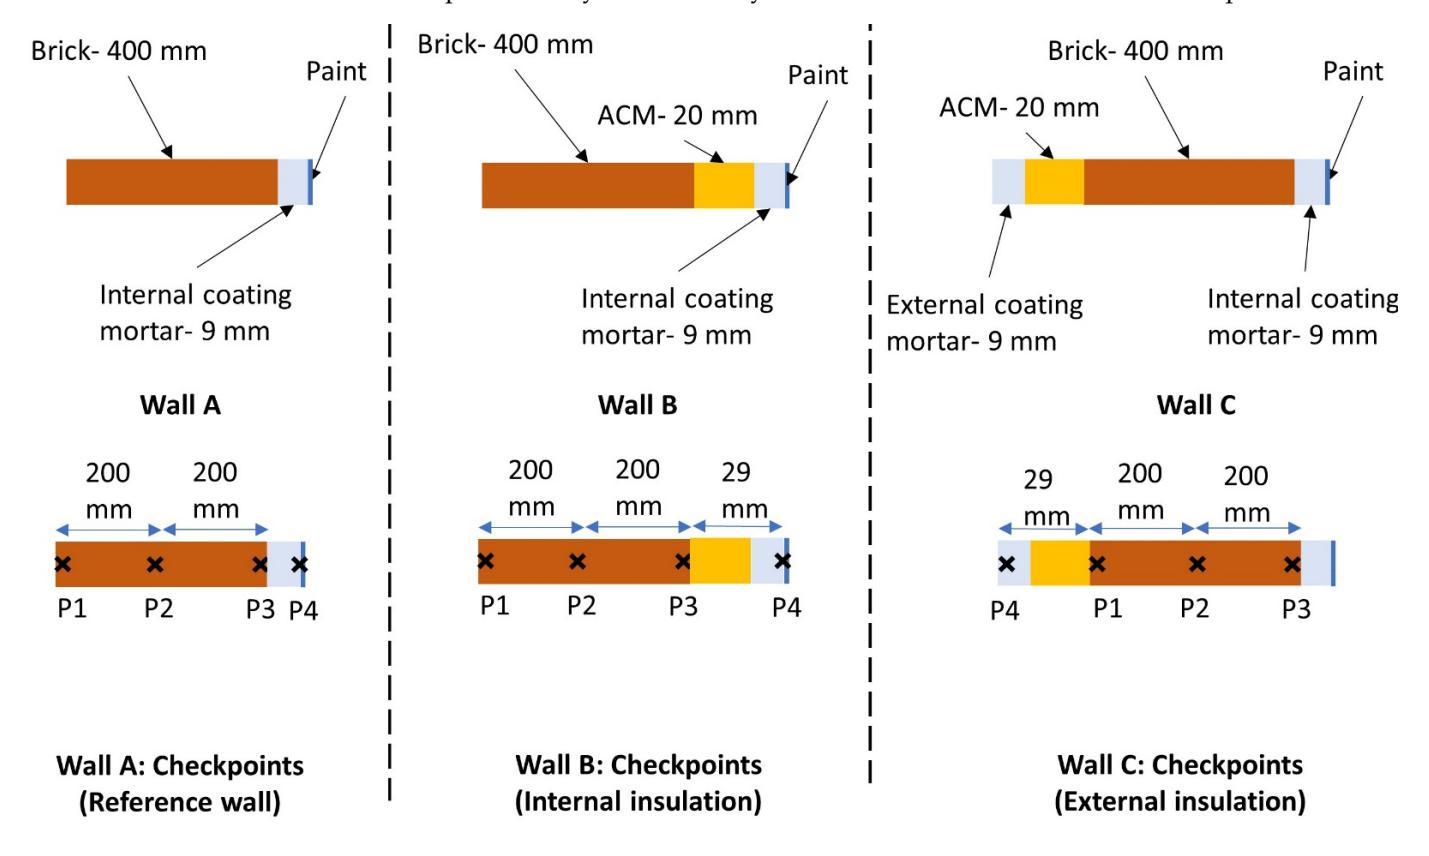
**Figure 10.** Geometries of the simulated wall elements (wall A, B, and C) and the positioning of the checkpoints (marked with ×).

In total, three wall configurations (wall A, wall B, and wall C) were considered in the simulations. The hygrothermal condition of these walls was studied for different simulation scenarios and at the checkpoints marked in Figure 10. Wall A represented the existing brick wall in the reference building where the problematic interior coating and paint have been removed and replaced by a new layer of coating and a vapor open paint. In wall B, the same brick wall was instead insulated internally by a multilayer wall system with 20 mm of ACM. Finally, wall C represented a case where the brick wall was insulated externally by a multilayer wall system with 20 mm of ACM. Like wall A, the original interior coating and paint were removed and replaced by new ones. As mentioned in Section 4.2.1, an external insulation of the reference building by ACM is not permitted in real-life practice. Thus, the case represented by wall C is only of theoretical value for the sake of comparison.

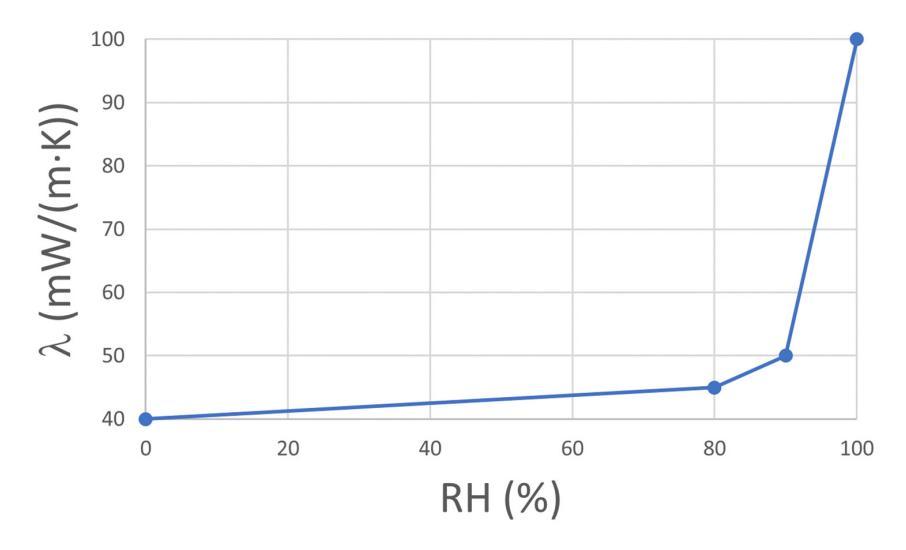
**Figure 11.** Declared moisture-dependent thermal conductivity of the ACM. The thermal conductivity is increased by less than 13% up to 80% RH and then rises sharply up to 100 mW/(m·K) at saturation [30].

In Table 6, the properties of the materials used in the simulations are presented. Also, the moisture-dependent thermal conductivity of the ACM is illustrated in Figure 11. Because the specific material properties of the brick (machine-made red brick) in the reference building were unknown, the study used available brick types in the WUFI database. Based on the results of the pre-study (scenario 0) summarized in Appendix A (Figures A1 and A2), the extruded brick was selected. For ACM, internal and external coating mortars and paint, the declared material properties of the products were used. For consistency, the same materials were used in all three walls (wall A, B, C). As illustrated in Figure 11, the thermal conductivity of the ACM is increased by less than 13% up to 80% RH. Above this limit, the thermal conductivity is increased by more than two times from 40 to 100 mW/(m·K).

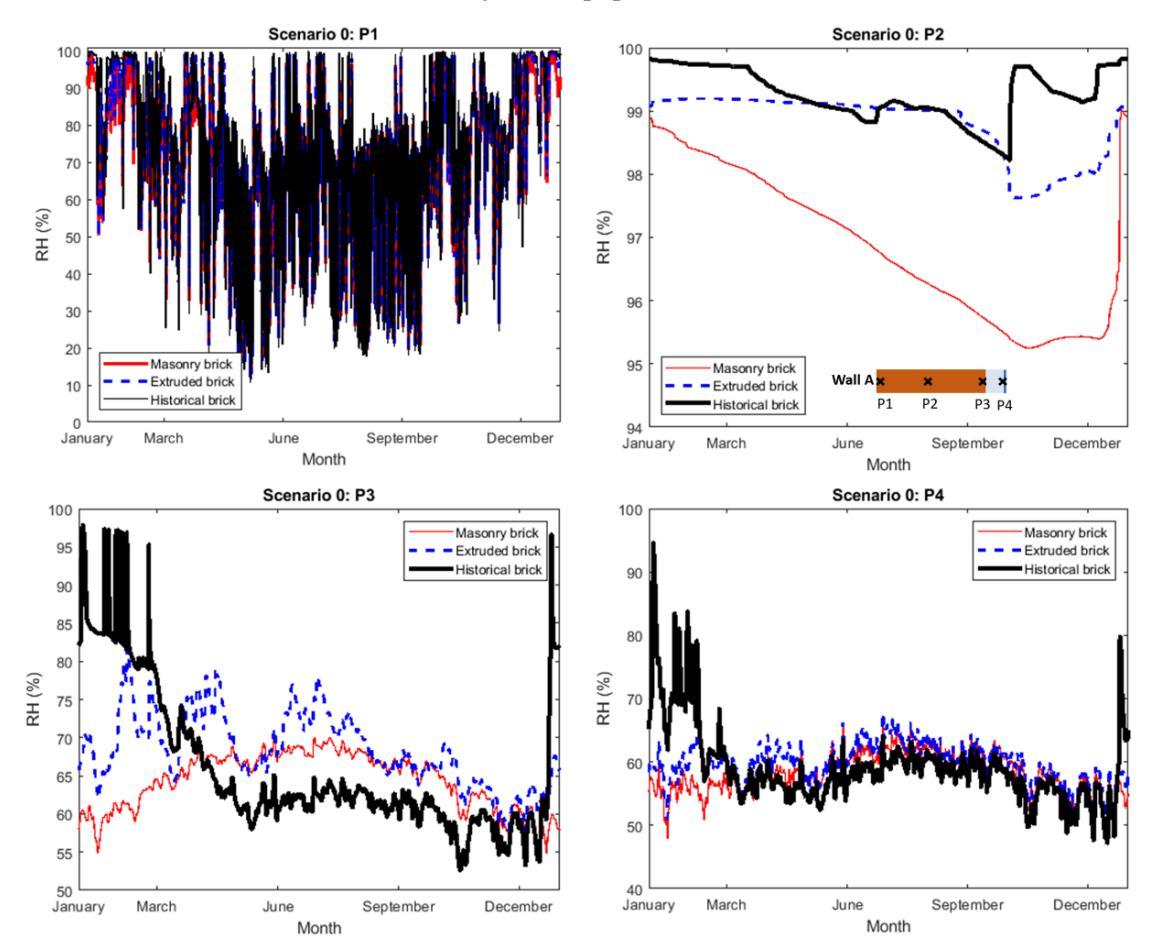
Figure A1. Scenario 0: Relative humidity at checkpoints P1-P4.

In Appendix A, the results of the pre-study (Scenario 0) are presented. The pre-study was carried out to compare the hygrothermal performance of the reference wall (wall A) with respect to the brick type selected in WUFI. In Tables A1 and A2, the details and properties of the materials used in scenario 0 are presented, respectively. To find the proper initial conditions in the wall, five consecutive years were simulated, while results are presented for the last year only. In Figure A1, the relative humidity (RH) at all checkpoints (P1–P4) is presented. Additionally, the number of freeze-thaw cycles and the total water content ( $W_{tot}$ ) in the brick section of the wall A are shown in Figure A2 for the last year. A freeze-thaw cycle was defined as one crossing of 0 °C in the respective checkpoint.

other words, the water content in the brick masonry, extruded brick, and historical brick was around 37, 30, and 11% of the saturated water content, respectively. The number of freeze-thaw cycles varied between 34–37 times at checkpoint P1 during the last year of simulations. No freeze-thaw cycles occurred at checkpoints P2–P4.

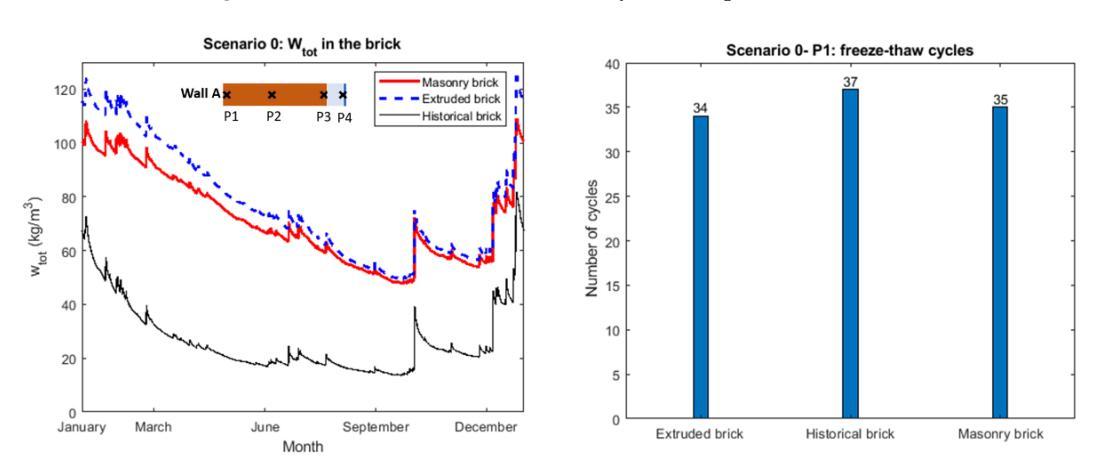
**Figure A2.** Scenario 0: Total water content in wall A and number of freeze-thaw cycles at checkpoint P1 (exterior surface).

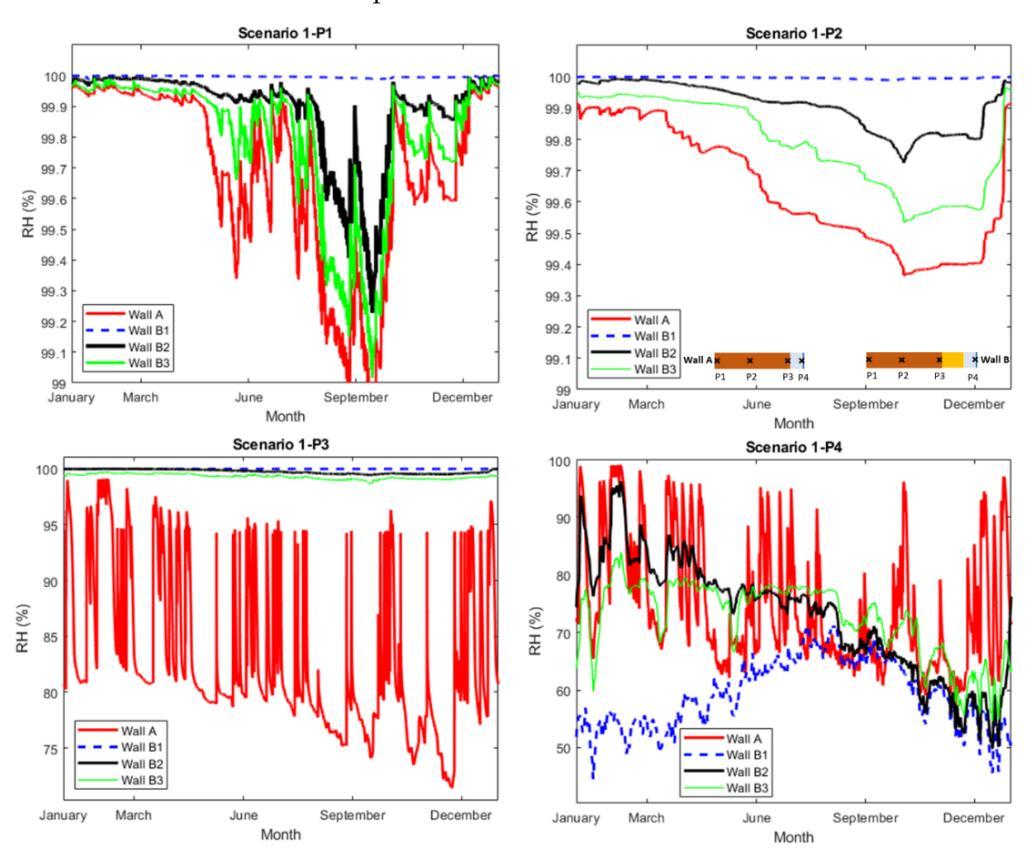
Figure A3. Scenario 1: Relative humidity at checkpoints P1–P4.

Appendix B includes complementary figures on the results of the numerical simulations for scenario 1. In scenario 1, the exterior wall surfaces were exposed to rain (Adhering Fraction of Rain, AFR: 0.7) and drying towards exterior was highly limited, simulating a case for the locally denser and low permeable bricks in the reference building. To evaluate the impact of varying capillary water absorptivity of ACM on the hygrothermal performance of the studied walls, three different ACMs were defined as input data in the analyses. Wall A represented the original wall of the reference building prior to the retrofitting. Wall B1, B2, and B3 represented the internally retrofitted wall with ACM, at which the A<sub>cap</sub> of the ACM was set to 0.04, 0.2 and 0.3 kg/m<sup>2</sup>·min<sup>2</sup>, respectively. These values were chosen based on the measured values presented in Section 4.1.

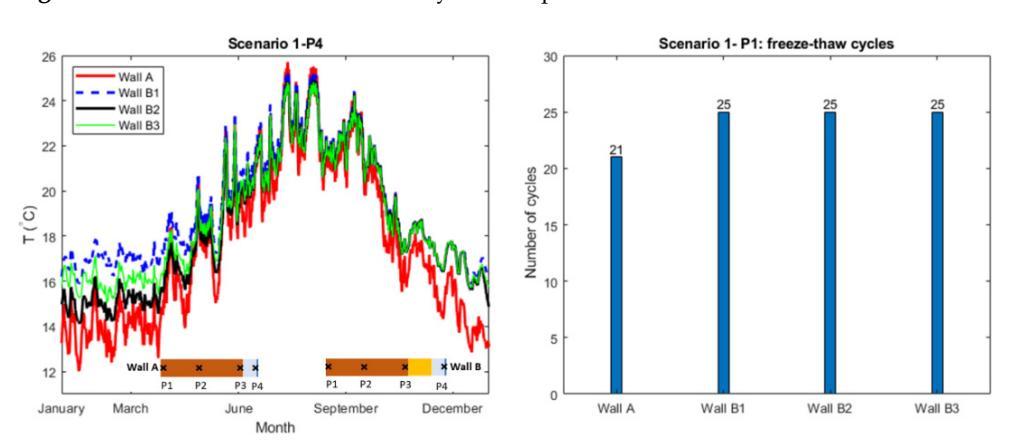
Figure A4. Scenario 1: Temperature at checkpoints P4 and number of freeze-thaw cycles at checkpoint P1.

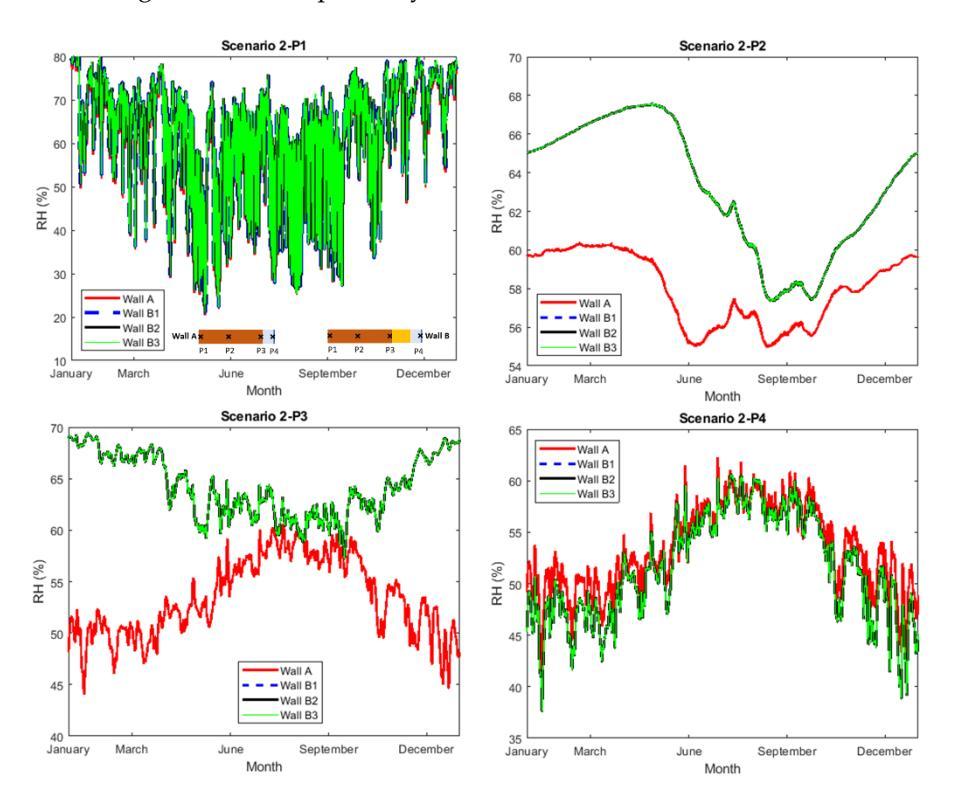
Figure A5. Scenario 2: Relative humidity at checkpoints P1–P4.

Appendix C includes complementary figures on the results of the numerical simulations for scenario 2. In scenario 2, the exterior wall surfaces were not exposed to rain (AFR: 0) and drying towards the exterior was highly limited, simulating a case for the locally denser and low permeable bricks in the reference building. Wall A represented the original wall of the reference building prior to the retrofitting. Wall B1, B2 and B3 represented the internally retrofitted wall with ACM, for which the A<sub>cap</sub> of the ACM was set to 0.04, 0.2 and 0.3 kg/m<sup>2</sup>·min<sup>2</sup>, respectively.

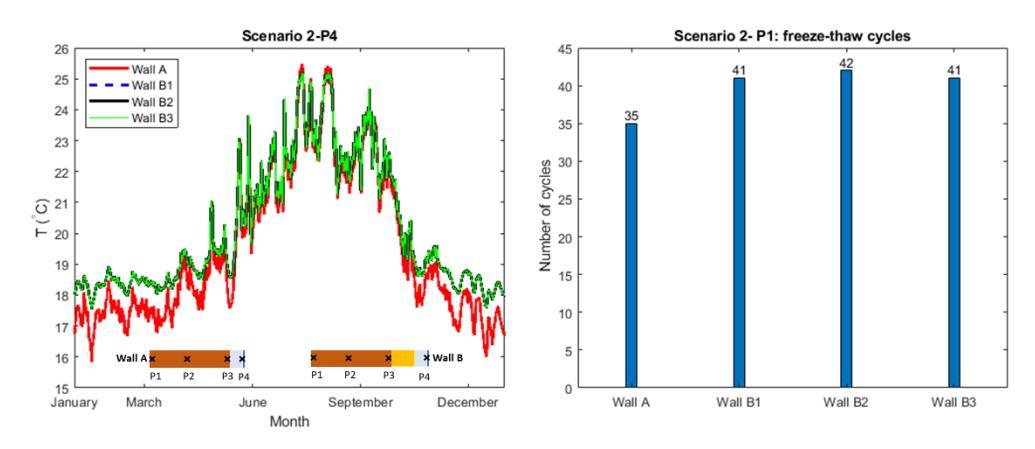
**Figure A6.** Scenario 2: Temperature at checkpoints P4 (interior surface) and number of freeze-thaw cycles at checkpoint P1 (exterior surface).

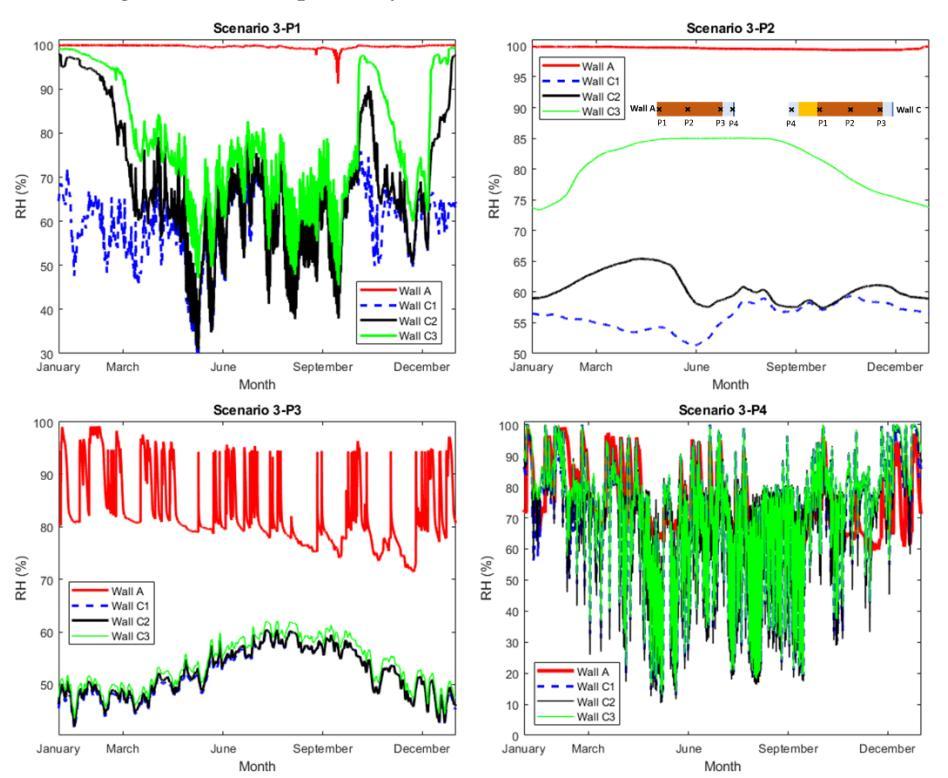
Figure A7. Scenario 3: Relative humidity at checkpoints P1–P4.

Appendix D includes complementary figures on the results of the numerical simulations for scenario 3. In scenario 3, the exterior wall surfaces were exposed to rain (AFR: 0.7) and drying towards the exterior was highly limited, simulating a case for the locally denser and low permeable bricks in the reference building. Wall A represented the original wall of the reference building prior to the retrofitting. Wall C1, C2 and C3 represented the externally retrofitted wall with ACM, at which the  $A_{cap}$  of the ACM was set to 0.04, 0.2, and 0.3 kg/m<sup>2</sup>·min<sup>2</sup>, respectively.
