# TOWARDS AN AUTOMATIZED AND OBJECTIVE ASSESSMENT OF DATA FROM VISUAL INSPECTIONS OF BUILDING ENVELOPES

### JAN MANDINEC\*, PÄR JOHANSSON

In the following case study, an in-house computer vision algorithm (Build-Sense model) based on the YOLO-tiny framework [2] capable of detecting damaged areas is applied to images of historical Tjolöholm castle in the west of Sweden. The main goal is to detect missing joints in a stone masonry wall.

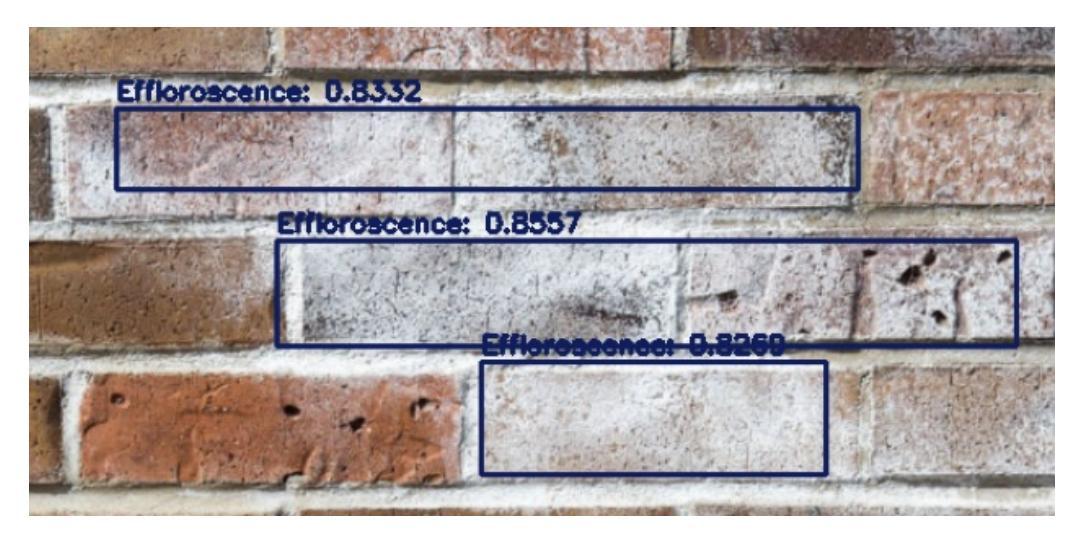
FIGURE 1. Example of output from the Build-Sense model – model draw bounding boxes around damaged area alongside with its level of confidence [18].

The Build-Sense model was originally built for detecting damage on brick walls specializing on drawing bounding boxes around cracks and bricks subjected to spalling and efflorescence. The model is utilizing the concepts of transfer learning and was trained based on 225 images of damaged brick walls (approximately 75 images for each damage type) manually annotated with more than 2 000 bounding boxes providing the model with the interpretation of how a damage looks like. Figure 1 shows bounding boxes around efflorescence as they were predicted by Build-Sense model.

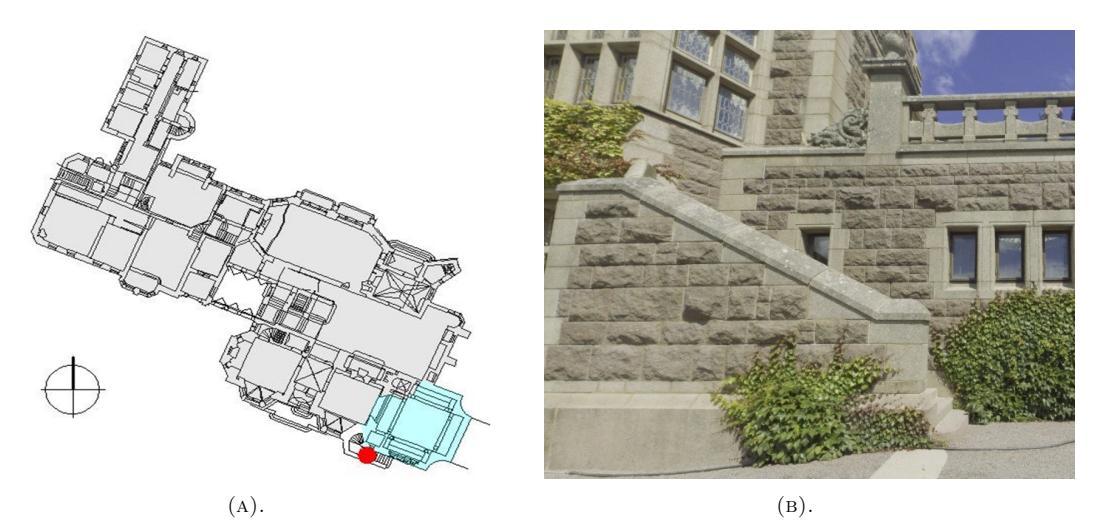
FIGURE 2. (A) Schematic plan on the building's ground floor to the left shows the location where the panoramic photograph was taken (red dot). Gray background indicates multi-storey parts while cyan colour indicates single storey part of the building. (B) Photograph was taken on the stairs leading to the roof of single storey part [19].

Given the fact that joints are continuously disintegrated, mainly on the east side of the south-west façade, the study is limited to the assessment of the Build-Sense model only to one panoramic image which closely depicts the area of interest. The positions of the panoramic image as well as the overall view over the wall of interest is on the Figure 2.

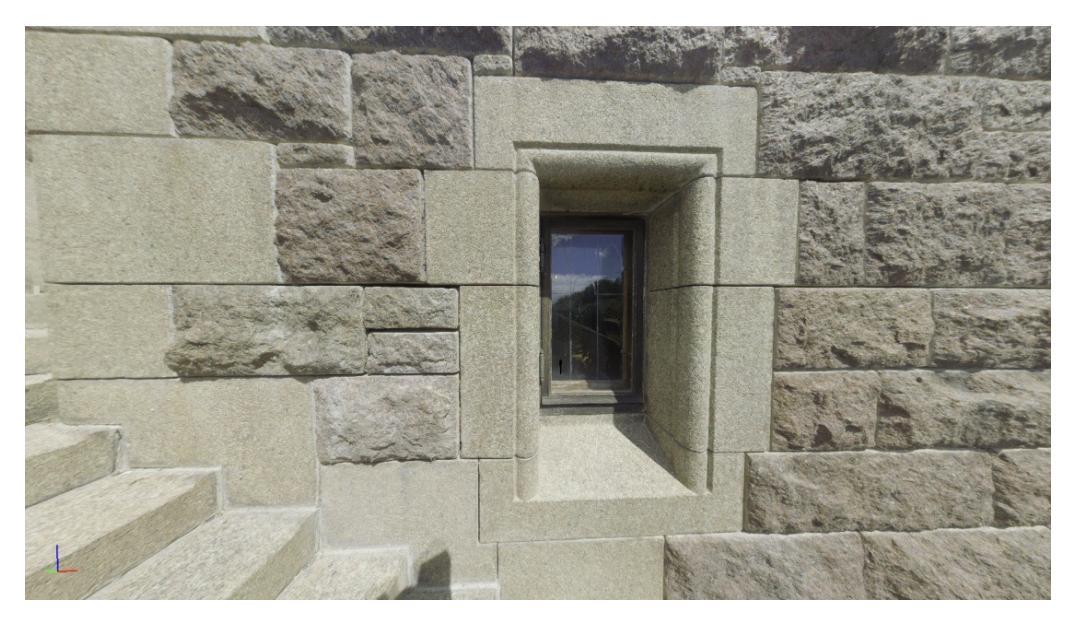
FIGURE 3. Default view from the panoramic image directly facing the area of interest [19].

All images altogether presented in this subchapter were analyzed using retrained Build-Sense model. Figure 3 shows the default (un-zoomed) view from the panoramic image directly facing the building envelope. Note that there are missing joints on the left side of the window. The model there fails to detect any objects of interest.

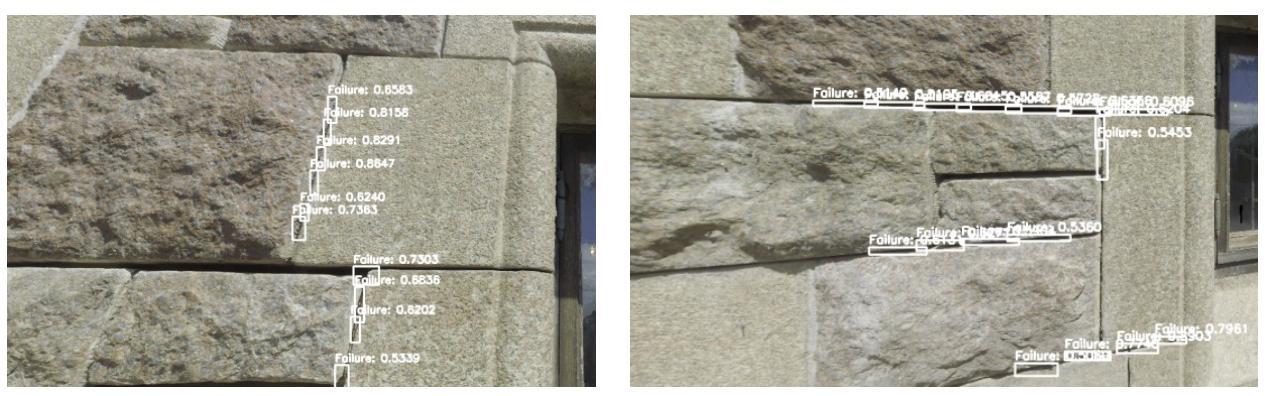
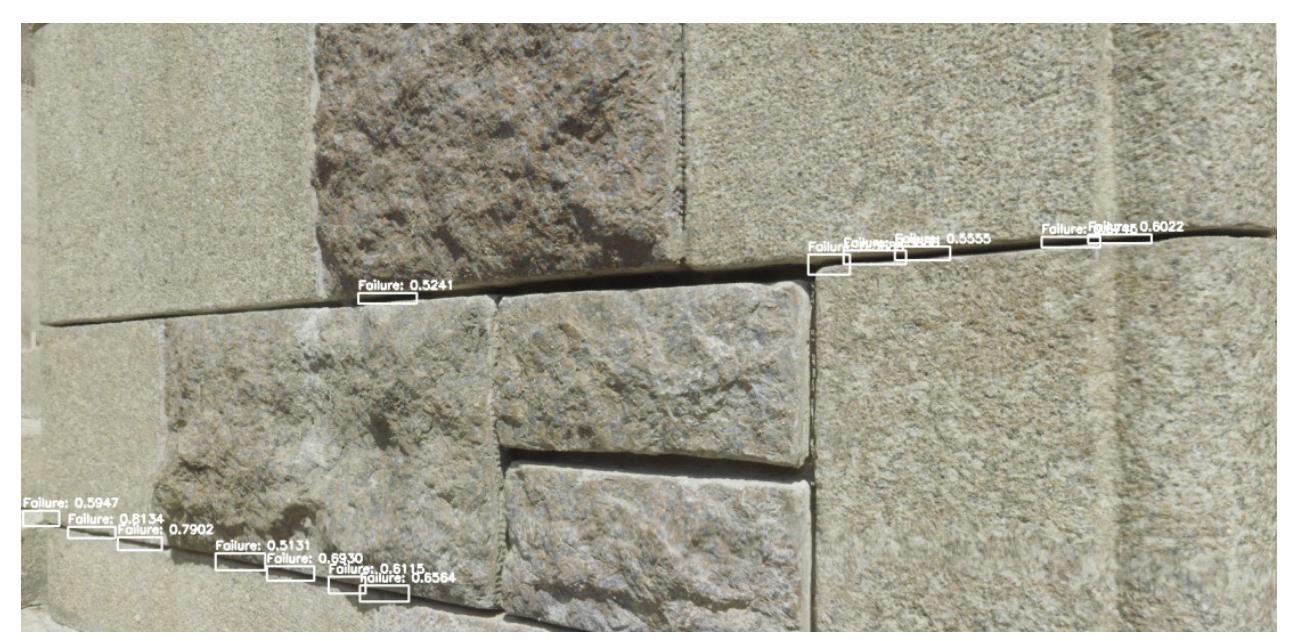
FIGURE 4. Detailed views. Credit: Anders Jansson, all rights reserved.

(A). Detailed view 1.

(B). Detailed view 2.

(C). Detailed view 3.

However, this was not a case for zoomed images. Figure 4a shows missing joints in the vertical direction but the algorithm failed to comprehend damages in the horizontal direction. Observe that the confidence of the model in predicting missing veneer is relatively high i.e., always above 70 %. Complete opposite picture gives the Figure 4b where the missing joints were detected mainly in horizontal direction while the model's confidence is in general lower.

The model failed to comprehend a majority of miss-

ing joints in Figure 4c. However, vertical joints are in this point of view badly visible and difficult to correctly interpret even for human eyes. Furthermore, the model again fails to comprehend joints in horizontal direction which makes the confidence of the model over individual bounding boxes rather low. Observe that the model prefers detecting missing joints of relatively thin size but fails to detect thicker joints. This is probably caused by the limited number of training images and by the low variance of images i.e., training set does not include missing joints of this size.

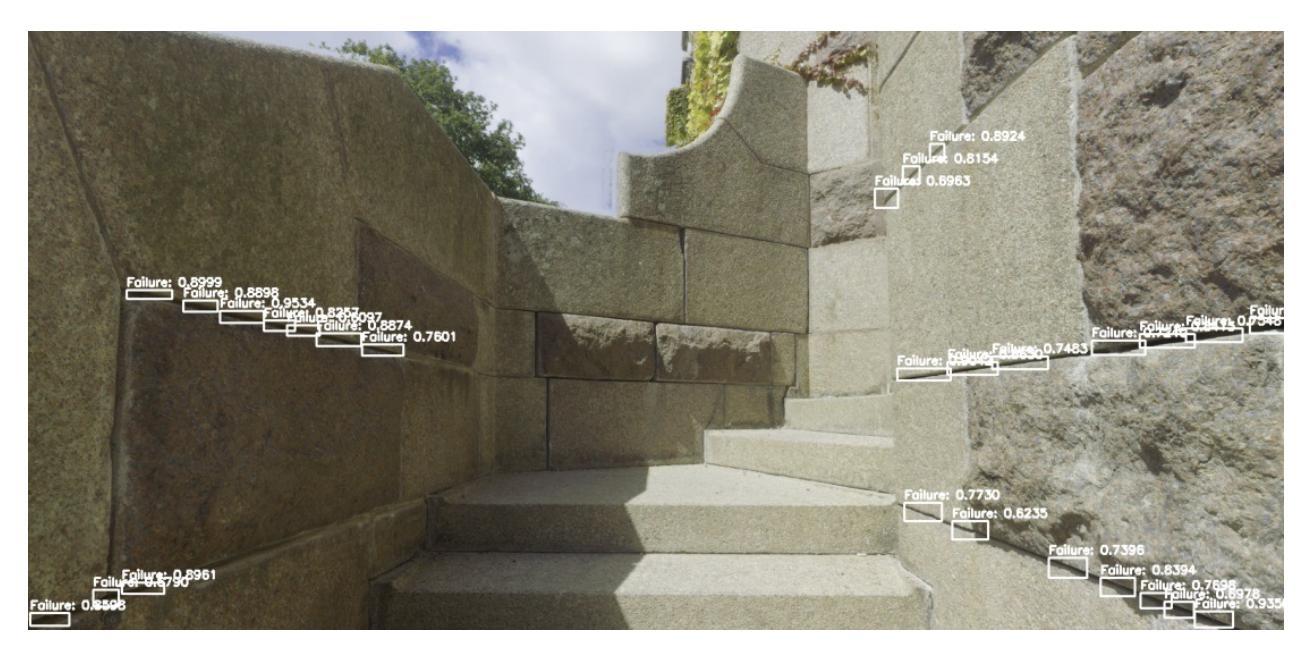
FIGURE 5. Image facing stairs [19].

The presumption that the low confidence in the previous case is caused by the low number of relevant training images is further strengthened by Figure 5 where most missing joints were correctly detected with high level of confidence. The model only fails to grasp missing veneers in the opposite wall in the distance and few parts of the joints on the sides.
