Fatigue Crack Propagation on Uniaxial Loading of Biaxially Predeformed Pearlitic Rail Steel

Gren, D., Ahlström, J. (2023). Fatigue Crack Propagation on Uniaxial Loading of Biaxially Predeformed Pearlitic Rail Steel. Metals, 13(10). http://dx.doi.org/10.3390/met13101726

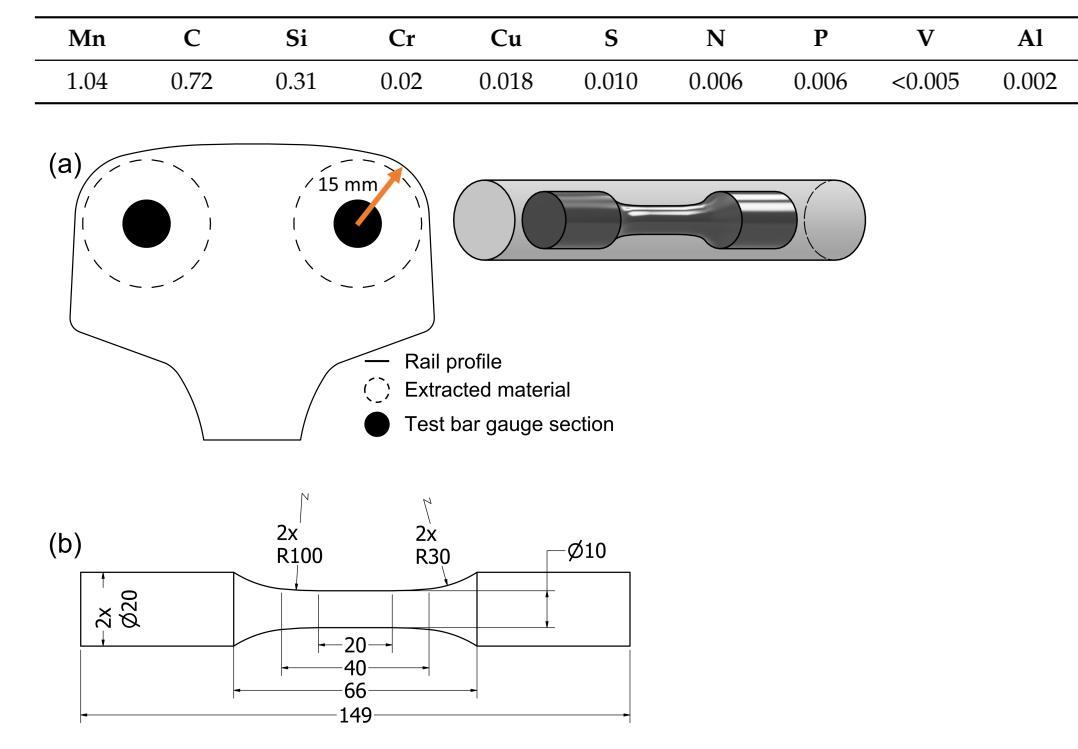
Figure 1. (a) Material extraction from virgin rail heads. The figure shows the cross-section of a UIC60 rail head profile. The dashed circle shows where the cylindrical rods were extracted and the black circle shows the material in the gauge section of the test bars. (b) drawing of test bars used for predeformation. Dimensions in [mm].

Uniaxial fatigue crack propagation was studied in predeformed fully pearlitic rail steel R260 (UIC900). The nominal chemical composition of this rail steel is detailed in Table 1. Cylindrical rods with a diameter of 26 mm were extracted from virgin rail heads, as illustrated in Figure 1a. The cylindrical rods were subsequently machined into test bars, following the dimensions provided by the drawing in Figure 1b.

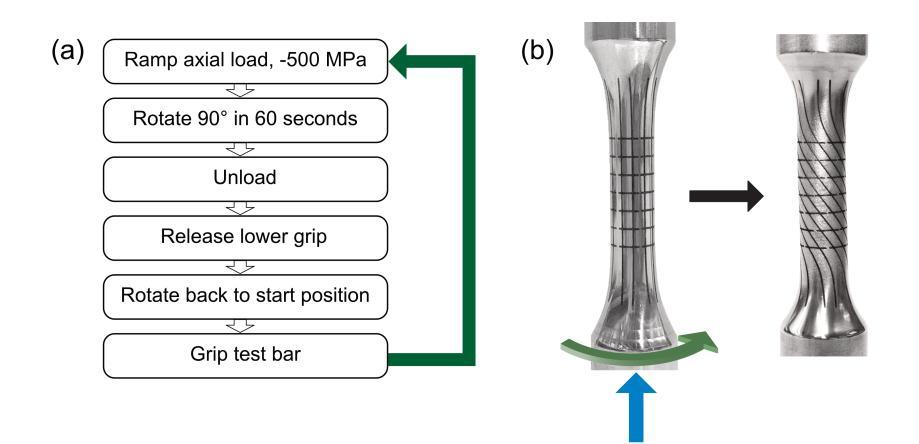
Figure 2. The predeformation process is shown in (**a**) and in (**b**) the shear deformation resulting after twisting 3×90 degrees is visualized by the laser etched grid.

The predeformation method developed by Meyer et al. [23] has been used to replicate the anisotropic surface material found in rails. The predeformation process is a cyclic sequence in which test bars are twisted under simultaneous compression, as illustrated and explained in Figure 2a. In total, two predeformed material states were produced, corresponding to twisting 3×90 degrees (PD3) and 6×90 degrees (PD6) under a nominal initial compressive stress of -500 MPa. The nominal compressive stress slightly decreases in each cycle as the diameter increases. The test bars used for predeformation were machined according to the drawing in Figure 1b. These test bars were prepared in two steps prior to predeformation. In the first step, they were gradually ground up to P1200 SiC abrasive paper to avoid pre-mature failure during predeformation. Thereafter, in the second step, a grid to measure surface shear strain was applied by laser etching, see Figure 2b. Naturally, undeformed test bars were also included as a reference, and these are called PD0.

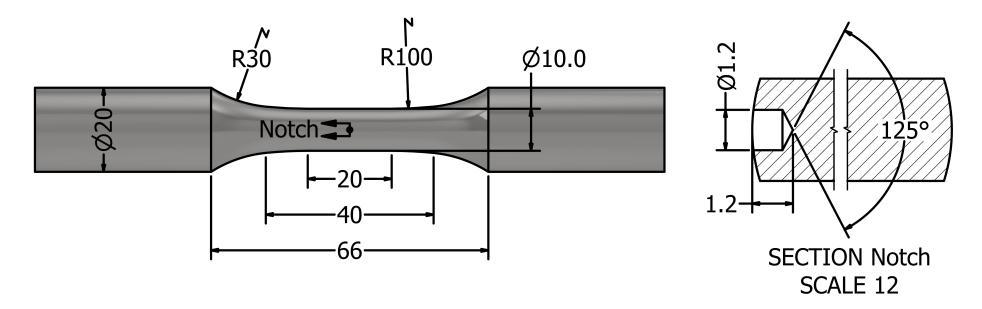
Figure 3. Drawing of the notched test bars. Dimensions in [mm].

The compressive load during predeformation causes a slight bending of the test bar gauge section besides decreasing the length/width ratio. Reprofiling was therefore required to make the test bars axi-symmetric and thereby suitable for fatigue testing. Test bars denoted PD6 were reprofiled according to the drawing in Figure 1b. However, it was not possible to reprofile PD3 test bars with this geometry due to the slight bending but limited widening of the profile. Therefore, the dimensions in Figure 1b were adjusted. The gauge section diameter was changed to 9.5 mm instead of 10 mm and the transition radius R30 was changed to R28.

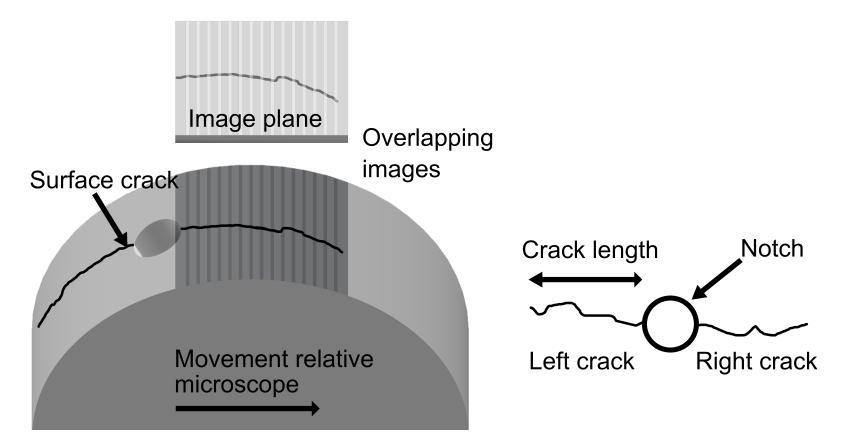
Figure 4. Visual representation of image acquisition for crack measurement using stereo and optical microscope, including the definition of crack length reported in Section 3.3.

Crack length has been measured with both stereo- and optical microscope at periodic intervals during the fatigue crack propagation experiments. Multiple micrographs were acquired along the lateral surface of the test bar to cover the whole crack, where each micrograph represents the projection of a small section on the lateral surface, see Figure 4. The acquired micrographs were stitched to form a single micrograph containing the whole crack. This was enabled by letting each section during image acquisition overlap with the adjacent sections. The measurements were conducted every 1000 cycles for the first 10,000 cycles and thereafter every 2000 cycles. Closer periodic measurements were applied towards the end of the fatigue life, when it was anticipated that the test bar would not withstand another full interval. The definition of crack length in the crack propagation measurements reported in Section 3.3 is defined in Figure 4, where the crack length is the horizontal crack extension, measured from the edge of the notch on the image plane. In addition, the crack length was corrected for the curvature of the test bar, i.e., the true length of the crack is longer than the length of the projected crack.

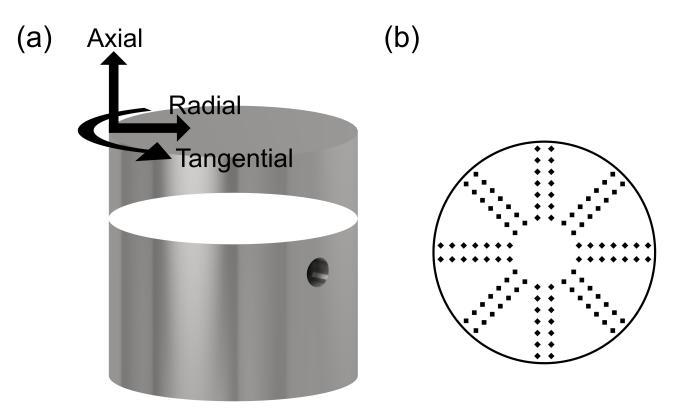
Figure 6. Illustration of the location of hardness measurement in (**a**) and indent pattern used for characterizing the hardness gradient in (**b**).

The hardness distribution in both undeformed and predeformed samples was determined and evaluated using the Vickers method. The equipment used for conducting the hardness measurements was the hardness tester DuraScan 70 G5 by Struers/Emcotest. In total, hardness was measured on seven samples: two samples for each material state and one reference sample. The reference sample was extracted from a reprofiled PD6 test bar whilst the other samples were extracted after the completed fatigue testing experiment. Figure 6a, shows the location of sample extraction (white cross-section). The cut were made 2 mm from the top of the hole that forms the notch. Hardness was measured along the radial direction on the cross-section on a polished surface according to the indent pattern shown in Figure 6b. In all measurements, the applied load was 5 kgf (HV5), to enable comparison between the samples without risking the possible size effect.

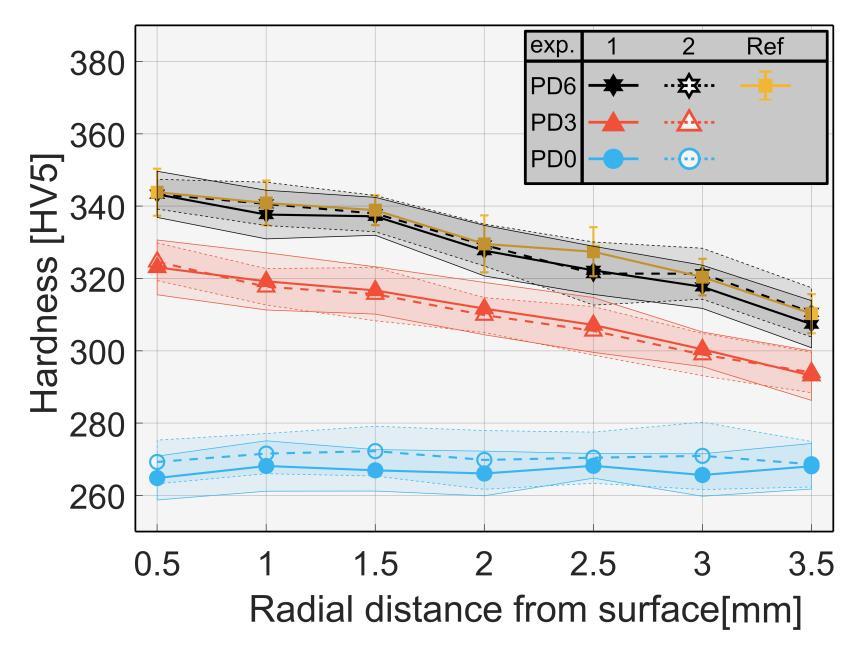
Figure 7. Hardness distribution, for both undeformed and predeformed samples, measured along the radial direction from the sample (lateral) surface.

The effect of predeformation on hardness distribution relative the undeformed material state is shown in Figure 7. The presented hardness values were measured along the radial direction, starting close to the sample surface (circumference). From the figure, it can be observed that the undeformed samples have a uniform hardness distribution, averaging 269 HV5 with a corresponding standard deviation of 7 HV5. As expected, these results are in accordance with the hardness requirement outlined in the European rail standard EN 13674-4, for the R260 rail steel. Comparing the hardness distribution of the predeformed samples with the undeformed, a notable difference can be observed. Predeformation introduces significant hardening throughout the cross-section, characterized by a nearly linear decrease in hardness along the radial direction, towards the sample center. This hardness gradient is similar for PD3 and PD6, with PD6 having a hardness level that is approximately 20 HV5 units higher than for PD3. In addition, it can be observed that for the same shear strain level in PD3 and PD6, there is a good agreement between the absolute levels in hardness. For example, the hardness level at 2.5 mm depth in PD6 correspond well to 0.5 mm depth in PD3 (at half the radius, half of the surface shear strain is expected). Lastly, the hardness measurements for the reference sample (PD6) completely overlaps the hardness levels for the PD6 samples, proving that the hardness distribution was unaffected by the fatigue crack propagation experiments.

From the principles of solid mechanics, the hardness gradient can be understood by considering the distribution of stresses and strains in a cylinder subjected to torsion. In this case, the stress and strain increases along the radial direction, away from the center. The shear strain is straightforward to analyze because of the concept that all planes can be assumed to remain planar. Thus, the shear strain varies linearly, from zero at the center, to the measured value at the surface, see Table 3. However, the stress distribution remains unknown, primarily because of plastic deformation, increasing diameter, and the subsequent decrease in diameter. Switching perspective, to the detailed, microstructural scale, the hardness gradient is instead mainly explained on the basis of differences in dislocation density and interlamellar spacing. Nikas et al. [25] measured the dislocation density and interlamellar in test bars predeformed by the method described in this study (Section 2.2). The dislocation density was found to increase almost linearly with increasing shear strain whilst only a slight decrease in interlamellar spacing was observed. Thus, it can be considered that the interlamellar spacing have a limited contribution to the increased hardness of the PD3 and PD6 test bars.

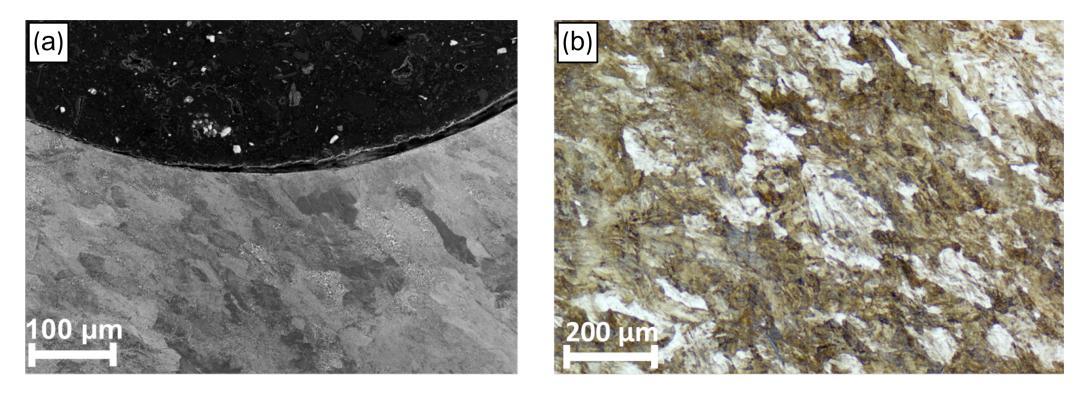
Figure 8. Microstructure of a PD3 test bar: (**a**) SEM micrograph at the notch and (**b**) optical micrograph, at the cross-section perpendicular to the radial direction, close to the lateral surface.

The micrographs in Figures 8 and 9 shows the microstructure of the deformed material state PD3. These micrographs depicts the cross-section perpendicular to the radial direction, close to the lateral surface, as indicated by the coordinate system in Figure 9. From Figure 8a,b it can be observed that the pearlite colony boundaries are distinguishable and the microstructure shows an overall alignment towards the tangential direction. It must be noted, that the overall microstructure alignment is not equivalent to the individual orientation of the lamellar structure within the pearlite colonies. This is qualitatively exemplified in Figure 9a,b. In Figure 9a, most of the lamellae are aligned along the shearing direction, as opposed to Figure 9b, where the lamellae orientation is observed to vary. This variation of lamellae orientation is not unexpected as the reorientation during shear deformation depends on the initial orientation. For example, comparing lamellae oriented perpendicular to the shear direction with lamellae oriented with an angle relative the shear load, the lamellae in the latter case will be more aligned along the shear direction [27,28]. As a consequence of the initial orientation variation, the interlamellar spacing will also vary throughout the structure. In addition, the micrographs of Figure 9a,b also features bent and curved cementite lamellae, which according to Zhang et al. [27] is explained on the basis of large inclination angles relative to the direction of the applied shear load. The reorientation of the cementite lamellae during predeformation was quantitatively measured by Meyer and Nikas [26]. They reported that the orientation of the cementite lamellae is statistically more probable along the tangential direction, at an angle depending on the pre-deformation level.

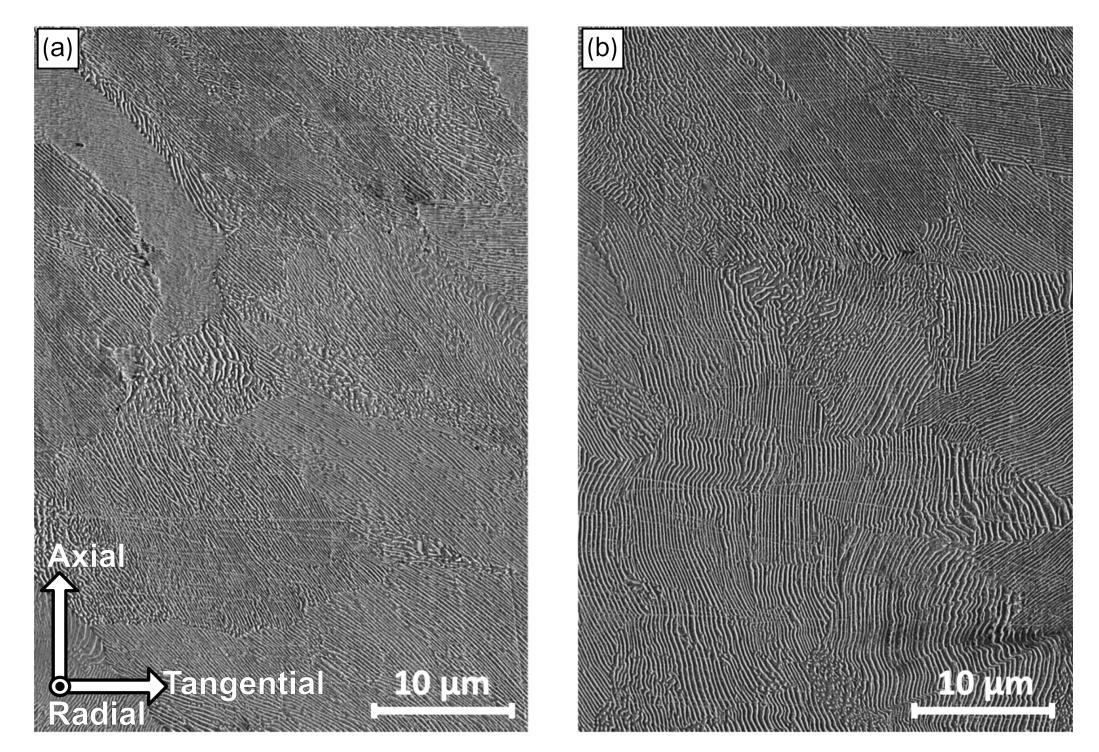
Figure 9. Orientation of pearlite lamellae in a PD3 test bar. In (a) most of the cementite lamellae have reoriented along tangential (predeformation) direction whilst no preferred direction is observed in (b).

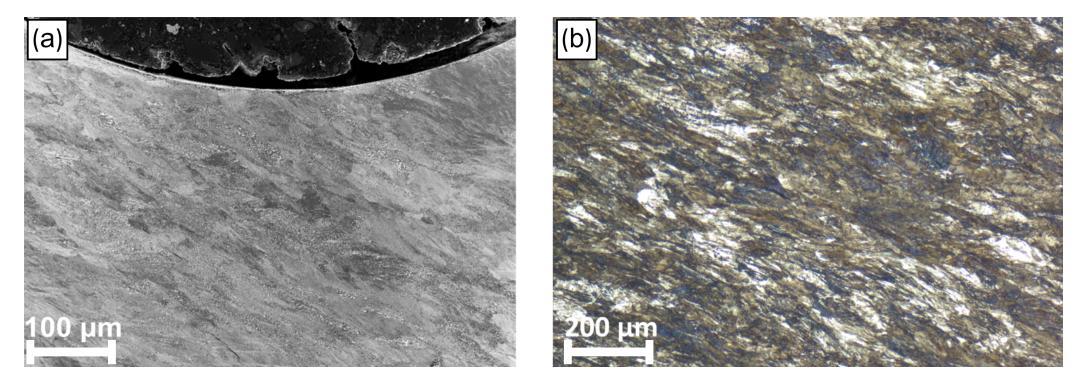
Figure 10. Microstructure of a PD6 test bar: (a) SEM micrograph at the notch and (b) optical micrograph at the cross-section perpendicular to the radial direction, close to the lateral surface.

The corresponding microstructure at the cross-section perpendicular to the radial direction, close to the lateral surface, for the predeformed material state PD6, is shown in

Figure 10a,b. Here, the microstructure shows an overall alignment towards the tangential direction. Compared with the material state of PD3, the alignment is more evident and the pearlite colony boundaries cannot easily be distinguished. The variation of the cementite orientation throughout the structure is observed as for the case of the PD3 microstructure. Several areas show curved lamellae, due to shear localization. This is exemplified in Figure 11a,b.

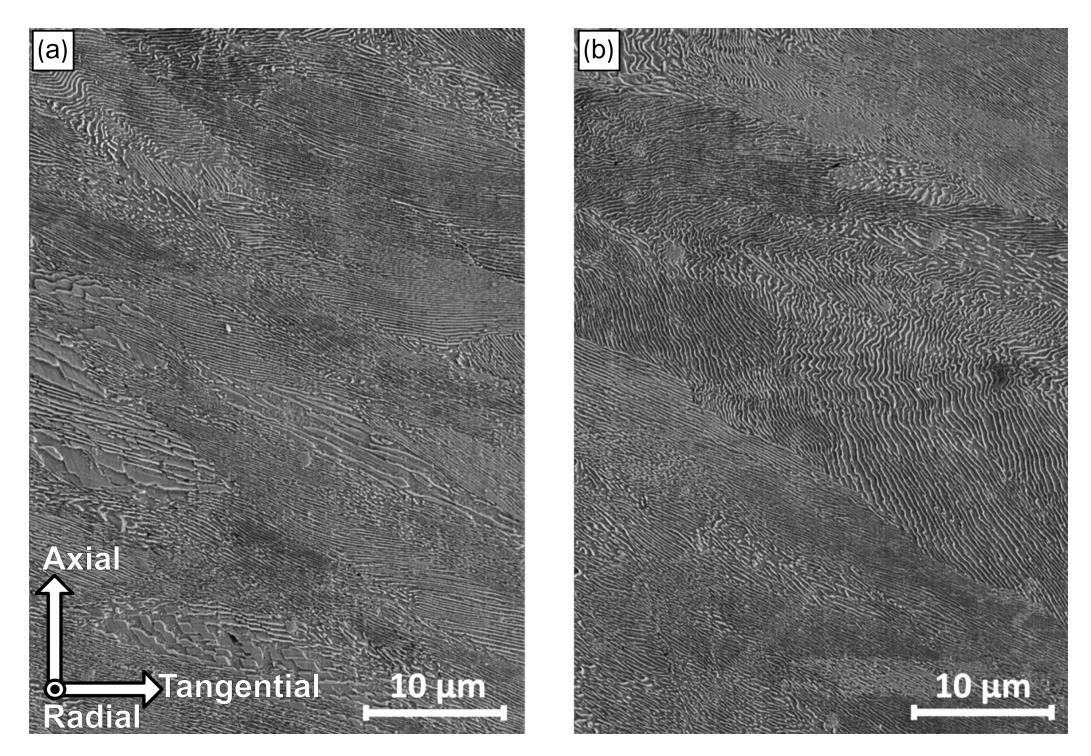
Figure 11. Orientation of pearlite lamellae in a PD6 test bar. In (**a**) most of the cementite lamellae have reoriented along the tangential (predeformation) direction whilst no preferred direction is observed in (**b**).

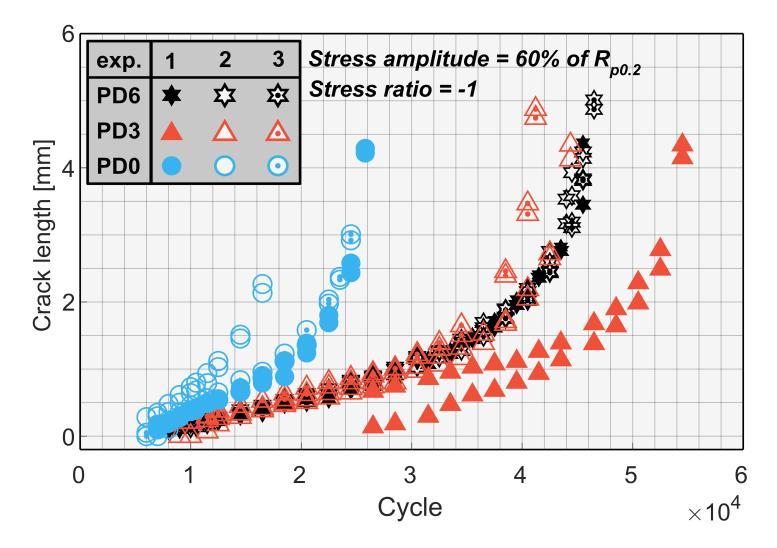
Figure 12. The results from the crack length measurements, conducted for the test series loaded with a nominal stress amplitude corresponding to 60% of Rp_{0.2}.

The crack length measurements, resulting from the crack propagation experiments conducted with a nominal stress amplitude corresponding to 60% of $\text{Rp}_{0.2,vg}$, are shown in Figure 12. In the graph, it can be seen how the surface crack length changes with the number of load cycles until failure. Note that in all measurements for each test bars, there are two measured cracks, one crack on each side of the notch. From the crack propagation measurements, it can be observed that the initial crack growth rate is constant, followed by a transition to an exponential increase in crack growth rate. This crack propagation

behavior is expected because the stress intensity at the crack front is dependent on the load bearing area, which reduces exponentially as the crack propagates. The area reduction can initially be considered as negligible, and the stress concentration induced by the notch dominates the local stress condition. Interestingly, the two cracks for each experiment almost extended at the same rate, indicating that the crack front becomes symmetric around the notch; cracks are initiating at each side of the notch, then joining to form a semi-elliptic crack front after some crack growth. This is further supported by the semi-elliptic fatigue fracture surface, see Figure A1.

When comparing the crack propagation resistance, a notable difference between undeformed and predeformed samples is observed. This difference is highlighted by the number of cycles to reach the same surface crack length, which was almost twice as many for predeformed test bars than for the undeformed. However, the predeformed material states PD3 and PD6 exhibit similar crack propagation resistance, except for one notable discrepancy; experiment 1 of PD3, which had approximately 25% longer fatigue life. In this case, crack initiation was delayed on one of the sides, with a subsequent lag in merging and progression into semi-elliptic crack growth, characterized by exponential crack growth rate.

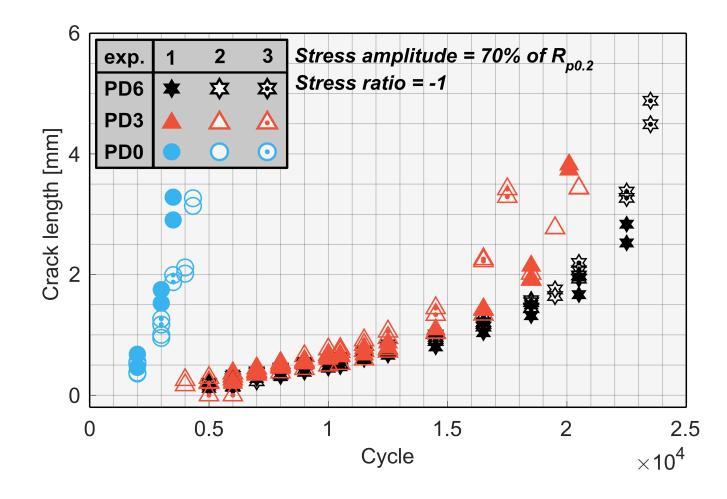
Figure 13. The results from the crack length measurements, conducted for the test series loaded with a nominal stress amplitude corresponding to 70% of $Rp_{0,2}$.

The crack length measurements, for the nominal stress amplitude corresponding to 70% of $\text{Rp}_{0.2,vg}$ is shown in Figure 13. Additionally, in this case, the two measured cracks follow each other well and the corresponding fracture surfaces are semi-elliptic, as shown in Figure A2. When compared to the lower nominal stress amplitude, it is observed that the initial constant crack propagation rate is higher, and the transition to exponential crack growth occurs earlier, for all tests. The difference in crack propagation resistance between undeformed and predeformed samples is large, larger than the corresponding difference observed for the lower nominal stress amplitude. In fact, the crack propagation rate in the undeformed test bars is so high that the crack measurement interval was too long to resolve the progression of the crack length. The comparison of the crack growth rates between the predeformed test bars PD3 and PD6 shows that there is a slight difference between them, with PD6 having higher crack propagation resistance. At this stress amplitude, the difference is clearer than what was observed at the lower stress amplitude, but still not drastic.

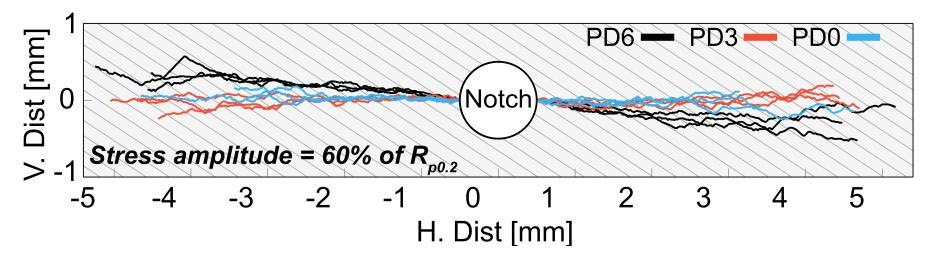
Figure 14. The final crack contour on the image plane (see Figure 4) for all test bars, loaded with a nominal stress amplitude corresponding to 60% of $Rp_{0.2}$.

For the length of the crack contours of the final crack before the fracture was measured on stitched micrographs from optical microscopy, see Section 2.3.2. In this case, the crack length was not corrected for the curvature of the test bar. To examine and visualize the correlation between crack path and material state, the crack surface contours were digitized. Digitization was done by extracting the crack contour in a commercial photo editing software. The pixel data of the crack contour was converted to spatial data by using a Matlab script. The processed crack contours are visualized in Figures 14 and 15 for respective nominal stress amplitude. The background grid represents the magnitude of surface shear deformation in PD6 test bars along the direction of microstructure alignment. It can be observed that for both nominal stress amplitudes, the surface crack in the undeformed material is on average straight with local crack kinking, as is the crack path for PD3. Comparing these crack paths with the crack paths of PD6 in the lower stress amplitude experiments, it can be seen that there is a slight difference in the average inclination angle. However, at the higher stress amplitude there is no distinct difference between the different material states. The crack paths are further discussed in Section 4.2. Validation data for the crack contours is available as Supplementary Material.

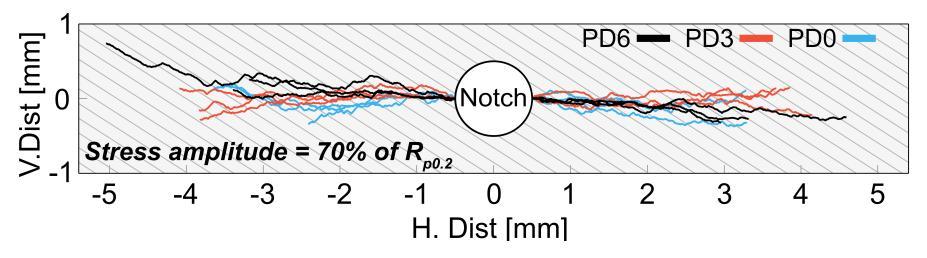
Figure 15. The final crack contour on the image plane (see Figure 4) for all test bars, loaded with a nominal stress amplitude corresponding to 70% of $Rp_{0.2}$.

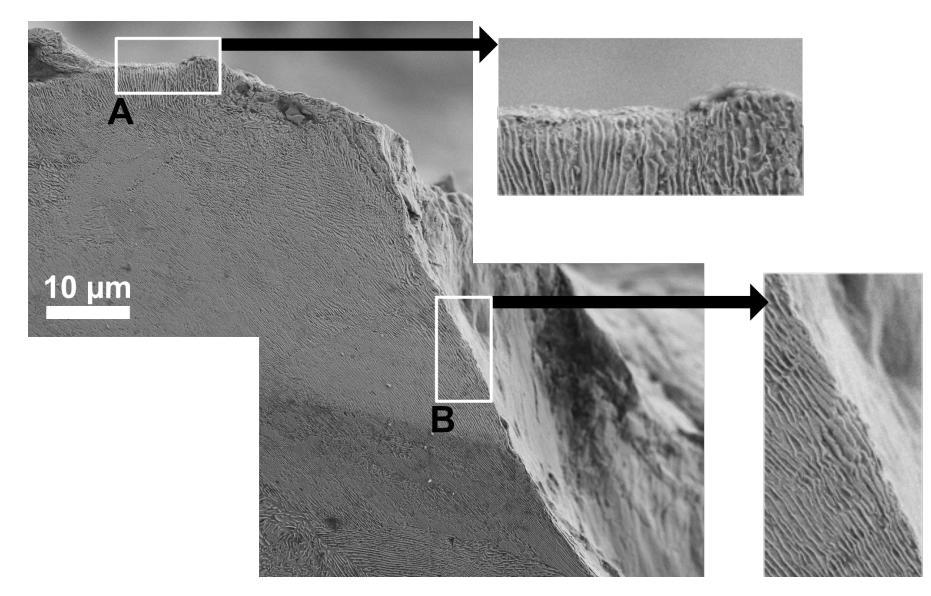
Figure 16. Surface crack path (on the lateral surface) for a PD3 test bar. The figure exemplifies the observed variation in crack growth direction on the surface. The detailed views A and B show the surface crack growth across and along the cementite lamellae, respectively.

The surface crack path relative the orientation of the cementite lamellae was closely examined in a scanning electron microscope (FEGSEM). The correlation between crack growth direction and orientation of the cementite lamellae was found to be limited. The variation of crack growth direction with respect to orientation of the cementite lamellae is exemplified in Figures 16 and 17, for PD3 and PD6 samples. These figures qualitatively demonstrate the variation in crack growth direction; only along small sections is the crack observed to propagate along the cementite lamellae, see detailed view B and A in Figures 16 and 17. In other sections the crack propagates across the cementite lamellae, as exemplified in the detailed views A and B of Figures 16 and 17.

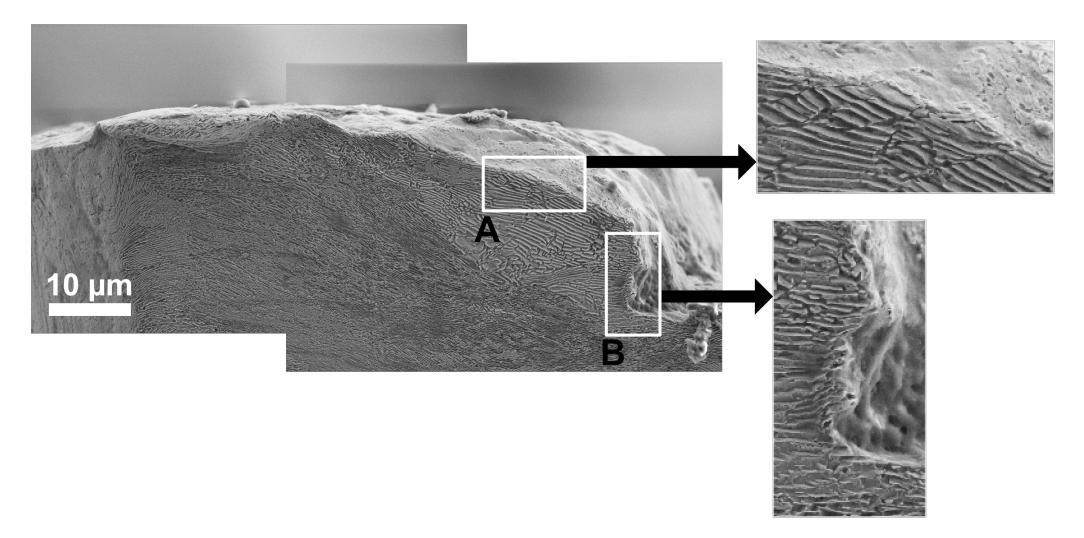
Figure 17. Surface crack path (on the lateral surface) for a PD6 test bar. The figure exemplifies the observed variation in crack growth direction on the surface. The detailed views A and B show surface crack growth along and across the cementite lamellae, respectively.

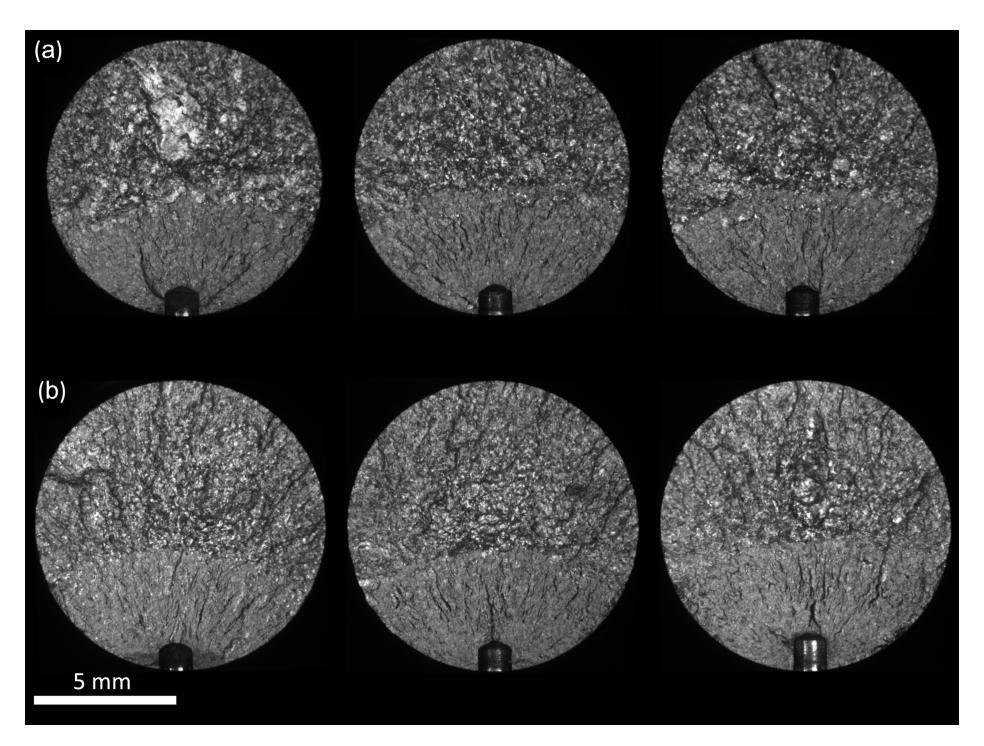
Figure A1. Fracture surface of the predeformed test bars loaded with a nominal stress amplitude corresponding to 60% of the offset yield strength, $Rp_{0.2}$. (a) shows the PD3 test bars and (b) shows the PD6 Test bars.

Meyer et al. [24] characterized the yield surface of the pearlitic rail steel R260 subjected to different levels of predeformation by using tubular specimens. The yield strength was determined by using plastic work W_p as a criterion for yielding. The yield stress of the undeformed material was 475 MPa. It was found that predeformation induces anisotropy in the plastic behavior. The increase in yield stress on axial loading in tension for $W_p = 0.5 \text{ mJ/mm}^3$ was 60 MPa for $\gamma = 0.6$ and 123 MPa for $\gamma = 1.13$. In compression even larger increases in yield stress were reported, with 234 MPa for $\gamma = 0.6$ and 274 MPa for $\gamma = 1.13$, i.e., a proof of stress asymmetry. The accumulated shear strain magnitudes of this study is close to the accumulated strain in the PD3 and PD6 test bars. The PD6 test bars have slightly higher accumulated shear strain and thereby the actual yield strength is expected to be slightly higher than for $\gamma = 1.13$. The main difference between the predeformed test bars in the present study and the hollow test bars is the strain gradient, which is present in only solid test bars. Thus, the further the crack grows in depth, the lower is the pre-strain level and consequently the mechanical behavior of the material in front of the crack varies along the radial direction. Interestingly, the crack front in our case is still semi-elliptic, as normally found in solid, homogeneous materials, governed by the local stress intensity along the crack front. The semi-elliptic shape of the final fatigue crack in our case proves that the fracture properties in the outermost pre-strained material are at least on par with the undeformed material. If it would have been significantly more brittle, the crack front would likely have advanced further around the perimeter of the test bar. The fatigue fracture surface for predeformed material is shown in Figures A1 and A2 for the respective nominal stress amplitude.

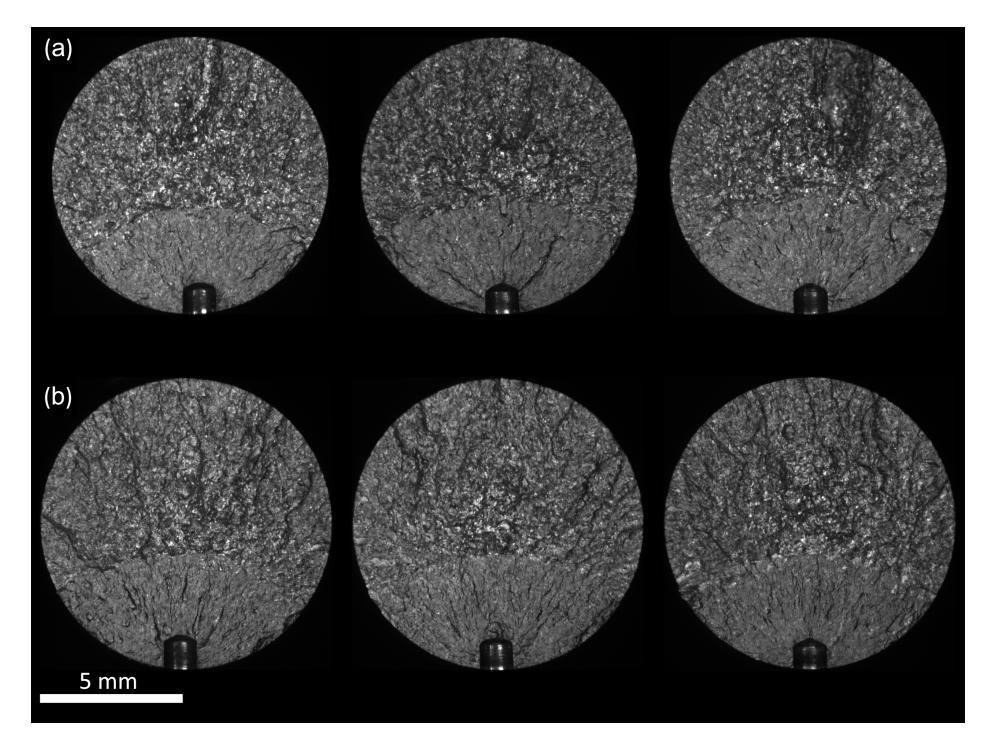
Figure A2. Fracture surface of predeformed test bars loaded with a nominal stress amplitude corresponding to 70% of the offset yield strength, $Rp_{0.2}$. (a) shows the PD3 test bars and (b) shows the PD6 Test bars.
