On wayside detector measurement of wheel-rail impact loads induced by wheel flats – Data analysis, alarm levels and regulations

Klara Mattsson^{1*}, Jens C.O. Nielsen², Lars Fehrlund³, Michele Maglio¹ and Tore Vernersson²

¹ Trafikverket, Gothenburg, Sweden ² Department of Mechanics and Maritime Sciences/CHARMEC, Chalmers University of Technology, Gothenburg, Sweden ³ Green Cargo AB, Stockholm, Sweden ^{*} klara.mattsson@trafikverket.se

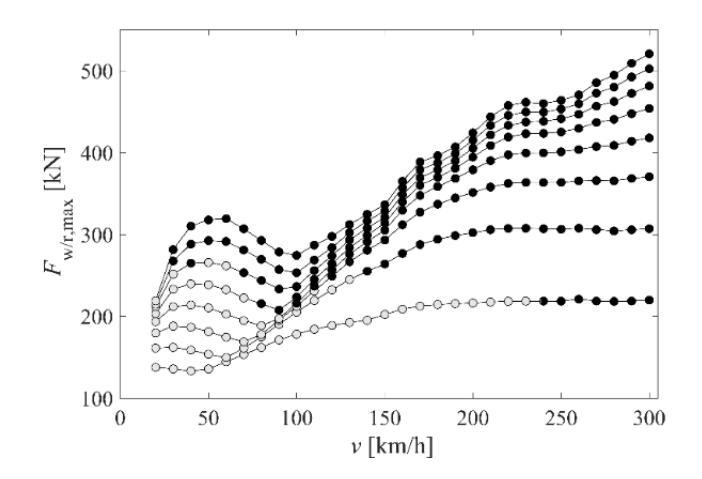
Figure 1: Simulated peak loads (including static wheel load 118 kN) due to a rounded wheel flat with length $l = 1.76 \cdot l_0$. The lines (from lower to upper) correspond to flat depths d = [0.25, 0.50, 0.75, 1.00, 1.25, 1.50, 1.75, 2.00] mm. Each circle illustrates the maximum of the impact loads from eight simulations with different initial angular positions of the wheel within one sleeper bay. Black circles indicate that loss of contact occurs for at least one of these eight simulations. From [11].

Field tests of dynamic vehicle-track interaction involving trains with different types of wheel tread irregularities have been reported in several studies, see [4–10]. For a given wheel flat, these measurements have indicated a local maximum in vertical wheel-rail contact force (impact load) in the train speed interval 30 - 60 km/h. It has also been reported that the speed of this local maximum was increased with increasing axle load [7]. For comparison, the simulated influence of train speed and depth of a wheel flat on the generated impact load is illustrated in Figure 1 [11]. With increasing flat depth d, it is shown that the magnitude of the impact load increases and momentary loss of wheel-rail contact occurs at a lower train speed. In the figure, it is observed that the speed dependence is essentially similar for different depths, but the local maximum and minimum of each curve are more pronounced for larger depths and are also shifted to higher speeds.

- For locomotives, the 'high' alarm level is 425 kN.
- If a locomotive wheel generates a peak load exceeding 350 kN and the ambient air temperature is below -10 C°, train speeds in the interval 15 45 km/h should be avoided [16], cf. the local force maximum in Figure 1.

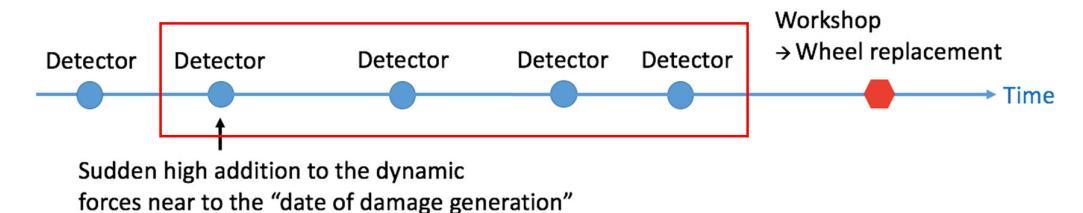
Figure 2: Timeline describing the approach used to extract detector data to be included in the analysis. In this example, data from four detector passages by the same wheelset were selected for the analysis. From [17].

The analysis started by examining a document containing information about wheel replacements in the workshop in Luleå. The document included information about when and for what reason a wheel was replaced. If the reason for replacement was a wheel flat, the length of the non-rounded part of the wheel flat had been measured in the workshop before wheel turning. As measurement of wheel flat length is notoriously difficult, flat lengths had generally been rounded up to the nearest 5 millimetres. For each detected wheel flat, data from the six WILDs was compiled for the corresponding wagons and the studied time period. The date of discovered damage that was stated in the document from Luleå was used as a starting point to manually find in between which two detectors the wheel flat was generated. In total, 823 detector passings by 149 different wheelsets (with at least one of the wheels on the axle being defective) were included in the analysis. Figure 2 illustrates an example of how four data points were extracted to the database.

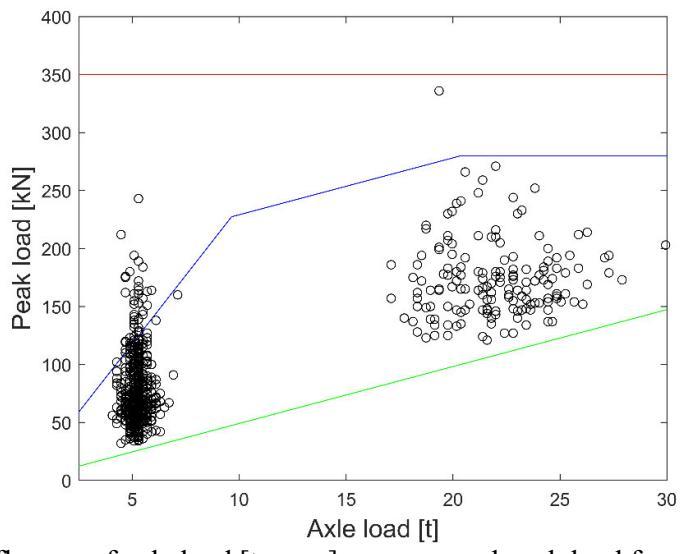
Figure 3: Influence of axle load [tonnes] on measured peak load for all 823 analysed detector passages. The red line is the 'high' alarm at 350 kN. The blue line indicates warning levels set by Trafikverket in terms of ratio (axle loads up to 10 tonnes), dynamic load (axle loads in the interval 10 – 20 tonnes) and peak load. The green line illustrates the relation between mean load and axle load. From [17].

- 'Warning' levels are set at 280 kN (peak load), 180 kN (dynamic load) and 4.8 (ratio) independent of vehicle type.
- If the measured peak load, dynamic load or ratio exceeds a 'warning' level (but not the peak load 350 kN), cf. Figure 3, the train may continue without regulations to its destination. From there it is not allowed to continue operating until the wheel has been rectified and approved by certified staff. This regulation holds unless it is found that the length of the wheel tread damage exceeds 60 mm.

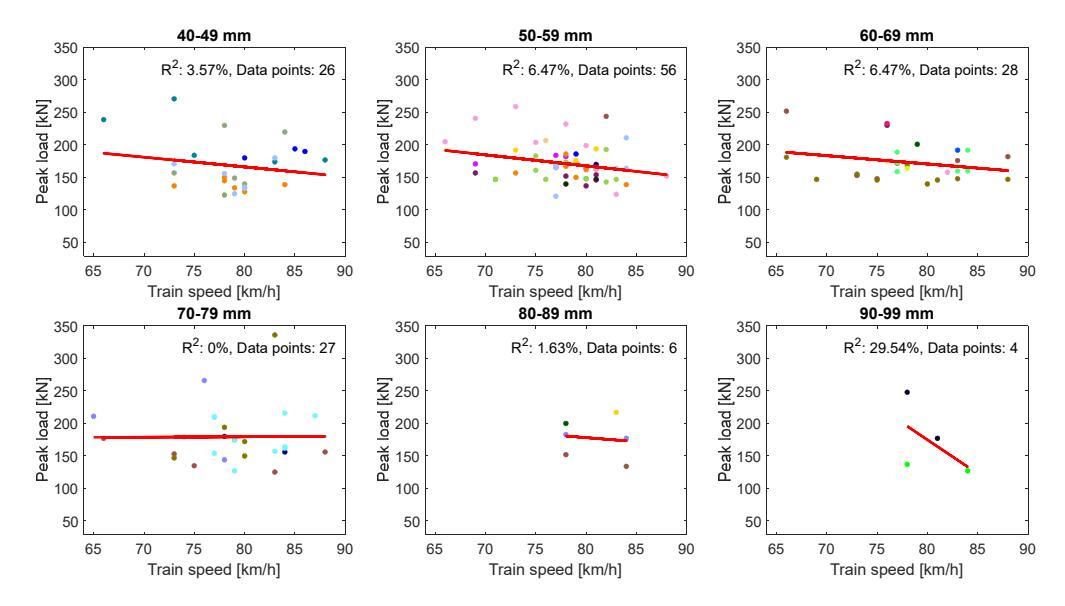
Figure 4: Influence of train speed on measured peak loads: different wheel flat length intervals, loaded wagons with axle loads 17 – 25 tonnes. From [17].

For different intervals of wheel flat length, and for loaded and unloaded wagons, Figures 4 and 5 present the influence of train speed on measured peak loads. A linear regression has been made in each subplot to indicate any possible trend in the data, but as the R^2 -value (coefficient of determination) is generally very low this could not be confirmed. In some of the subplots, the number of data points is very small. Nevertheless, based on these measurements, there seems to be no evident increase in peak load with increasing train speed for any of the wheel flat length intervals. Neither can a local maximum as in Figure 1 be observed. In each subplot, each colour represents one specific wheel flat. Thus, if the same colour is repeated several times, this means that the same wheel flat has passed several detectors. For the two wheels on an axle, the highest peak load was extracted from each detector passage. Thus, the same colour could potentially represent either the left or the right wheel on the same axle. As mentioned above, wheel flat lengths were measured in the workshop before the wheels were turned. Figures 6 and 7 show the same data, but in this case for different intervals of train speed. Although the scatter in data is again very significant, an expected trend indicating higher peak loads with increasing flat length can be distinguished in most subplots.

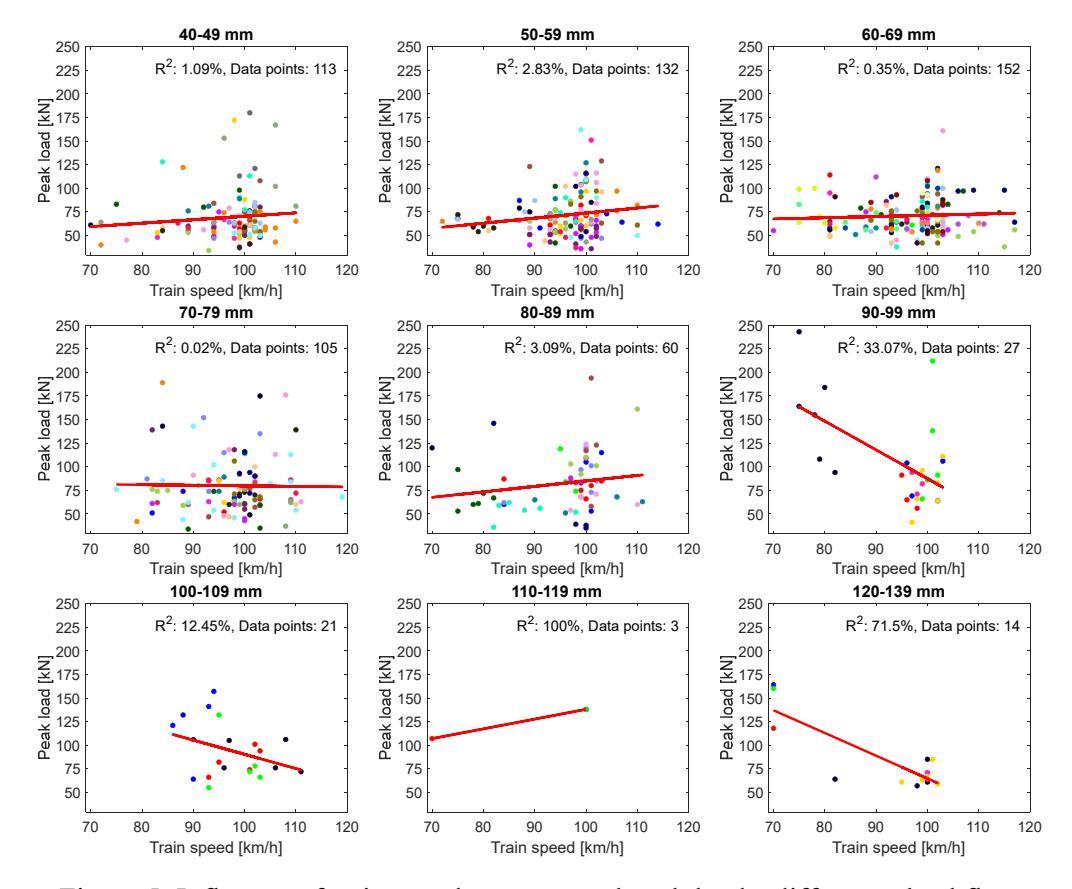
Figure 5: Influence of train speed on measured peak loads: different wheel flat length intervals, unloaded wagons with axle loads 4.5 - 6 tonnes. From [17].

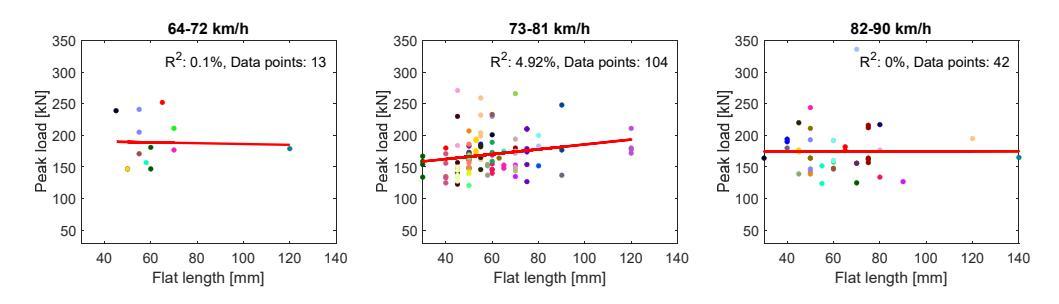
Figure 6: Influence of wheel flat length on measured peak loads: different train speed intervals, loaded wagons with axle loads 17 – 25 tonnes. From [17].

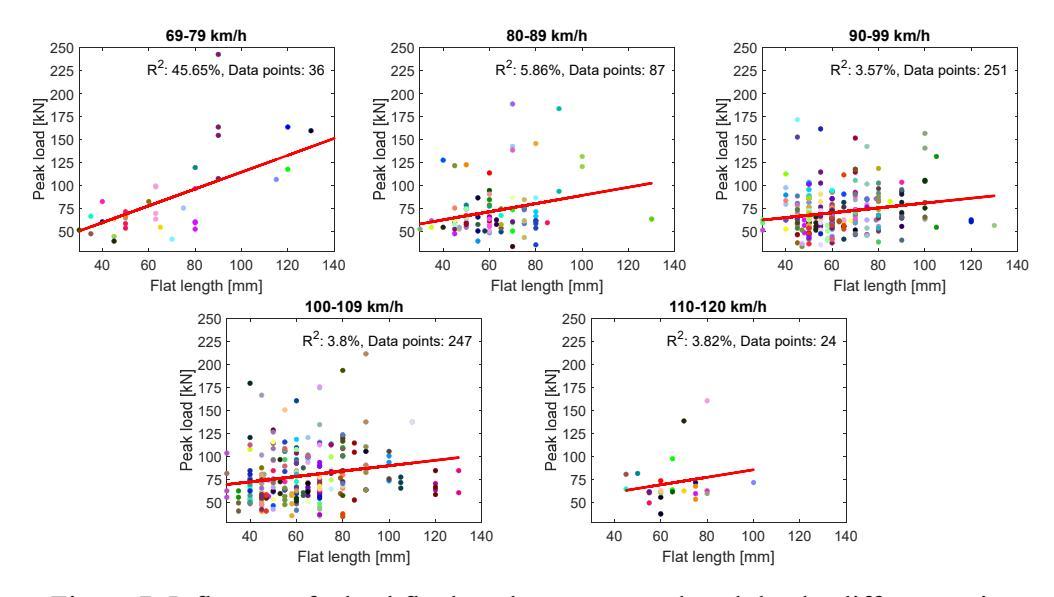
Figure 7: Influence of wheel flat length on measured peak loads: different train speed intervals, unloaded wagons with axle loads 4.5 – 6 tonnes. From [17].

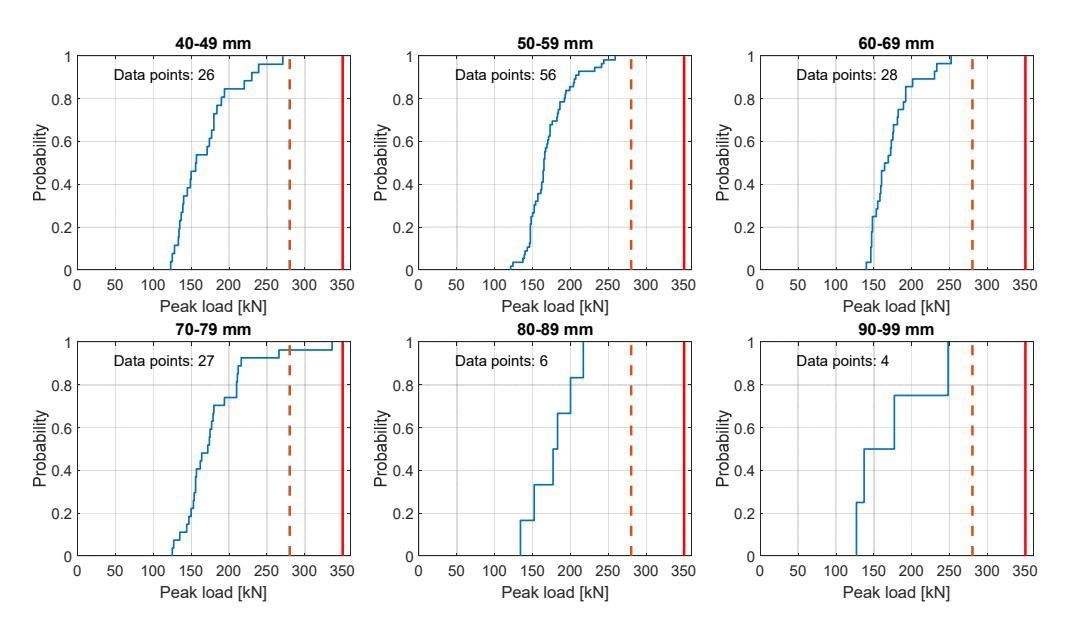
Figure 8: Cumulative distributions of peak load for different intervals of wheel flat length: loaded wagons with axle loads 17 – 25 tonnes. From [17].

Figure 8 presents the cumulative distributions of peak load for the same data as in Figure 4. The red line indicates the 'high' alarm limit of 350 kN, while the orange dashed line is the warning level 280 kN set by Trafikverket. In summary, based on the 823 investigated detector passages with wheel flats of different lengths, there was no case of peak load exceeding 350 kN. This was surprising since several of the investigated cases involved wheel flats significantly longer than 60 mm.

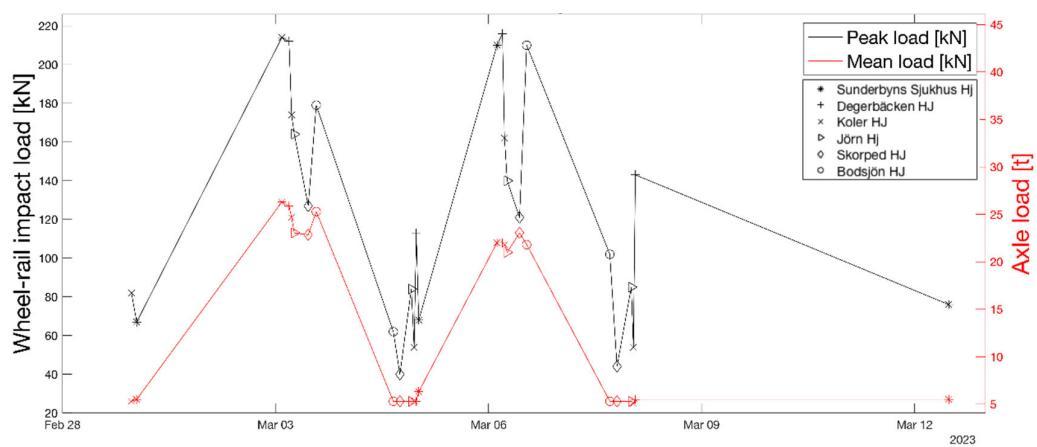
Figure 9: Peak loads and axle loads for one given wheel flat with length 75 mm measured in six WILDs along the route of *Stålpendeln*. From [17].

For a given 75 mm wheel flat, all registered peak loads and mean loads in six different WILDs along the route of Stålpendeln have been studied, see Figure 9. The presented data covers the period from when the flat had been generated until the wheelset was taken out of service for repair. Two journeys in loaded conditions and three journeys in tare conditions are considered. A large variation in measured loads between different detectors during a given journey is observed. Further, a clear pattern in how the detectors measured relative to each other is noted, see for example differences in data from the detectors at Degerbäcken and Skorped. This indicates that besides the

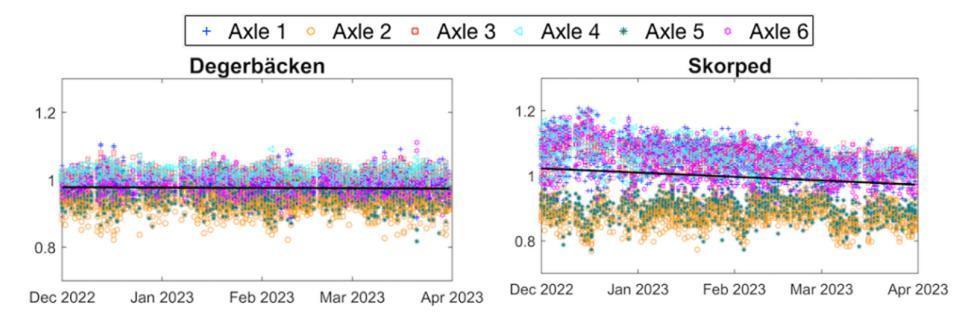
Figure 10: Ratio between measured mean load and nominal axle load for Transmontana CoCo locomotives. WILDs at Degerbäcken and Skorped.

According to regulations set by Trafikverket, measured mean loads for locomotives should be within a tolerance of \pm 5%. The accuracy of mean loads measured in the detectors at Degerbäcken and Skorped have been assessed by collecting measured loads from the Transmontana CoCo locomotives that are used to pull the *Stålpendeln* wagons. For each wheelset, the mean loads of both wheels on the same axle were summed and divided by the nominal axle load of the locomotive. Note that the nominal weight (125 tonnes) of the locomotive may vary during the winter due to accumulation of ice in the bogies. The evaluated ratios between mean load and nominal axle load are presented in Figure 10. A linear regression has been made based on all data in each plot. For both detectors, it is observed that the measured loads for axles 2 and 5 are consistently lower than for the outer axles in each bogie. Nevertheless, it is argued that the measurement accuracy (in terms of mean load) of the detector at Degerbäcken is considerably higher than for the detector at Skorped.

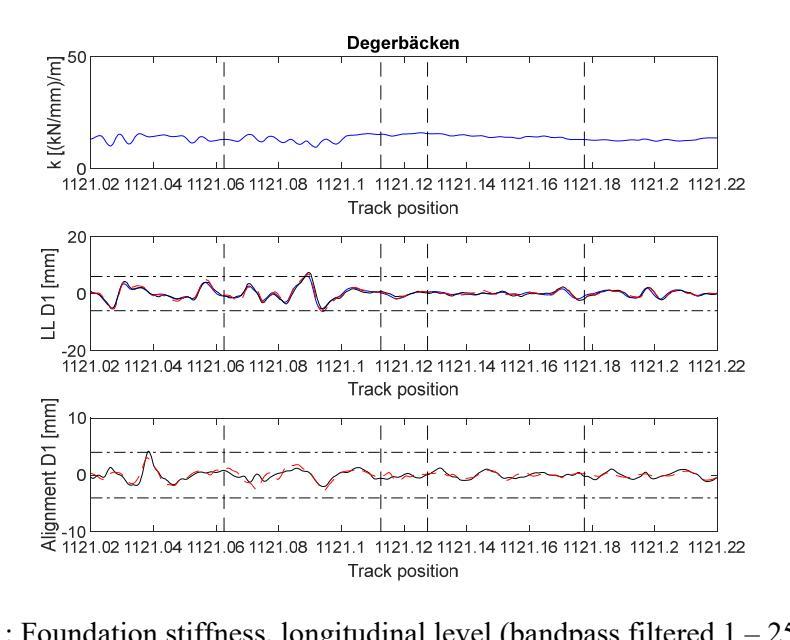
Figure 11: Foundation stiffness, longitudinal level (bandpass filtered 1 – 25 m) and alignment (1 – 25 m) measured over a distance of 200 m in the WILD at Degerbäcken. Blue curves were measured on 2022-06-07. Black (left rail) and red (right) curves were measured on 2023-05-31. The inner pair of vertical lines indicates detector area 1 (15 m), while the outer pair of vertical lines indicates detector area 2 (50 m on either side of detector area 1). Horizontal dash-dotted lines indicate suggested tolerances in terms of planned maintenance for tracks with maximum allowed speed up to 160 km/h.

In parallel, track foundation stiffness and track irregularities in the detectors along the route of *Stålpendeln* have been measured by track recording cars [18], see Figures 11 and 12. For the WILD at Degerbäcken, it was found that measured vertical track stiffness is relatively uniform and that the track geometry is within the proposed tolerance limits. On the other hand, it is observed that the WILD at Skorped has irregularities within the detector area both in terms of track stiffness and track geometry, which could affect the vehicle dynamics while passing through the detector. In summary, the calibration of the detectors, as well as the measured variations in track stiffness and track geometry at the detector sites might have contributed to the scatter in measured peak loads.

line (axle load, speed, passenger/freight etc.). Further, as illustrated in Figures 11 and 12, irregularities in track geometry and track stiffness should be monitored and rectified.

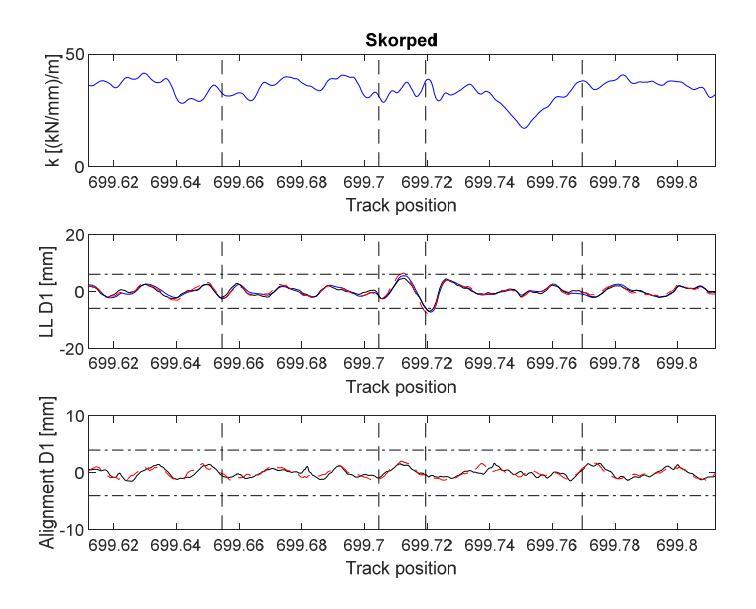
Figure 12: Foundation stiffness, longitudinal level (bandpass filtered 1 - 25 m) and alignment measured in the WILD at Skorped. Blue curves: 2022-10-05. Black and red curves: 2023-08-13.
