Environmental Risks Posed by Sunken Wrecks

Research methods and environmental aspects

Case No.: 1399-14-01942-6

Swedish Maritime Administration, 2014

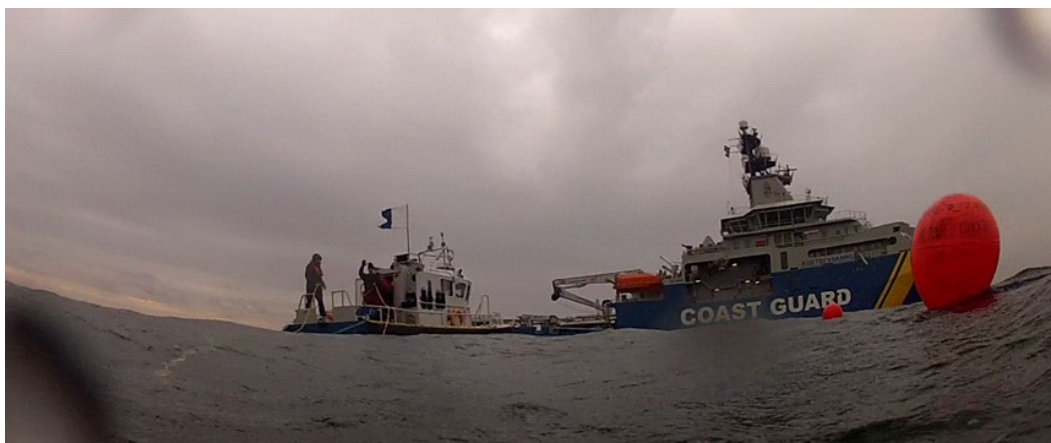
Figure 3. Diving inspection of KBV 003 Amfitrite. Photography: The Coast Guard

Certain diving operations require additional arrangements to ensure safety (Figure 3). A safe and effective diving operation requires planning and preparations, which, among other things, means taking weather conditions into account—such as waves, wind, and currents—and also the light and visibility conditions in the water. The type of work, methods, tools, and other aids must be carefully planned and prepared. A safe and stable platform with proper equipment and detailed information for preparations are required to be able to perform the work safely and effectively, which will also minimize the time the vessel spends in the area. A diving operation for documentation of a large wreck in water that is shallower than 40 meters normally takes one day. Investigations involving measurement of hull thickness and sampling normally take an additional day.

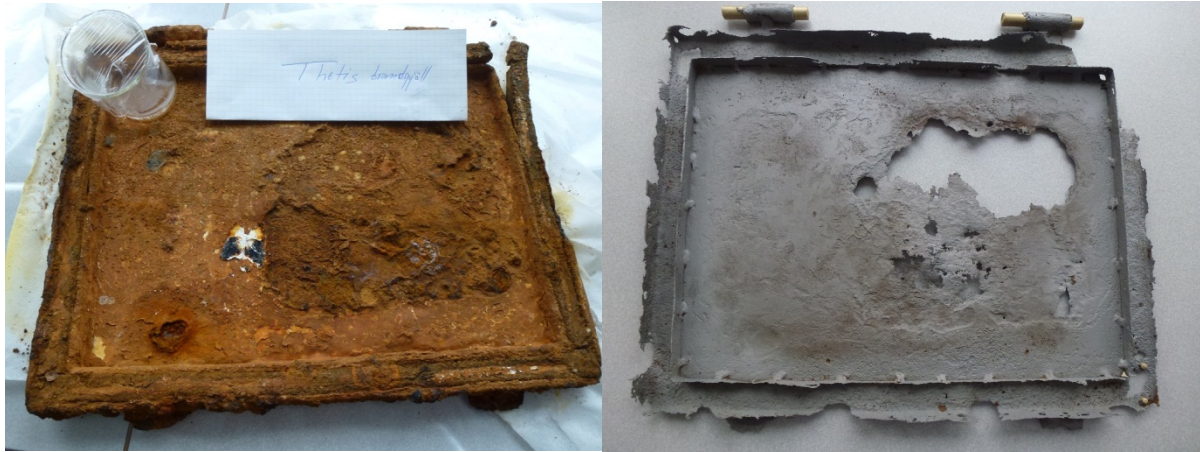
Figure 4. Ventilation hatch from before and after blasting. Photography: Swerea-KIMAB

Samples for further assessment of corrosion status and corrosion rate should preferably be taken from tanks that—based on archive data on the wreck—are suspected of containing a potentially hazardous substance. In those cases where diving into the wreck entails significant occupational risks, samples can be taken from the plates on the hull or, alternatively, from steel structures on the deck, such as goose-neck vents, hatches, etc. (Figure 4).

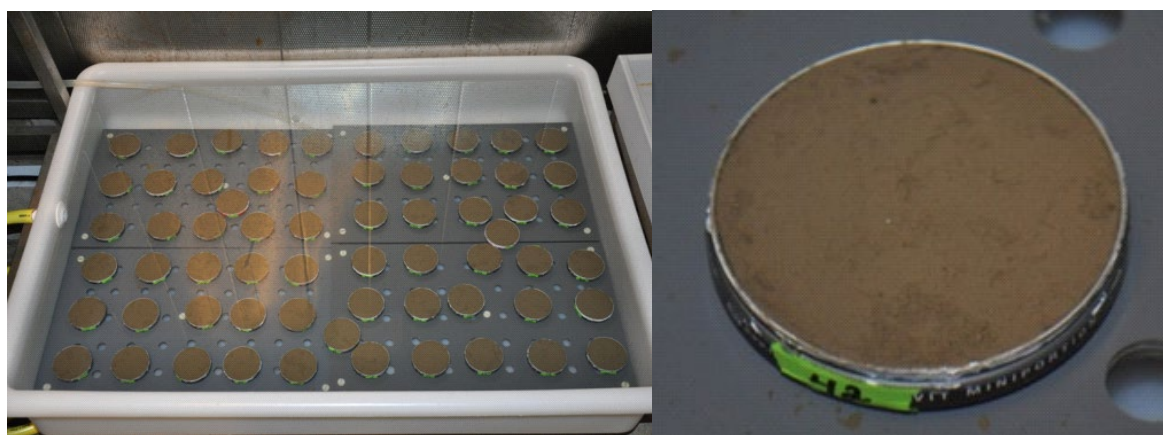
Figure 6. Experimental set-up at the Sven Lovén Center for marine sciences, with conditions similar to those in situ. The panel to the right shows a sediment plug (actual size).

Three different experiments were performed in the laboratory at the Sven Lovén Center for marine sciences, Kristineberg, with sediment taken in or just outside of the Gullmar Fjord. The type of oil used was MK-1 diesel, and the concentrations to be studied were based on calculations of PAH content.

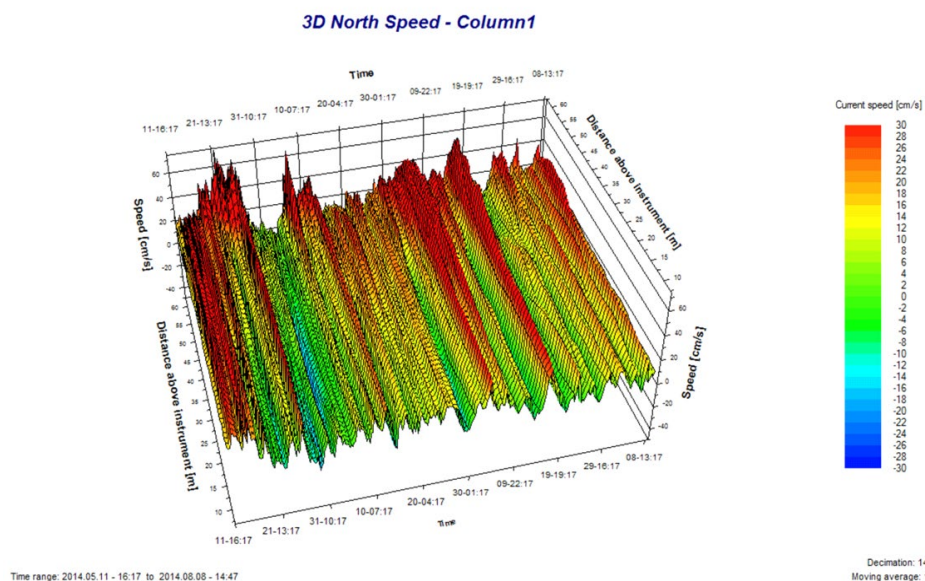
Figure 14. Analysis of current components in the north-south direction. Predominantly northbound current.

The current-measuring equipment (RDCP) with oxygen, turbidity, temperature, and salinity (conductivity) sensors was used on May 11, 2014, by the hydrography vessel Anders Bure. There was a weak southerly wind with a northbound current of about two knots. The RDCP ended up about 84 meters north-east of the wreck. The first retrieval of data was done on August 8, 2014, and showed a clearly prevalent northerly current with a typical current speed of 0.2–1.7 knots (Figure 14).

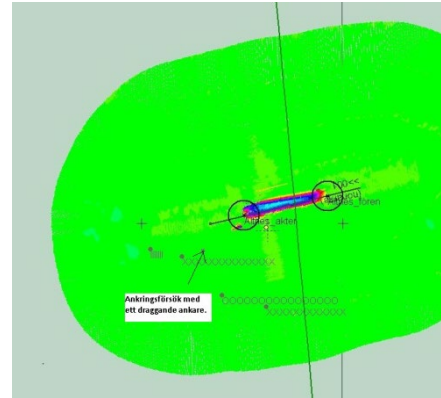
Depth 36–37 meters with sediment of clay and sand. Anchoring in a crowfoot, with the main anchor of Anders Bure (50 kg anchor, about 15 meters of chains and 75 meters of wire, 90 meters in total). Assisted by reserve anchor (25 kg, with 10 meters of chains and 80 meters of tarp, 90 meters in total).

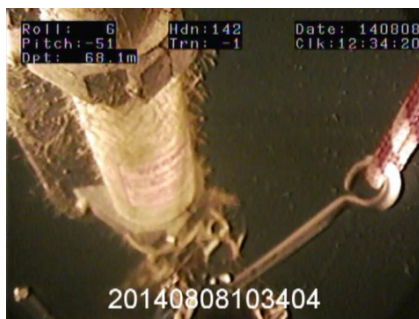
ROV-based salvaging of ADCP with a hook and salvaging rope on the right-hand side of the picture. The acoustic release was somewhat bio-fouled after about three months in the water. Due to strong current, it was necessary to use almost 300 meters of cable for the ROV.

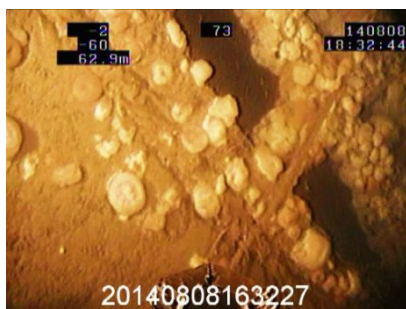
The remains of the fishing gear are located next to the bow on the port side.
