Manufacturing of Valve Bridge Component Utilizing Lean Alloyed Powders and Vacuum Sintering

MANUFACTURING OF VALVE BRIDGE COMPONENT UTILIZING LEAN ALLOYED POWDERS AND VACUUM SINTERING

R. Shvab, M. V. Sundaram, H. Karlsson, D. Chasoglou, S. Berg, E. Hryha, L. Nyborg

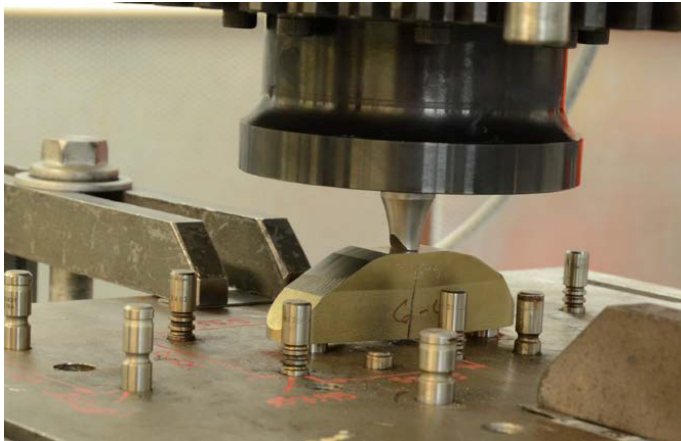
The high cycle fatigue properties of the valve bridges were tested in the RUMUL vibrophore machine. Loads were measured with the built in load cell. The fixture consisted of two valve shafts cut and fitted into a 25 mm thick steel plate. The diameter of the valve shafts were 10 mm. A flat wedge with a rounded top was used for load application in the middle between the valve shafts to create a 3 point bending load, see Figure 2. Fatigue testing frequency was 112 Hz. The cycling was carried out until the frequency dropped 3 Hz.

Fig.2. High cycle fatigue testing set-up.

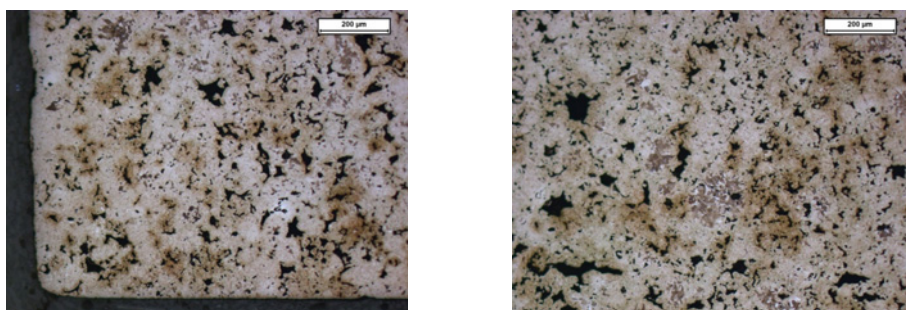
The microstructure of low Cr alloyed material is mostly martensitic with areas of ferrite and pearlite, see Figure 5.

Fig.5. The microstructure of low Cr alloyed material sintered at 1120°C.

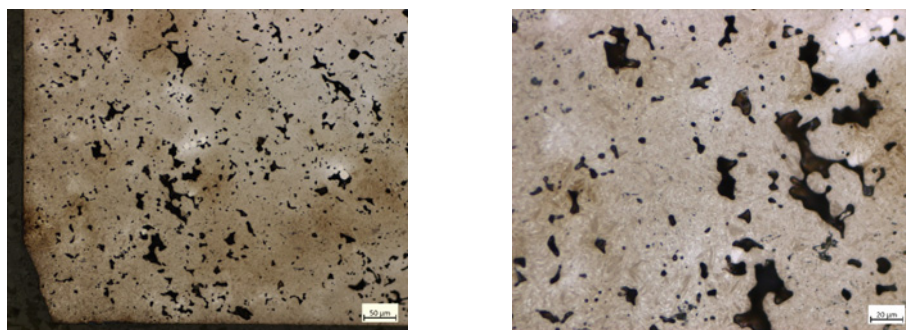
The microstructure of Astaloy CrA material contains martensite with Ni-rich austenite areas and some bainite, see Figure 6. Areas of austenite and bainite are smaller for material sintered at 1250°C due to better diffusion at higher temperature.

Fig.6. The microstructure of Astaloy CrA material sintered at 1120°C.

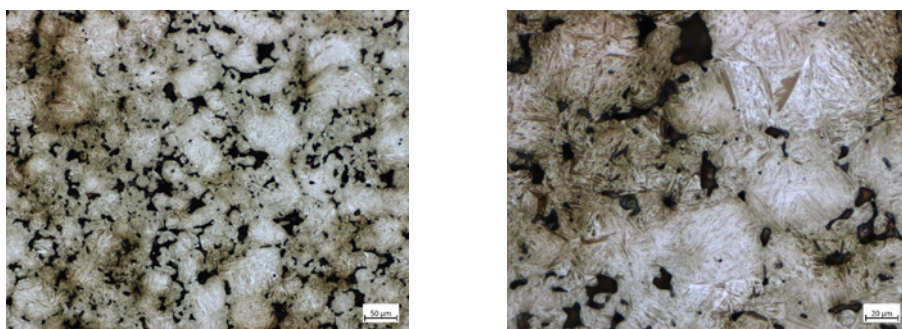
In the case of Distaloy DH, the microstructure was martensitic, see Figure 7.

Fig.7. The microstructure of Distaloy DH material sintered at 1120°C.

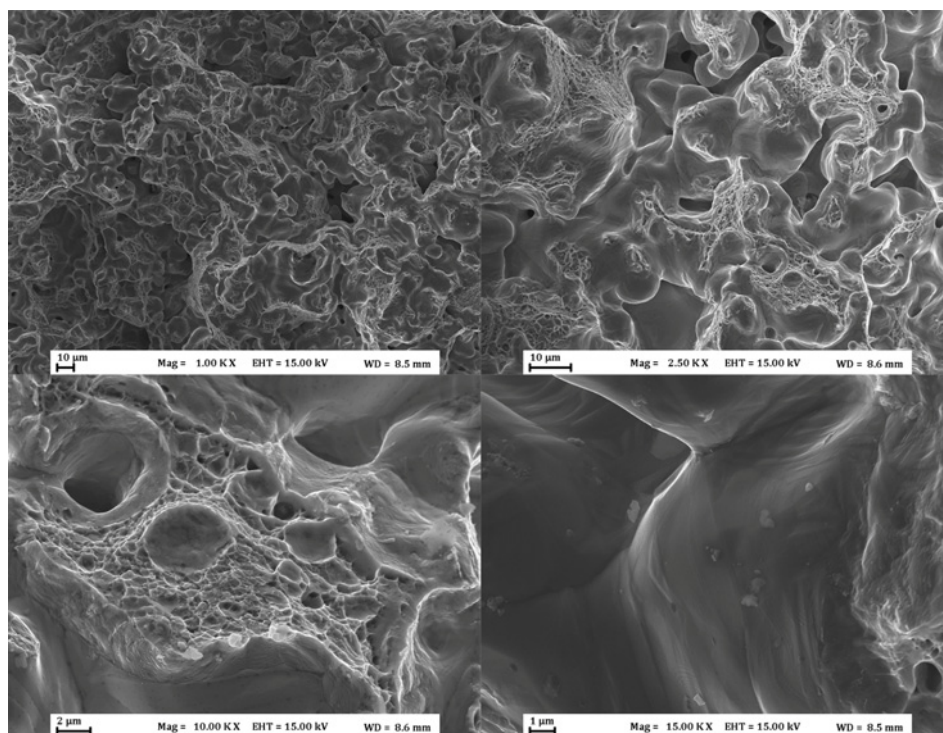
Similarly to low Cr alloyed material, ductile fracture was the main mechanism of failure for Distaloy DH material sintered at both 1120 and 1250°C temperatures, see Figure 11. Well developed sintering necks with absence of residual oxides indicate good quality of sintering process.

Fig.11. Fracture surface of Distaloy DH material sintered at 1120°C.
