## **Performance of insulation materials for historic buildings: case-studies comparing super insulation materials and hemp-lime**

Johansson, P., Donarelli, A., Strandberg, P. (2018). Performance of insulation materials for historic buildings: case-studies comparing super insulation materials and hemp-lime. Proceedings of the 3rd International Conference on Energy Efficiency in Historic Buildings, EEHB2018: 80-88

# Performance of insulation materials for historic buildings

Case studies comparing a super insulation material and hemp-lime

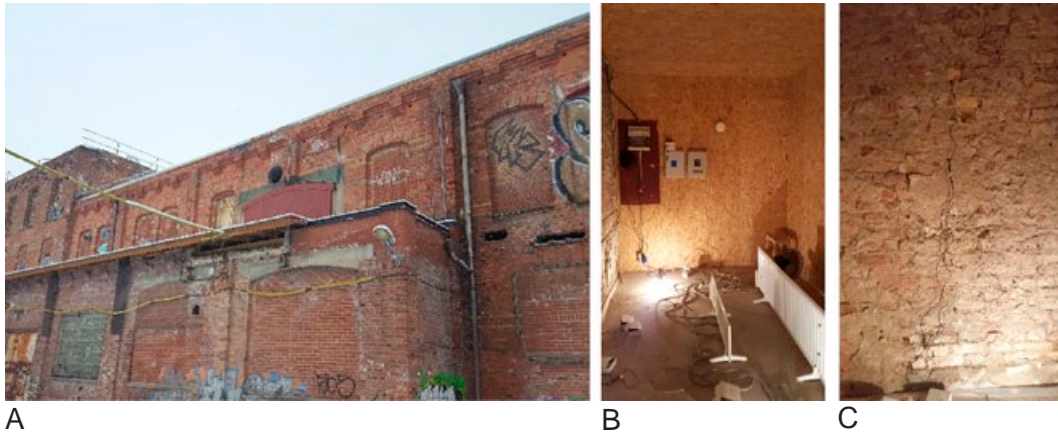
An old industrial brick building, see Figure 3, south of Gothenburg is planned to be equipped with VIP on the interior of the wall during 2018. The walls are made of 500 mm thick non-insulated homogenous brick masonry which gives a calculated U-value of 1.0 W/m<sup>2</sup>K. The building was constructed in 1896 and has been reconstructed several times since then.

Figure 3. A) Industrial building from 1896 south of Gothenburg to be insulated on the interior with VIP, B) The test room inside the industrial building, C) Sensors in the external brick wall. Photos: Pär Johansson.

There are several challenges to renovate the building where the thermal performance of the walls is one example. The cultural values of the building have been evaluated and one of the features that is considered important is the brick façade. Therefore, interior insulation is considered to be a possible solution to reach sufficient energy performance [19]. Inside a part of the deserted building, a small room (2.1 x 2.6 x 4.0 m) has been constructed which consist of floor, walls and roof insulated with 170 mm mineral wool, and the exposed brick wall, see Figure 3. The room is heated to around 22 °C and ventilated by natural ventilation with 0.5 h<sup>-1</sup> air exchange rate. The air in the room is circulated by a fan to create homogenous temperature and moisture conditions in the entire room. The exterior wall is divided in three parts where VIP will be tested and compared to a non-insulated reference. The wall is equipped with hygrothermal sensors that every hour registers the temperature and relative humidity in the middle of the wall and at the interior surface. A weather station monitors the outdoor temperature, relative humidity, wind speed and rain intensity.

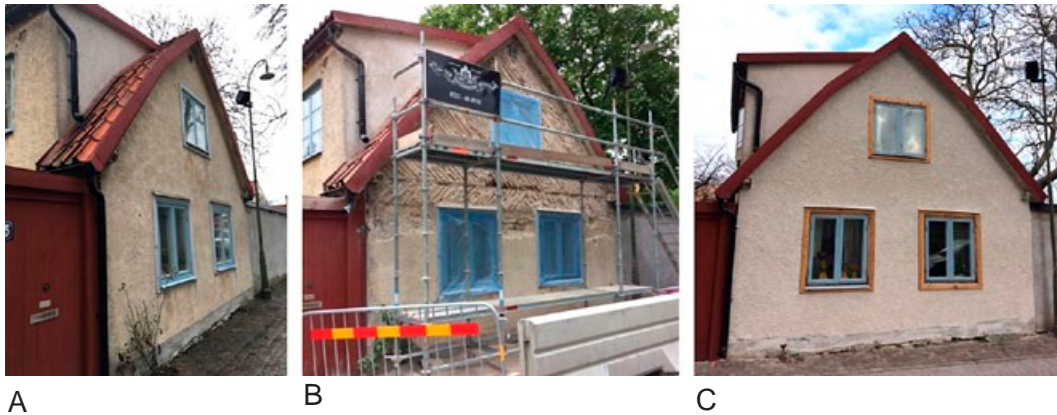
One gable section of a detached single family house in Visby's historic centre was renovated with hemp-lime render in September 2017, see Figure 4. The house was built in the mid-1800s and rebuilt to a large extent in the 1930's. It is built with a mix of construction techniques; the gable section of the eastern wall is built with wooden planks and the lower part of the same wall is built with lime stone. All façades are covered with lime rough-cast. The preservation of the

Figure 4. Detached historic single family house in Visby renovated with hemp-lime, A) Before renovation, B) During renovation, C) After renovation. Photos: Paulien Strandberg.

When the old render on the façade of the building was removed, the original wooden slats, placed diagonally on the timber for carrying the render, were exposed. These slats were kept for carrying the hemp-lime render. Since the space between the slats was only a few centimetres, some slats were removed to create some space between the slats for applying hemp-lime. A layer of hemp-lime of approximately 50 mm (the original thickness of the lime render) was put on the façade and finished with a 15 mm layer of traditional lime render on the outside. The hemp-lime was allowed to dry for a few weeks before a new lime render was applied. The mixing ratio of the hemp-lime was 1 part by volume air hardening lime for 2.5 parts by volume hemp shiv. Sensors to monitor temperature and relative humidity were placed in different locations and depths in the wall. Monitoring started in September 2017 and continues for one year. The results will give a better understanding of moisture levels and moisture flows in the walls. It will also give some indication regarding the temperature flows and insulating properties of the wall after renovation with hemp-lime.

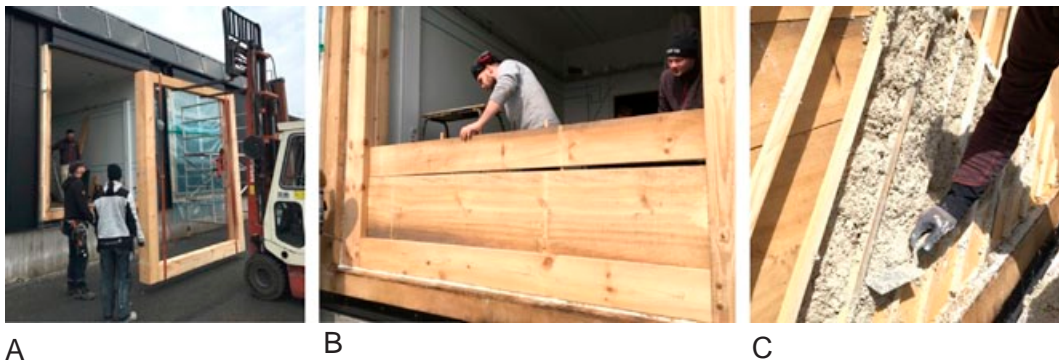
At Lund University, two façades have been built at the laboratory of the Division of Energy and Building Design, see Figure 5. One façade resembles a traditional post-and-plank construction with a thick lime render about 80 mm. The other façade resembles a traditional post-and-plank construction that is renovated using hemp-lime (~100 mm) as additional external insulation. Behind each façade there is a room (3x3 m) that is insulated at all sides (floor, walls, ceiling). Therefore, the only heat loss that takes place will be through the façade. The energy use for heating the rooms behind the façades is monitored to evaluate the thermal performance of both façades. This way, a historic façade with a lime

Figure 5. Construction of two full-scale test walls at Lund University, A) Construction of post-and-plank walls, B) Timber planks mounted between the posts, C) Application of hemp-lime on the post-and-plank wall. Photos: Paulien Strandberg.

render can be directly compared to a façade that is renovated with hemp-lime. The façades were constructed in April/May 2017, monitoring started in September 2017 and continues for one year. The façades are exposed to the outdoor climate. Moisture conditions (RH and moisture content) and temperature are being monitored at four depths inside the wall. The aim of the study is to compare the walls with regards to their energy performance. Therefore, the energy use (kWh/m<sup>2</sup>, year) is measured and recorded continuously.

The preliminary results from the laboratory show a lower energy use for heating in the room behind the hemp-lime façade. The room behind the hemp-lime façade uses 60–70 % of the energy use that is required by the room with the lime façade. The temperature variations are also less apparent in the insulated room.
