THESIS FOR THE DEGREE OF LICENTIATE OF ENGINEERING

High Temperature Corrosion of Superheaters in Biomass- and Waste-Fired Boilers: Combat on two fronts

Towards a better understanding of corrosion mechanisms and the development of solutions

Julien Phother-Simon

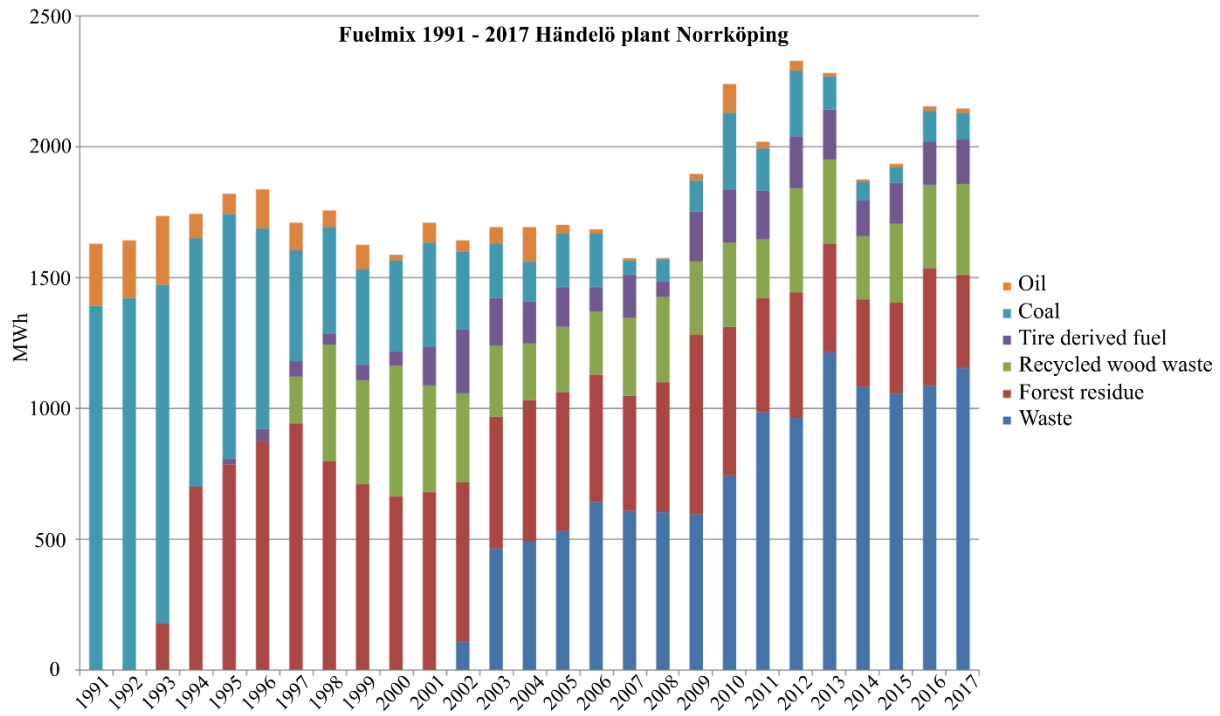
Figure 1: Power generation by fuel type from 1991 to 2017 at the Händelö plant (owned by E.ON Värme AB) in Norrköping, Sweden [32].

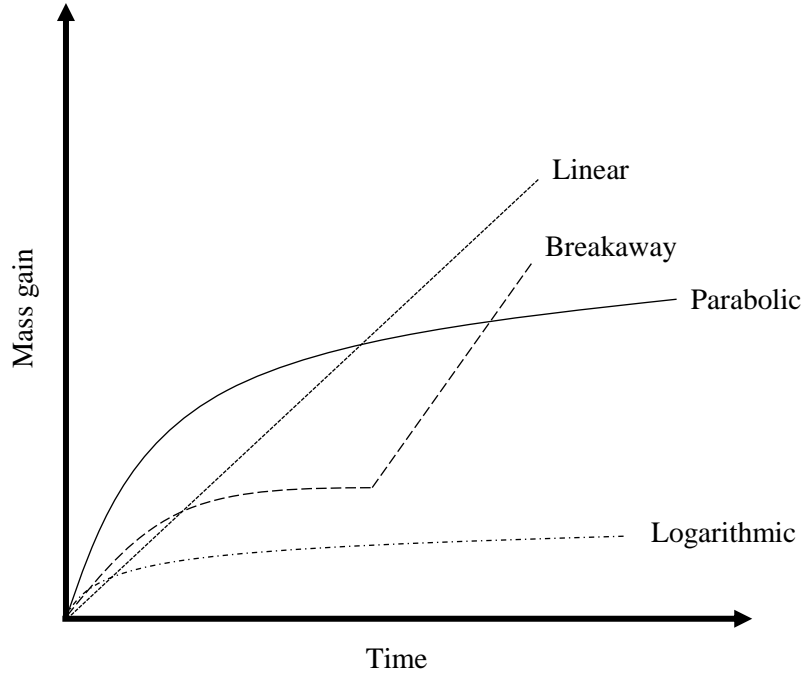
Figure 6: Various kinetic laws of metal oxidation

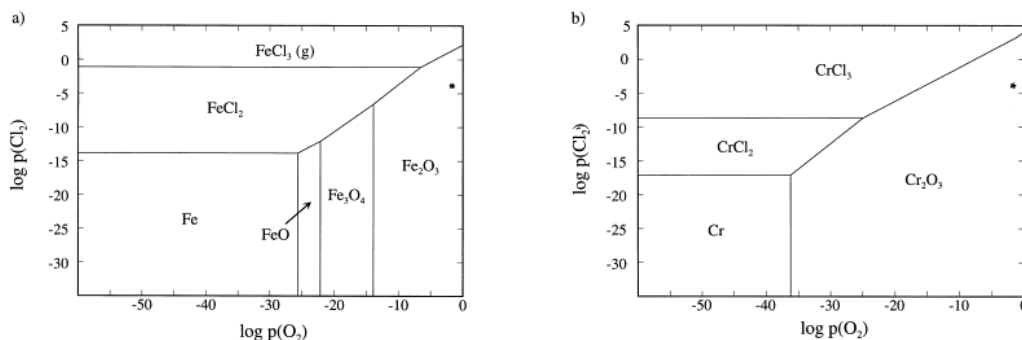
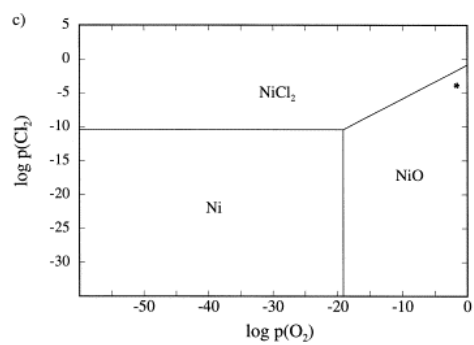
Figure 7: Thermodynamic stability diagrams of the systems $\text{Fe-O}_2\text{-Cl}_2$ (a), $\text{Cr-O}_2\text{-Cl}_2$ (b) and $\text{Ni-O}_2\text{-Cl}_2$ (c) at 600 °C [44].

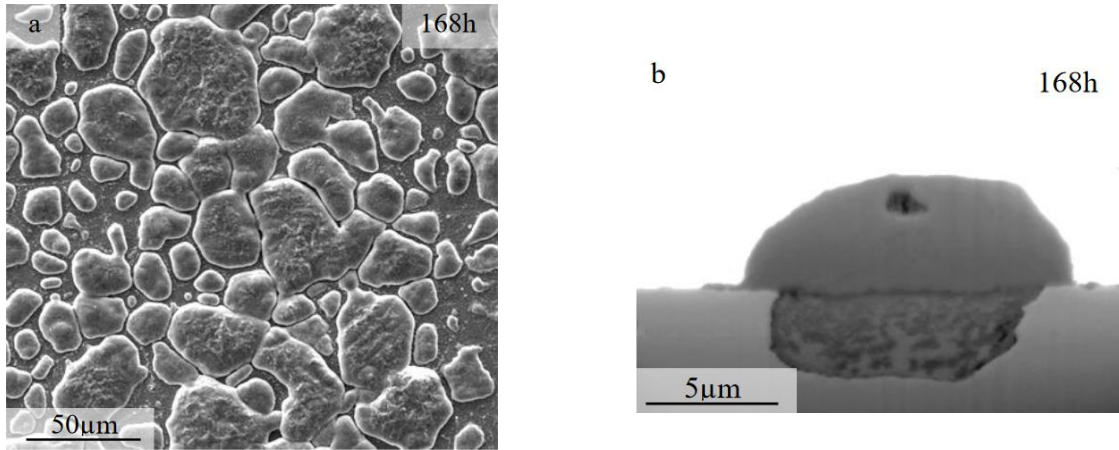
Figure 8: a) SE images of 304L samples exposed to 5% O₂ and 40% H₂O for 168h at 600 °C and b) BSE images of FIB cross-sections of an oxide island [47].

The supply of chromium occurs via grain boundaries diffusion at 600 °C, which explains the morphology of the corrosion products observed, for example, after exposure in O₂ and H₂O for 168 hours, as shown in Figure 8 [47]. As the transport of chromium is faster at the grain boundaries, the surrounding area is more protected than the center of a grain. This explains the island-like shape of the growing oxides on top of the substrate, where the iron oxide becomes thicker towards the center of the grain and thinner towards the grain boundaries. The cross section in Figure 8b) shows that the island-like feature consists of an outward-growing scale, which is hematite (Fe₂O₃), and an inward-growing scale which is a spinel-type oxide ((Fe,Cr,Ni)₃O₄) [47].

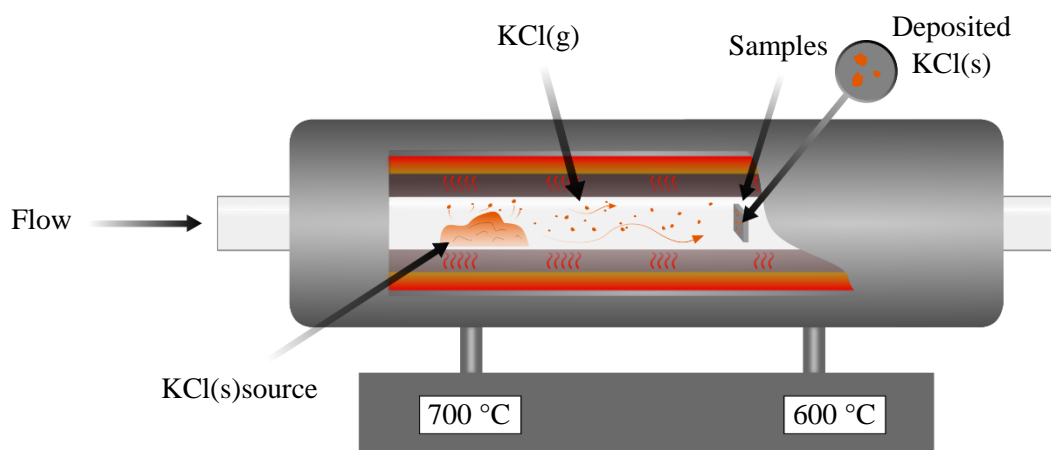
Figure 9: Schematic drawing of the experimental setup.

(First row) Drawing: Schematic drawing of the experimental setup depositing KCl continuously.

The exposures under continuous KCl deposition were performed in an atmosphere of 5 % O₂ + 20 % H₂O and balanced with nitrogen. The water vapor content was established using the nafion membranes FC 125-240-5MP from Perma Pure. The flow rate used was 2.5 cm/s, and the rate was measured with a flowmeter Definer 220 from Bios. A 3-zone furnace ETF 80/12-III, from Entech Energietechnik AB equipped with a 70-mm diameter silica tube from Quarzglas Komponenten und Service QCS GmbH was used. An alumina boat with KCl(s) from VWR BDH Chemicals was placed upstream at 700 °C where the calculated vapor pressure of KCl(s) was 65.9 ppm, while the samples were placed downstream at 600 °C where the calculated vapor pressure was 3.4 ppm. Therefore, massive condensation of the salt in the sample area was expected during the exposure. The vapor pressures of KCl(g) at these two temperatures were calculated using the software FactSage 7.2 and the FTslat database. The positions of the KCl boat and the samples remained consistent for all exposures. A schematic drawing of the setup is shown in Figure 9. The duration of the exposures was set to 24 hours.

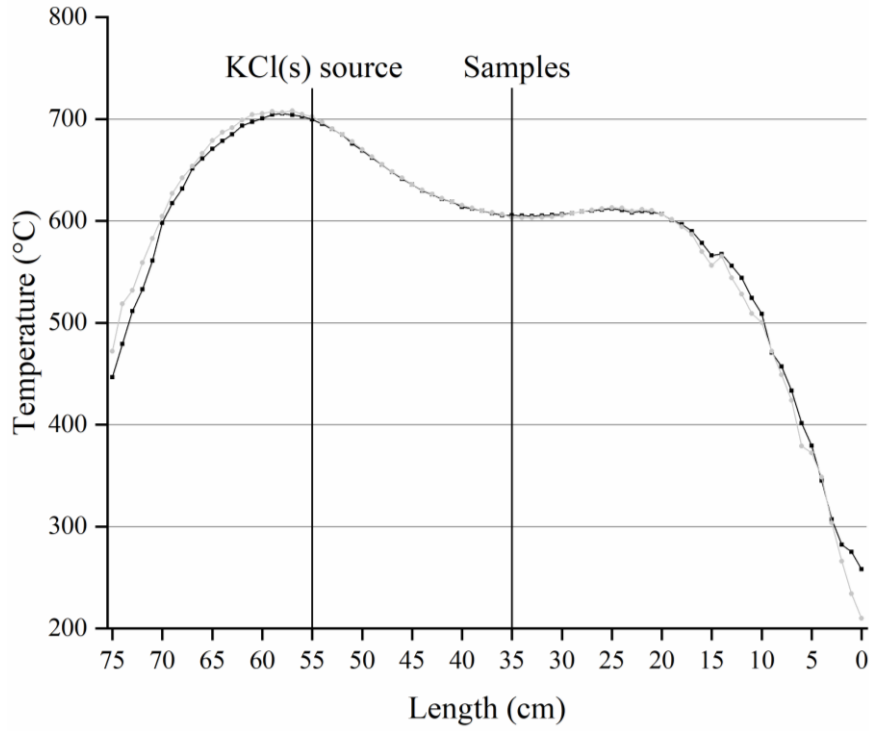
Figure 10: Temperature profile for the 3-zone heating furnace measured twice with a shutdown in between.

The temperature gradient profile in the furnace is shown in Figure 10. The gradient was measured two times in order to find the temperature variance between two experiments as the furnace was turned off in between. The measurements were performed by moving a thermocouple 20-25301000 from Pentronic forward every 1 cm from one side of the tube to the other side for a total length of 75 cm, see Figure 11. The position of the thermocouple remained consistently at the center of the furnace (co-axial). It can be seen in Figure 10 that the temperature gradient between the source of KCl(s) and the samples remained stable between two experiments, once the temperatures at each location had been reached.

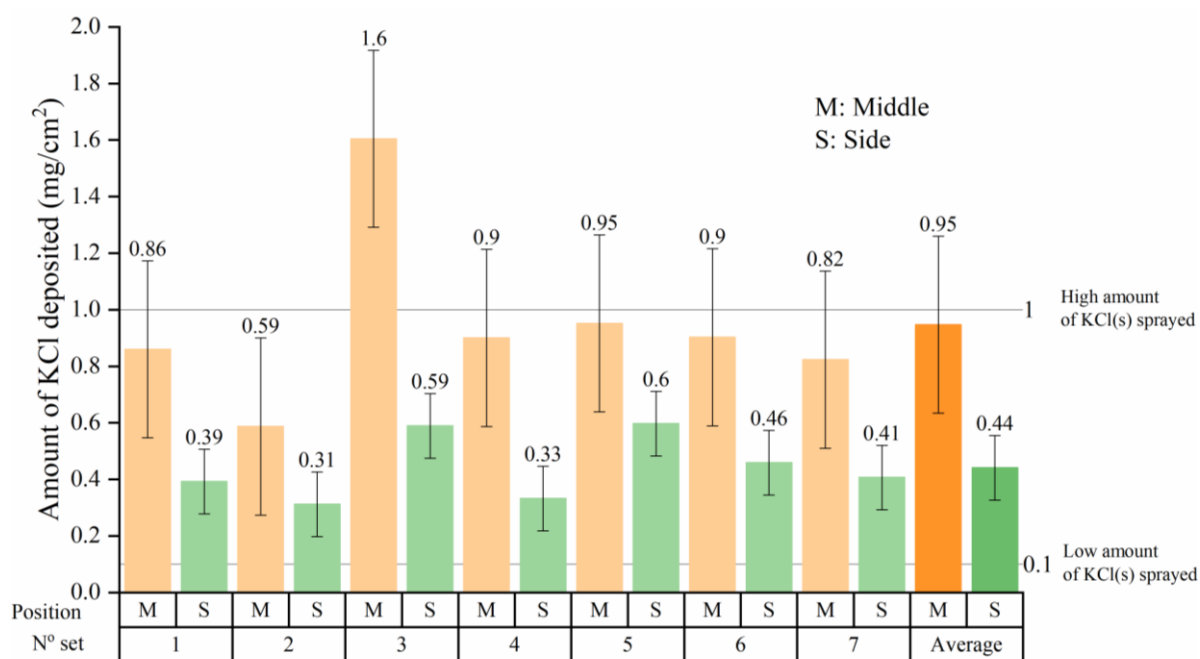
Figure 13: Amounts of KCl deposited on gold foils every 24 hours for one week at two sample positions. The reference lines represent the two different amounts of KCl(s) sprayed onto the samples prior to exposure (previous method).

The measurements were performed using two parallel gold foils, whose mass gains of KCl were measured discontinuously every 24 hours for one week due to the deposition. Every 24 hours, the two gold foils were taken out of the furnace and weight measured, while a set of two new gold foils were placed for the next 24 hours. One of the gold foils was aligned with the axis of the tube furnace (middle position) while the second gold foil was located at one of the sides, in order to replicate the position of future samples at the same locations. The side positions were located 1.8 cm apart from the middle position, and 1.5 cm apart from the walls of the tube furnace. Figure 14 shows a schematic drawing of the positions of the samples in the furnace.

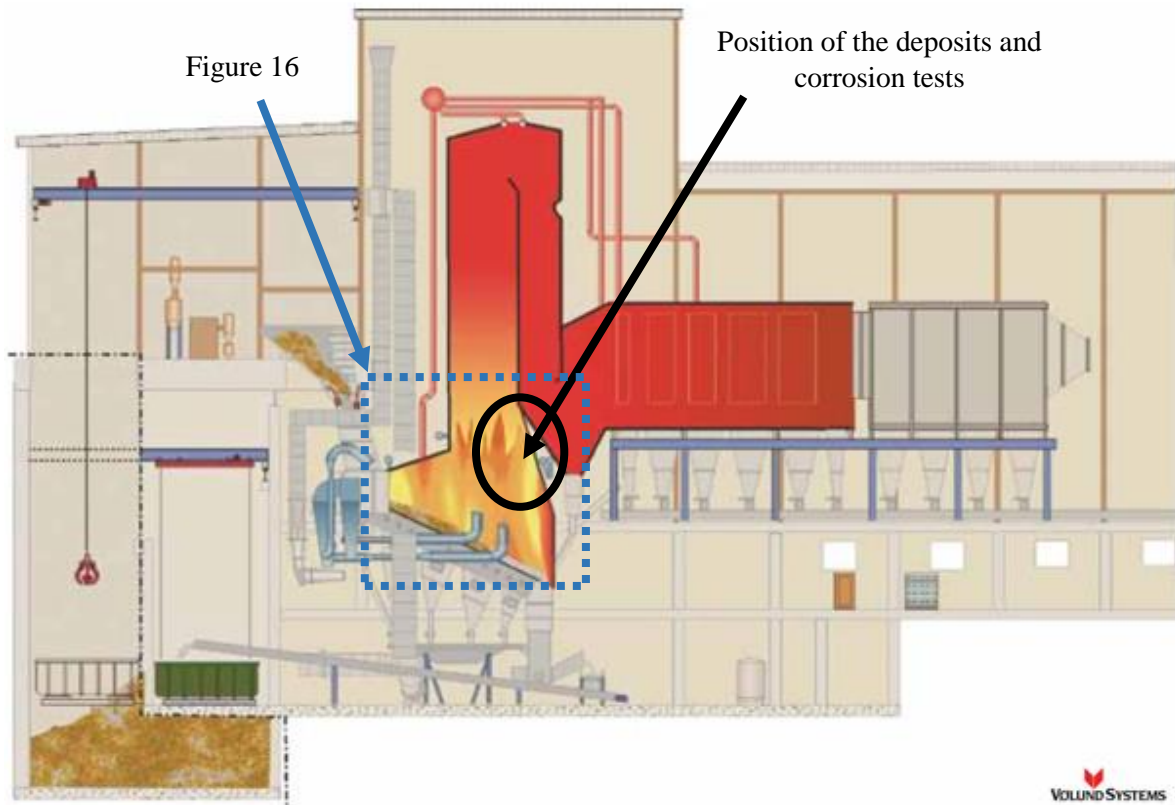
Figure 15: Schematic drawing of the combined Heat and Power plant AffaldPlus in Denmark [59, 60].

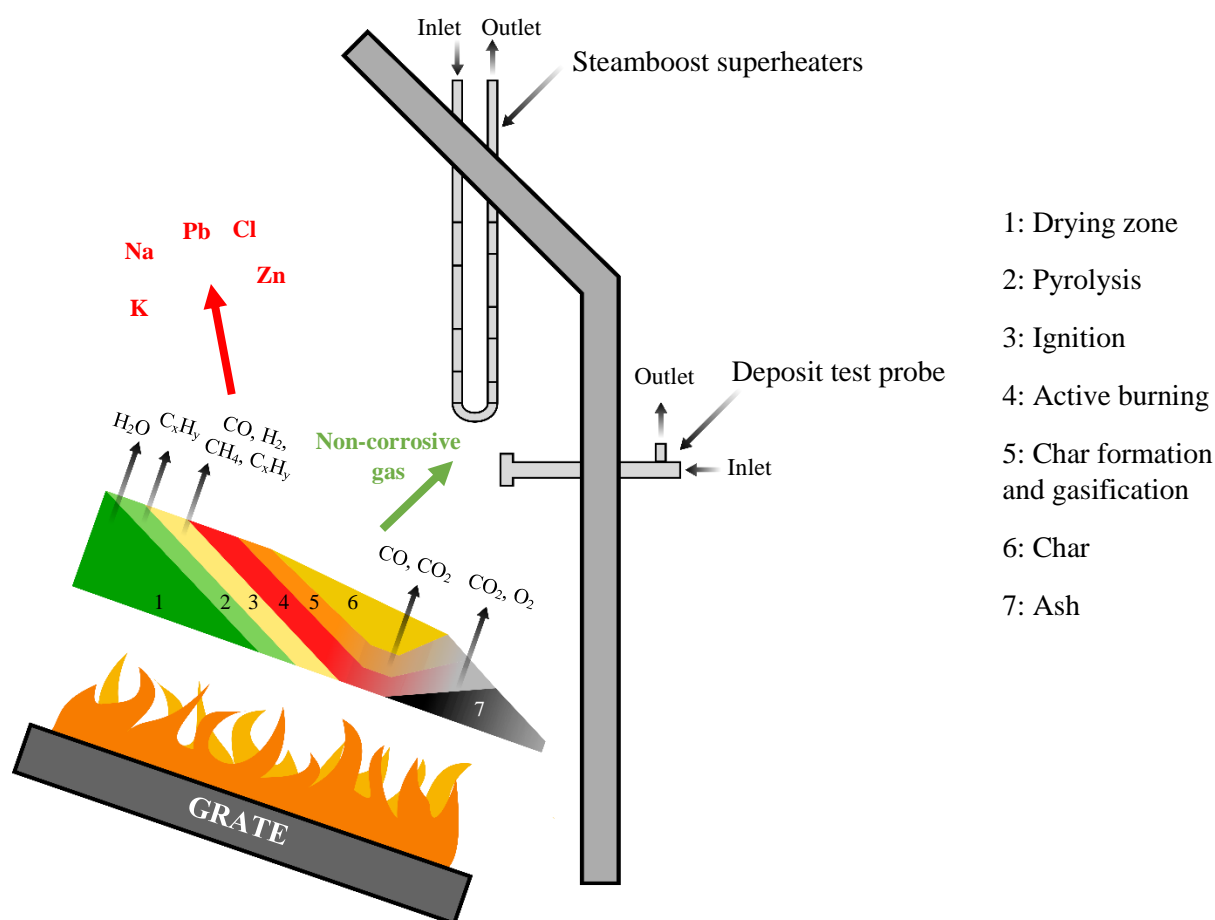
Figure 16: Schematic drawing of the principle of the Steamboost.

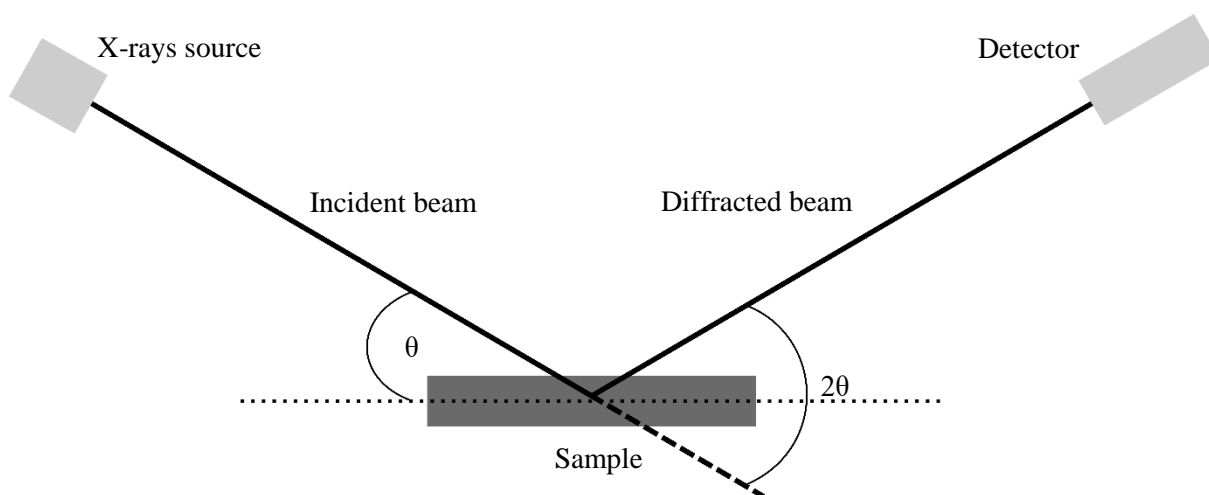
Figure 19: Schematic representation of a diffractometer with Bragg-Brentano geometry.

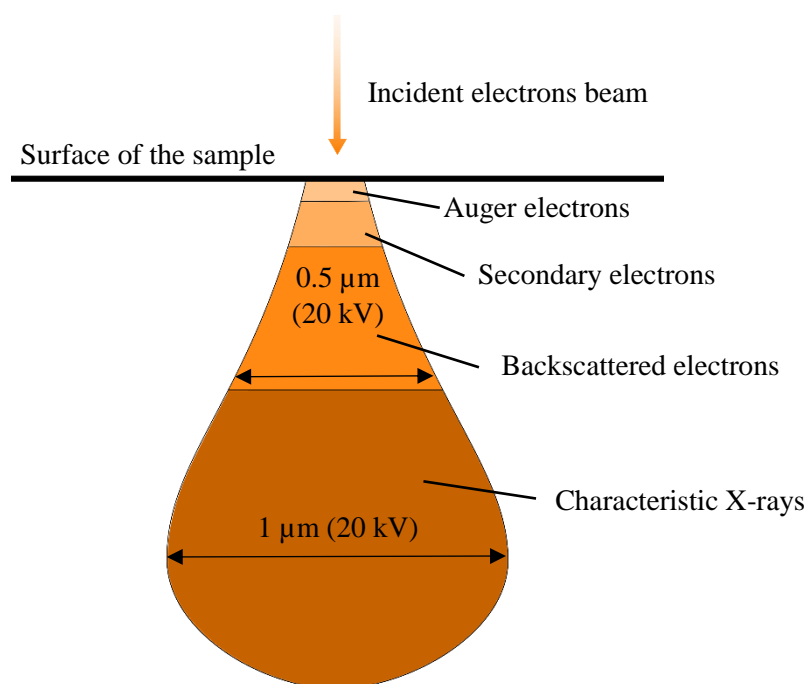
Figure 20: Schematic illustration of the interaction volume and the products of interaction.

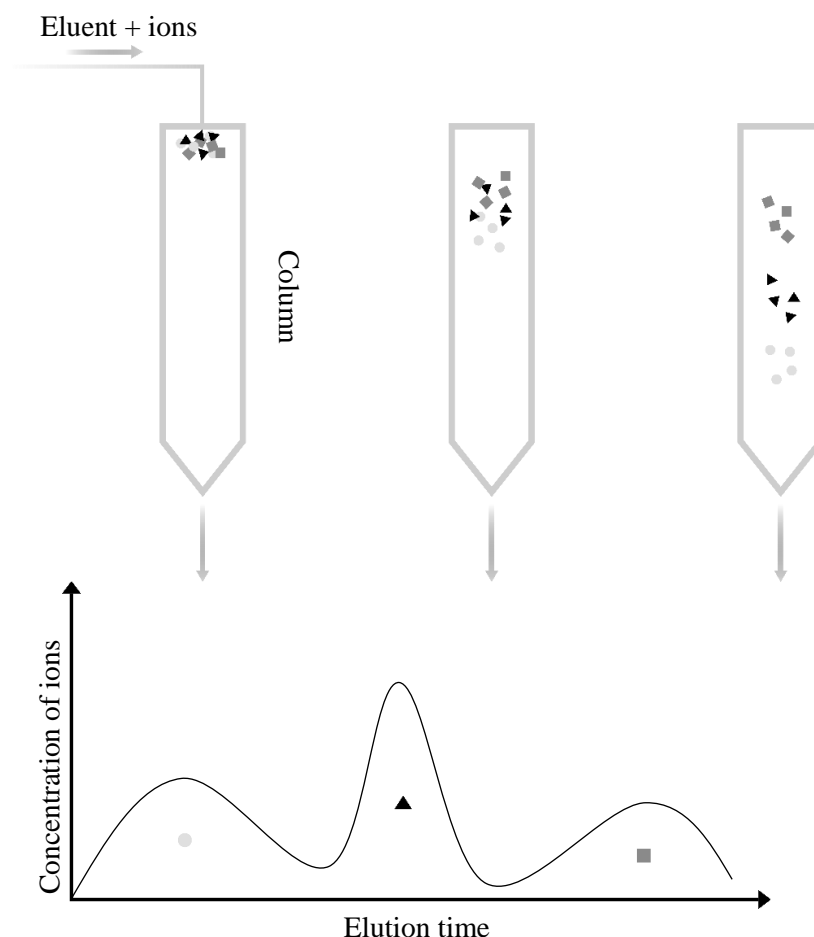
Figure 22: Schematic representation of the ion chromatography technique (top). Signal of the detected ions as a function of time (bottom).

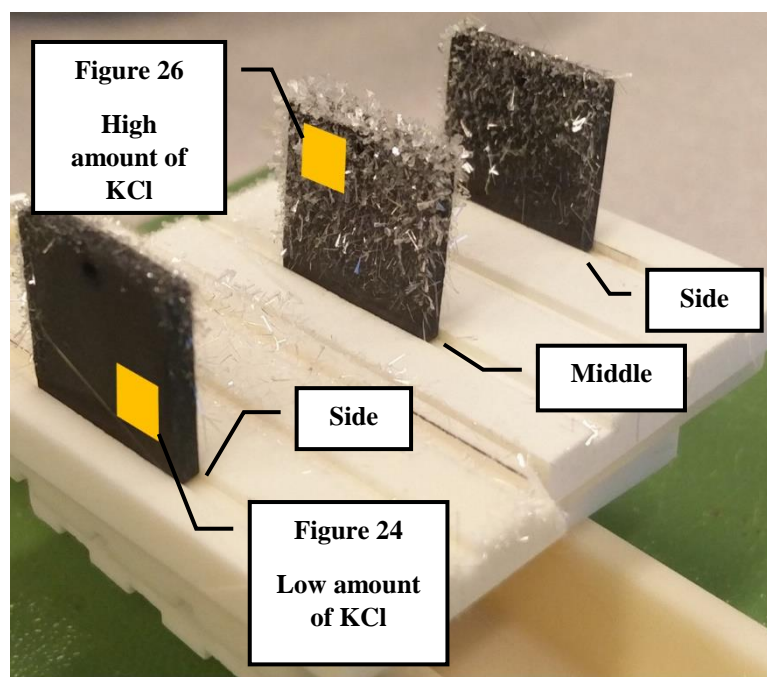
Figure 23: Photograph of 304L samples after an exposure for 24 hours at 600 °C in 5% O₂ + 20% H₂O under continuous KCl deposition.

(Second row) Left photograph: Photograph of 304L samples after 24 hours at 600 °C in 5%O₂ + 20%H₂O.

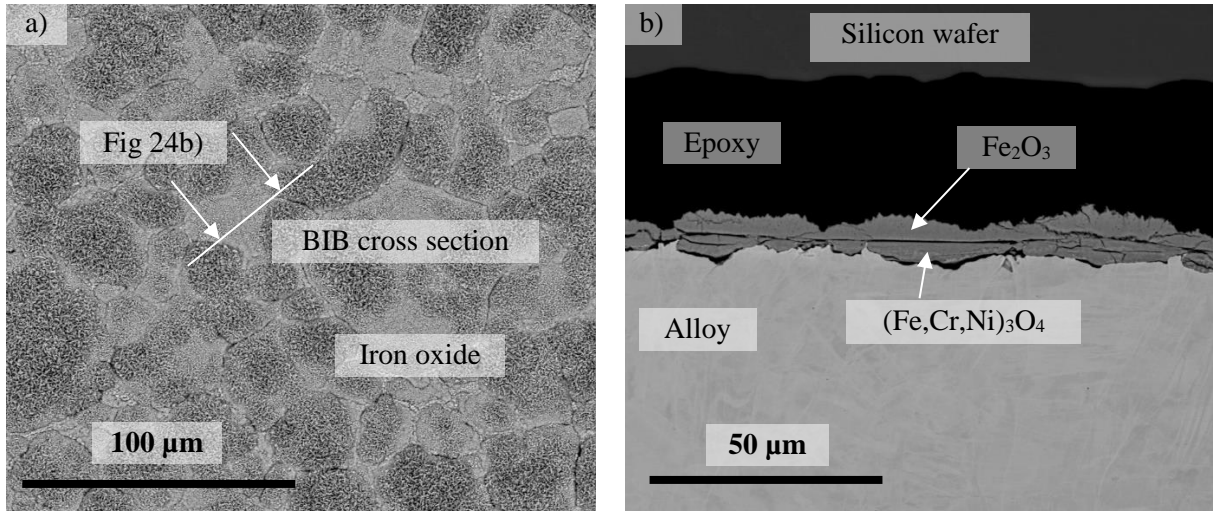
Figure 24: SEM image using BSE of a) the plan view of a "low amount of KCl"-area of a 304L sample after 24 hours in 5% O_2 + 20% H_2O exposure under continuous KCl deposition at 600 °C and b) a cross-sectional view.

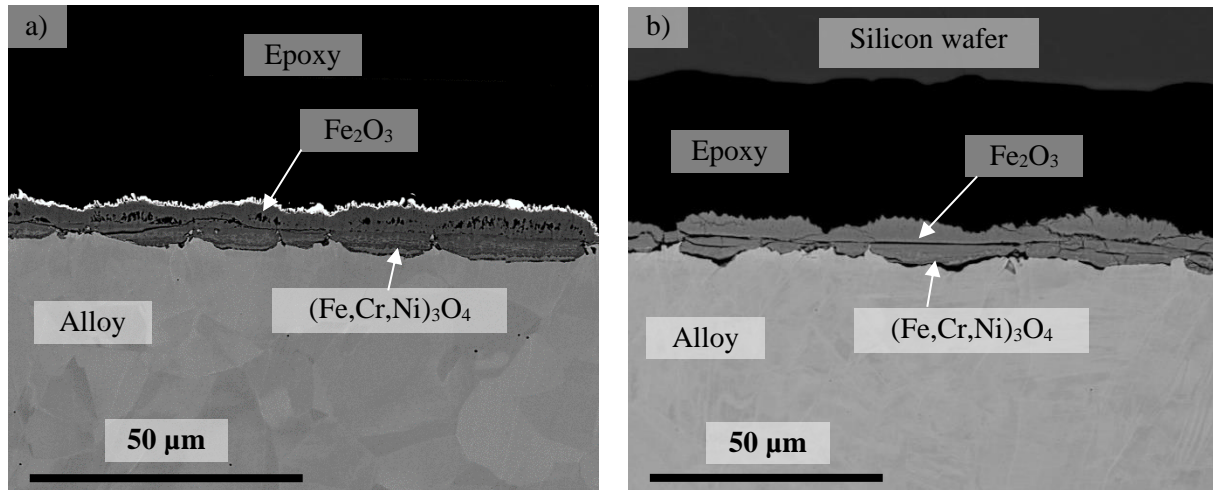
Figure 25: SEM image using BSE of a cross section of a) 304L sample exposed to 0.1 mg/cm² KCl(s) applied prior to exposure after 24 hours at 600 °C in 5% O_2 + 40% H_2O [24] b) 304L sample exposed to KCl(s) under continuous KCl deposition after 24 hours at 600 °C in 5% O_2 + 20% H_2O .

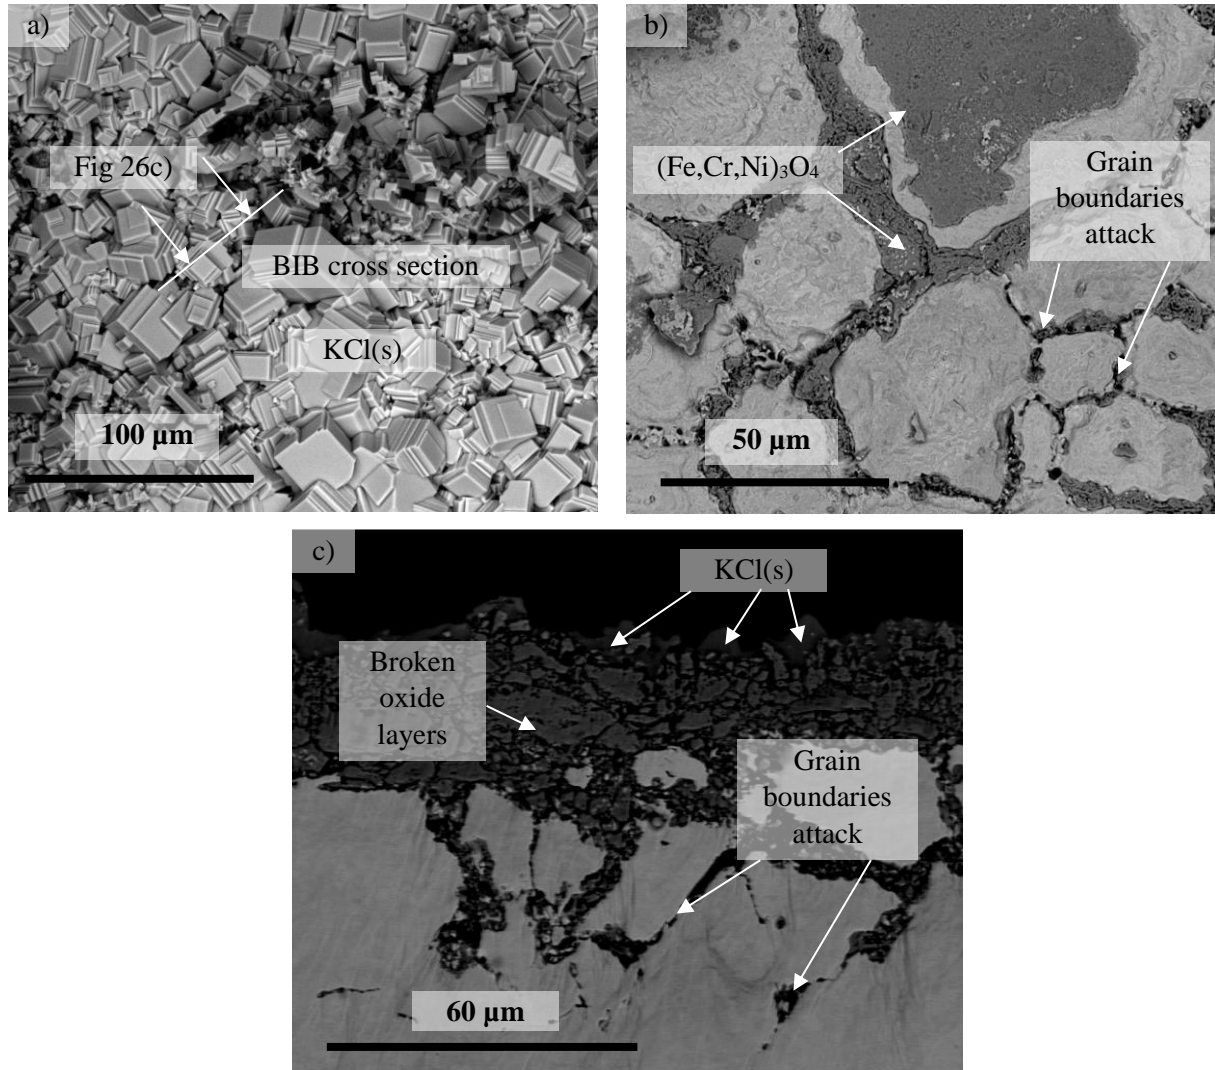
Figure 26: SEM image using BSE for a) the plan view, b) a spalled area and c) a cross sectional view of a "high amount of KCl"-area after 24 hours at 600 °C in 5% O₂ + 20% H₂O.

(Second row) Middle photograph: SEM image using BSE of the plan view of a “high amount of KCl”-area from a 304L sample, after 24 hours at 600 °C in 5%O₂ + 20%H₂O.

(Second row) Right photograph: SEM image using BSE of a cross-sectional view of a “high amount of KCl”-area from a 304L sample, after 24 hours at 600 °C in 5%O₂ + 20%H₂O.

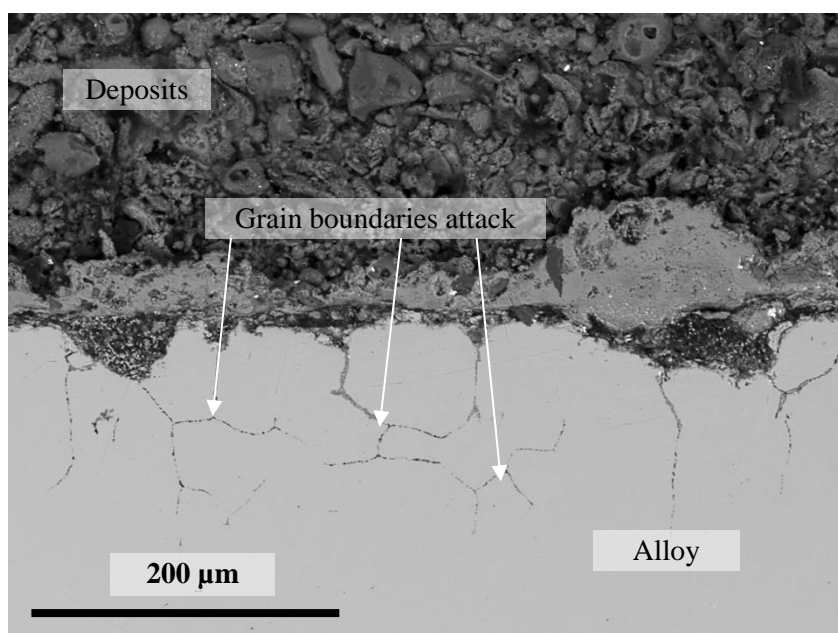
Figure 27: SEM image using BSE of the cross section of a 304L sample exposed for 24 hours at 600 °C in a CFB boiler burning a waste mix (SRF+bark) [14].

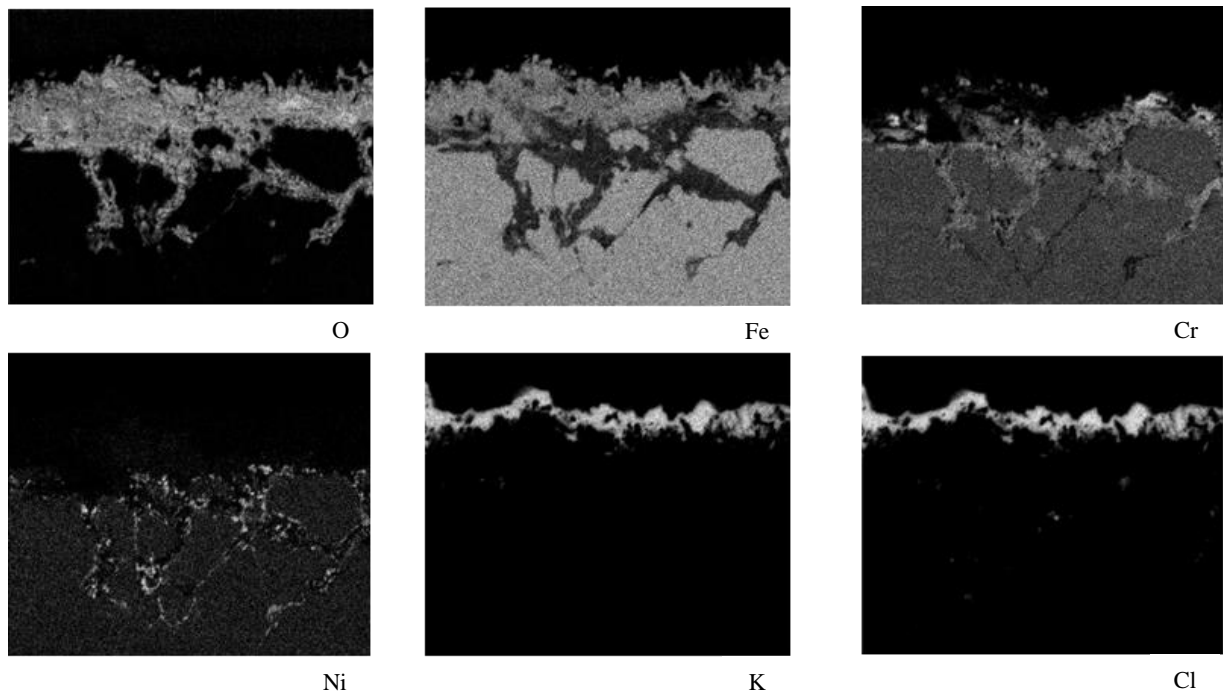
Figure 28: EDX map of the cross-sectional view in Fig.26c

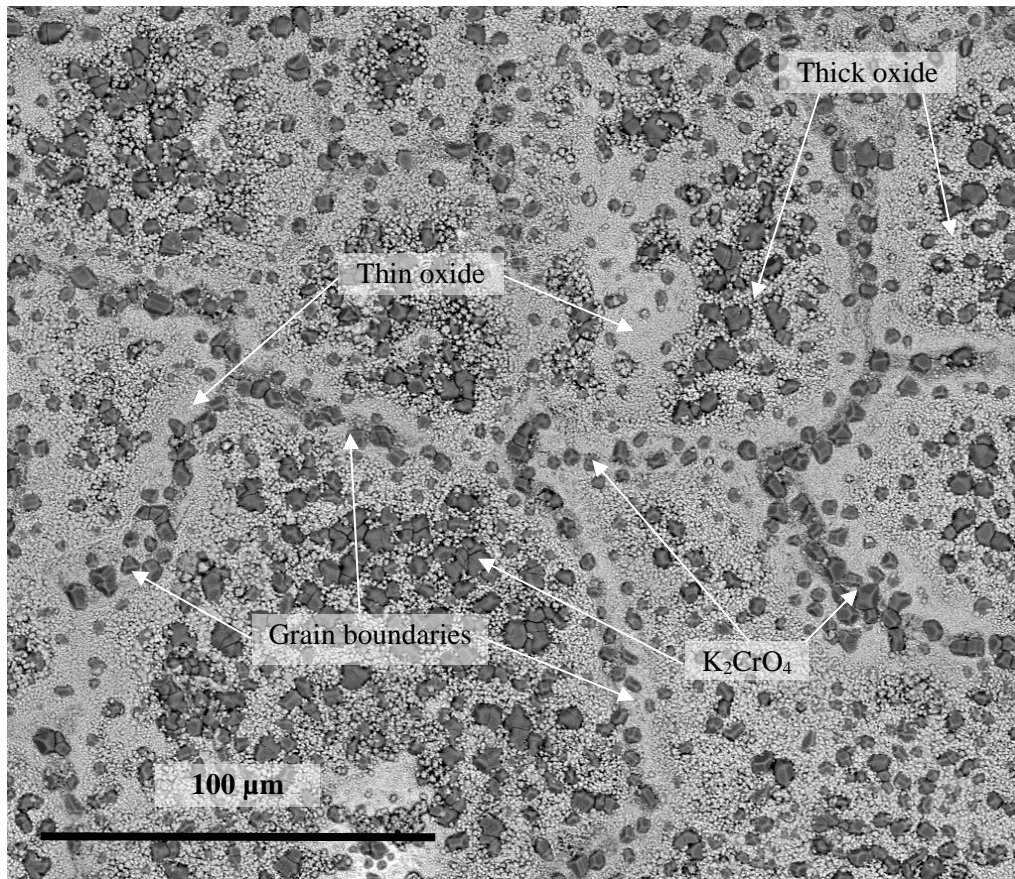
Figure 29: SEM image using BSE of the plan view of a “low amount of KCl”-area from a Sanicro 28 sample after 24-hour exposure at 600 °C in 5% O₂ + 20% H₂O under continuous KCl deposition.

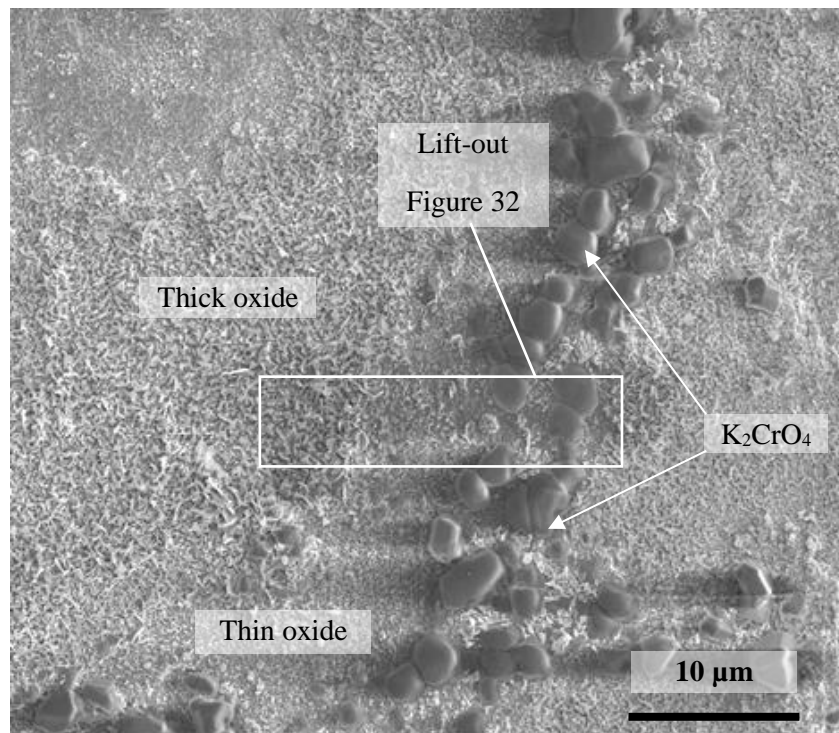
Figure 30: SEM image using SE of the plan view of a Sanicro 28 sample after 24-hour exposure at 600 °C in 5% O₂ + 40% H₂O with 0.1 mg/cm² KCl(s) [69].

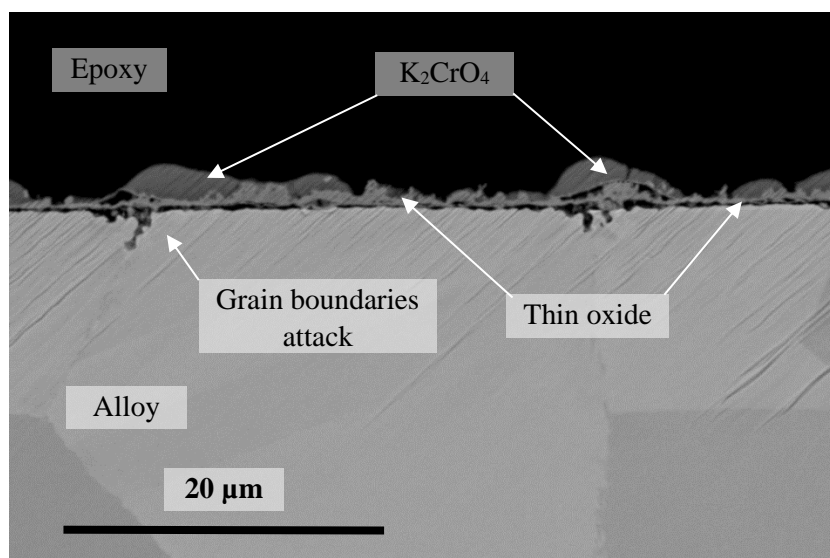
Figure 31: SEM image using BSE of the cross section of a “low amount of KCl”-area from a Sanicro 28 sample after 24-hour exposure at 600 °C in 5% O₂ + 20% H₂O under continuous KCl deposition.

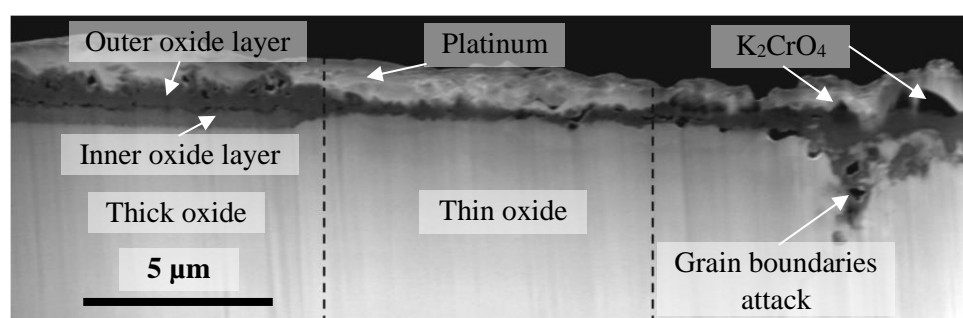
Figure 32: SEM image using SE of the cross section a Sanicro 28 sample (Figure 30) after 24-hour exposure at 600 °C in 5% O₂ + 40% H₂O with 0.1 mg/cm² KCl(s) [69].

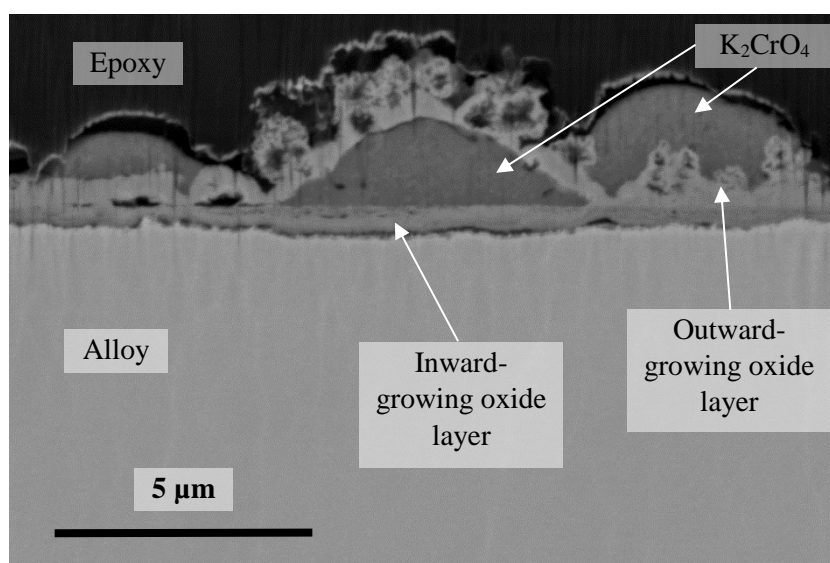
Figure 33: SEM image with higher magnification using BSE of the plan view of a “low amount of KCl”-area from a Sanicro 28 sample after 24-hour exposure at 600 °C in 5% O_2 + 20% H_2O under continuous KCl deposition.

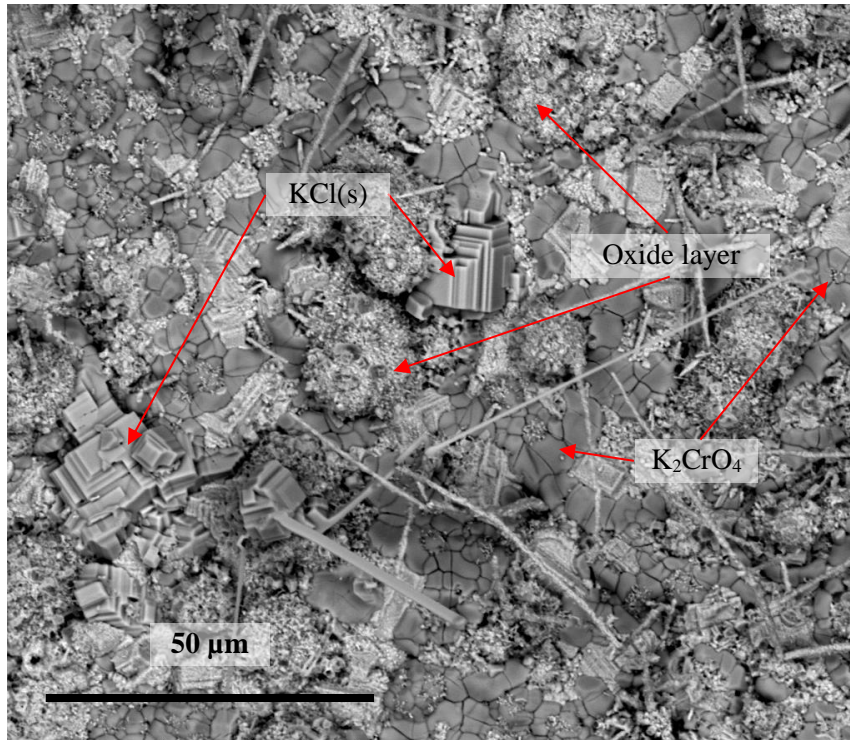
Figure 34: SEM image using BSE of the plan view of a “high amount of KCl”-area from a Sanicro 28 sample after 24-hour exposure at 600 °C in 5% O₂ + 20% H₂O under continuous KCl deposition.

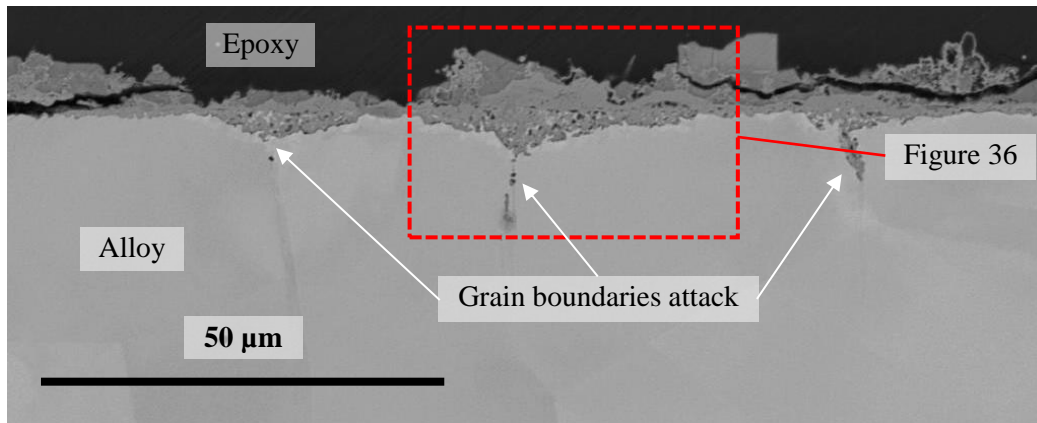
Figure 35: SEM image using BSE of the cross section of a “high amount of KCl”-area from a Sanicro 28 sample after 24-hour exposure at 600 °C in 5% O₂ + 20% H₂O under continuous KCl deposition.

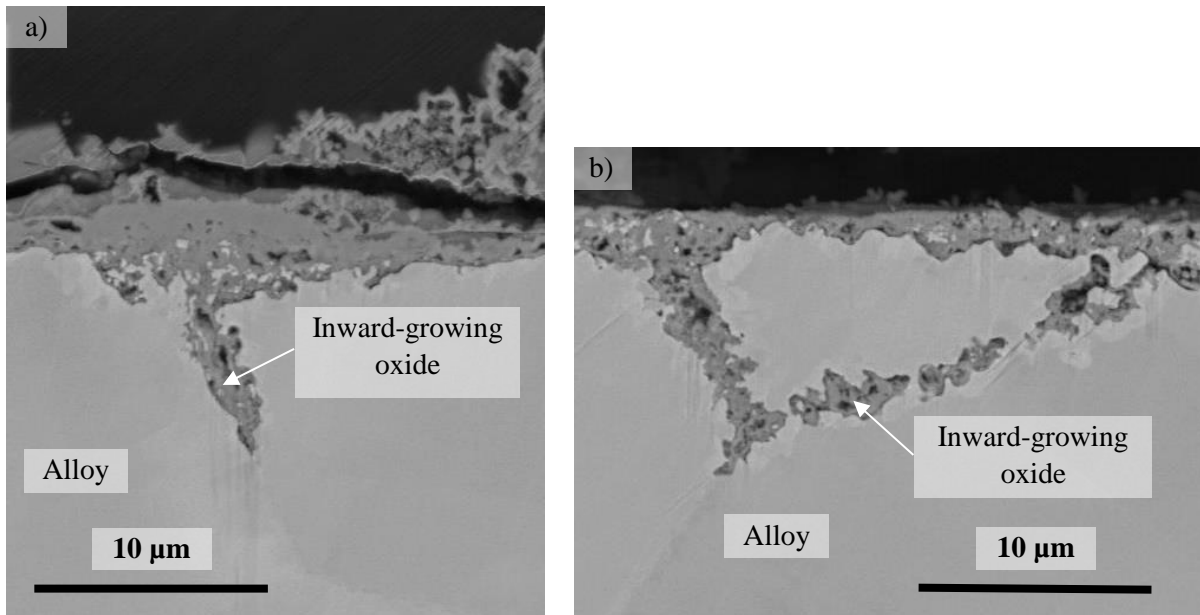
Figure 37: SEM image using BSE of the cross section of two other “high amount of KCl”-areas from a Sanicro 28 sample after 24-hour exposure at 600 °C in 5% O₂ + 20% H₂O under continuous KCl deposition showing a) growth of oxide along the grain boundaries and b) isolation of a grain by a connection of two grain boundaries attacks.

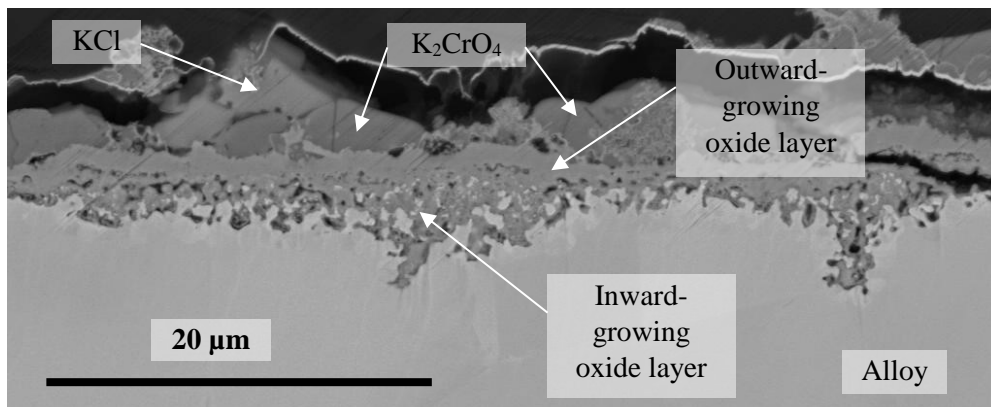
Figure 38: SEM image using BSE of the cross section of another “high amount of KCl”-area from a Sanicro 28 sample showing internal corrosion after 24-hour- exposure at 600 °C in 5% O₂ + 20% H₂O under continuous KCl deposition.

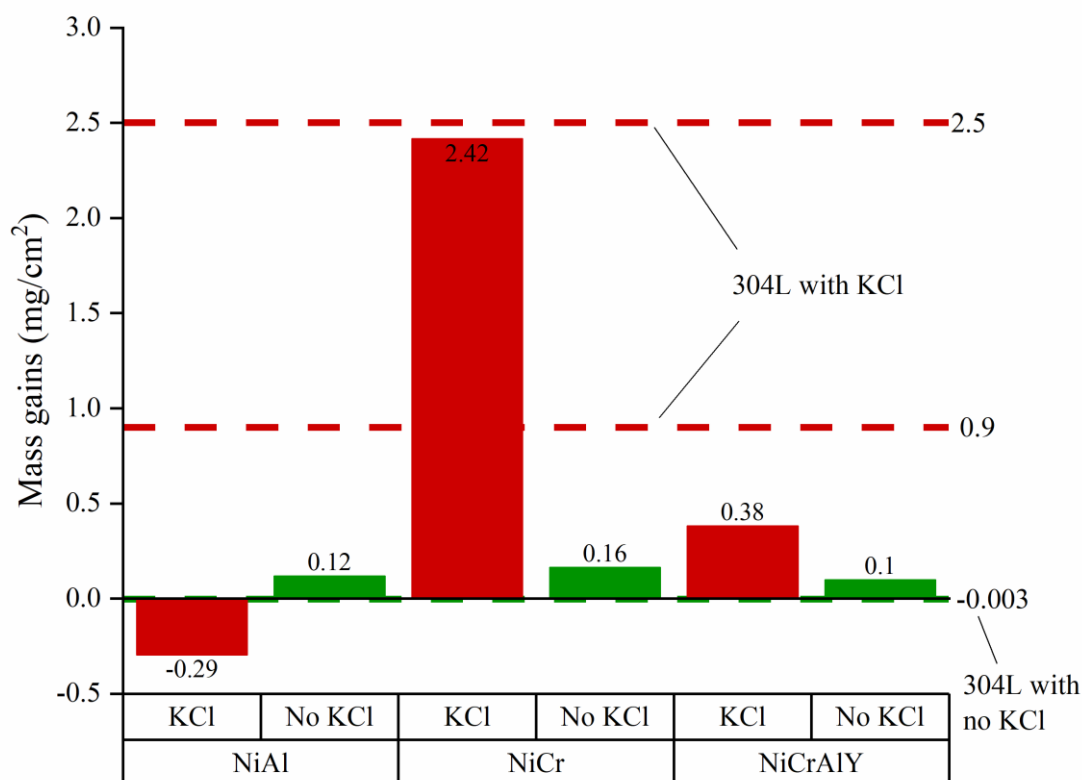
Figure 39: Mass gains of the coated samples after 168 hours exposure in 5% O_2 + 20% H_2O + N_2 at 600 °C with and without KCl. The dashed reference lines represent the mass gains of 304L in the presence of KCl (red dashed lines) and without it (green dashed line). The mass gains of 304L were calculated based on oxide thickness.

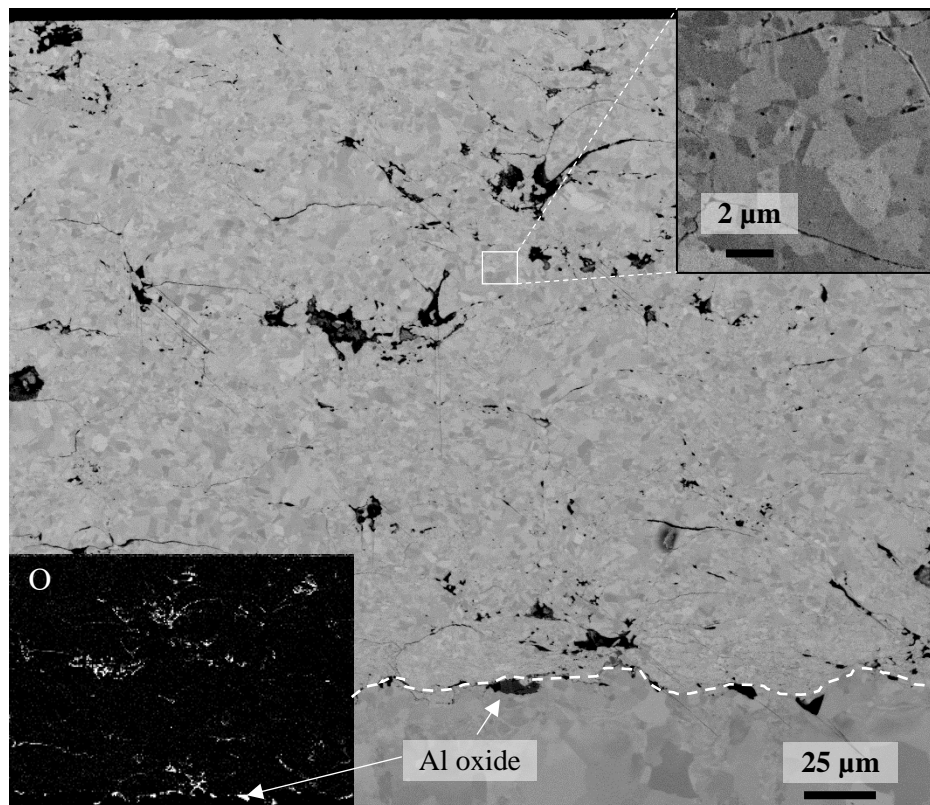
Figure 40: SEM image using BSE of a cross section of a NiCr-coated sample after exposure in 5% O_2 + 20% H_2O + N_2 at 600 °C for 168 hours. The signal for oxygen from the EDX analysis is located at the bottom left of the picture. A higher magnification of an area of the coating is shown at the top right. The dashed line represents the coating/substrate interface.

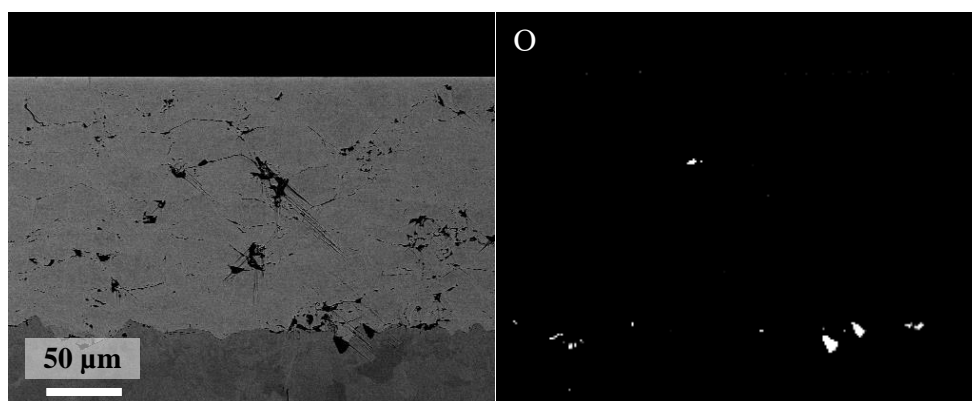
Figure 41: SEM image using BSE of a cross section of a non-exposed NiCr-coated sample (left) and the signal for oxygen from the EDX analysis of the area (right).

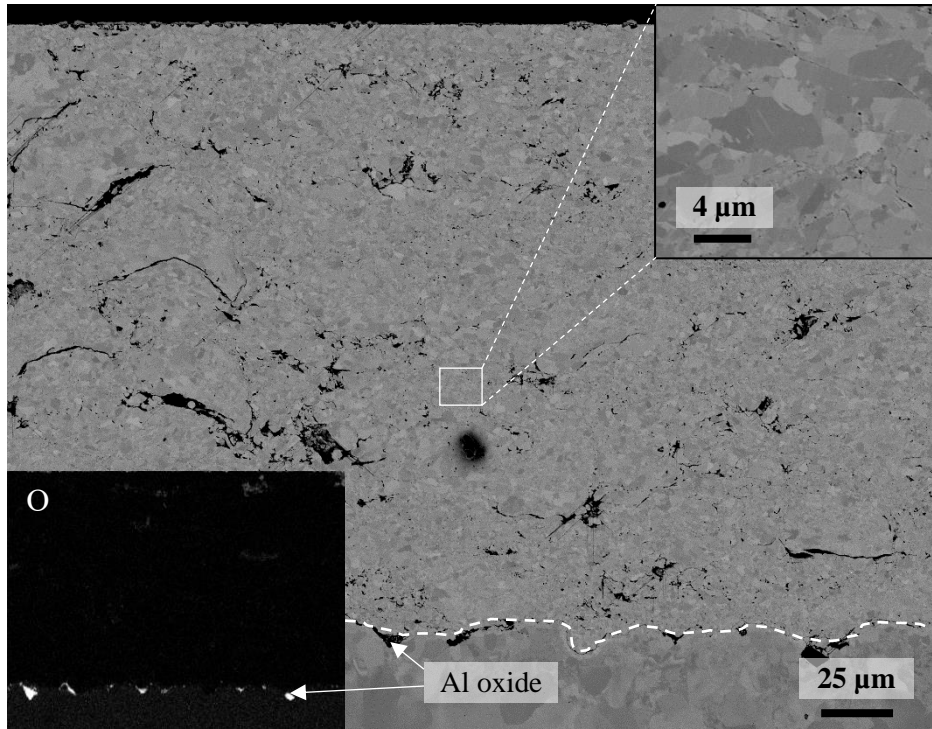
Figure 42: SEM image using BSE of a cross section of a NiAl-coated sample in 5% O_2 + 20% H_2O + N_2 at 600 °C for 168 hours. The signal for oxygen from the EDX analysis is located at the bottom left of the picture. A higher magnification of an area is shown at the top right. The dashed line represents the coating/substrate interface.
