THESIS FOR THE DEGREE OF LICENTIATE OF ENGINEERING

High Temperature Corrosion of Superheaters in Biomass- and Waste-Fired Boilers: Combat on two fronts

Towards a better understanding of corrosion mechanisms and the development of solutions

Julien Phother-Simon

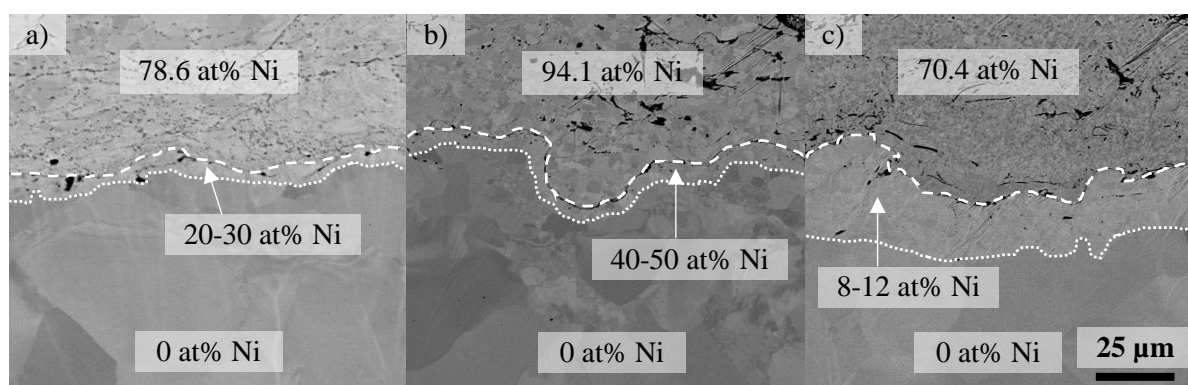
Figure 44: SEM images using BSE of cross-sections of a) NiCr coating, b) NiAl coating, and c) NiCrAlY coating at the coating/substrate interface, after an exposure in 5% O_2 + 20% H_2O + N_2 at 600 $^\circ\text{C}$ for 168 hours. The regions between the dashed lines are the austenitized areas.

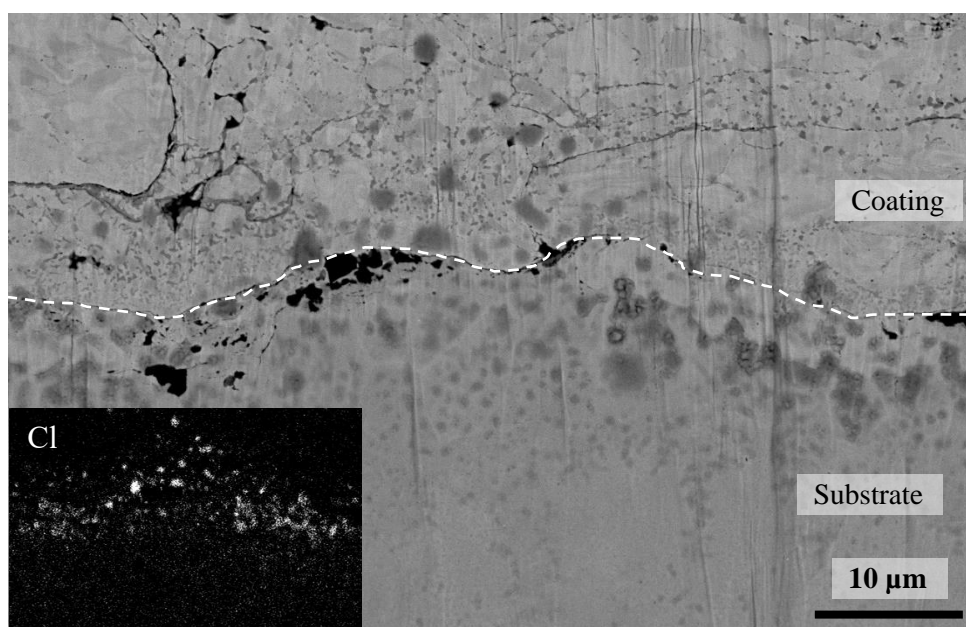
Figure 46: SEM image using BSE of a cross section of the coating/substrate interface of a NiCr-coated sample after exposure in 5% O₂ + 20% H₂O + N₂ + 1.0 mg/cm² at 600 °C for 168 hours. The signal for chlorine from the EDX analysis is located at the bottom left of the picture. The dashed line represents the coating/substrate interface.

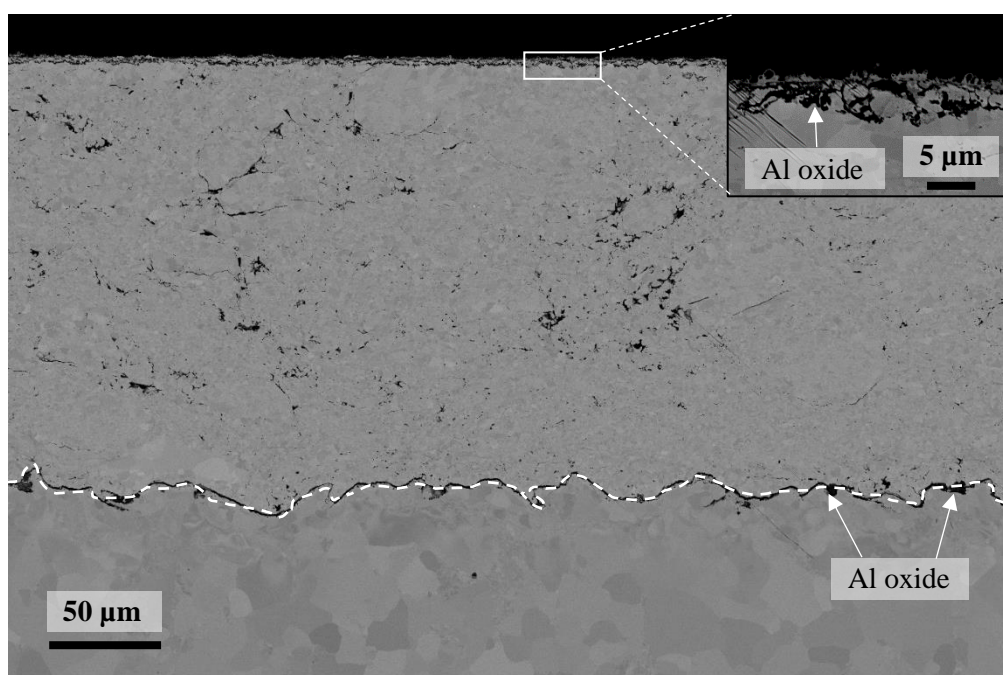
Figure 47: SEM image using BSE of a cross section of a NiAl-coated sample after exposure in 5% O_2 + 20% H_2O + N_2 + 1.0 mg/cm^2 at 600 $^\circ\text{C}$ for 168 hours. The dashed line represents the coating/substrate interface.

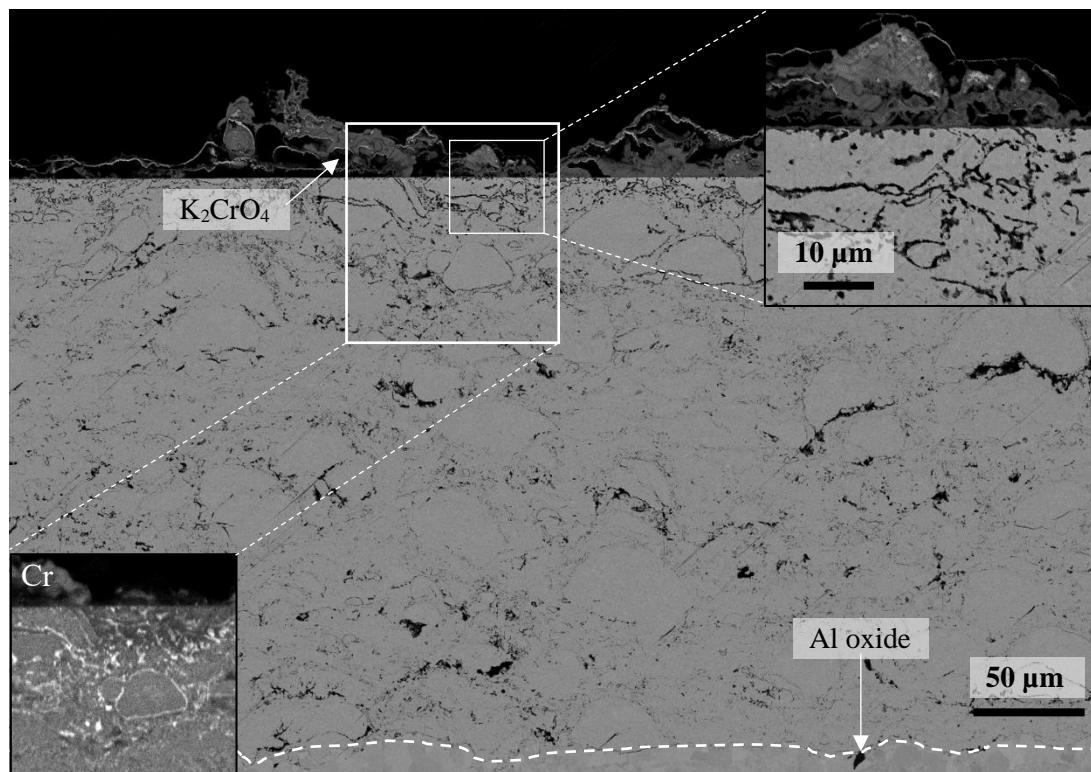
Figure 48: SEM image using BSE of a cross section of a NiCrAlY-coated sample after exposure in 5% O₂ + 20% H₂O + N₂ + 1.0 mg/cm² at 600 °C for 168 hours. The signal for chromium from the EDX analysis is located at the bottom left of the picture. A higher magnification of the surface is shown at the top right. The dashed line represents the coating/substrate interface.

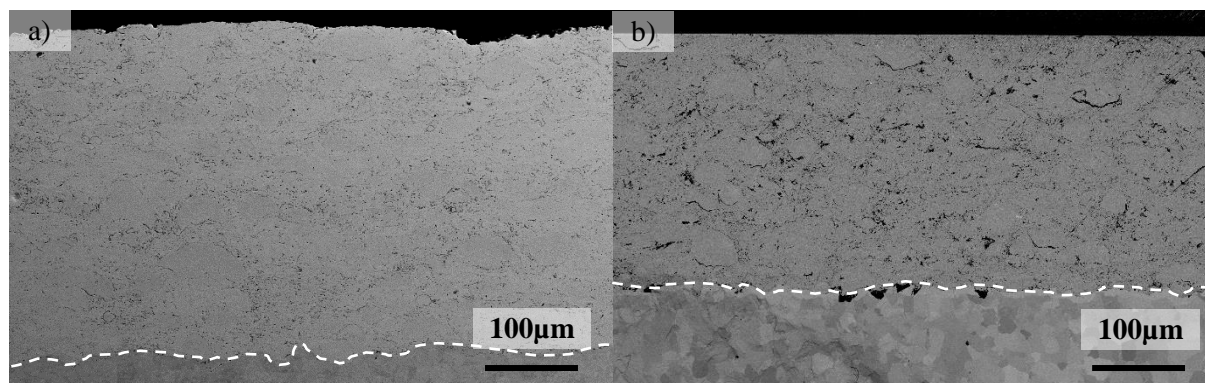
Figure 49: SEM image using BSE of the cross-section of the NiCrAlY coated sample after a) mechanical polishing and after b) broad ion milling (BIB). The dashed line indicates the coating/substrate interface.

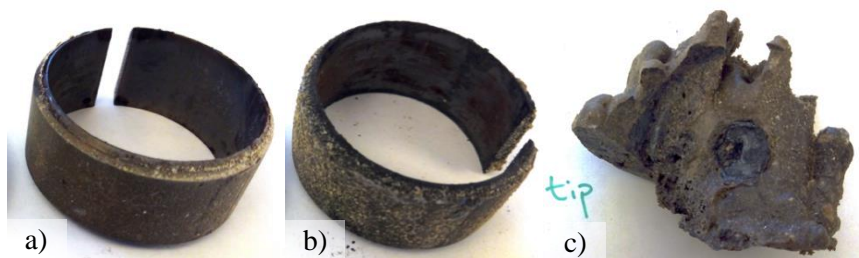
Figure 50: Photographs of three different amounts of deposits accumulated on Sanicro 28 for three different settings after 2-hour exposures. A) small amount, b) moderate amount, and c) large amount.

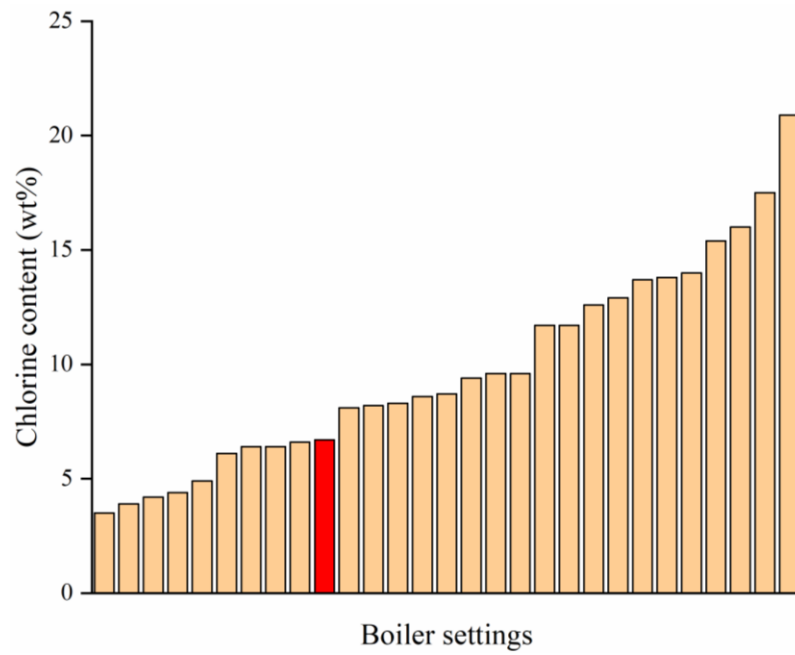
Figure 51: Chlorine content (wt%) in the deposits accumulated on an air-cooled probe at the Steamboost position, for the 29 different boiler settings for 2 hours.

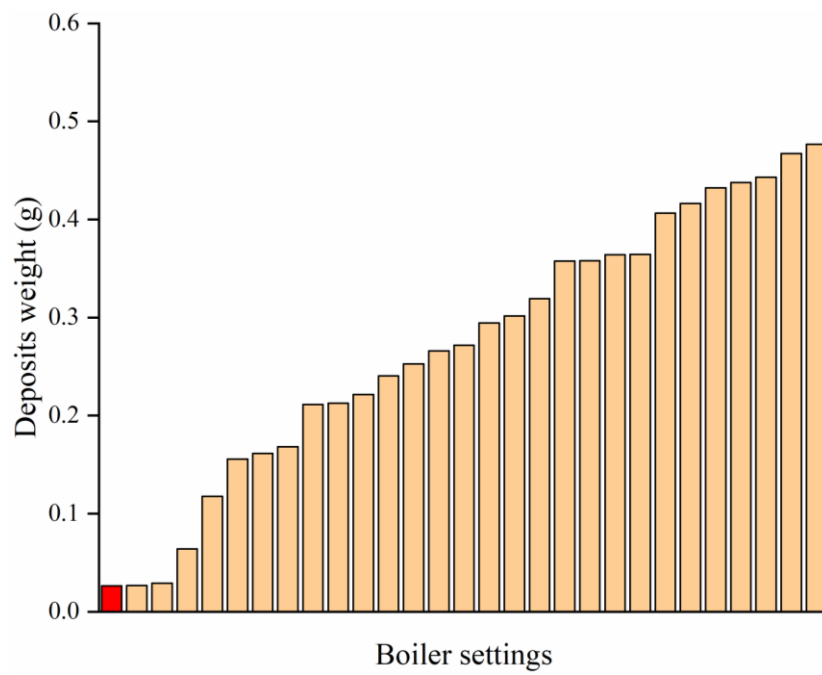
Figure 52: Amount of deposits accumulated on the air-cooled probe for the 29 different settings for 2 hours.

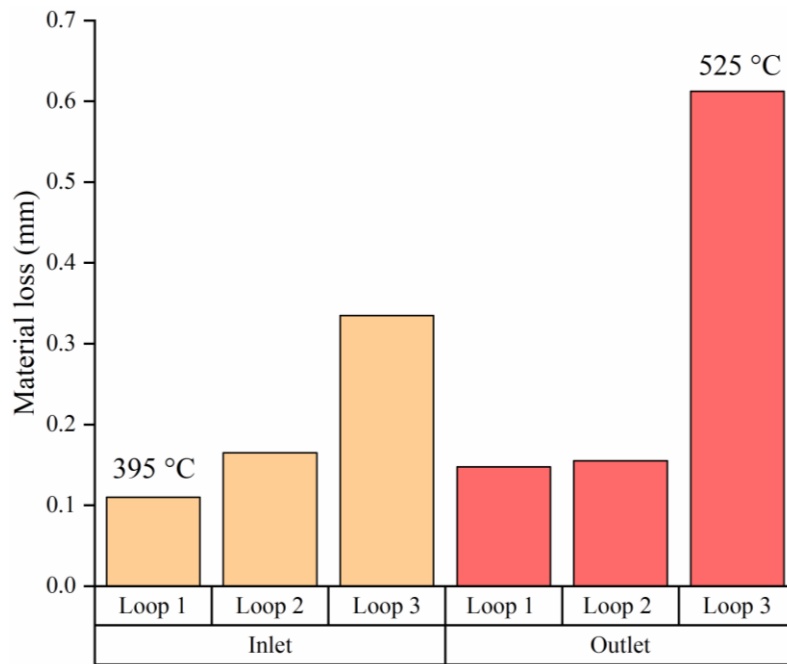
Figure 53: Material loss of 347H samples exposed at 600 °C at six different locations for 8000 hours.

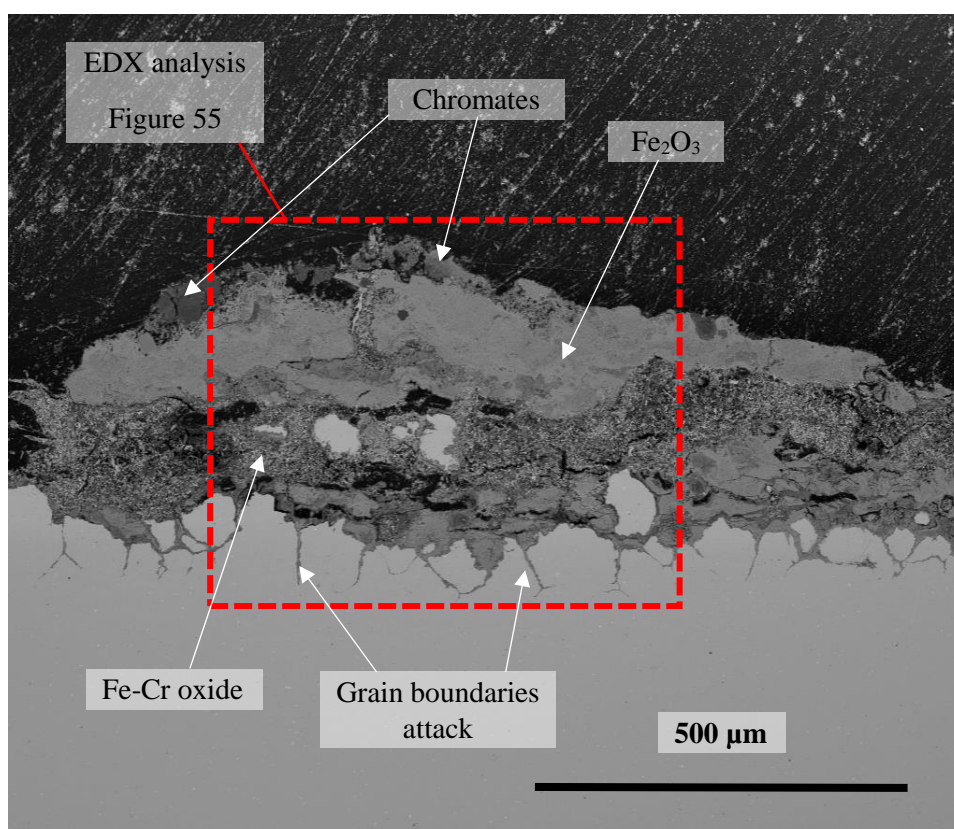
Figure 54: SEM image using BSE of 347H material exposed in the outlet of loop 3 at the Steamboost position for 8000 hours.

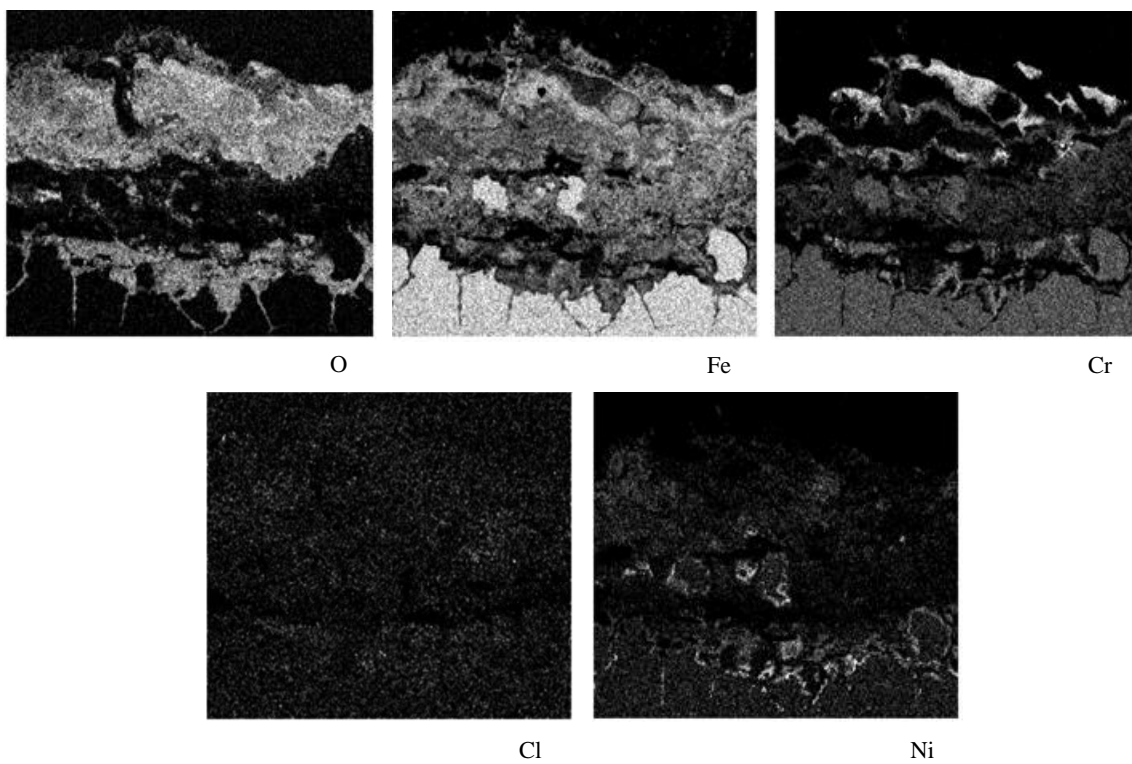
Figure 55:EDX analysis of the marked area in Figure 54.
