# The Onsala tide gauge station: experiences from the first three years of operation

Gunnar Elgered, Jonas Wahlbom, Lars Wennerbäck, Lars Pettersson, and Rüdiger Haas Chalmers University of Technology, Onsala Space Observatory, SE-439 92 Onsala, Sweden

The 24th Meeting of the European VLBI Group for Geodesy and Astrometry (EVGA), Las Palmas, Canary Islands, Spain, March 17–19, 2019

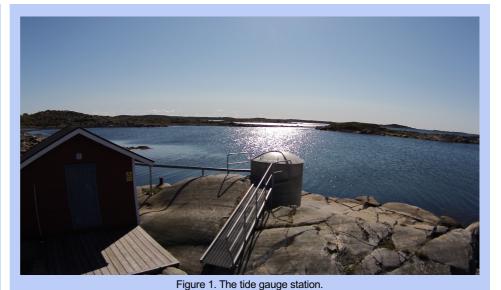
Figure 2. The radar sensor, CS476, operating at 26 GHz.

The official tide gauge station has several independent sensors: one radar (Fig. 2) and three pneumatic sensors (Fig. 3, also referred to as bubblers). Now in March 2019 there are one laser (Fig. 4) and two more radars installed in the well for quality assessment of the official data. One of the bubblers is mounted outside the well. The sketch shown in Fig. 5 gives an overall impression of the design and the locations of the sensors.
