## Experimental study of cavitation erosion around a surface-mounted semi-circular cylinder

**Keywords:** cavitation erosion, vortex shedding, semi-circular cylinder

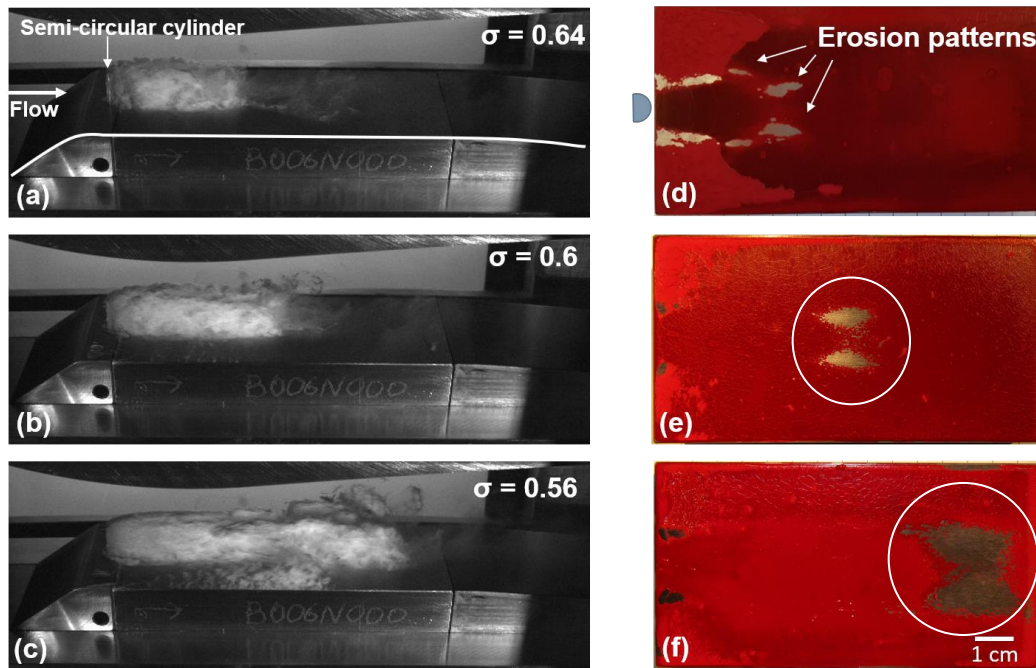
**Figure 1:** (Left) Video frames of cavitating flow behind the semi-circular cylinder. The flow is from left to right and light grey represents the cavitation region. (Right) Photographs representing the corresponding erosion patterns after 40-60 mins of operation.

Three erosive cases at different cavitation numbers are shown in Figure 1 (a) – (c). The flow is from left to right and light grey represents the cavitation region. At lower cavitation number more intense cavitation can be seen. In Figure 1 (d) – (f), the erosion patterns (removal of paint) after 40-60 mins of operation can be seen for the corresponding cavitation numbers. At a high cavitation number, one would expect less erosion due to less intense cavitation as compared to the other two cases. However, a large number of Karman-vortex-like cavities are shed downstream of the obstacle. This results in a higher number of collapse events and ultimately more erosion (Figure 1 (d)). On the other hand, at the lower cavitation numbers ( $\sigma = 0.56, 0.6$ ), most of the erosion took place at the closure

line of the cavity (Figure 1 (e) and (f)). This is mainly because the vapor cavities are just shed at the closure line of the cavity, hence the collapse of vapor takes place in the same region but not upstream.
