Effects of high-pressure cooling in the flank and rake faces of WC tool on the tool wear mechanism and process conditions in turning of alloy 718

Tamil Alagan, N., Hoier, P., Zeman, P. et al (2019). Effects of high-pressure cooling in the flank and rake faces of WC tool on the tool wear mechanism and process conditions in turning of alloy 718. *Wear*, 434-435. <http://dx.doi.org/10.1016/j.wear.2019.05.037>

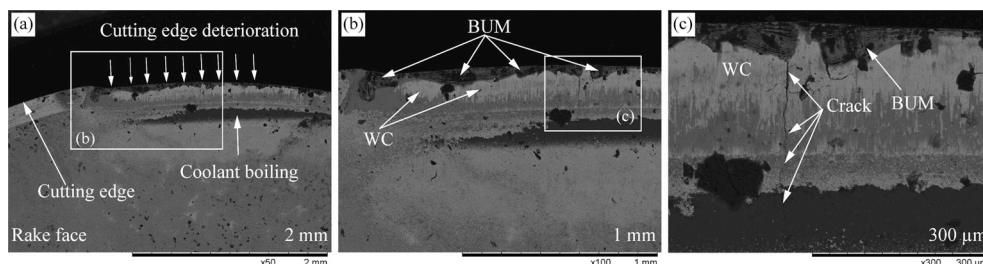
Fig. 11. Rake face of the cutting tool machined with rake pressure of 16 MPa and flank pressure 4 MPa (a) cutting edge deterioration (b) BUM on the cutting edge, and (c) crack initiation from the cutting edge crossing the tool-chip contact area.

intense tool wear rate and cause tool breakage in form of cracks, as seen in Fig. 11 (c).
