## **Effects of high-pressure cooling in the flank and rake faces of WC tool on the tool wear mechanism and process conditions in turning of alloy 718**

Tamil Alagan, N., Hoier, P., Zeman, P. et al (2019). Effects of high-pressure cooling in the flank and rake faces of WC tool on the tool wear mechanism and process conditions in turning of alloy 718. *Wear*, 434-435. <http://dx.doi.org/10.1016/j.wear.2019.05.037>

# Effects of high-pressure cooling in the flank and rake faces of WC tool on the tool wear mechanism and process conditions in turning of alloy 718

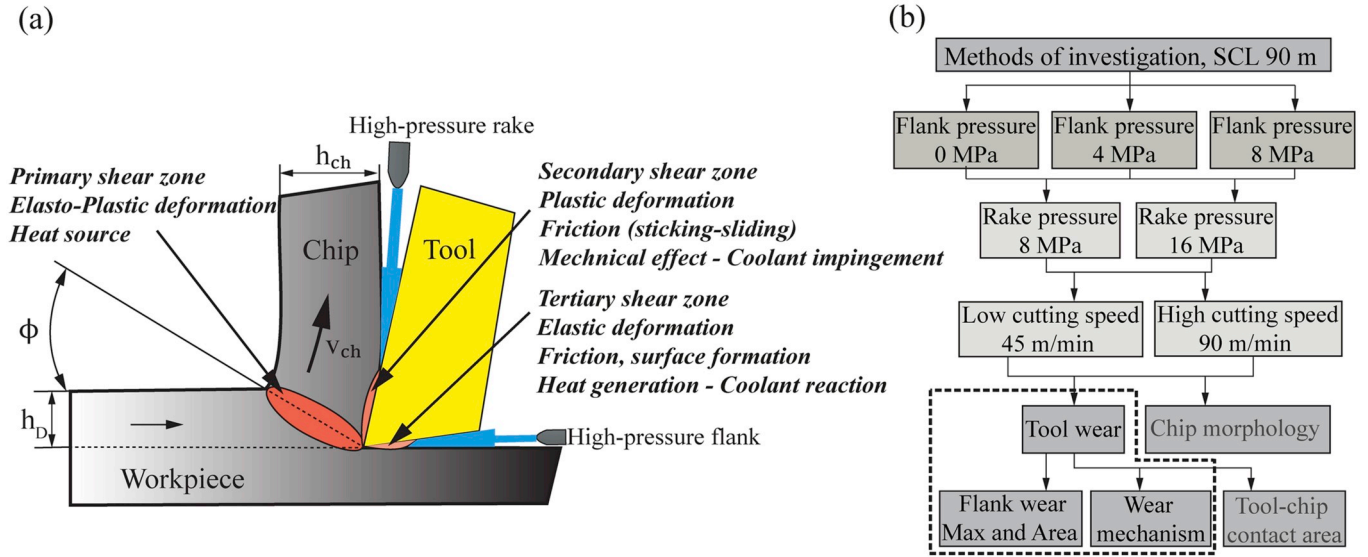
**Fig. 1.** (a) Illustrates three shear zones with focus of high-pressure coolant and (b) Overview of the research methodology incorporating investigation methods and process conditions focussed on tool wear.

The investigations were focussed on the maximum flank wear ( $VB_{\max}$ ), flank wear area ( $VB_{\text{area}}$ ) and wear mechanism observed on the WC cutting tools, by varying flank pressures conditions (0, 4 and 8 MPa) for rake pressure 8 and 16 MPa at cutting speeds 45 and 90 m/min (Fig. 1(b)). The findings are explained in the corresponding sub-sections.

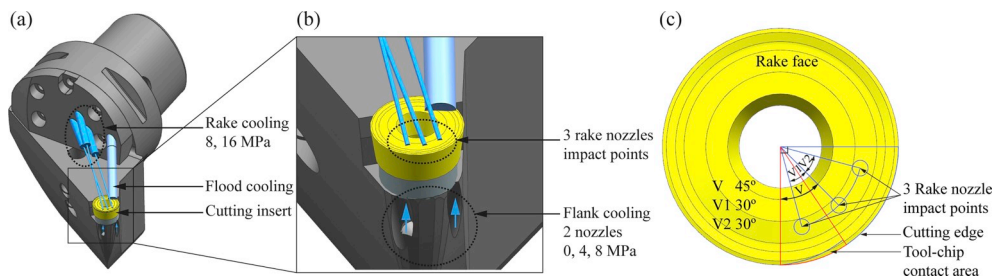
**Fig. 2.** (a) CAD model of special tool holder with internal delivering of high-pressure coolant to rake and flank extracted from Ref. [9]; (b) Magnified close to the cutting tool and impact directions; and (c) Illustration of the impact points of the coolant on the rake face as extracted from Ref. [9].

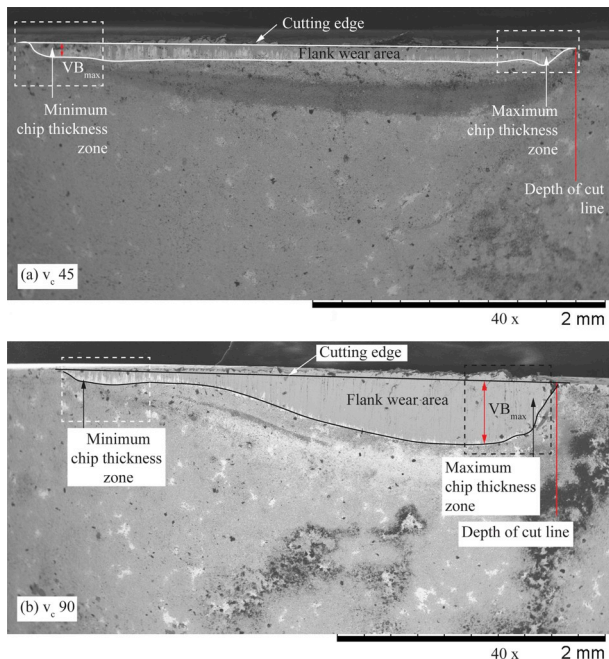
**Fig. 3.** Flank face of the WC cutting tool for rake pressure 16 MPa and flank pressure 8 MPa and a cutting speed  $v_c$  of (a) 45 m/min and (b) 90 m/min.

uniformly distributed and  $VB_{\max}$  was measured in the region the maximum chip thickness zone and as shown in Fig. 3 (b). In addition,  $VB_{\text{area}}$  was measured to increase the understanding and avoid just one single number ( $VB_{\max}$ ) value to describe the flank wear. Values of the reached wear levels, extracted from a 3-D scanning microscope, can be found in Table 2.

Various researchers like Ezugwu et al. [20, 21], Machado and Wallbank [22], and Suárez et al. [23] have investigated machining with the use of high-pressure coolant and reported increases in tool life by lowering flank wear compared to flood cooling or even dry cutting conditions. However, the dominant depth of cut notch wear was observed in their research work for both carbide and ceramic tools. This failure mode was reported to be the most prominent cause for tool failure while machining Alloy 718. Shalaby and Veldhuis [24] mentioned that the probable cause of notch wear can be caused by one effect or a combination of the following: adhesion effects, work-hardened surfaces, stresses, adverse chip flow conditions with chip curling, and temperature gradients. Further, notch wear is the dominant tool failure criterion when machining at higher cutting speeds. However, in some cases notch wear was identified even at lower cutting speeds [23]. In this experiment, no such observation of groove shape or notch wear were found for any of the cutting tools at the depth of cut line (at approx. 3.6 mm as shown in Figs. 3 and 12).

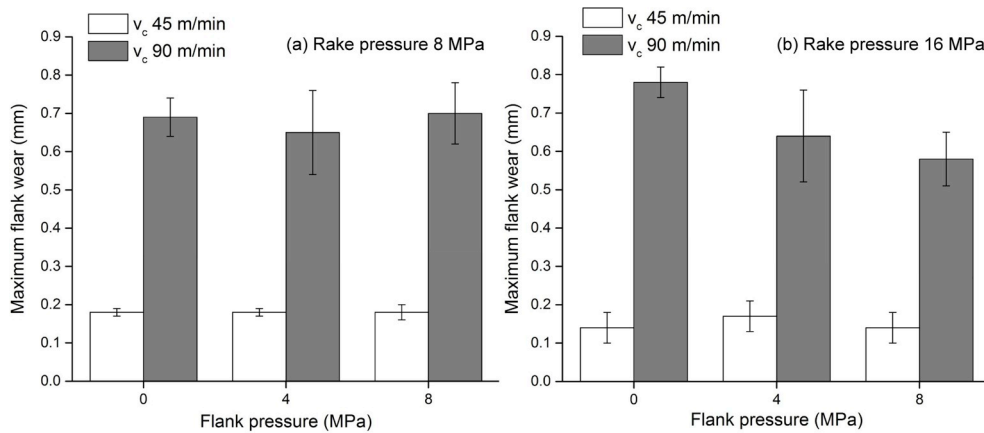
Fig. 4. Comparison of measured maximum flank wear for different cutting speeds and flank pressures; (a) Rake pressure 8 MPa (b) Rake pressure 16 MPa.

The maximum flank wear was measured for all the cutting trials (including the replicates, which is shown by the error bar), see Fig. 4. In addition, the flank wear area of the worn zone was measured and values are plotted as shown in Fig. 5. While comparing the effects of varying  $v_c$ , the difference in mean value of  $VB_{\max}$  and  $VB_{\text{area}}$  can be readily seen. The numbers have increased significantly (by approx. 3 to 4 times) for all the cutting conditions. Despite using a high-pressure coolant, the increase in cutting speed reduced the tool life significantly. This is in line with the theory that increased cutting speed leads to rises in the temperature at the cutting edge due to the heat generated in tool-chip and tool-workpiece shear zones, which consequently accelerates tool wear and lowers tool life [6,14].

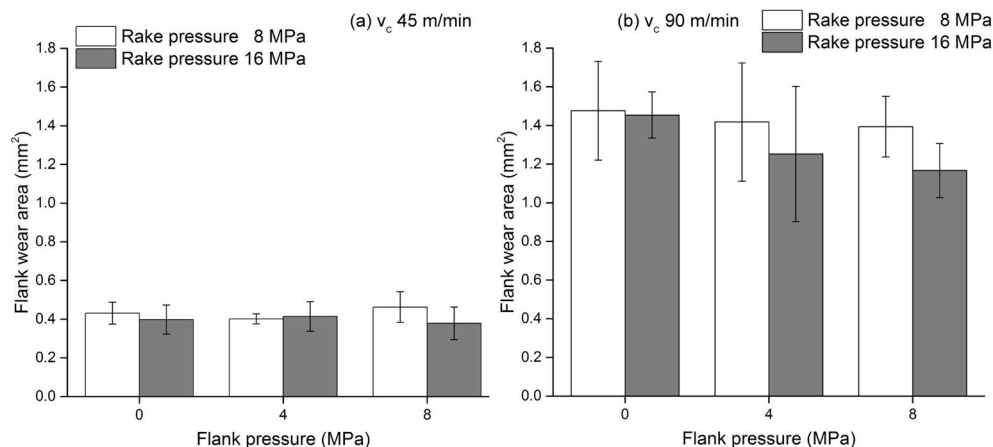
Fig. 5. Comparison of measured flank wear area for different flank and rake pressures at cutting speeds of (a)  $v_c$  45 m/min, and (b)  $v_c$  90 m/min.

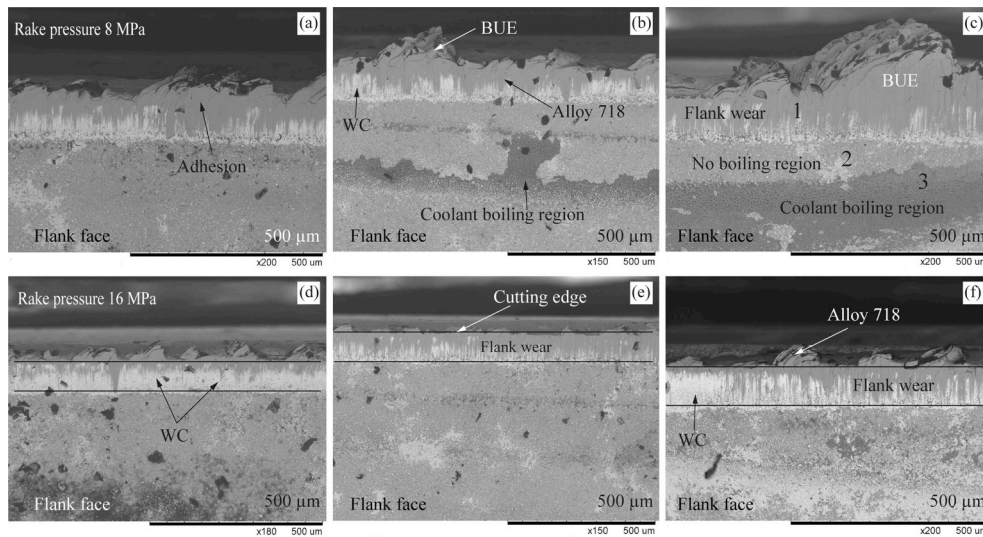
**Fig. 6.** Wear observation on the selected tool at  $v_c$  45 m/min for rake pressure of 8 MPa and flank pressure of (a) 0 MPa, (b) 4 MPa, and (c) 8 MPa and for rake pressure of 16 MPa and flank pressure of (d) 0 MPa, (e) 4 MPa, and (f) 8 MPa.

Further analysis by SEM and EDX revealed the adherence of the workpiece material, Alloy 718 as a uniform grey region on the flank wear land as shown in Fig. 6 (a, b and e), while the white regions (varying spikes) were identified as the WC tool material.

The coolant-boiling region formed as a continuous layer below the flank wear region for flank pressure conditions between 4 and 8 MPa, Fig. 6 (b and c). However, continuous formation of the coolant-boiling

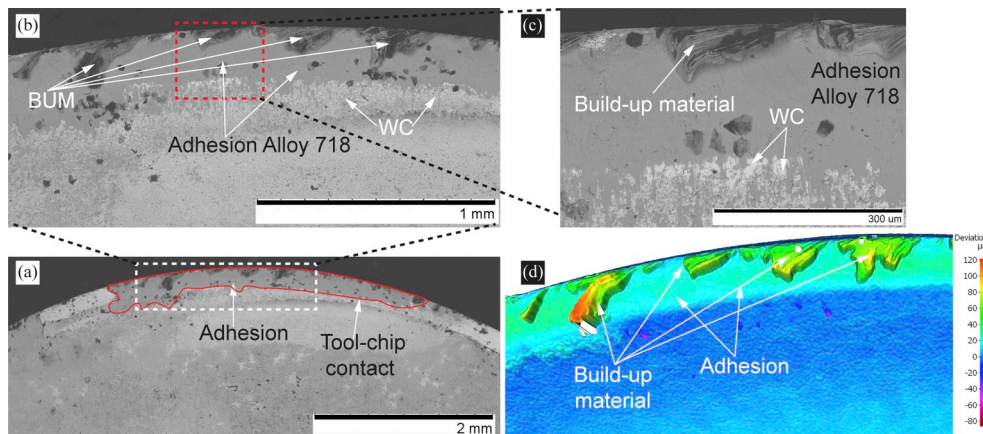
**Fig. 7.** Wear mechanism observed on rake face of the tool for  $v_c$  45 m/min with rake pressure of 8 MPa and no flank cooling.

The rake face of all the cutting tools had the build-up layer (BUL) on the tool-chip contact area; one of the tools is shown in Fig. 7 (a). In addition, build-up material (BUM) formation was observed in different areas along the contact zone, as seen Fig. 7 (b) is not the build-up edge (BUE). Normally the BUE is non-stable, breaks periodically and takes away a small amount of tool material, which in turn leads to deterioration of the cutting edge [18]. In this case, the BUM can be from the chips adhered to the tool during the cutting tool disengagement from the workpiece. BUM is scattered along the tool-chip contact area, it

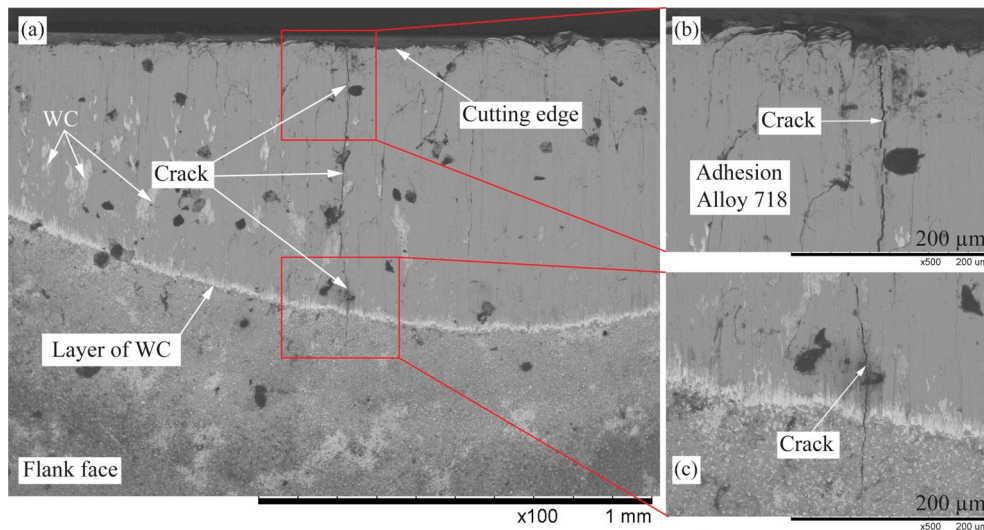
**Fig. 8.** Flank face of the cutting tool at rake pressure of 16 MPa and flank pressure of 8 MPa (a) Flank wear focussed on the crack (b) crack from the cutting edge, and (c) propagation of crack across the flank wear area.

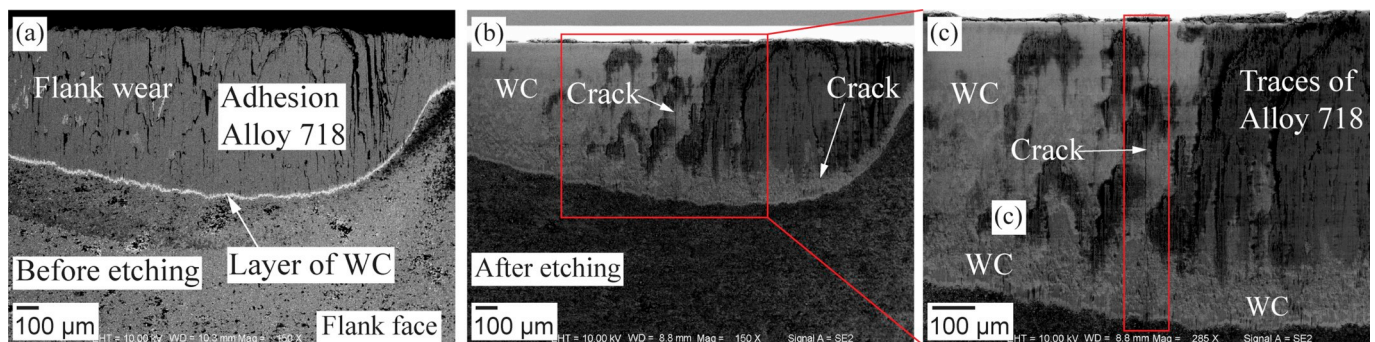
**Fig. 9.** SEM micrographs of the flank face of selected tool machined with a rake pressure of 16 MPa and no flank cooling (a) before etching, (b) after etching, and (c) higher magnification showing the crack.

When investigating the cutting tool in SEM, it was not possible to see a crack before etching the sample (Fig. 9(a)). Since the adhered workpiece material obscured the actual flank wear land, the tools were investigated after etching (Fig. 9(b)). After removing the adhered workpiece material from the flank face, the presence of the cracks was revealed see Fig. 9 (b & c). This could be seen as a kind of confirmation that the cracks are actually present in the tool and are not just part of the adhered layer.

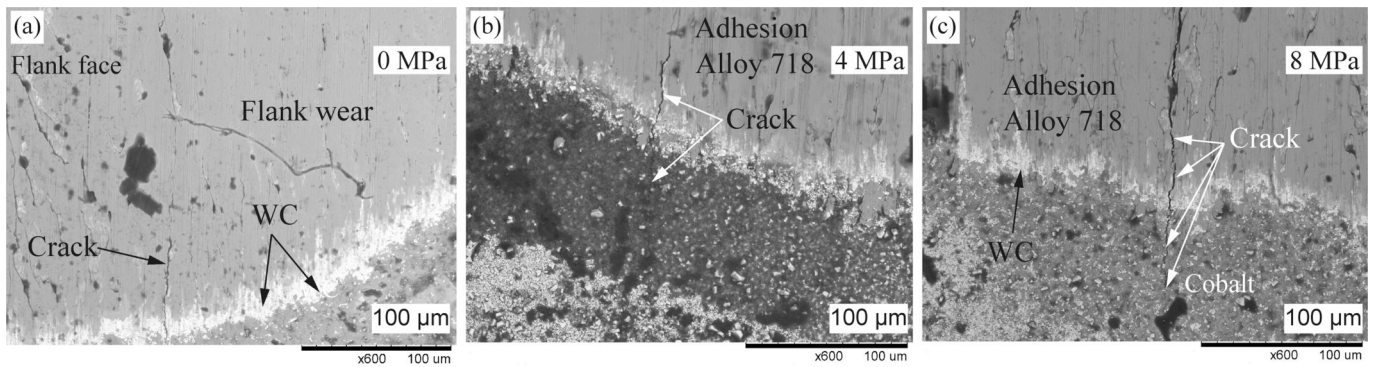
**Fig. 10.** For a rake pressure of 16 MPa selected tools SEM micrograph of flank face at higher magnification on the crack for different flank pressures condition (a) 0 MPa (b) 4 MPa (c) 8 MPa.

Selected cutting tools from different flank pressure conditions were investigated for cracks in flank wear zone using SEM, micrograph showing the crack propagation for all three conditions can be seen in Fig. 10. For 4 and 8 MPa of flank pressure, the maximum flank wear and area were measured to be lowered compared to no cooling conditions. However, cracks exist in the tools as can be seen in Fig. 10. In addition to adhesion of Alloy 718 and cracks, abrasion in form of sliding led to

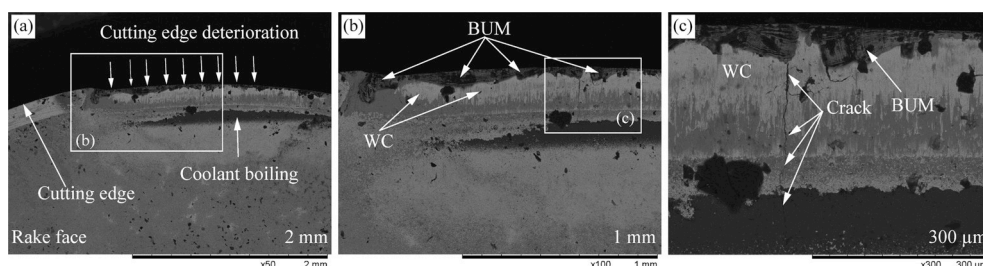
**Fig. 11.** Rake face of the cutting tool machined with rake pressure of 16 MPa and flank pressure 4 MPa (a) cutting edge deterioration (b) BUM on the cutting edge, and (c) crack initiation from the cutting edge crossing the tool-chip contact area.

intense tool wear rate and cause tool breakage in form of cracks, as seen in Fig. 11 (c).

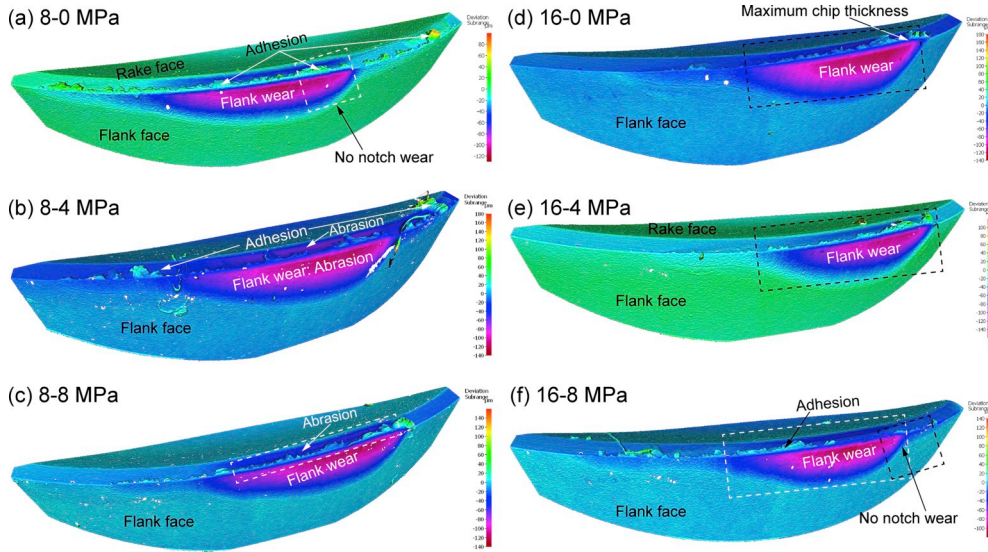
Fig. 12. Volume difference measurement of the cutting tools at different pressure conditions for  $v_c$  90 m/min.

At higher cutting speed of 90 m/min and disregarding the strength of insert geometry and flank pressure conditions, the tool wear mechanism changed between 8 and 16 MPa. Instead of crater wear, which is one of the common wear mechanism in machining Alloy 718, loss of material was observed on the cutting edge (see Fig. 12 a, b and c), in form of abrasion. However, the shape looks like a “crater valley” than a localized crater wear. For the cutting tools machined with a rake pressure of 16 MPa, abrasion rate and flank wear area were less. In addition, the tool-chip contact area was more constrained and showed less abrasion compared to the tools with a rake pressure of 8 MPa (see Fig. 12).

At the high cutting speed, 3-D measurement results of the tools showed the formation of a crater in the shape of a valley on the cutting edge at a rake pressure of 8 MPa condition. By increasing the rake pressure to 16 MPa significantly decreased the rake wear and abrasion.

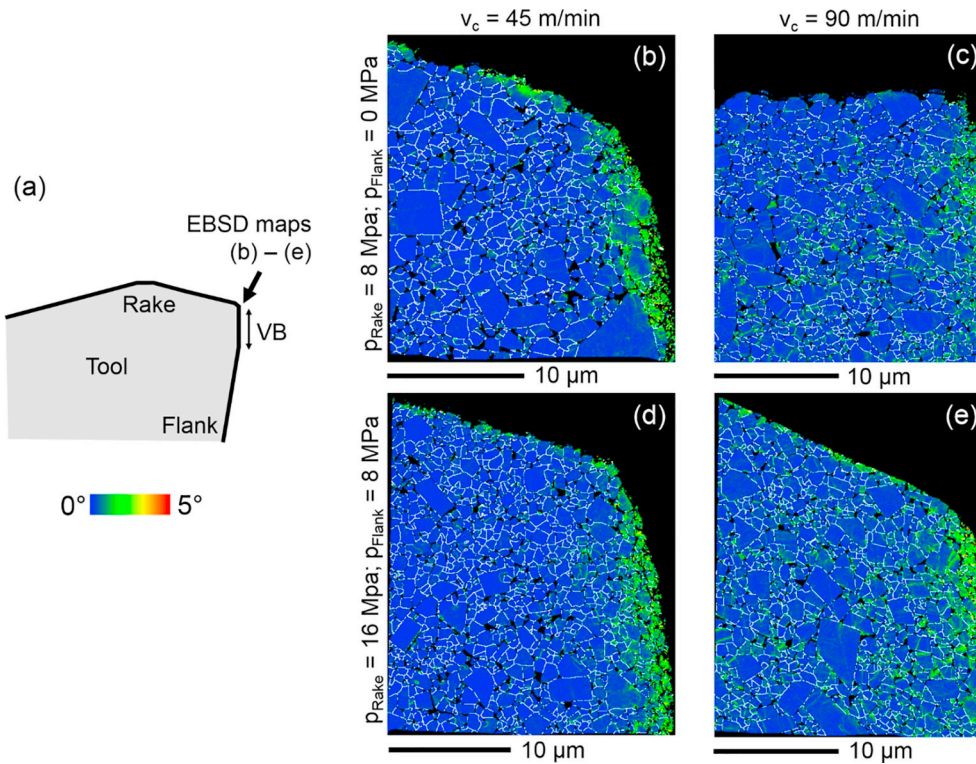
Fig. 13. EBSD results of worn cutting tools: (a) schematic representation of cross section through worn tools with location of EBSD maps indicated; (b)–(e) EBSD local misorientation maps of WC grains for low cutting speed (left column) and high cutting speed (right column) with low and high coolant supply pressures to rake ( $p_{\text{Rake}}$ ) and flank ( $p_{\text{Flank}}$ ) in the upper and lower row respectively. The local misorientation maps were generated using  $3 \times 3$  pixel filter size,  $5^\circ$  subgrain exclusion angle. Grain boundaries ( $> 10^\circ$ ) are shown in white.

dependence of the machining and coolant conditions, cross sections of four worn inserts were prepared and examined with EBSD regarding the plastic deformation of WC grains. Local misorientation maps of EBSD datasets acquired at the cutting edge can be seen in Fig. 13. The colour of every pixel represents its average orientation difference with a set of surrounding pixels [13]. According to the colour code in Fig. 13 (a), undeformed regions with low/no local misorientation are therefore shown in blue while higher misorientations due to deformation of the WC grains are shown by green, yellow, and red. As can be seen, the majority of all four maps are coloured blue indicating that these areas are free of deformation. However, close to the worn surfaces on the rake and flank faces, green and yellow coloured pixels show significant local misorientation (deformation) within WC grains. The affected zones extend a few rows of WC grains into the tools (below 5 μm). The examined part of the rake face in Fig. 13 (c) shows an exception where no local misorientations can be seen in close vicinity to the worn tool surface. As indicated by the significantly different geometry of the cutting edge (compare with e.g. Fig. 13 a), it is believed that this tool exhibited local chipping of the cutting edge in the region where the tool was sectioned. Brittle fracture of the tool material due to chipping instead of gradual wear might explain the absence of deformation in Fig. 13 (c).

the tools used with the higher cutting speed of 90 m/min as compared with the tools used for 45 m/min cutting speed (compare Fig. 13 (c and e) with Fig. 13 (b and d)). This is likely to be the result of higher thermal and mechanical loads, which are expected to act on the cutting edge when for the higher cutting speed, resulting in a larger zone of the network of WC grains to be deformed during cutting.
