Can Appropriate Thermal Post-Treatment Make Defect Content in as-Built Electron Beam Additively Manufactured Alloy 718 Irrelevant?

Goel, S., Bourreau, K., Olsson, J. et al (2020). Can Appropriate Thermal Post-Treatment Make Defect Content in as-Built Electron Beam Additively Manufactured Alloy 718 Irrelevant?. *Materials*, 13(3). <http://dx.doi.org/10.3390/ma13030536>

Article

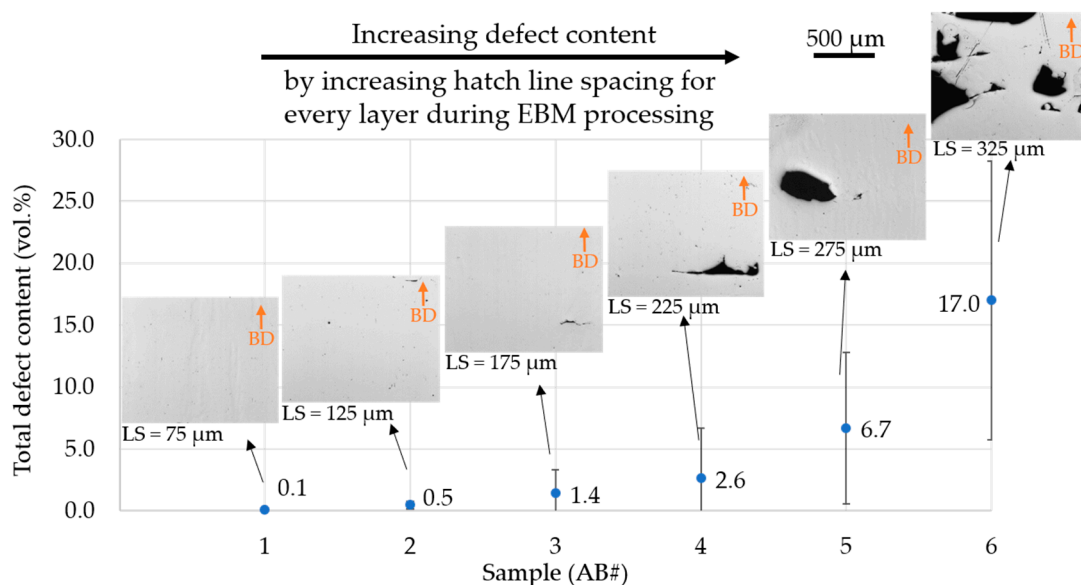
Figure 2. Defect content in as-built samples intentionally built with varied hatch line spacing (LS). The size and amount of defects are visualized in the insets. Arrows in the inset indicate build direction.

The as-built microstructures of samples processed with varying LS corresponding to different melting speeds (Table 1) are depicted in Figure 2. Increase in LS above the “recommended” value resulted in a rise in the defect content, as shown in Figure 2. The defect contents stated represent the sum of all types of defects observed in the as-built samples, i.e., gas and shrinkage porosity, and lack of fusion. Incidentally, these defects were also present in samples produced at the recommended LS = 125 μm (AB#2) as well as at lower LS = 75 μm (AB#1). Samples intentionally produced with higher LS exhibited defect contents up to 17%, as shown in Figure 2 and also visualized in accompanying micrographs. In a word, a systematic increase in line offset (processing speed) from 75 to 325 μm resulted in an increased defect content ranging from 0.1% to 17% in the investigated samples. It is worth mentioning that large defects such as those observed in samples AB#5 (LS = 275 μm) and AB#6 (LS = 325 μm) are not typical of an EBM built even with not fully optimized processing conditions [23]. However, these samples were produced for the present ‘proof of concept’ investigation regarding the extent of defect closure enabled through HIPing.

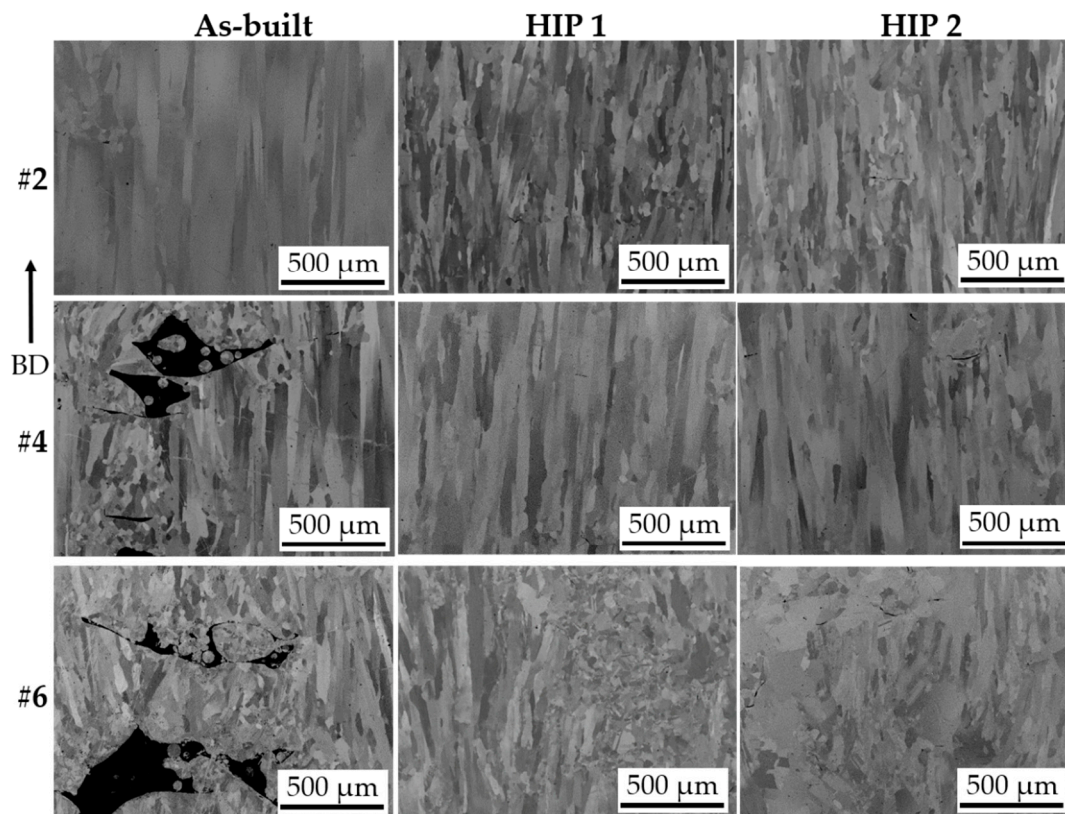
Figure 3. SEM micrographs showing defects in samples #2 (LS = 125 μm), #4 (LS = 225 μm), and #6 (LS = 325 μm) in as-built and HIP'ed conditions. The arrow indicates the build direction.

Samples with distinct defect contents, i.e., AB#2, AB#4, and AB#6 were subjected to two HIPing treatments to investigate the efficacy of defect closure. The defect contents in as-built samples AB#2, AB#4, and AB#6 (corresponding to LS = 125, 225, and 325 μm , respectively) were 0.5%, 2.6%, and 17%, respectively. After both the HIPing treatments, the defect content in all samples was significantly reduced, regardless of the original extent, as summarized in Table 4. Moreover, the difference in the extent of defect closure accomplished at 1120 $^{\circ}\text{C}$ (HIP1) and 1185 $^{\circ}\text{C}$ (HIP2) was not significant. The considerable densification of samples achieved by HIPing is also visualized from the microstructures in Figure 3. Furthermore, the small amount of remnant defects in all HIP'ed samples discussed were found to be typically associated with the presence of Al-rich oxide, which can inhibit complete defect closure. This is clearly evident from the representative EDS results given in Figure 4. It is worth mentioning that Al-rich oxides are thermodynamically very stable and not removed by HIPing, as previously observed in HIP'ed EBM Alloy 718 [24].

Such extensive and efficient reduction in the defect content by orders of magnitude (as evident from Table 4 and Figure 3) *prima facie* provides an opportunity to also potentially increase productivity—at least to some reasonable extent—during EBM processing. It is worth mentioning that the melting step typically comprises ~35% (the exact value depends on the build design [22]) of the layer heating time (preheat + melt + post-heat), which corresponds to 15% of the total layer processing time (also including lowering of build platform + powder raking) spent during the EBM process. Therefore, decreasing the melting time (by increasing the LS, as done in this study) would also have a corresponding effect on the overall EBM processing time.

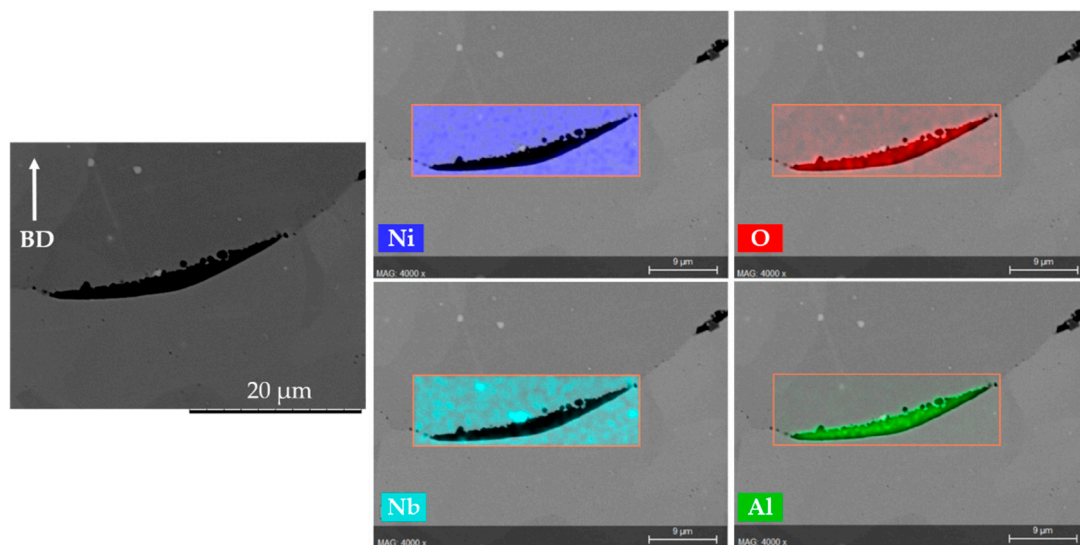
Figure 4. Representative EDS analysis showing inclusions typically associated with many remnant defects in sample #4 (LS = 225 μm) after HIP1. The arrow indicates the build direction.

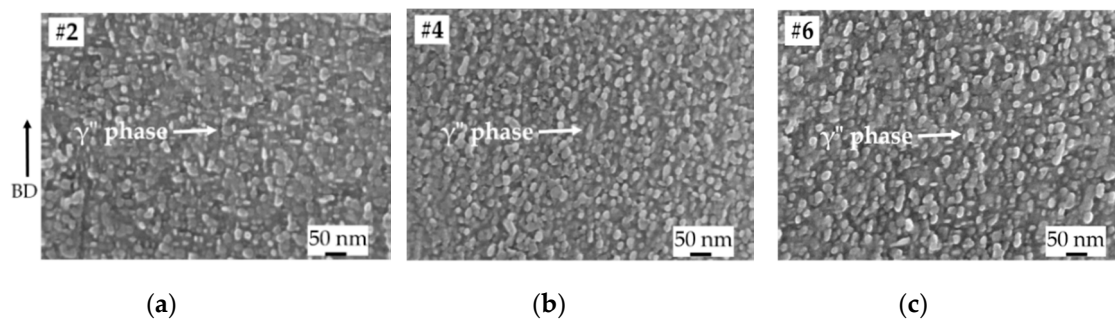
Figure 6. SEM micrographs of HIP1 + STA samples (a) LS = 125 μm , (b) LS = 225 μm , and (c) LS = 325 μm showing similar distribution of the γ'' phase. The arrow indicates the build direction.

observed in solution-treated EBM Alloy 718 that was not subjected to prior HIPing [10]. The effect of aging treatment can be readily seen from the similar distribution of γ'' phase as shown in Figure 6a–c. These microstructural similarities in the three samples (HIP1 + STA #2, #4, #6) were also reflected in the microhardness results, as described below.
