Fatigue crack repair in welded structures via tungsten inert gas remelting and high frequency mechanical impact

al-Karawi, H., von Bock und Polach, R., al-Emrani, M. (2020). Fatigue crack repair in welded structures via tungsten inert gas remelting and high frequency mechanical impact. *Journal of Constructional Steel Research*, 172.
<http://dx.doi.org/10.1016/j.jcsr.2020.106200>

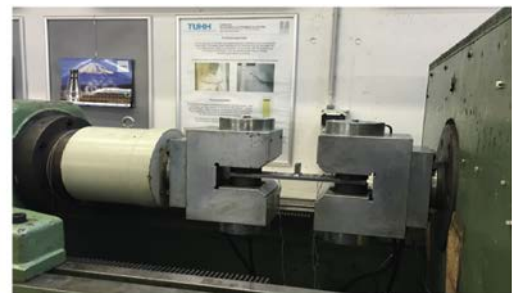
Fig. 4. L: Schematic figure shows the hydraulic clamp. R: Fatigue testing rig.
