Exploratory investigation of return air temperature sensor measurement errors in refrigerated display cabinets

Månsson, T., Ostermeyer, Y., Sasic Kalagasidis, A. (2021). Exploratory investigation of return air temperature sensor measurement errors in refrigerated display cabinets. *Energy Efficiency*, 14(1). <http://dx.doi.org/10.1007/s12053-020-09912-1>

Tommie Månsson · York Ostermeyer ·
Angela Sasic Kalagasidis

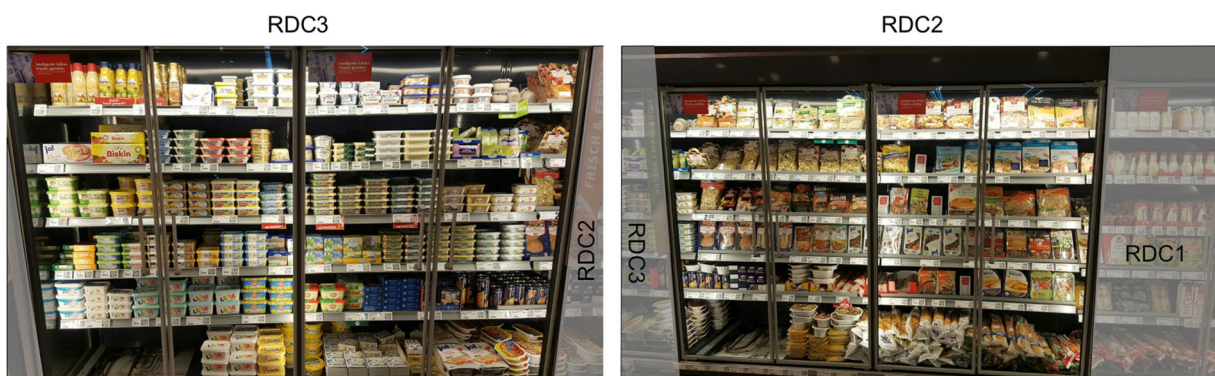
Fig. 1 Photos from the investigated supermarket, showing the neighbouring refrigerated display cabinets, RDC_2 and RDC_3

shown in Fig. 1 it can be seen that the products are not identical, but the occupied volume is similar.

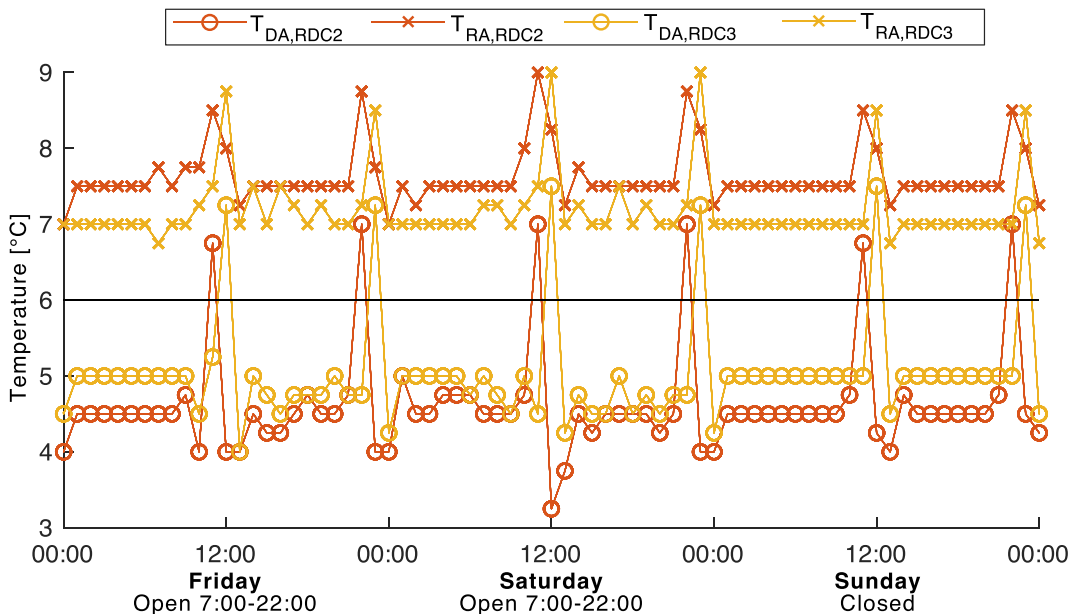
Fig. 3 The return and discharge air temperature of two neighbouring RDCs, namely RDC_2 and 3, where an unexpected difference in temperature levels can be seen. Even outside of the

stores opening hours when there are no customer interactions, the temperatures differ between the RDCs

The temperature readings presented in Fig. 3 show that RDC_2 was operating with a lower T_{DA} and yet reporting a higher T_{RA} than RDC_3 . During Friday and Saturday, this anomaly could be addressed to the differences in customer interactions with these RDCs. However, the same trend continued during Sunday, even though the supermarket was closed. In theory, identical RDCs exposed to the same ambient conditions should maintain equal T_{RA} and T_{DA} . The small differences in the RDCs' setup are rather unlikely to cause the 32% increase in heat extraction. Therefore, it was concluded that the anomaly might be a result of inadequately measured temperatures as explained in the next section.

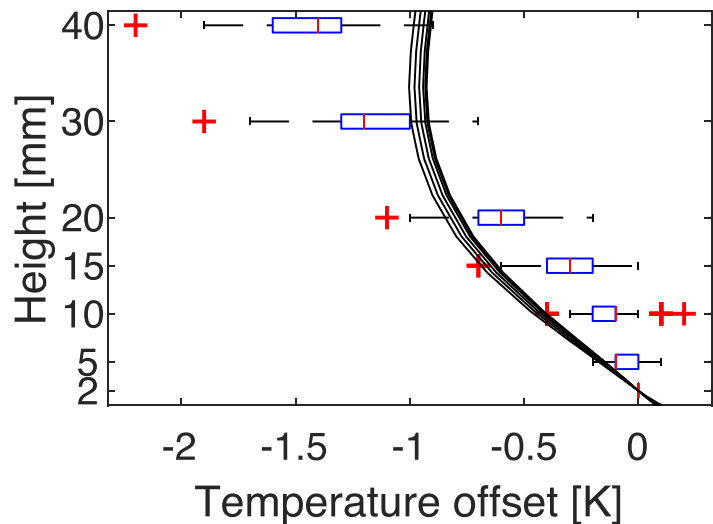
Fig. 8 Left: Photo of thermocouples fixed at 2, 5, 10, 15, 20, 30 and 40 mm on a steel bracket. Right: The box-plot shows the measured temperature offset for the validation experiment. The

black lines show the calculated temperature offset with varying inlet velocity and emissivity. The shown data represents the temperatures along the line C1 from Fig. 9

temperature profile, the corresponding offsets are presented as box-plots at each respective height as shown in Fig. 8.

In the same figure, the black lines show the offset results from the CFD model where the inlet velocity was varied by $\pm 50\%$ and emissivity between $\epsilon = 0 - 1$. The variation in velocity was made to investigate the impact of RDC loading of food, i.e. packaging blocking the flow in certain areas which consequently would increase velocity in other areas. As can be seen in Fig. 8, the velocity has a negligible effect in relation to the spatial variations of the air temperature in the considered area. As the actual emissivity of the floor surface was unknown, this parameter was varied between the extremes, 0–1, to evaluate the impact range. Also here, the effects were of negligible magnitude compared to the spatial variations in temperature.

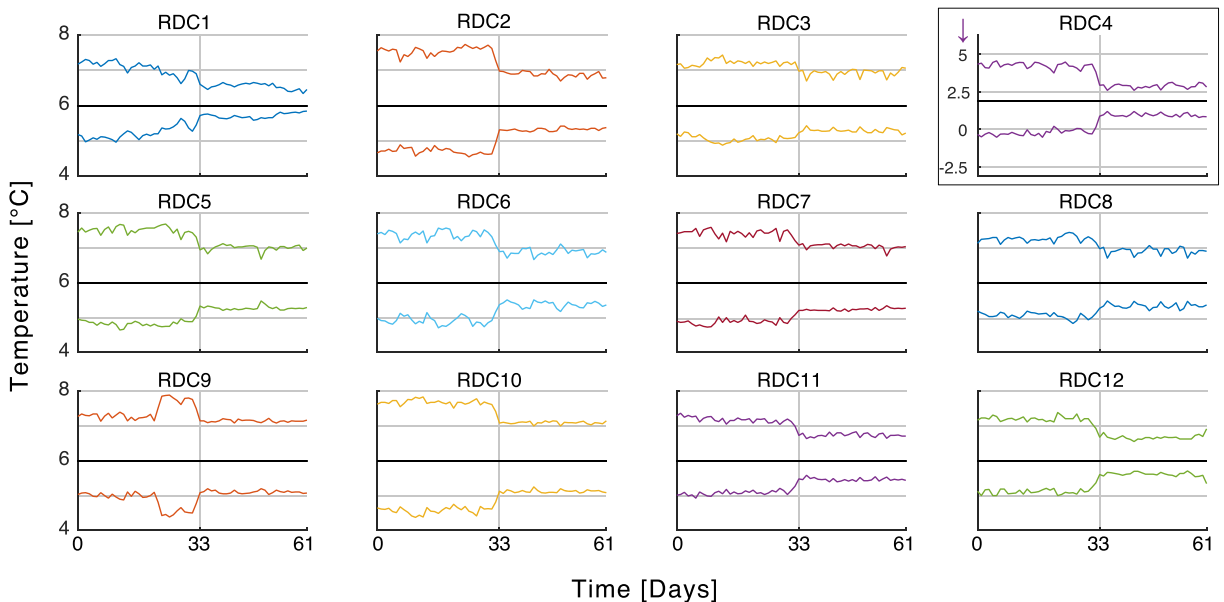
Fig. 12 Temperature data for one month before and after the relocation of the return air temperature sensor in a supermarket outside of Hamburg. The relocation occurred on day 33. The

second graph on the top row (RDC_2) shows temperature data for the sensor in Fig. 11. Notice: RDC_4 is used for meat and therefore has a lower temperature

In total, 12 RA temperature sensors were re-positioned in this supermarket. In Fig. 15, the original position is marked with red in the graph and in Fig. 12 the effect on the measured temperature of the relocation can be seen. The presented graphs in Fig. 12 are showing the measured daily average temperature for the return and discharge air. Here the relocation of the return air temperature sensors occurred on the 33rd day. This is clearly visible as a step-change in both T_{RA} and T_{DA} . The increase of T_{DA} is a consequence of the control system responding to the

perceived decreased RA temperature, which is interpreted by the control system as decreased heat gains to the RDC. Hence a decreased temperature difference between T_{DA} and T_{RA} , which indicates a lowered heat extraction rate. However, it should be explicitly stated that the T_{RA} prior to the re-positioning of the sensor
