# Laser-based powder bed fusion of non-weldable low-alloy steels

Hearn, W., Steinlechner, R., Hryha, E. (2022). Laser-based powder bed fusion of non-weldable low-alloy steels. Powder Metallurgy, 65(2): 121-132. http://dx.doi.org/10.1080/00325899.2021.1959695

This study focuses on the processability of four low-alloy steels (AISI 4130, 4140, 4340 and 8620) via laser-based powder bed fusion (LB-PBF). In the as-built condition, the alloys consisted of tempered martensite that was the result of an intrinsic heat treatment (IHT) during LB-PBF. In terms of defects, a distinct transition in porosity was observed that correlated to the volumetric energy density (VED). At low VED, specimens contained a lack of fusion porosity, while at high VED, they contained keyhole porosity. Additionally, cold cracking was observed in 4140 and 4340 specimens produced at low/intermediate VEDs. This cracking could be mitigated by increasing the VED or laser power, as both enhance the IHT. This enhanced IHT lowered the material hardness below specific thresholds (<500HV 4340 and <460 4140), increasing ductility and allowing the specimens to avoid cracking. From these findings, crack-free, high-density (>9

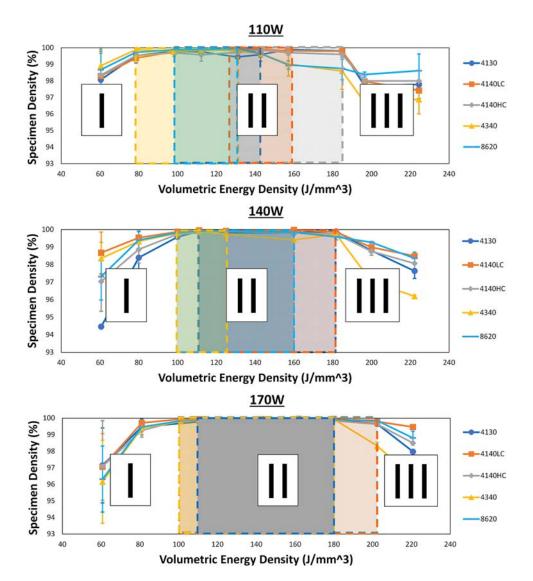
Figure 2. Relative density as a function of VED for each examined low-alloy steel. Marked areas (I, II or III) denote the defined process regions, where the segmentation of each region is marked using dashed box lines. Region II represents the ideal processing window where specimen densities of >99.8% are produced.

Measurement of the as-built specimen density revealed its strong dependence on the VED, where three distinct regions could be identified (see Figure 2). At low VED (Region I), irregularly shaped pores (up to 500 µm in size) could be

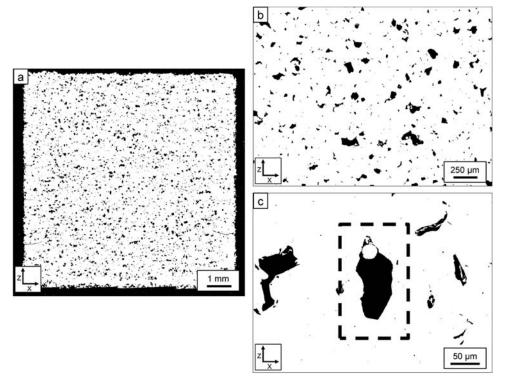
Figure 3. (a) Lack of fusion porosity in an AISI 4140HC specimen produced at 60 J mm<sup>-3</sup> using a 170 W laser power. (b) Higher magnification of image (a). (c) Higher magnification of image (a) showing a lack of fusion porosity within a partially sintered powder particle (outlined by the black box).

found within the as-built specimens (see Figure 3). These characteristics, coupled with the presence of unmelted powder particles, helped identify them as lack of fusion defects [2122]. The formation of the lack of fusion porosity at these low VEDs was not caused by inadequate bonding between layers, as the melt pool depths were much larger than the chosen layer thickness (see Figure 14). Instead, the lack of fusion porosity formed due to inadequate overlap between deposited melt tracks. This insufficient overlap could be observed within the top surface of the specimens, as lower VED specimens had a more irregular surface that contained numerous cavities between deposited melt tracks (see Figure 4a). These issues of surface irregularity and cavities went away once higher VEDs

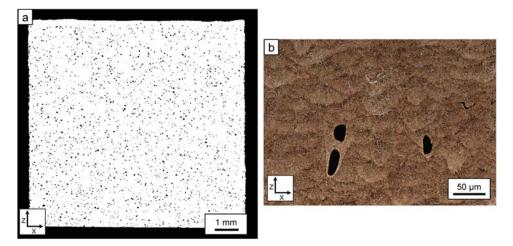
Figure 5. (a) Keyhole porosity in an AISI 4340 steel specimen produced at 185 J mm<sup>-3</sup> using a 110 W laser power. (b) Example of keyhole pores at the bottom of melt pools in an AISI 4340 specimen produced at 140 J mm<sup>-3</sup> using a 110 W laser power.

At high VED (Region III), oval-shaped pores (up to 150 µm in size) could be found within the as-built specimens (see Figure 5). These pores formed at the bottom of the melt pool boundaries (see Figure 5) and could be identified as keyhole porosity [23–25].

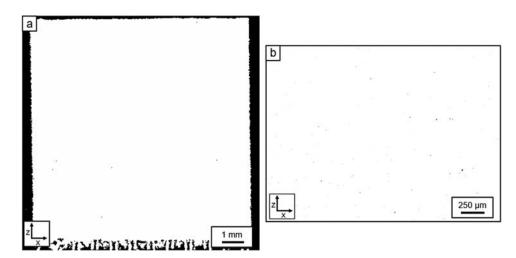
Figure 6. (a) High-density (>99.8%) AISI 8620 specimen produced at 110 J mm<sup>-3</sup> using a 110 W laser power. (b) Higher magnification of specimen from (a) showing the presence of minimal porosity.

At regions of intermediate VED (Region II), highdensity (>99.8%) specimens with minimal porosity could be produced (see Figure 6).

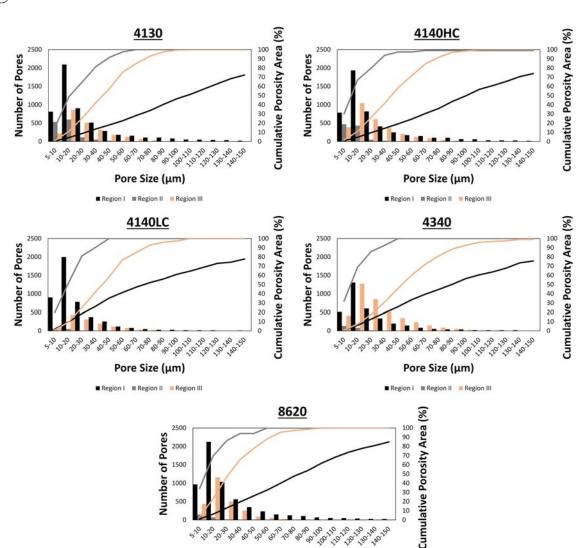
Figure 7. Histogram and cumulative porosity area for low-alloy steel specimens from each process region.

primarily to medium-sized pores (20–100  $\mu m)$  that maintained similar shape characteristics to the porosity found in Region II specimens. A comparison of the pore size distribution (see Figure 7) helped to better distinguish the porosity found in Region III from the porosity found in Region III. First, Region III specimens contained pores sized 20–100  $\mu m$ , which were not present in Region II specimens. This size range is the characteristic of keyhole porosity (see Figure 5). Second, Region III specimens also had an increase in small pores (<20  $\mu m$ ), which helped to distinguish the transition from Region II to Region III as marking the beginning of keyhole porosity as well as an increase in small, circular pores.

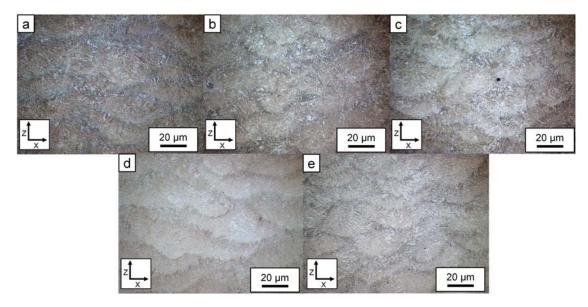
**Figure 8.** As-built microstructure for (a) AISI 4140LC alloy specimen produced at 110 J mm<sup>-3</sup> using a 140 W laser power, (b) AISI 4130 alloy specimen produced at 110 J mm<sup>-3</sup> using a 170 W laser power, (c) AISI 4140HC alloy specimen produced at 100 J mm<sup>-3</sup> using a 110 W laser power, (d) AISI 4340 alloy specimen produced at 110 J mm<sup>-3</sup> using a 170 W laser power and (e) AISI 8620 alloy specimen produced at 100 J mm<sup>3</sup> using a 110 W laser power.

Figure 8 shows the as-built microstructure of each low-alloy steel. For all alloys, a martensitic microstructure was observed. In addition, these microstructures displayed numerous overlapping boundaries that

related to the heat-affected regions of deposited melt tracks. These boundaries could be distinguished because they were preferentially etched in comparison to the rest of the material.

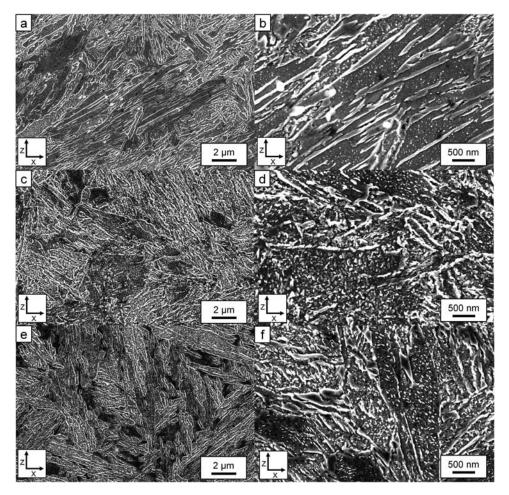
Figure 9. SEM images of tempered lath martensite in (a,b) an AISI 4130 alloy specimen produced at 80 J mm<sup>-3</sup> using a 110 W laser power, (c,d) an AISI 4140HC alloy specimen produced at 200 J mm<sup>-3</sup> using a 140 W laser power and (e,f) an AISI 4340 alloy specimen produced at 140 J mm<sup>-3</sup> using a 170 W laser power.

SEM analysis (see Figure 9) was used to study the as-built specimen microstructure at a higher resolution. Said analysis revealed a fine lath structure of martensite that had an abundance of nanoscale precipitates, that are likely small cementite or transitional carbides that can form during the short-time tempering of a martensitic structure [26–29]. Hardness measurements (see Figure 10) provided additional evidence of tempering, as the as-built specimens had a hardness that was similar to specimens that had been quenched and tempered after processing.

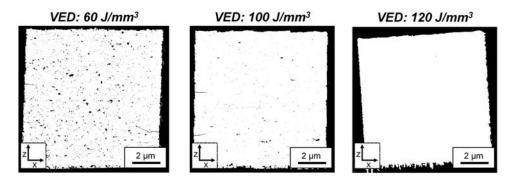
Figure 13. Evolution of cold cracking in the AISI 4140LC alloy as a function of VED for specimens produced with a laser power of

The occurrence of cold cracking in the AISI 4140LC, 4140HC and 4340 alloy specimens was dependent on both the VED and the laser power (see Table 6). Increasing the VED reduced crack propensity and crack size until an upper VED threshold was reached, above which no cracking occurred (see Figure 13). While increasing the laser power would reduce the VED that was required to avoid cold cracking.

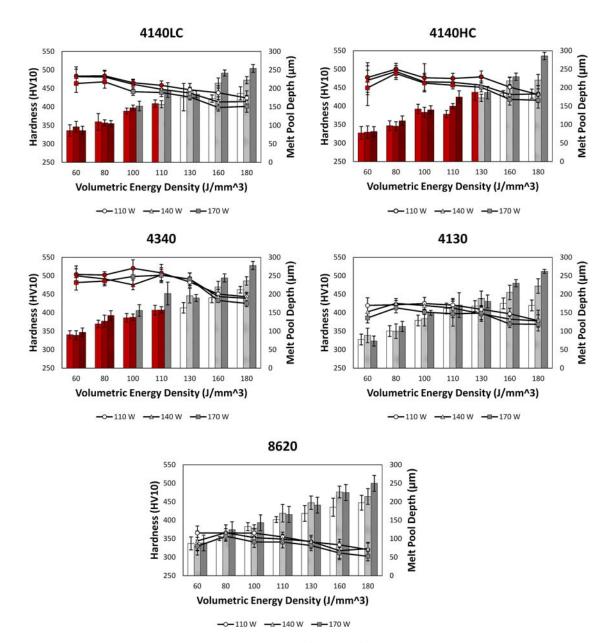
Figure 14. Variation in bulk hardness and melt pool depth as a function of the VED. Hardness is displayed as a scatter plot, while melt pool depth is displayed as a bar chart. The VEDs at which cold cracking occurred are indicated with fill.

and melt pool depth were plotted as a function of VED (see Figure 14). This analysis showed that increasing the VED or laser power increased the depth of the melt pool and subsequently decreased the hardness of the as-built material. During LB-PBF, an intrinsic heat treatment (IHT) occurs as new layers of material are deposited on top of previously solidified layers [3031]. The extent of this heat treatment is influenced by the distance from the deposited layer and the number of times the material is reheated. Owing to the larger melt pool depths at higher VEDs and laser powers, there is a larger volume of melted and subsequently reheated material, providing an enhanced IHT.

The hardness measurements from Figure 14 showed that cold cracking would occur at a hardness level >460HV for the AISI 4140 alloys and >500HV for the AISI 4340 alloy. This indicates that if a large enough VED or laser power is used, the IHTIHT during LB-PBF can adequately temper the material so it can avoid cold cracking defects. This hardness threshold could also explain why the AISI 4130 and 8620 alloys did not display any cold cracking, as the highest hardness for said alloys (~425HV) was below the aforementioned thresholds.
