Fatigue Crack Propagation on Uniaxial Loading of Biaxially Predeformed Pearlitic Rail Steel

Gren, D., Ahlström, J. (2023). Fatigue Crack Propagation on Uniaxial Loading of Biaxially Predeformed Pearlitic Rail Steel. *Metals*, 13(10). <http://dx.doi.org/10.3390/met13101726>

Abstract: Rolling contact fatigue loading causes the surface material in the top of the rail to severely deform. The microstructure aligns along the shear direction and the mechanical behavior in terms of plastic flow becomes anisotropic. Cracks are initiated in the severely deformed surface region and propagates along the direction of microstructure flow lines. However, the effect of large shear deformation on fatigue crack growth is not yet well understood. In this study, uniaxial fatigue crack propagation of undeformed and biaxially predeformed pearlitic rail steel R260 has been investigated. The material was predeformed to different deformation states using combined axial compression and shear deformation, corresponding to material found at different depths in the severely deformed surface layer of rails. Fatigue crack propagation rate was dependent on the material state and influenced by both work hardenin

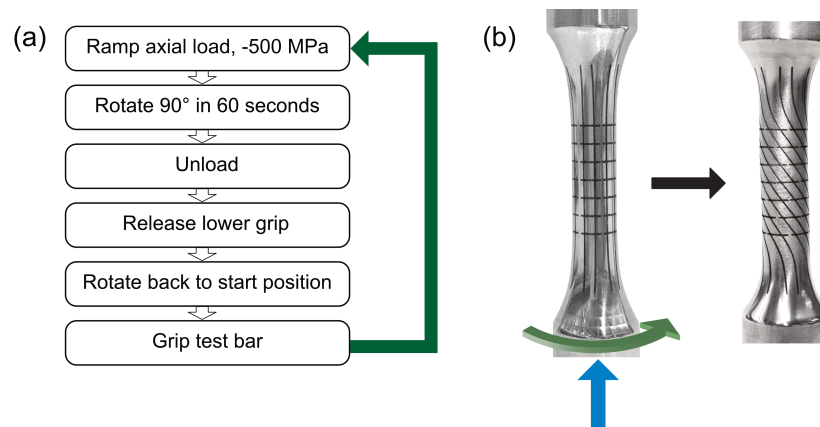
Figure 2. The predeformation process is shown in (a) and in (b) the shear deformation resulting after twisting 3×90 degrees is visualized by the laser etched grid.

The predeformation method developed by Meyer et al. [23] has been used to replicate the anisotropic surface material found in rails. The predeformation process is a cyclic sequence in which test bars are twisted under simultaneous compression, as illustrated and explained in Figure 2a. In total, two predeformed material states were produced, corresponding to twisting 3×90 degrees (PD3) and 6×90 degrees (PD6) under a nominal initial compressive stress of -500 MPa. The nominal compressive stress slightly decreases in each cycle as the diameter increases. The test bars used for predeformation were machined according to the drawing in Figure 1b. These test bars were prepared in two steps prior to predeformation. In the first step, they were gradually ground up to P1200 SiC abrasive paper to avoid pre-mature failure during predeformation. Thereafter, in the second step, a grid to measure surface shear strain was applied by laser etching, see Figure 2b. Naturally, undeformed test bars were also included as a reference, and these are called PD0.

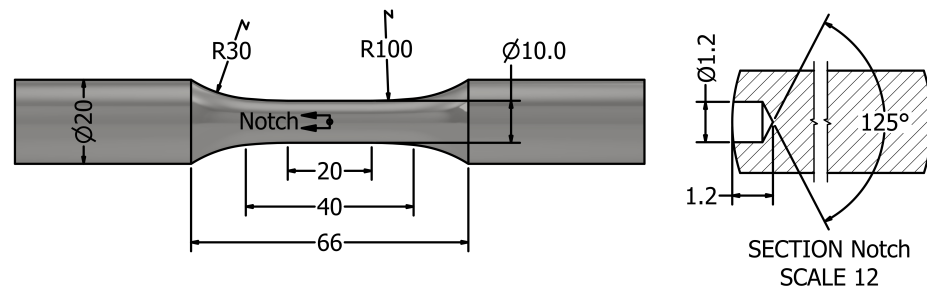
Figure 3. Drawing of the notched test bars. Dimensions in [mm].

The compressive load during predeformation causes a slight bending of the test bar gauge section besides decreasing the length/width ratio. Reprofilng was therefore required to make the test bars axi-symmetric and thereby suitable for fatigue testing. Test bars denoted PD6 were reprofiled according to the drawing in Figure 1b. However, it was not possible to reprofile PD3 test bars with this geometry due to the slight bending but limited widening of the profile. Therefore, the dimensions in Figure 1b were adjusted. The gauge section diameter was changed to 9.5 mm instead of 10 mm and the transition radius R30 was changed to R28.

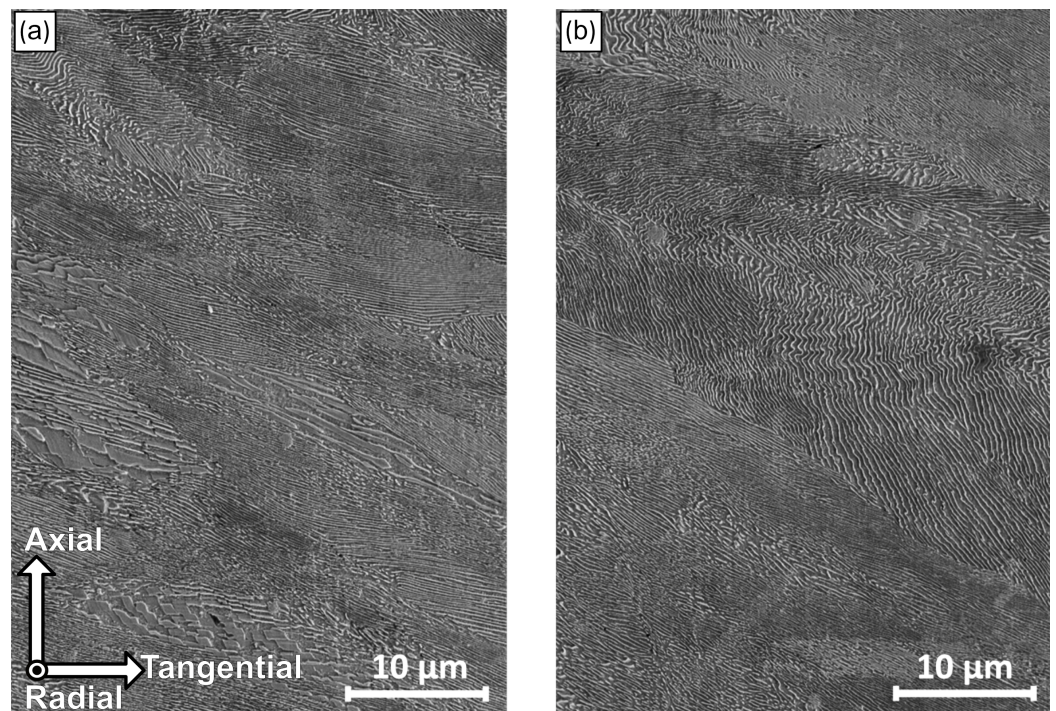
Figure 11. Orientation of pearlite lamellae in a PD6 test bar. In (a) most of the cementite lamellae have reoriented along the tangential (predeformation) direction whilst no preferred direction is observed in (b).

Figure 10a,b. Here, the microstructure shows an overall alignment towards the tangential direction. Compared with the material state of PD3, the alignment is more evident and the pearlite colony boundaries cannot easily be distinguished. The variation of the cementite orientation throughout the structure is observed as for the case of the PD3 microstructure. Several areas show curved lamellae, due to shear localization. This is exemplified in Figure 11a,b.
