Investigation on Pollution-Induced Flashovers of In-Service Insulators in Ethiopian Power Transmission Lines

Berhanu Zelalem Desta ^{1,2,*}, Mengesha M. Wogari ² and Stanislaw M. Gubanski ³

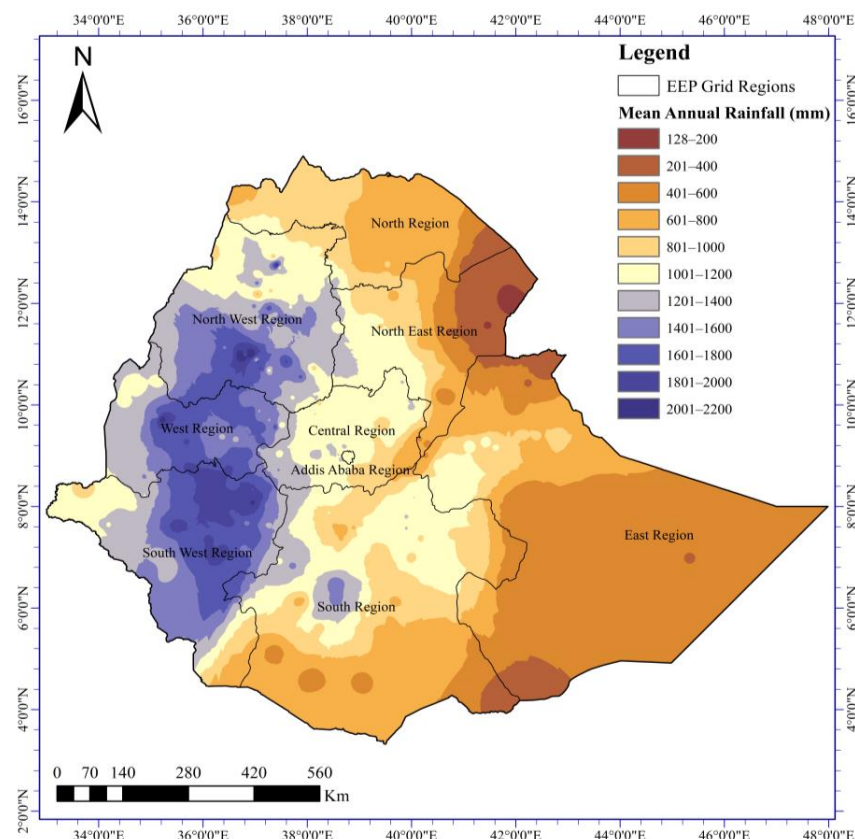
Figure 1. Map of annual average rainfall of Ethiopia showing the grid regions of EEP.

The interaction between the meteorological and environmental conditions of Ethiopia, in terms of pollution accumulation, wetting, and natural cleaning ability is used to derive a classification of grid regions. Identifying the season in each grid region that exhibit similar patterns in accumulating a high level of pollution on the insulator surface, conducive for critical wetting and favorable for self-cleaning and an overall reduction in pollution accumulation, is the base for the classification. This facilitates the classification of the country's territory into distinct groups of grid regions and offers a convenient structure for examination of unexplained faults in more detail. Accordingly, the grid management regions of the EEP are classified into four grid region groups. The North, Northwest, Addis Ababa, and Central grid regions of EEP are classified as Group 1 (G1), the West and Southwest regions are classified as Group 2 (G2), the South region is classified as Group 3 (G3), and the East and Northeast regions are classified as Group 4 (G4). Figure 1 shows the geographical location of these grid regions with the indicated annual average rainfall of the Ethiopian territory.

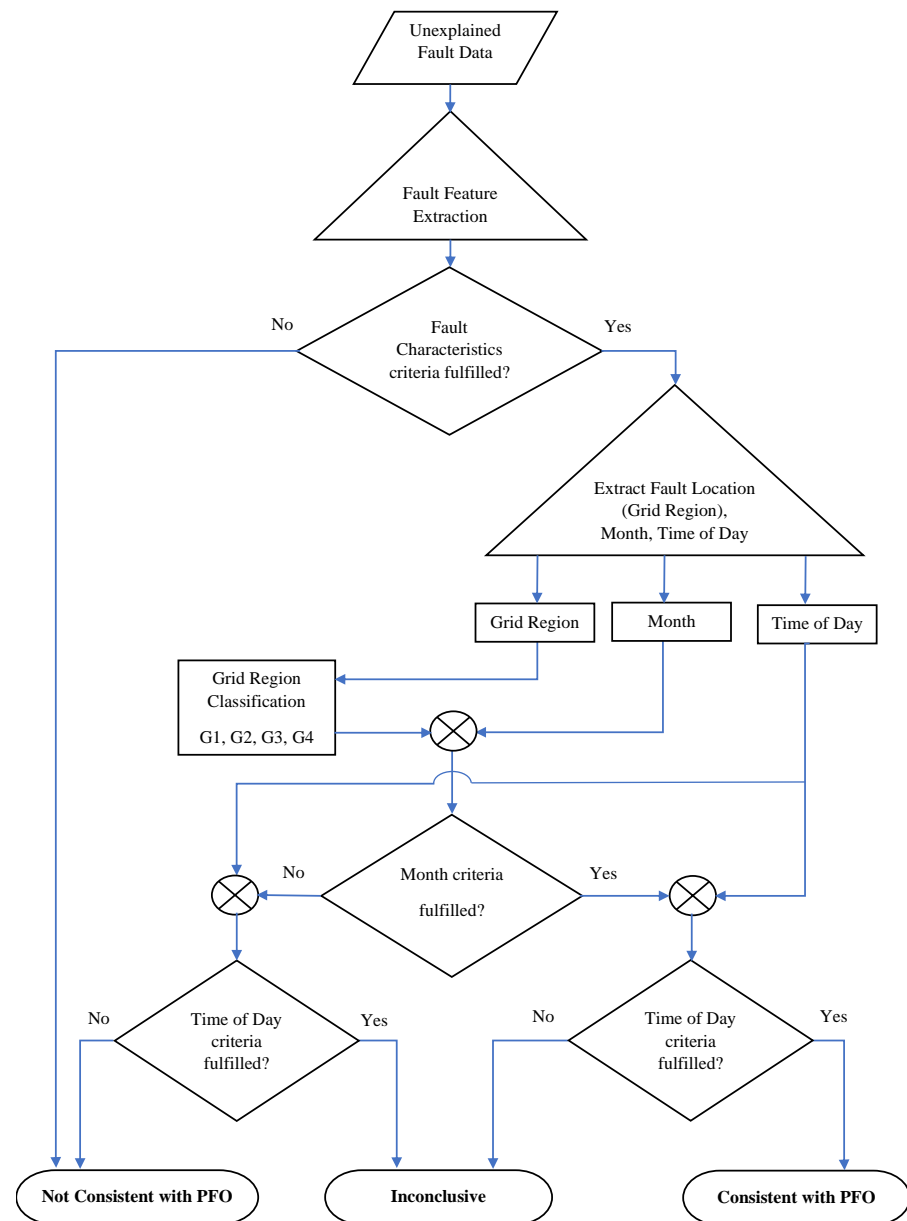
Figure 3. Procedure for application of criteria for identifying pollution flashover-induced faults.

The implementation of these criteria can best be demonstrated through the flowchart depicted in Figure 3. The criteria and the procedure described in the flowchart serve as a general guideline for evaluating the roots of unexplained faults. The first decision block checks whether an unexplained fault fulfils the characteristics criteria outlined in Section 2.1.5. If the unexplained fault does not satisfy this criterion, then this fault is not considered as pollution caused and categorized as “Not Consistent with PFO”. Otherwise, the process continues, and information on the fault location (Grid Region), month, and

In the following steps, after assigning the right grid region group to the fault, it is tested for the month and time-of-the-day criteria. If the conditions are fulfilled, then the fault is categorized as “Consistent with PFO”. If only one of the criteria is fulfilled, then it becomes difficult to assign it as PFO because other possible environmentally induced causes of unexplained fault may also exhibit similar characteristics. So, such cases are “Inconclusive” and need further investigations to assign their possible causes. Moreover, if it fails to fulfill both criteria, then it is not considered as pollution-induced flashover and hence assigned as “Not Consistent with PFO”.

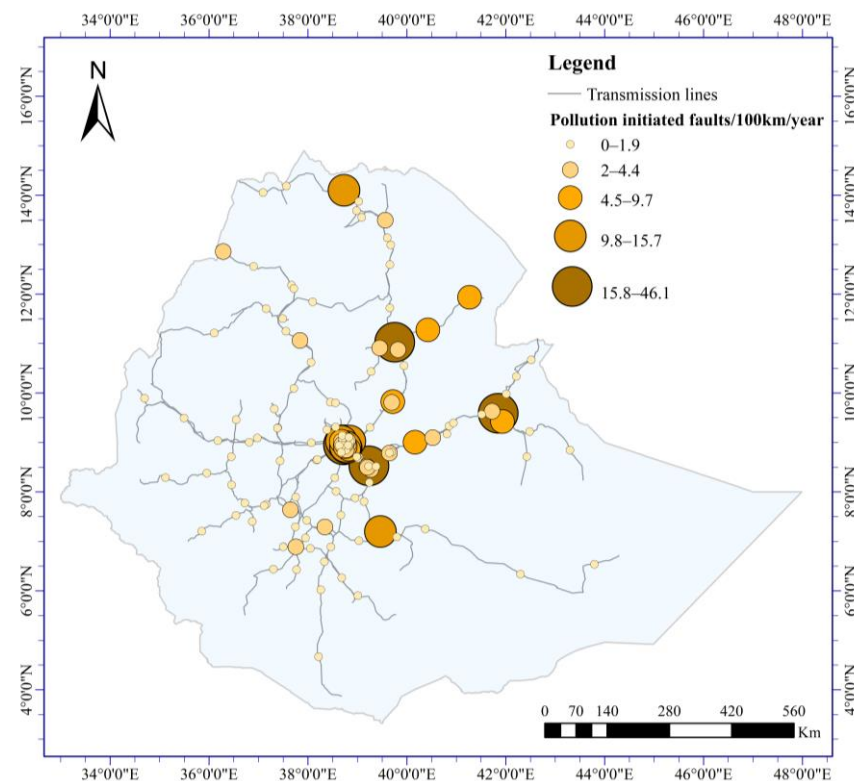
Figure 5. Geographical distribution of pollution induced faults across Ethiopia from 2015–2022.

Pollution flashover faults were found in 152 circuits, with an average of 3.0 faults per 100 km per year. In terms of geographical variations, the majority of these circuits were concentrated in the Northeast, Eastern, and Central part of Ethiopia as shown in Figure 5.
