Fortes Brollo, M., Caputo, F., Naidjonoka, P. et al (2025). Structural changes and cellulose ultrastructure mapped with electron microscopy and SAXS after enzymatic hydrolysis of mildly steam pretreated Norway spruce. *Biotechnology for Biofuels and Bioproducts*, 18(1). <http://dx.doi.org/10.1186/s13068-025-02616-7>

# Structural changes and cellulose ultrastructure mapped with electron microscopy and SAXS after enzymatic hydrolysis of mildly steam pretreated Norway spruce

**Background** The efficient use of softwood in biorefineries requires harsh pretreatment conditions to overcome biomass recalcitrance. While this allows the solubilization of hemicellulose, it also leads to the formation of compounds that act inhibitory against microorganisms during the fermentation step. To improve the efficacy of biomass utilization and identify optimal processing conditions, we evaluated the microstructural alterations occurring during pretreatment and enzymatic hydrolysis in Norway spruce. The biomass was steam pretreated at six different severities defined by two different temperatures (180 °C and 210 °C), with and without the addition of various acids (HAc, H<sub>3</sub>PO<sub>4</sub>, H<

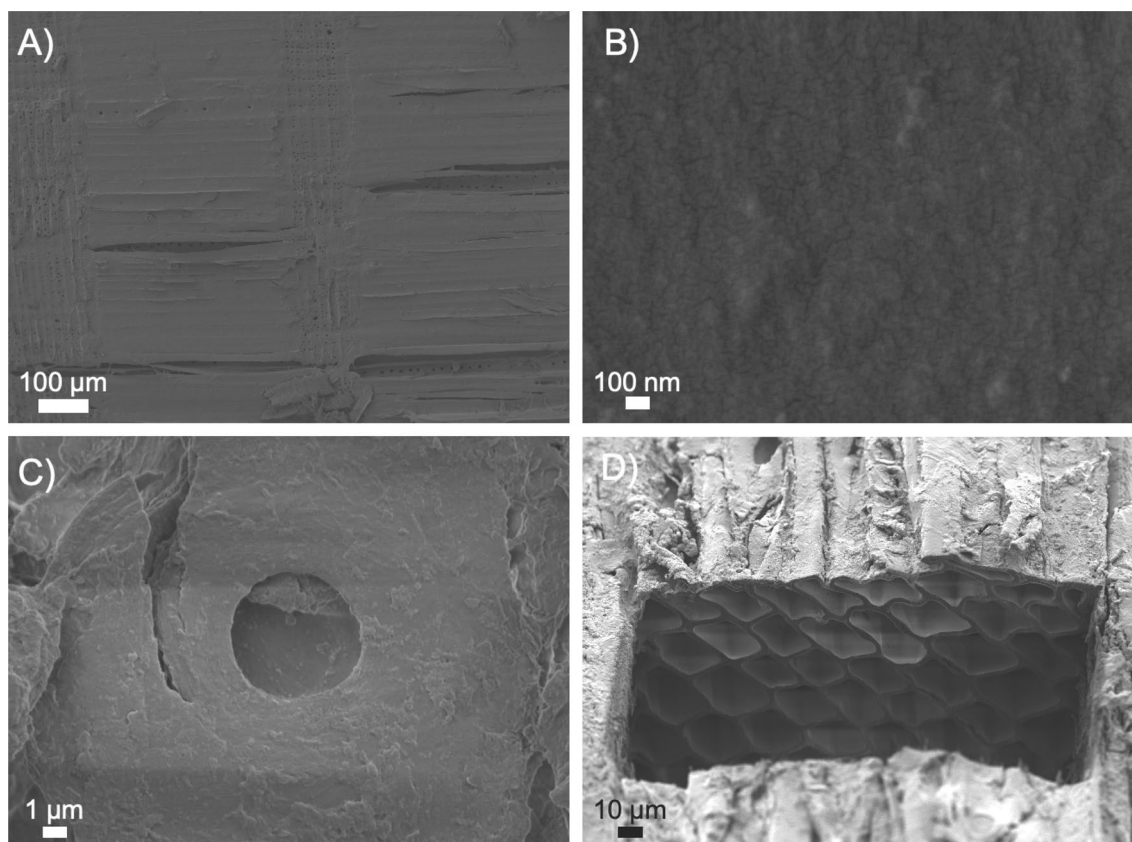
**Fig. 1** SEM images obtained using the secondary electron signal from untreated Norway spruce wood at **A** low magnification (100×) and **B** high magnification (50,000×). **C** Detail of a bordered pit obtained by SEM. **D** Internal tracheid structure revealed in a cross-section obtained by combined SEM–FIB

SEM was used to visually compare the surface and porosity of steam-pretreated spruce with respect to untreated material (Figure 1). At low magnification (100×), a well-defined structure, with visible tracheids (“longitudinal lines”) and ray cells (“perpendicular lines”) was clearly visible (Figure 1A). At a higher magnification (50000×), the surface appeared flat and compact (Figure 1B). The smaller cracks observed on the surface were due to a 5-nm gold coat sputtered during sample preparation. Figure 1C shows an intact and well-rounded bordered pit, whose shape is due to the curving of cellulose microfibrils [36]. Combined SEM–FIB imaging of cross-section cuts revealed the internal organization of tracheids (Figure 1D).

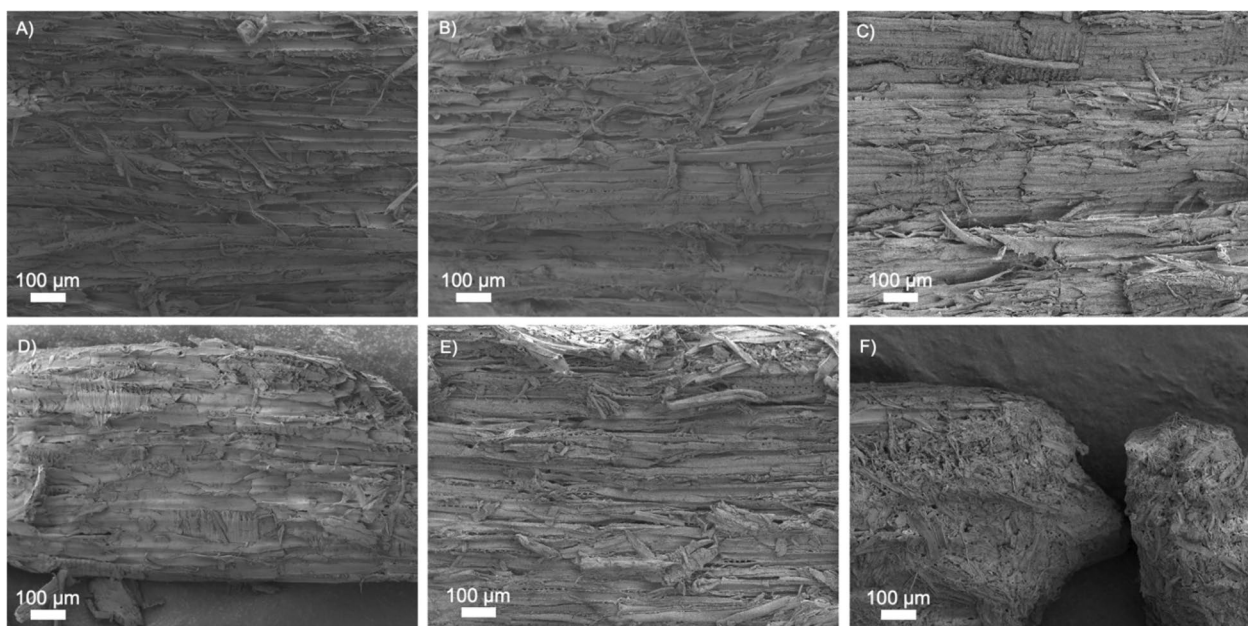
**Fig. 2** SEM images obtained at low magnification (100×) using the secondary electron signal from Norway spruce wood subjected to different pretreatments. **A**  $STEX_{180^{\circ}C/autoclave}$ , **B**  $STEX_{210^{\circ}C/autoclave}$ , **C**  $STEX_{210^{\circ}C/HAc}$ , **D**  $STEX_{210^{\circ}C/H_3PO_4}$ , **E**  $STEX_{210^{\circ}C/H_2SO_4}$ , and **F**  $STEX_{210^{\circ}C/SO_2}$

Low-magnification (100×) SEM images of steam-pretreated materials are presented in Fig. 2. Clear cracks between tracheids can be observed in all substrates, and an increase in surface defibrillation can be noted with increasing severity of pretreatment. No clear difference can be detected between samples *STEX*<sub>180°C/</sub>auto (Fig. 2A)

and  $STEX_{210^{\circ}C/autoclave}$  (Fig. 2B), due to the small difference in severity of the pretreatment (Table S1). In the absence of a catalyst, steam pretreatment relies on the natural release of acetyl groups from galactoglucomannan on hemicellulose (only 1 acetyl group every 3–4 hexose units) [12, 37]. Addition of a catalyst during pretreatment alters profoundly the structure of lignocellulosic biomass.  $STEX_{210^{\circ}C/HAc}$ ,  $STEX_{210^{\circ}C/H_3PO_4}$ , and  $STEX_{210^{\circ}C/H_2SO_4}$  samples displayed a more defibrillated surface, characterized by numerous large cracks (Fig. 2C–E). Such changes are linked to greater hemicellulose solubilization, lignin depolymerization/recondensation, and cellulose microfibrils rearrangement [16]. In the  $STEX_{210^{\circ}C/SO_2}$  sample, which was subjected to a highly severe pretreatment (Table S1), hemicellulose was completely solubilized (Table S2) while the effect on the cellulose and lignin was greater compared to the other catalysed materials [16]. For these reasons the material after the pretreatment has an almost disrupted structure (Fig. 2F).

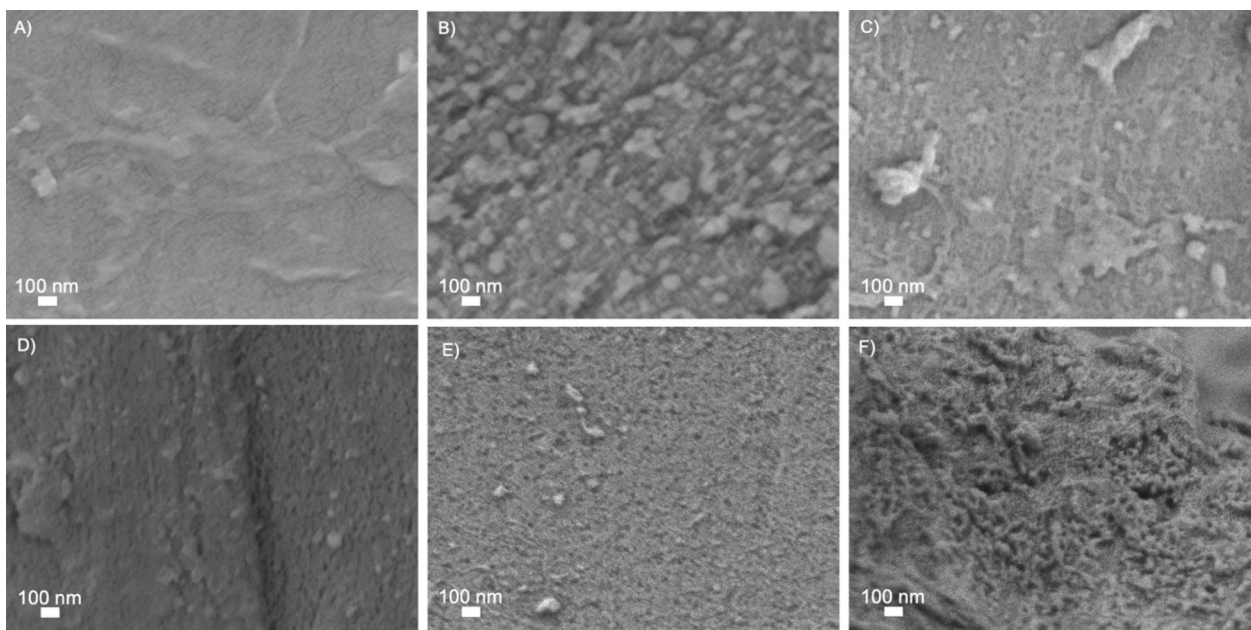
**Fig. 3** SEM images obtained at high magnification (50,000 $\times$ ) using the secondary electron signal from Norway spruce wood subjected to different pretreatments. **A**  $STEX_{180^{\circ}C/autor}$ , **B**  $STEX_{210^{\circ}C/autor}$ , **C**  $STEX_{210^{\circ}C/HAc}$ , **D**  $STEX_{210^{\circ}C/H_3PO_4}$ , **E**  $STEX_{210^{\circ}C/H_2SO_4}$ , and **F**  $STEX_{210^{\circ}C/SO_2}$

High-magnification (50,000×) images of all pretreated materials are presented in Fig. 3. Surface roughness augmented dramatically with increasing severity of pretreatment. Spruce samples subjected to the least severe conditions ( $STEX_{180^{\circ}C/autoclave}$ ) exhibited a compact and flat surface (Fig. 3A). The temperature used during pretreatment (180 °C) is close to the lignin transition glass temperature (140–160 °C) [38], suggesting that lignin likely failed to recondense and form droplets on the surface

In contrast, samples  $STEX_{210^{\circ}C/autoclave}$ ,  $STEX_{210^{\circ}C/HAc}$ ,  $STEX_{210^{\circ}C/H_3PO_4}$ , and  $STEX_{210^{\circ}C/H_2SO_4}$  (Fig. 3B–E) displayed increased surface roughness with increasing severity of pretreatment. A more pronounced roughness, compared to the  $STEX_{180^{\circ}C/autoclave}$ , could be linked to relocation of lignin to the surface, as well as to hemicellulose solubilization. At 210 °C, there is a larger depolymerization/recondensation of lignin on the surface [38]. Also, when an acid catalyst is added during pretreatment, it favours the solubilization of hemicellulose, which no longer acts as a spacer between cellulose microfibrils and leads to their rearrangement [16]. Sample  $STEX_{210^{\circ}C/SO_2}$  (Fig. 3F) exhibited an extremely rough surface compared to all other materials. Boarded pits (Figure S1) were also imaged after pretreatment. In line with previous literature [8], the presence of cracks was observed in the pits of materials subjected to pretreatment with a catalyst.

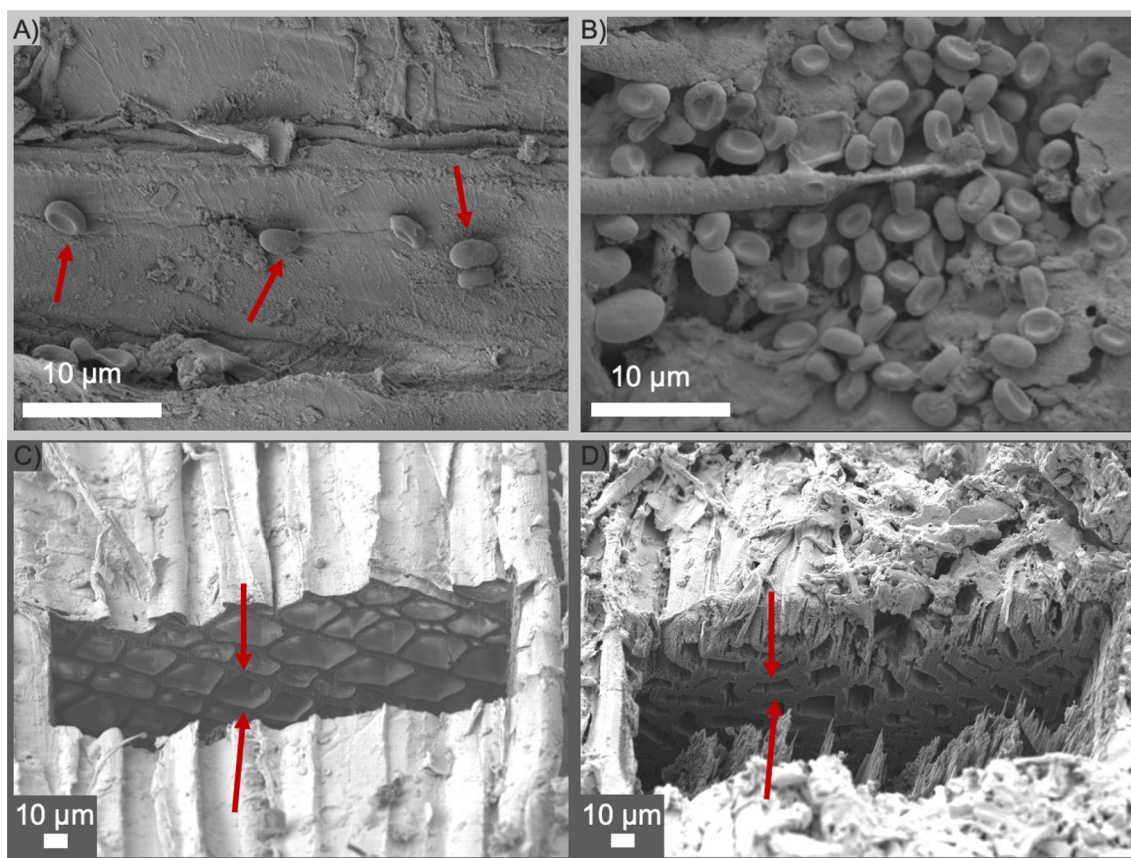
**Fig. 4** SEM images obtained using the secondary electron signal from Norway spruce wood subjected to different pretreatments. Lignin droplets are clearly visible (red arrows) on the surface of **A**  $STEX_{210^{\circ}C/aut0}$  and **B**  $STEX_{210^{\circ}C/SO_2}$  samples. Low-magnification SEM images obtained using the secondary electron signal of FIB cross-sections reveal the internal structure of tracheids in **C**  $STEX_{210^{\circ}C/aut0}$  and **D**  $STEX_{210^{\circ}C/SO_2}$  samples. The collapsed cell walls of tracheids are highlighted with red arrows

SEM images of the surface were obtained to gain a deeper knowledge of the presence of the lignin droplets on the surface (Fig. 4A, B) while SEM–FIB imaging of cross-section cuts revealed the internal organization of tracheids (Fig. 4C, D). Lignin droplets were detected on the surface of both  $STEX_{210^{\circ}C/autoclave}$  (Fig. 4A) and  $STEX_{210^{\circ}C/SO_2}$  (Fig. 4B) samples, although they were more numerous and larger in the latter. These two samples were chosen because they represent two extremes of pretreatment conditions that were used in the present work. As

mentioned before, depolymerization and recondensation of lignin on the surface is linked to both the transition glass temperature and to the catalyst used during pretreatment. As severity of the latter increases, the frequency of lignin droplets augments [14, 15]. A comparison between the cross-sections of  $STEX_{210^{\circ}C/autor}$  (Fig. 4C) and  $STEX_{210^{\circ}C/SO_2}$  (Fig. 4D) samples revealed a more collapsed structure in the latter (highlighted by red arrows); whereas the internal structure of the former was very similar to untreated material (Fig. 1D). Overall, SEM and FIB images show a strong agreement between the internal and superficial features of steam-pretreated samples (Figs. 2, 3, 4). This can be explained by complete solubilization of hemicellulose and larger effect on the lignin in the  $STEX_{210^{\circ}C/SO_2}$  sample, which leads to the collapse of tracheid cell walls.

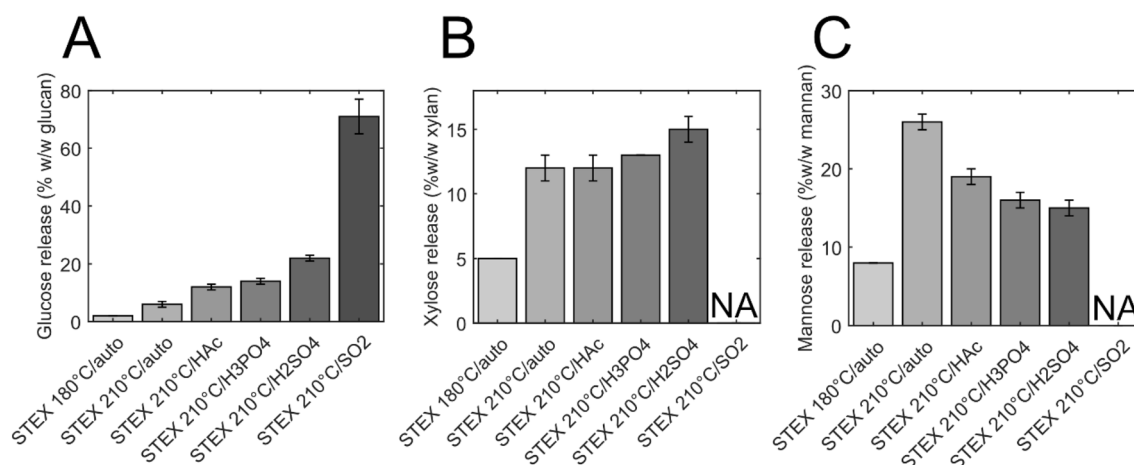
**Fig. 5** Enzymatic hydrolysis of steam-pretreated spruce. Release of **A** glucose, **B** xylose, and **C** mannose after 48 h of hydrolysis with Celluclast® 1.5 L, Novozym® 188, and Ultraflo®. The grey scale used in the bar plots denotes the corresponding increase in the severity of pretreatment. Data represent the mean ± standard deviation of triplicate measurements

To investigate the action of enzymes on the structure of various steam-pretreated spruce materials, enzyme-catalysed sugar release was assessed. Previously, enzymatic hydrolysis of steam-pretreated softwood using Celluclast<sup>®</sup> 1.5 L and Novozym<sup>®</sup> 188 resulted in low amount of sugars being released from hemicellulose [16]. Therefore, in the present work, these two commercial cocktails were supplemented with Ultraflo<sup>®</sup> to improve hemicellulose hydrolysis and evaluate the ensuing structural changes. Glucose was released from both cellulose and galactoglucomannan (Fig. 5). The release of glucose increased from

2% w/w DM in the  $STEX_{180^{\circ}C/autor}$  sample to 22% w/w DM in  $STEX_{210^{\circ}C/H_2SO_4}$  and 71% w/w DM in  $STEX_{210^{\circ}C/SO_2}$  (Fig. 5A). Xylose, which was released from the arabinoglucuronoxylan backbone on hemicellulose, reached 15% w/w DM in the  $STEX_{210^{\circ}C/H_2SO_4}$  sample (Fig. 5B); whereas mannose released from the galactoglucomannan backbone (26% w/w DM) was maximal in the  $STEX_{210^{\circ}C/autor}$  sample (Fig. 5C). Residual hemicellulose after catalyst-mediated pretreatment is harder to hydrolyse compared to that in autocatalysed materials [16]. Here, supplementation with Ultraflo<sup>®</sup> favoured the release of xylose and particularly mannose.

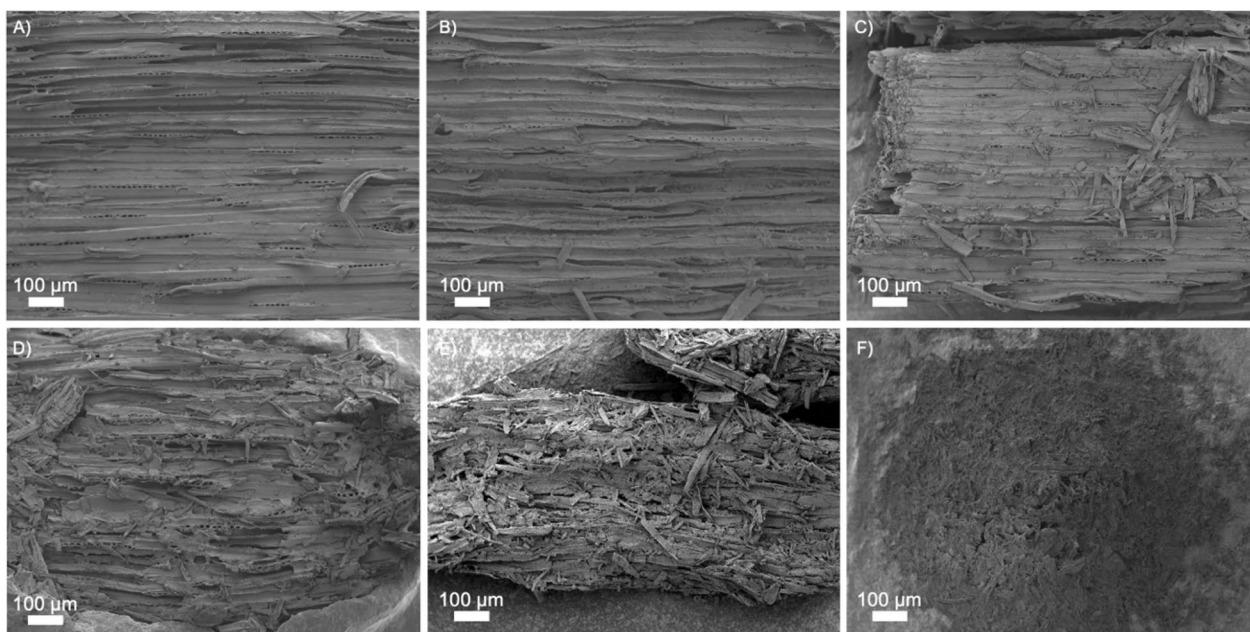
**Fig. 6** SEM images obtained at low magnification (100×) using the secondary electron signal from Norway spruce wood subjected to different pretreatments and subsequent enzymatic hydrolysis. **A**  $STEX_{180^{\circ}C/autor}$  **B**  $STEX_{210^{\circ}C/autor}$  **C**  $STEX_{210^{\circ}C/HAc}$  **D**  $STEX_{210^{\circ}C/H3PO4}$  **E**  $STEX_{210^{\circ}C/H2SO4}$  and **F**  $STEX_{210^{\circ}C/SO2}$

The impact of enzymatic hydrolysis on the surface of steam-pretreated spruce was assessed by SEM and is summarized in Fig. 6 (100 $\times$  magnification). A qualitative comparison between low-magnification (100 $\times$ ) SEM images reporting changes caused by enzymatic hydrolysis (Fig. 6) and surface changes after pretreatment (Fig. 2) shows that enzymatic hydrolysis had different effects depending on pretreatment severity. In the absence of catalyst ( $STEX_{180^{\circ}C/autor}$  and  $STEX_{210^{\circ}C/autor}$ ) all fibres present on the surface after pretreatment were successfully degraded by the enzymes (Fig. 6A, B). In the presence of a catalyst ( $STEX_{210^{\circ}C/HAc}$ ,  $STEX_{210^{\circ}C/H_3PO_4}$ , and  $STEX_{210^{\circ}C/H_2SO_4}$ ) enzymatic degradation was more pronounced showing a more

disrupted surface than the two autocatalysed materials (Fig. 6C–E). Severe pretreatment conditions facilitated enzyme access to the binding sites and caused

greater structural disruption. Indeed, in the  $STEX_{210^{\circ}C/SO2}$  sample, the structure was not visible anymore as it was entirely degraded (Fig. 6F). Therefore, the observed

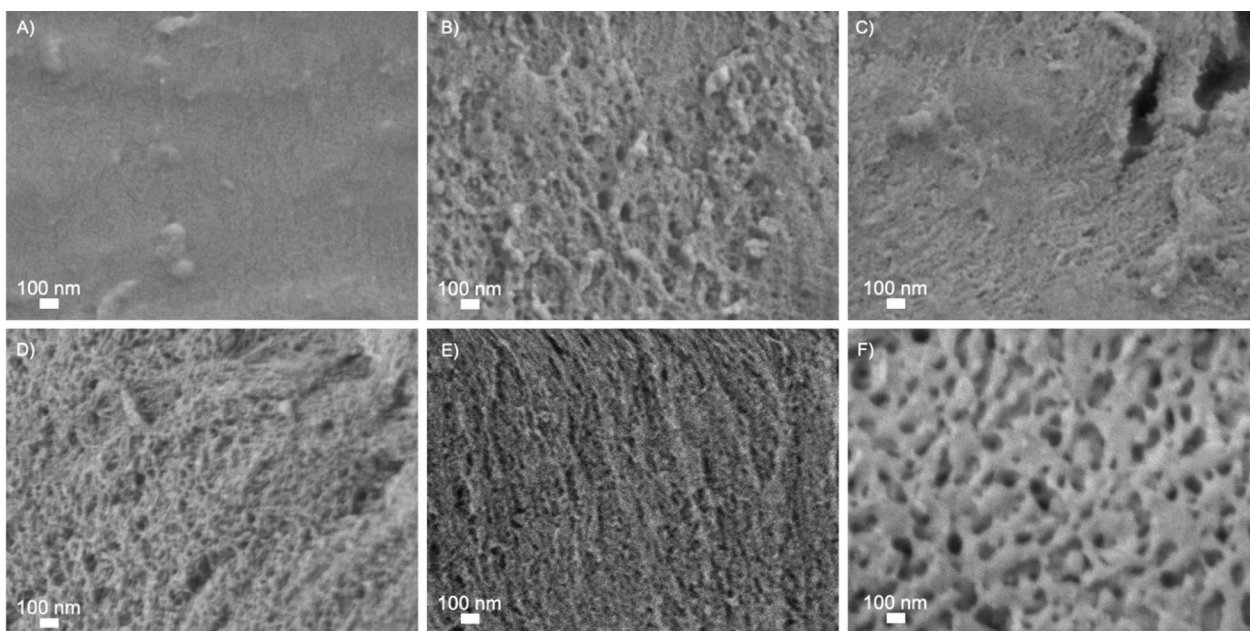
**Fig. 7** SEM images obtained at high magnification (50,000×) using the secondary electron signal from Norway spruce wood subjected to different pretreatments and subsequent enzymatic hydrolysis. **A**  $STEX_{180^{\circ}C/autor}$  **B**  $STEX_{210^{\circ}C/autor}$  **C**  $STEX_{210^{\circ}C/HAc}$  **D**  $STEX_{210^{\circ}C/H3PO4}$  **E**  $STEX_{210^{\circ}C/H2SO4}$  and **F**  $STEX_{210^{\circ}C/SO2}$

A qualitative comparison between high-magnification (50,000×) SEM images reporting changes caused by enzymatic hydrolysis (Fig. 7) and surface changes elicited by pretreatment (Fig. 3) revealed that the enzymes' primary impact was to increase roughness and create/enlarge pores. Again, the effect of the enzymes varied depending on the severity of pretreatment. For lowest severely pretreated samples (*STEX*<sub>180°C/aut</sub>), the surface looked very similar after saccharification (Fig. 7A) as following pretreatment only (Fig. 3A). Accordingly, the enzymes accessed and degraded only the fibres sticking out from the surface. This hypothesis is in line with the low yield of sugars released from the *STEX*<sub>180°C/aut</sub> sample after enzymatic hydrolysis (Fig. 5). Hemicellulose and lignin are not significantly affected by pretreatments conditions used for the *STEX*<sub>180°C/aut</sub> sample and, as a result, the enzymes' accessibility to the material is diminished [16]. The *STEX*<sub>210°C/SO<sub>2</sub></sub> sample represents the other extreme, whereby hemicellulose is fully solubilized following pretreatment. Compared to the surface of pretreated sample (Fig. 3F), enzymatic hydrolysis of the *STEX*<sub>210°C/SO<sub>2</sub></sub> substrate resulted in a very rough surface with enlarged pores (Fig. 7F). The *STEX*<sub>210°C/SO<sub>2</sub></sub> is more accessible to enzymes and easier to degrade, as confirmed also by high glucose release (Fig. 5). Therefore, increased pretreatment severity induces substantial structural changes that improve enzyme accessibility and, consequently, sugar release.

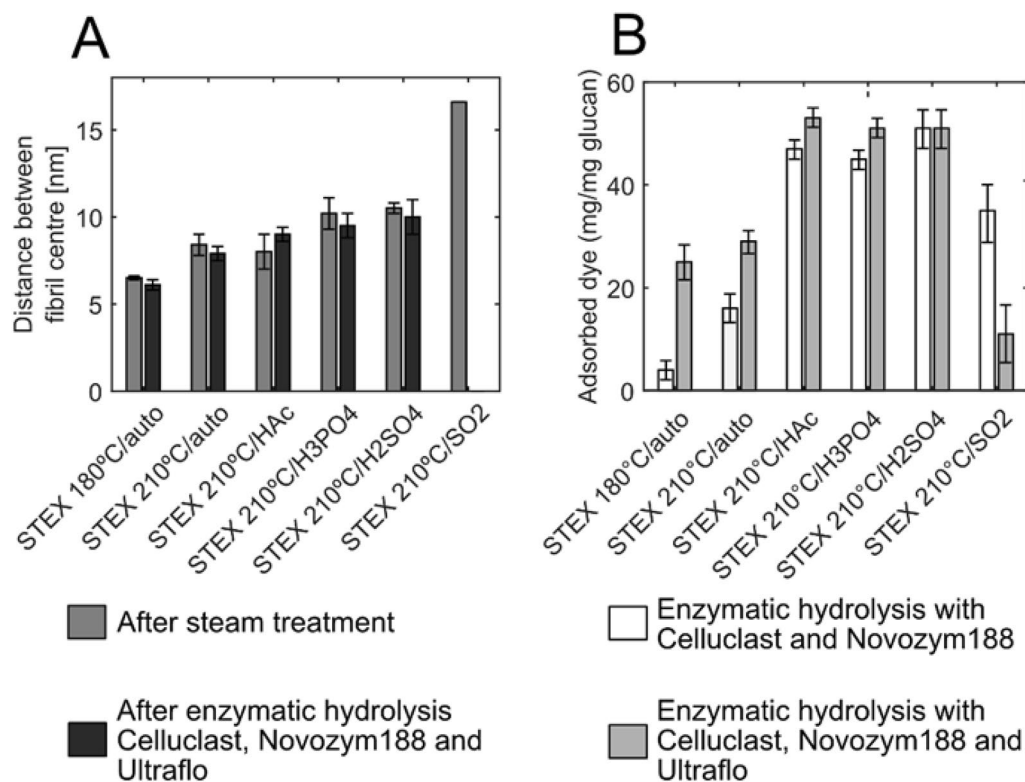
**Fig. 9** Cellulose ultrastructure evaluation before and after enzymatic hydrolysis with or without Ultraflo<sup>®</sup> supplementation. **A** The distance between cellulose fibril centres in the different steam-pretreated materials before (light grey bars) and after (dark grey bars) enzymatic hydrolysis with Celluclast<sup>®</sup> 1.5 L, Novozym<sup>®</sup> 188, and Ultraflo<sup>®</sup> was assessed using SAXS. Values are presented as average with standard deviation of three measurements, and were obtained from the Gaussian fits extracted from Kratky plots. **B** Adsorbed Congo red in the different steam-pretreated materials after enzymatic hydrolysis with (dark grey bars) or without (light grey bars) Ultraflo<sup>®</sup>. Values are presented as average of duplicates and the average of the absolute deviations from the mean
